TREASURE ROAD MITIGATION SITE

2016 Annual Monitoring Report

(14 October 2016)

USACE Permit No.: SAJ-2012-02348 (SP-AWP), issued 3/11/2013

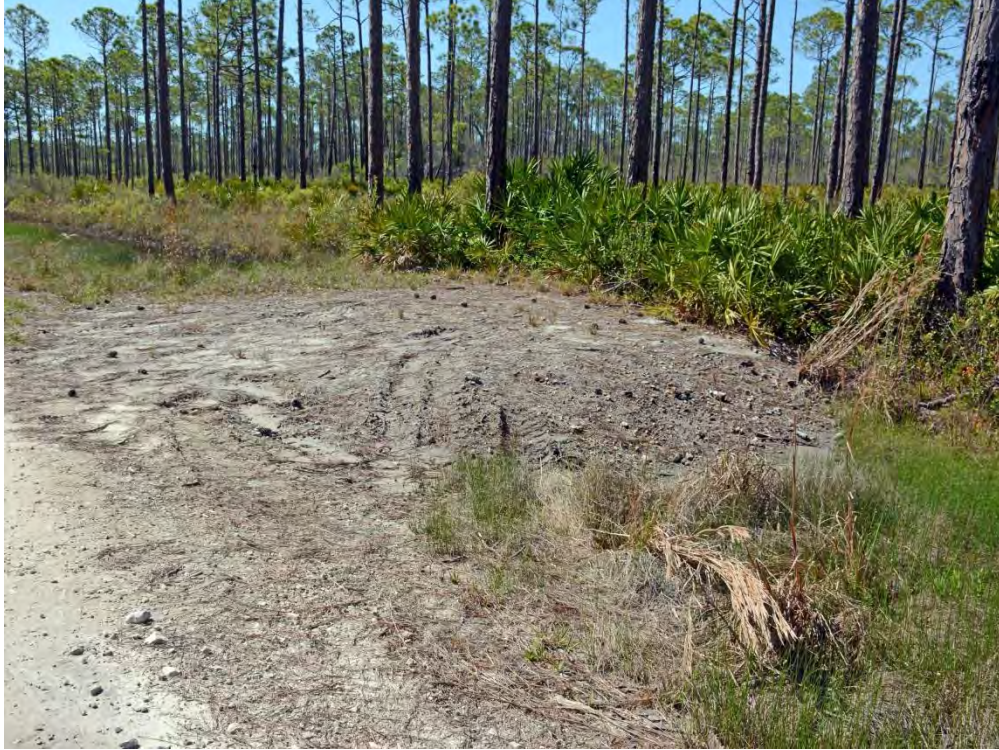
Typical Ditch Plug with Adjacent Hydric Pine Flatwoods in Background (4/19/2016)

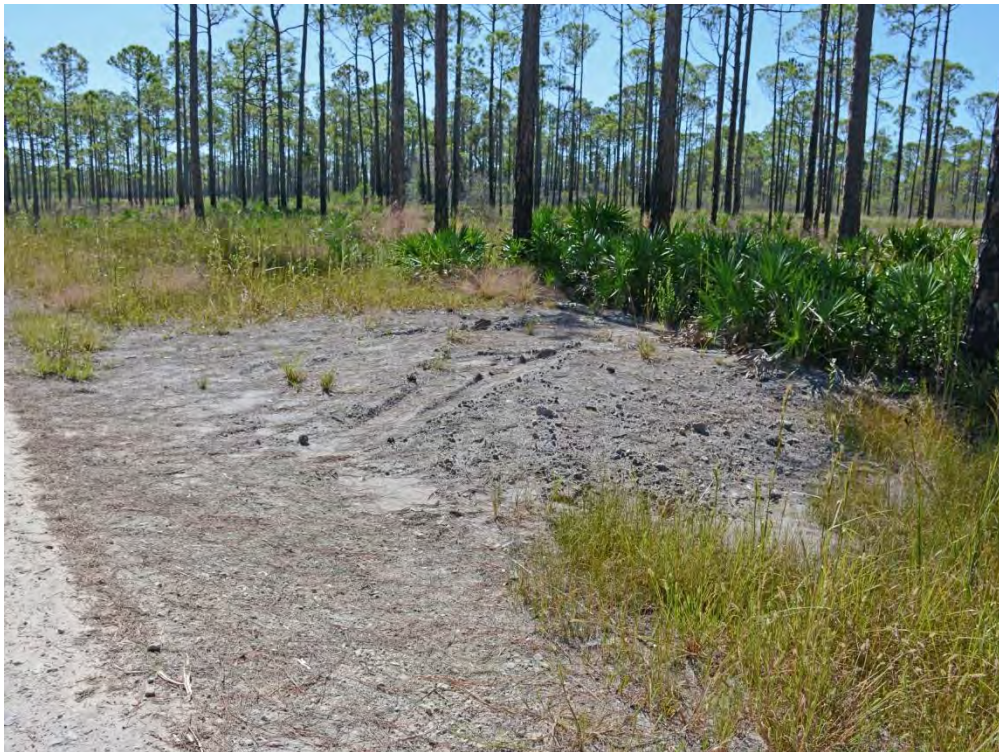
Typical Ditch Plug with Adjacent Hydric Pine Flatwoods in Background (10/13/2016)
