## TREASURE ROAD MITIGATION SITE

2017 Annual Monitoring Report

(27 October 2017)

Date of Inspection: 10/26/2017

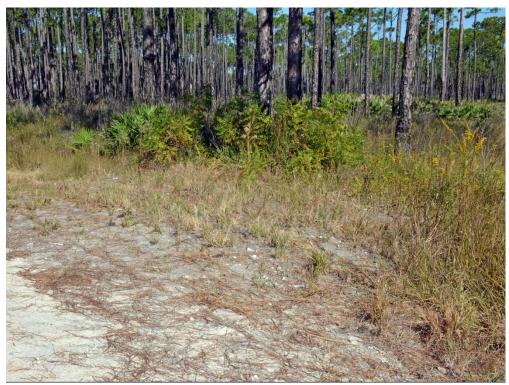
Typical Ditch Plug with Adjacent Hydric Pine Flatwoods in Background (10/26/2017)

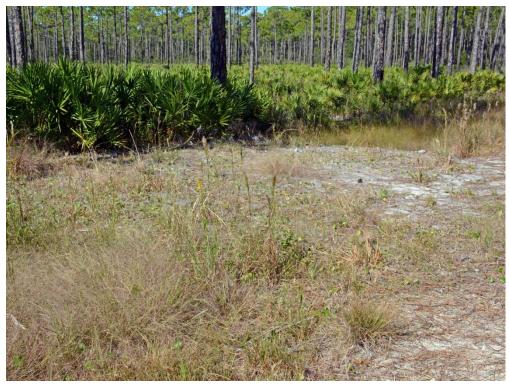
Typical Ditch Plug with Adjacent Hydric Pine Flatwoods in Background (10/26/2017)
