TREASURE ROAD MITIGATION SITE

2018 Final Monitoring Report

USACE Permit No.: SAJ-2012-02348 (SP-AWP), issued 3/11/2013

Date of Inspection: 11/5/2018

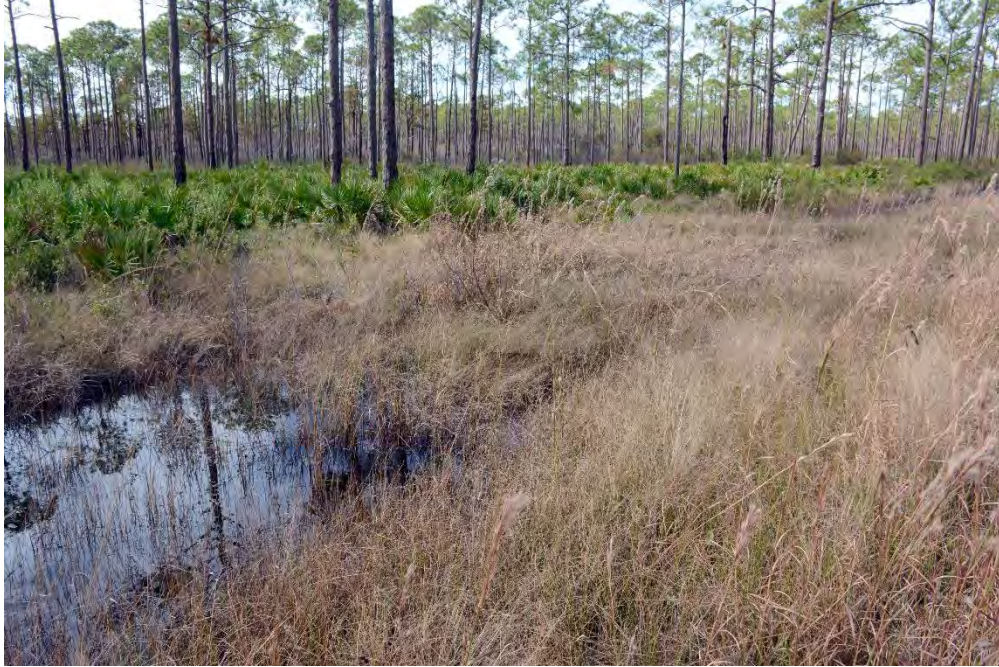
Typical Ditch Plug with Adjacent Hydric Pine Flatwoods in Background (11/5/2018)

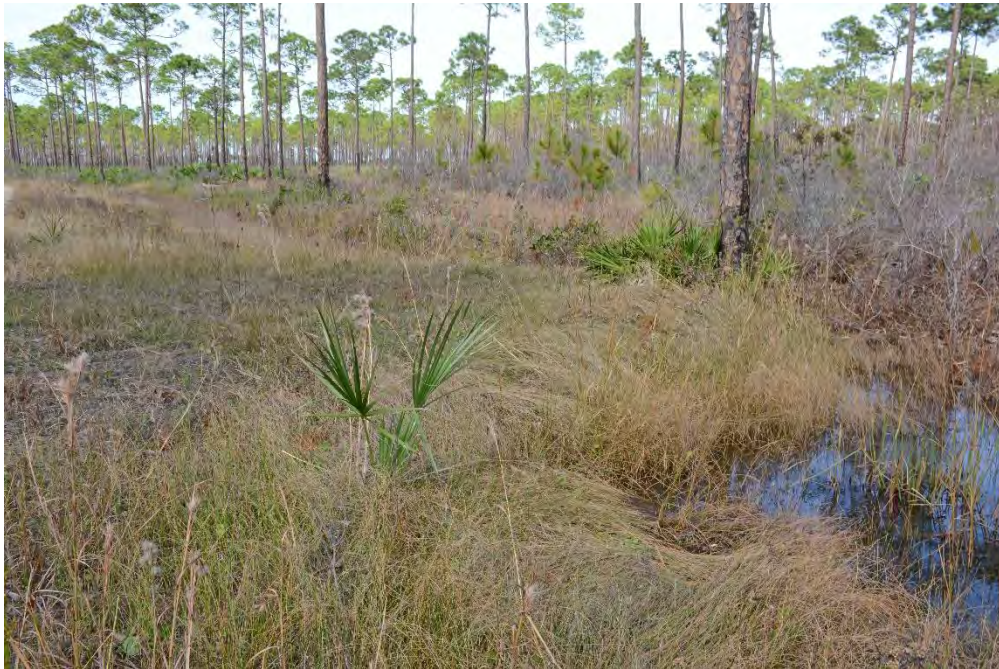
Typical Ditch Plug with Adjacent Hydric Pine Flatwoods in Background (11/5/2018)
