CAT POINT MITIGATION SITE
Annual Monitoring Report, Year 5 of 5
January 11, 2012

Impact: SR 300 St. George Island Bridge, Franklin County
USACE Permit No.: SAJ-2003-05450 NW-JWS, issued 6/6/2003
Mitigation: Cat Point, Franklin County
Permittee/Consultant: Northwest Florida Water Management District (NFWFMD)
Responsible Party for Monitoring: NFWFMD
81 Water Management Dr.
Havana, FL 32333
Date of Inspection: November 9, 2011
Inspectors: Leigh Brooks, Graham Lewis

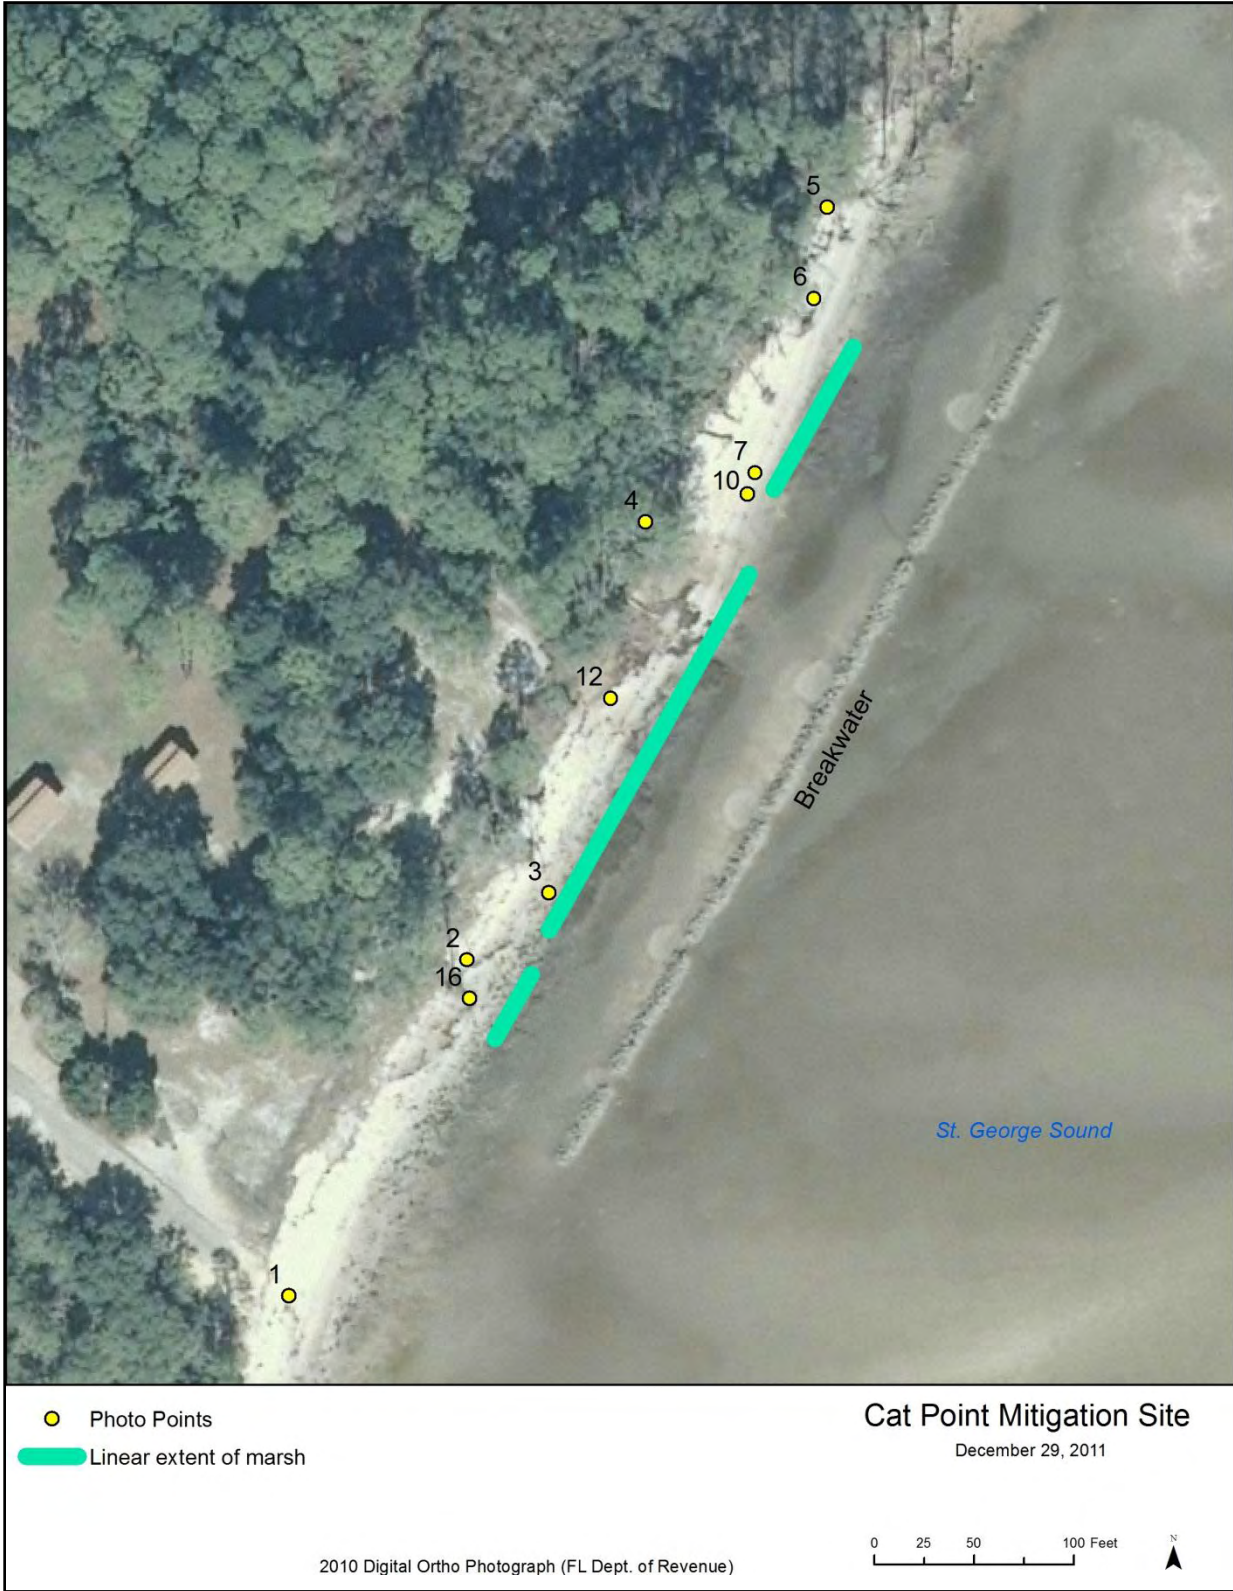
Figure 4. Aerial photograph of mitigation site with location of photographic points indicated. At the time of inspection the marsh (indicated in bluegreen) had expanded to cover nearly the entire length of the breakwater.

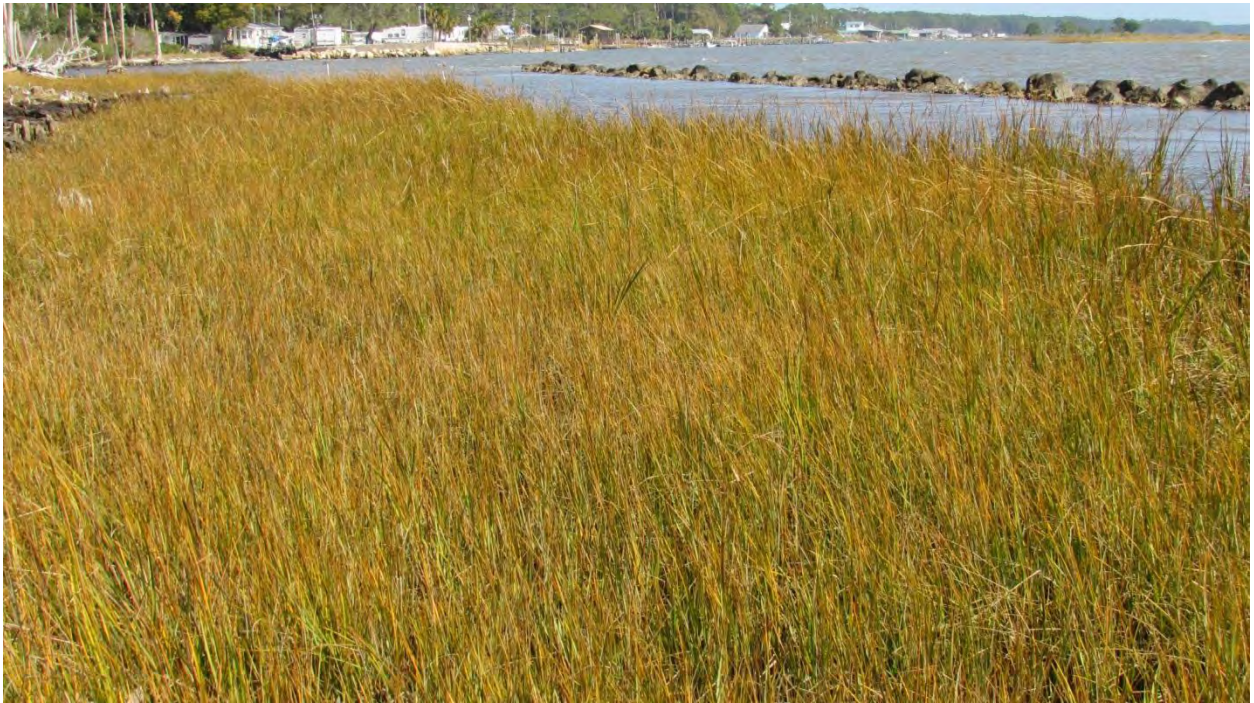
The salt marsh restoration area exhibited 64% overall cover (GIS calculation) of *Spartina alterniflora* in three dense patches along the shoreline ([Figures 4](#) and [5](#), [Photo 1](#)). There appeared to be very good survival of planted *Spartina alterniflora* as well as natural recruitment through both sexual and vegetative reproduction that is filling in the lower shoreline. Species planted or naturally recruited on the upper beach comprised approximately 60-70% overall cover ([Photos 2-4](#)). The *Spartina patens* planting from January 2010 shows over 80% survival and also exhibits both vegetative and sexual reproduction. Most of the other native beach species that were planted at the site in 2007 are still present; however these species are not present in large numbers indicating limited survival, probably due to past hurricane/storm events. Many of the planted and naturalized plant species were in fruit or flower at the time of the survey, indicating a trend toward greater species cover and an increase in the desired species composition. No nuisance or invasive exotic species were seen within the restoration area.

Photo 1. Created marsh of *Spartina alterniflora* ; spreading vegetatively. Photo point 3, looking northeast. 11/09/2011. [RTN](#)

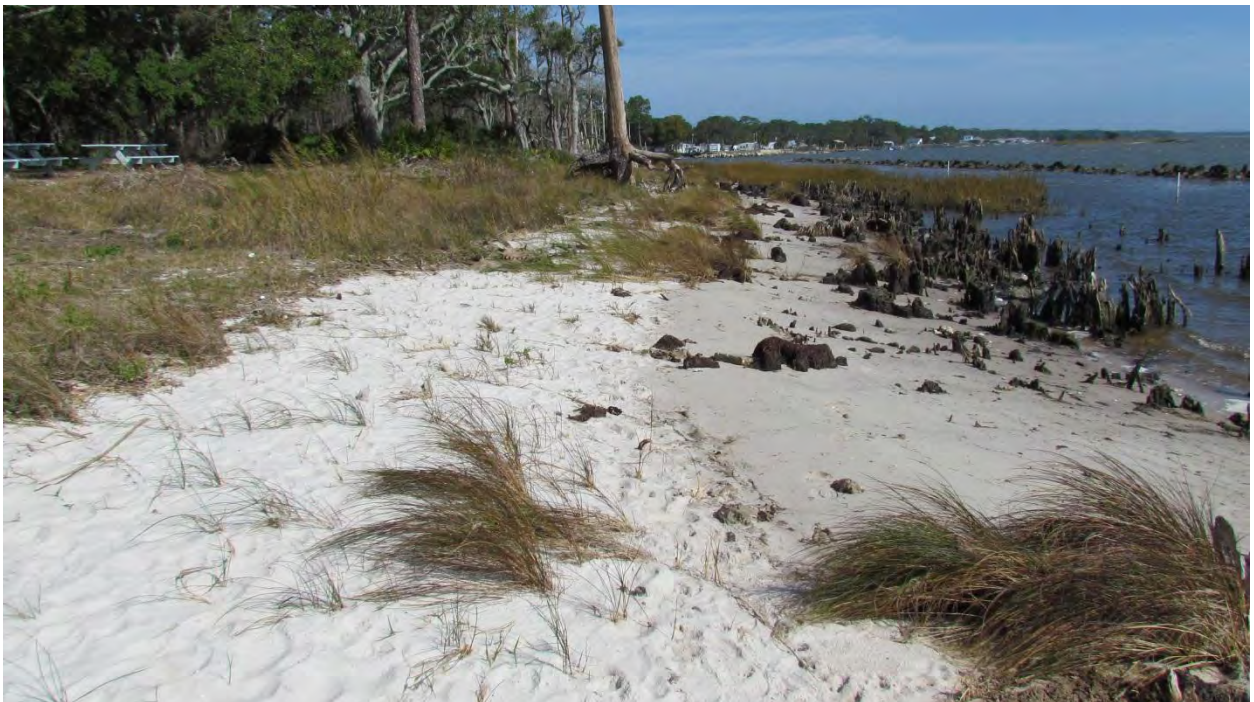
Photo 2. Upland buffer with marsh in background. Photo point 1, looking northeast. 11/09/2011. [RTN](#)

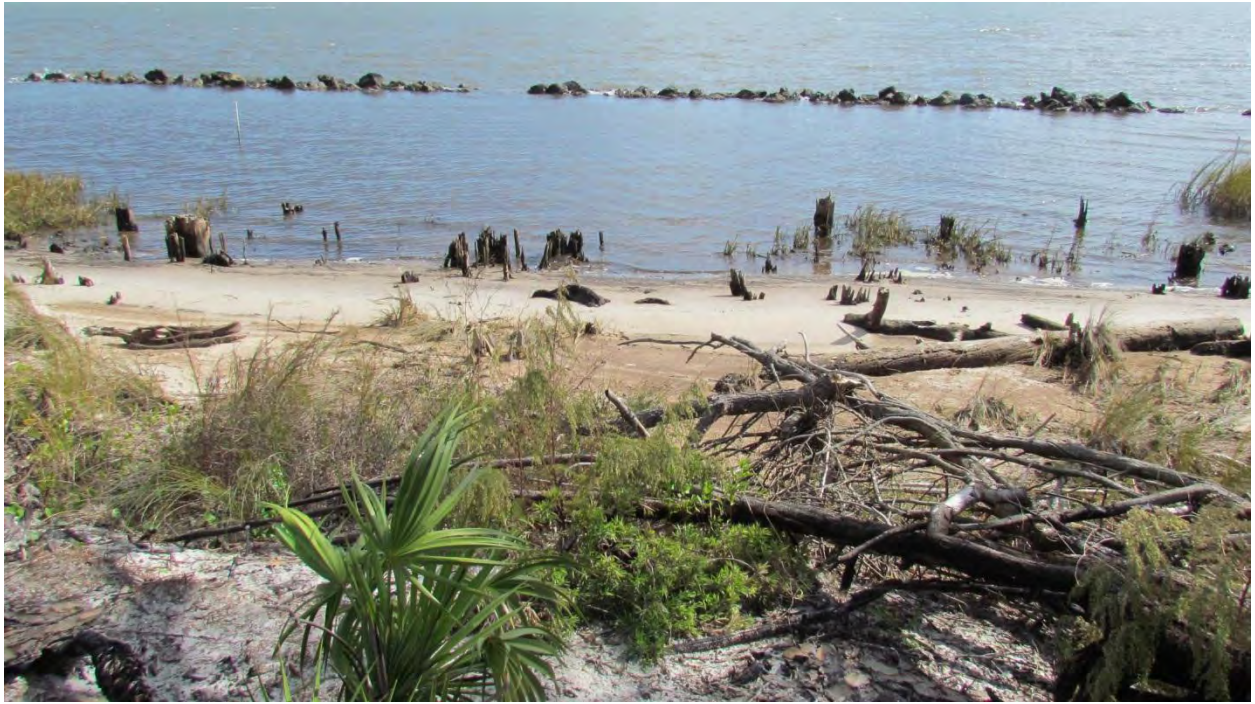
Photo 3. Scattered portions of marsh growing together. Photo point 4, looking east. 11/09/2011. [RTN](#)

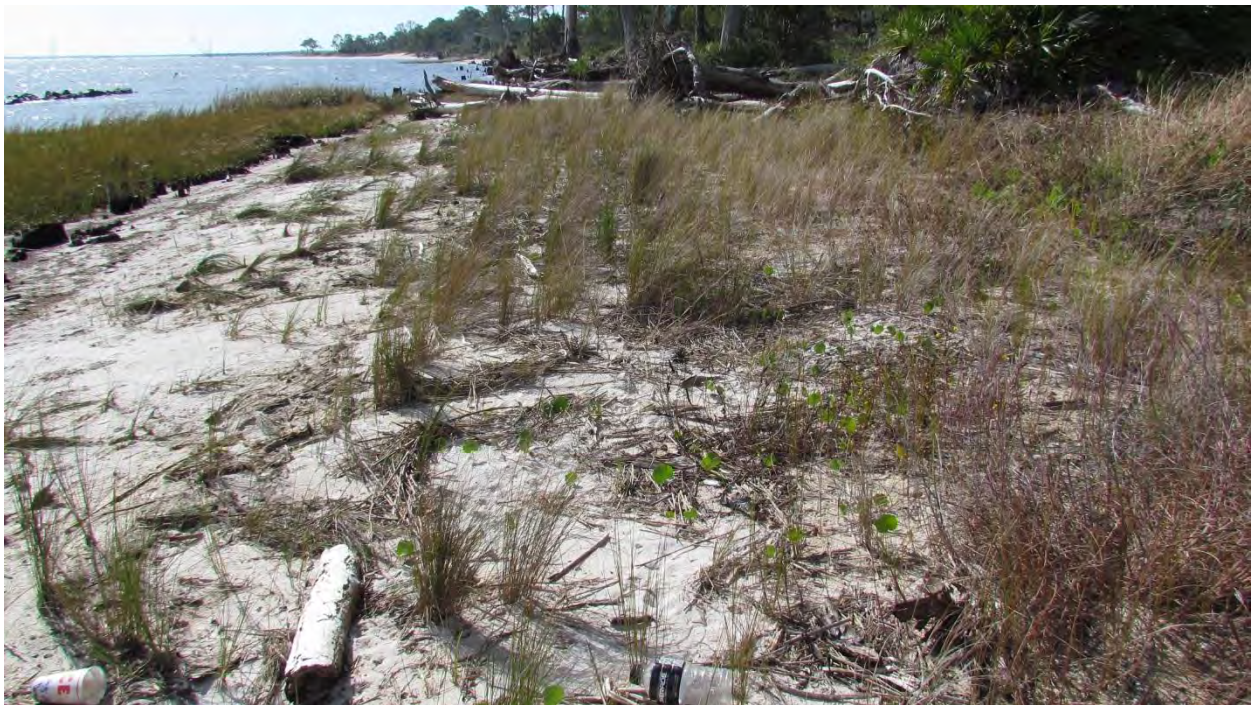
Photo 4. Natural recruitment of upland plants in buffer. Photo point 10, looking southwest. 11/09/2011. [RTN](#)

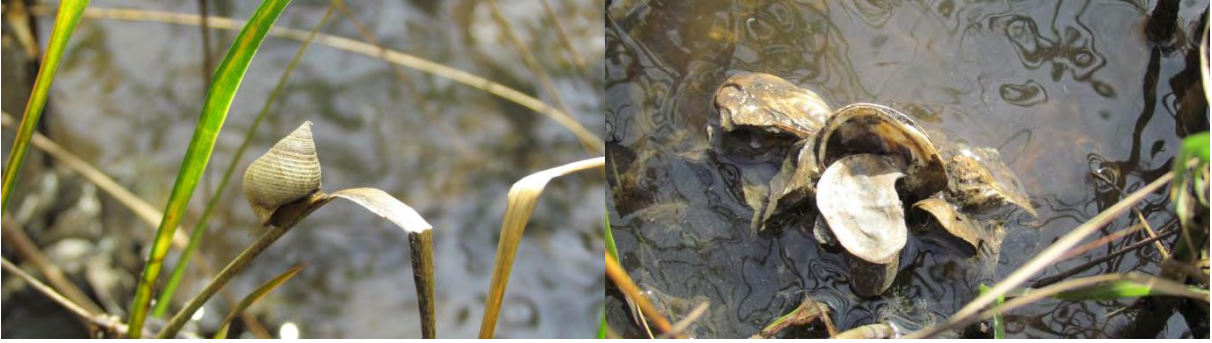
(*Hydrocotyle* sp.), St. John's wort, smooth cordgrass, and perennial saltmarsh aster. Animal species observed included marsh periwinkle (*Littorina irrorata*) (Photo 5), moon snail (*Polinices duplicatus*), Eastern oyster (*Crassostrea virginica*) (Photo 5), fiddler crab (*Uca* sp.), hermit crab (*Pagurus* sp. and *Clibanarius vitatus*), monarch butterfly (*Danaus plexippus*), and Gulf fritillary (*Agraulis vanillae*). Tracks of raccoon (*Procyon lotor*) were seen.

Photo 5. Marsh periwinkle (*Littorina irrorata*) and Eastern oyster (*Crassostrea virginica*) were common in the created *Spartina alterniflora* marsh. 11/09/2011. [RTN](#)
