Northwest Florida Water Management District

Re: Progress Report 8

Please accept this submittal as the **semi-annual progress report** for the SHLMB.

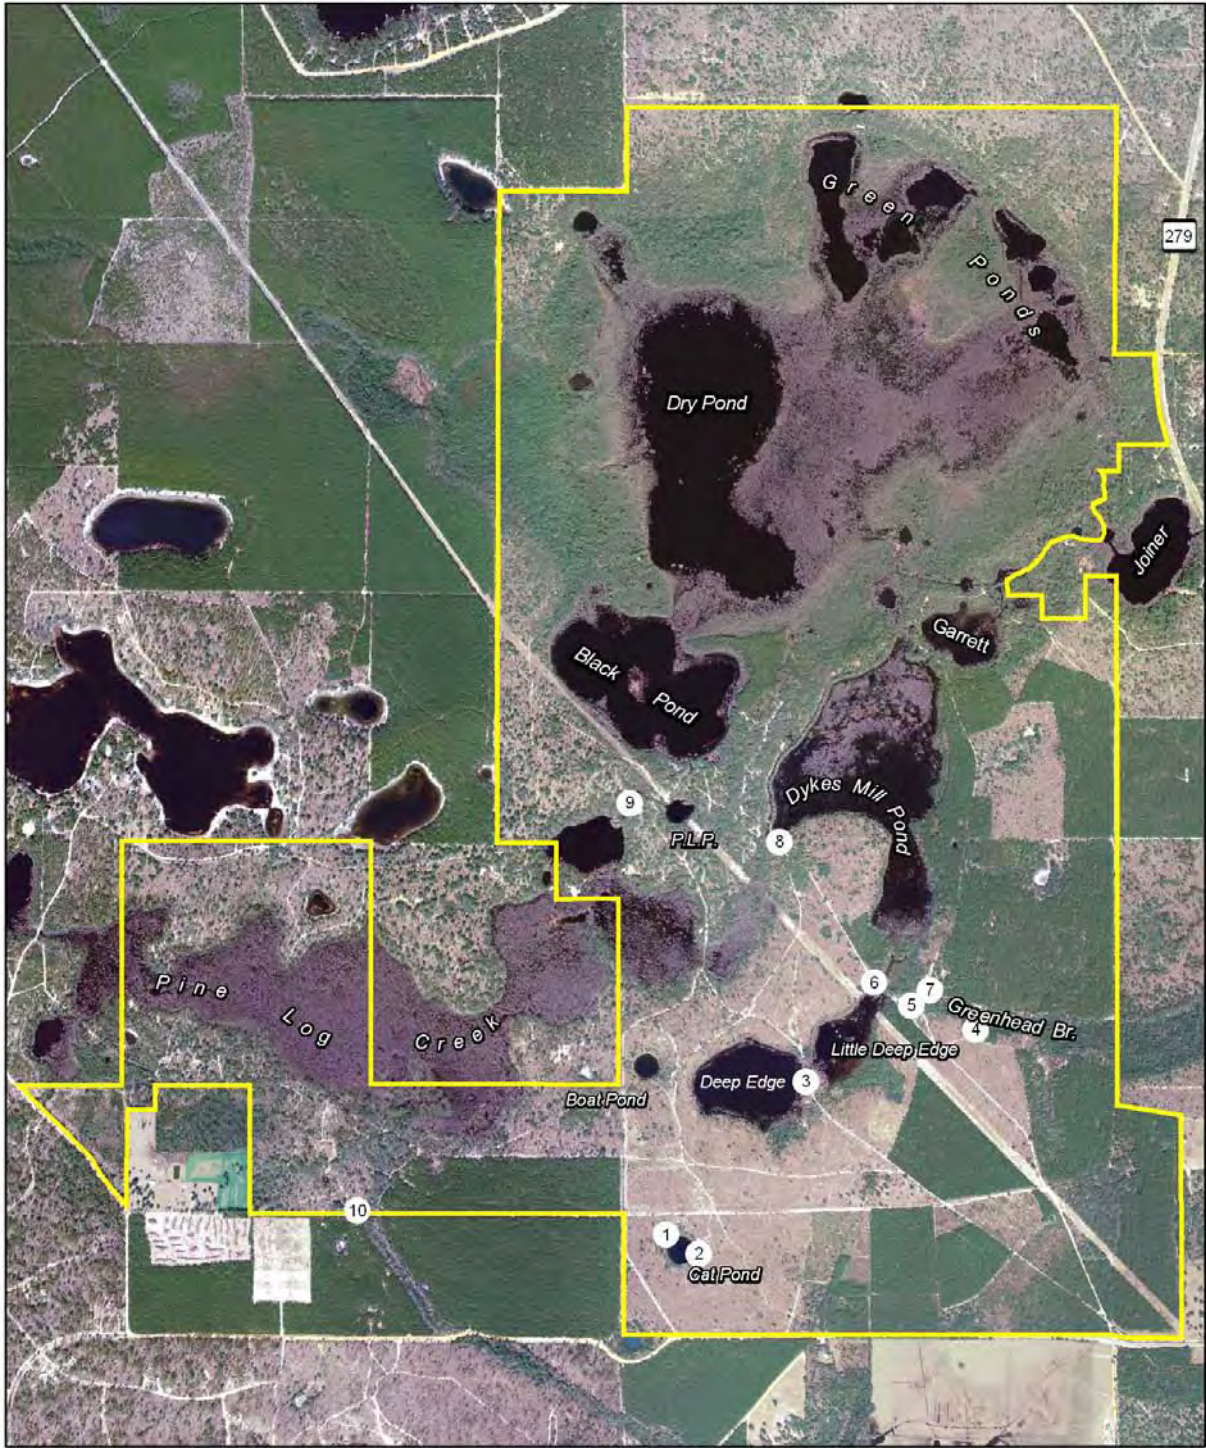
Figure 4 - Erosion Stabilization Sites

3. Due to inappropriate mulch used by the contractor, Bahia grass was observed within the erosion stabilization areas #1, #2, #3 and #10 in 2007. These areas were treated with herbicide by the contractor twice in 2007, until no living plant was observed. These areas were inspected in March and April of 2008 and small coverage of Bahia grass had re-sprouted. BRA has been contracted to treat the Bahia grass in June and August of 2008 (Figure 4).

8. Due to poor survival, wire grass, cypress and long leaf pine tublings were re-planted in erosion stabilization areas #1, #2, #3 and #10 in early spring 2008 in accordance with the planting plan. Follow up site inspection indicates excellent survival of the re-planted material (Figure 4).

3. Gyrotrack work will continue for an additional 38 acres adjacent to the Western portion of Dry Pond (Figure 14).
4. Erosion areas identified with Bahia grass cover (Figure 4) will be treated several times until eradicated.

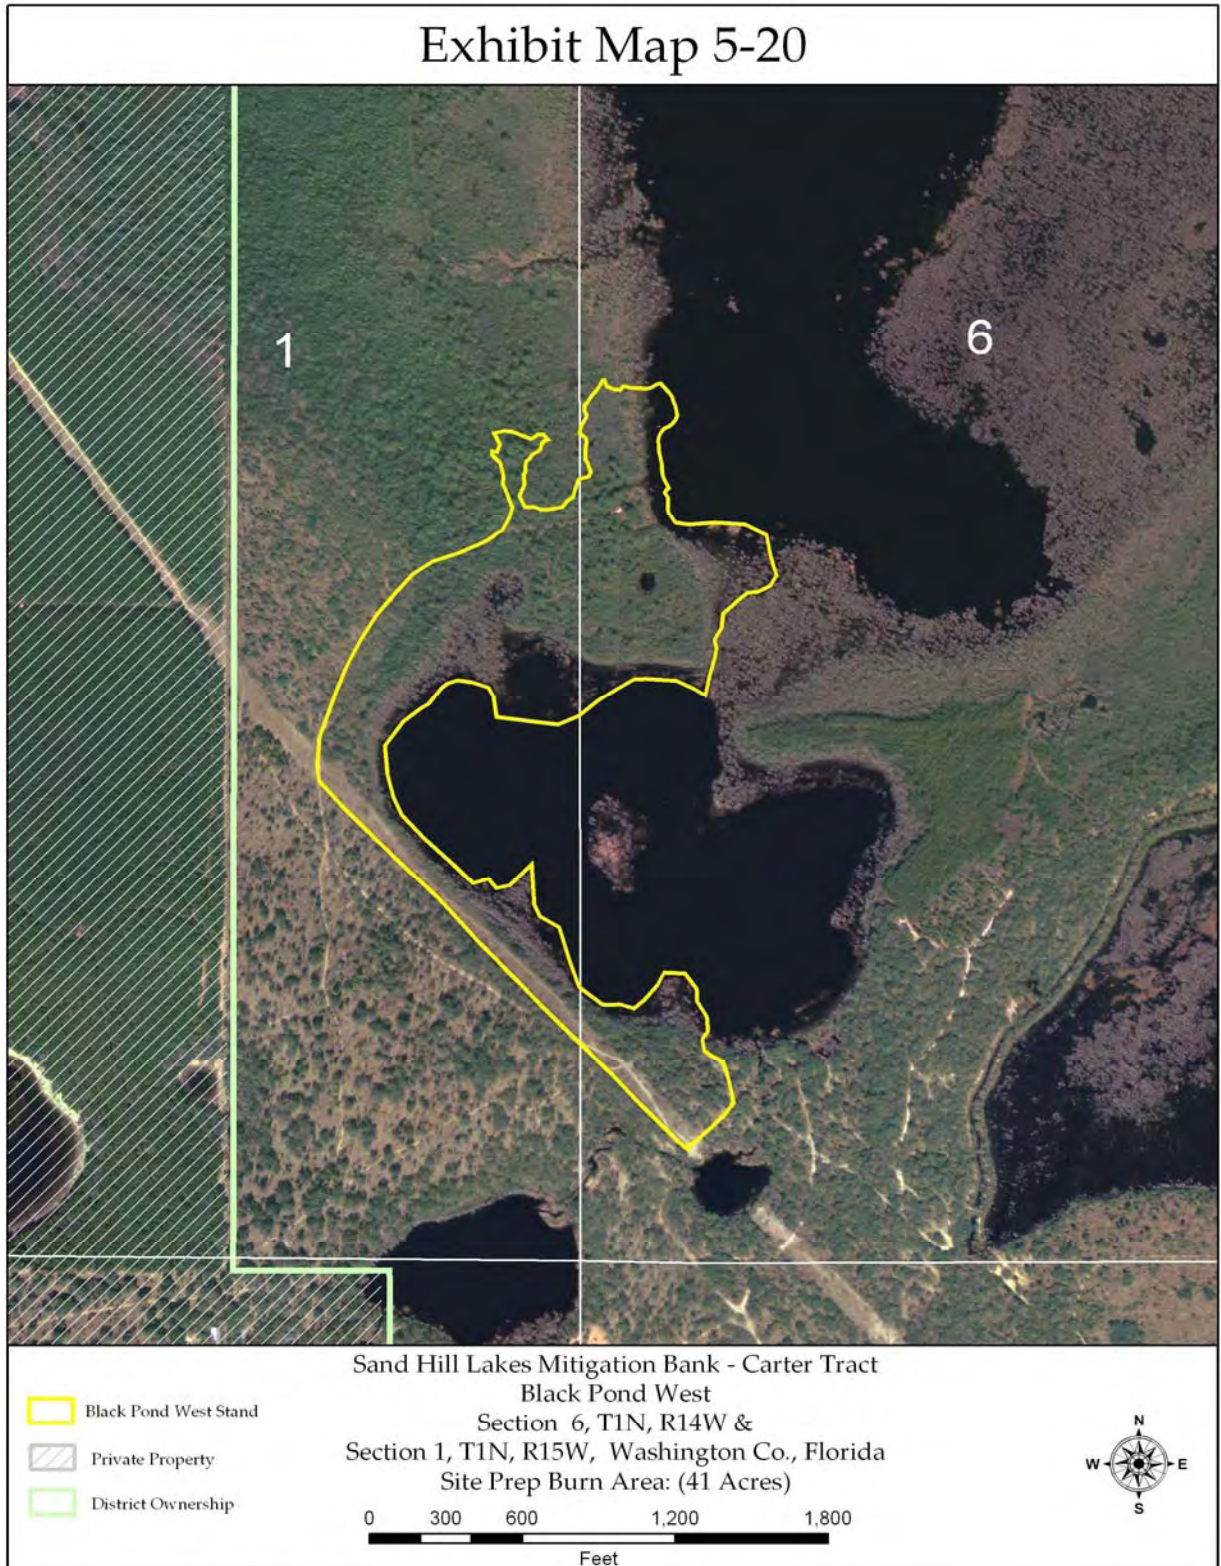
Figure 10. Spring SHLMB Dry and Black Pond Site Prep Burn

7. Remaining winter burns were completed by April of 2008. The area adjacent to Dry Pond and the back side of Black Pond that had been gyrotracked was burned with a very hot fire in late April. Some minor spot over occurred but were quickly extinguished. The end result was an excellent burn though a few pines were killed in the fire (Figure 10 and 11).

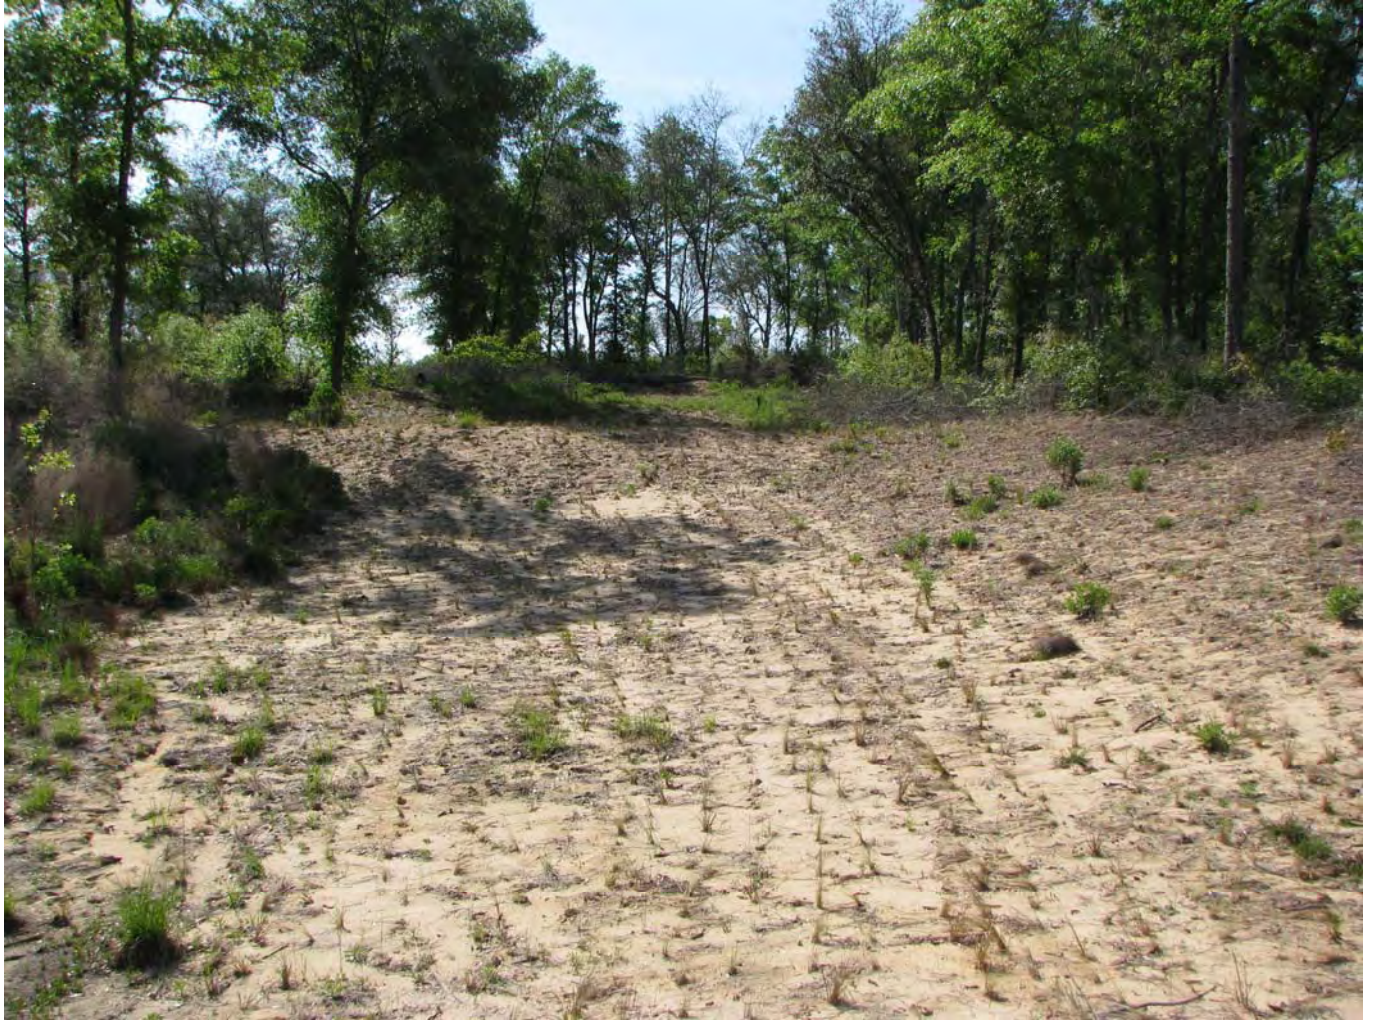
Re-planted Erosion Areas Showing Good Wire Grass Survival (040308)

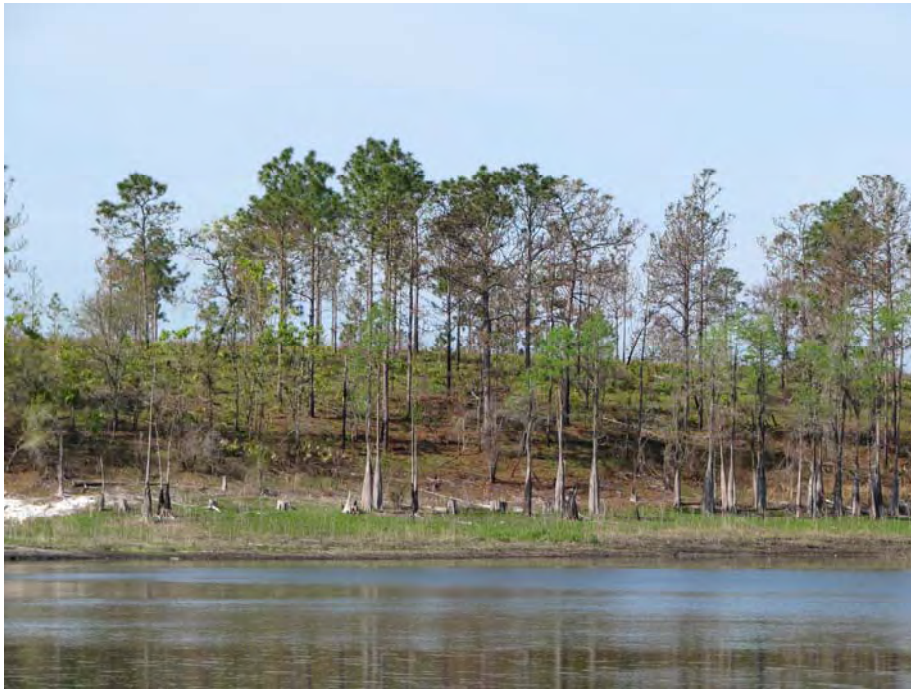
Western Side of Deep Edge Following Winter Burn 040308

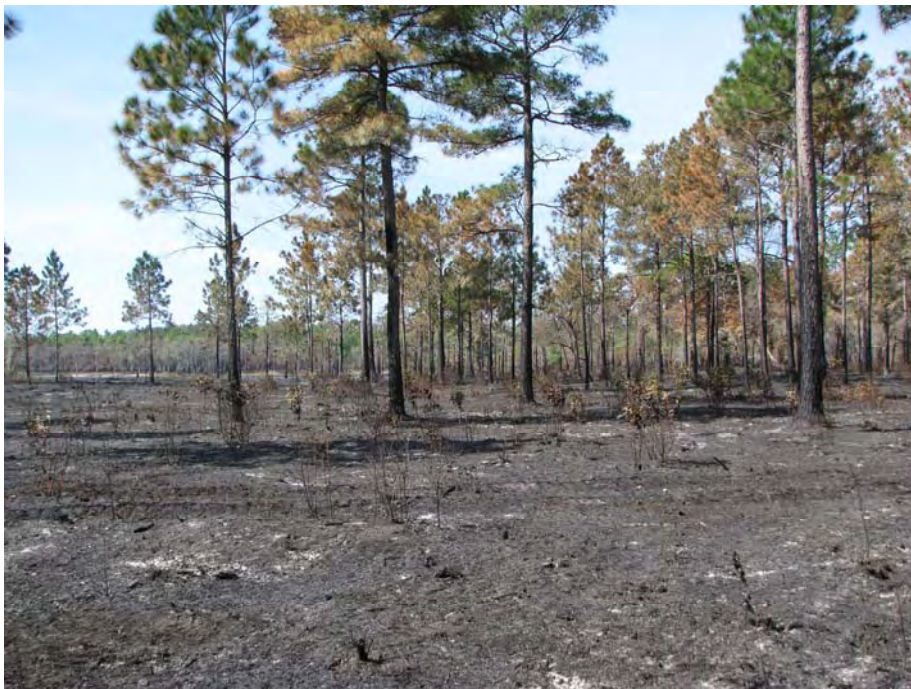
Gyrotrack Area Adjacent to Dry Pond Following Spring Burn 04020

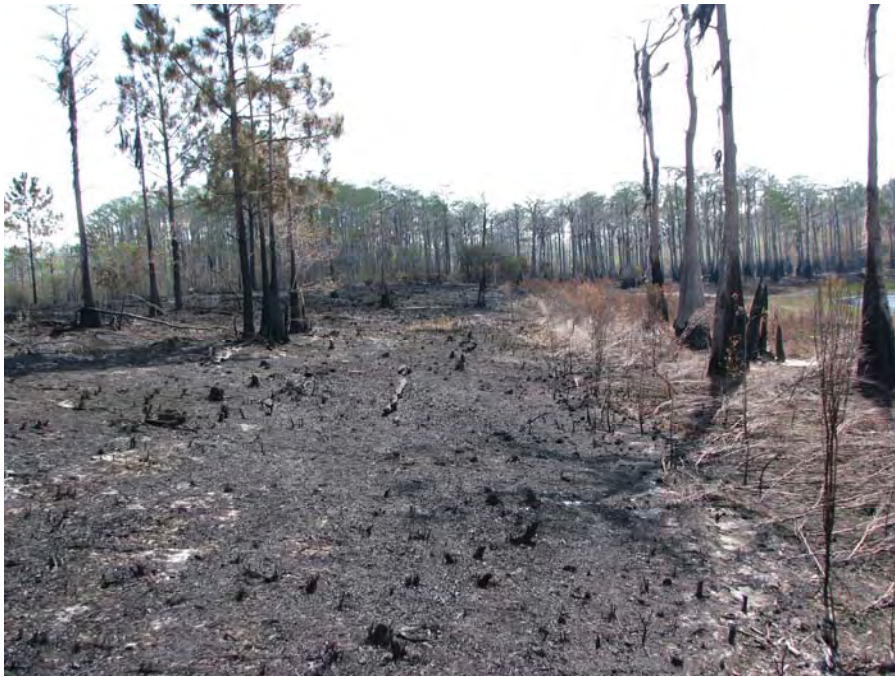
Gyrotrack Area Near Dry Pond and Black Pond Following Spring Burn 040208

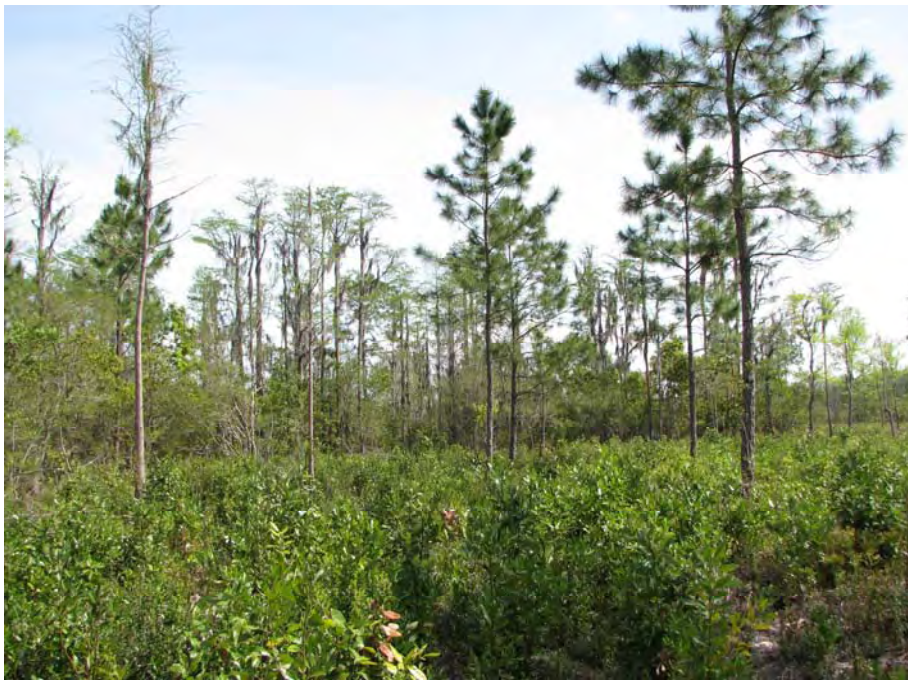
Gyrotrack Area Following Poor Burn Adjacent to Dry Pond and Pine Log Flow Way 040308
(Area will be burned this summer)

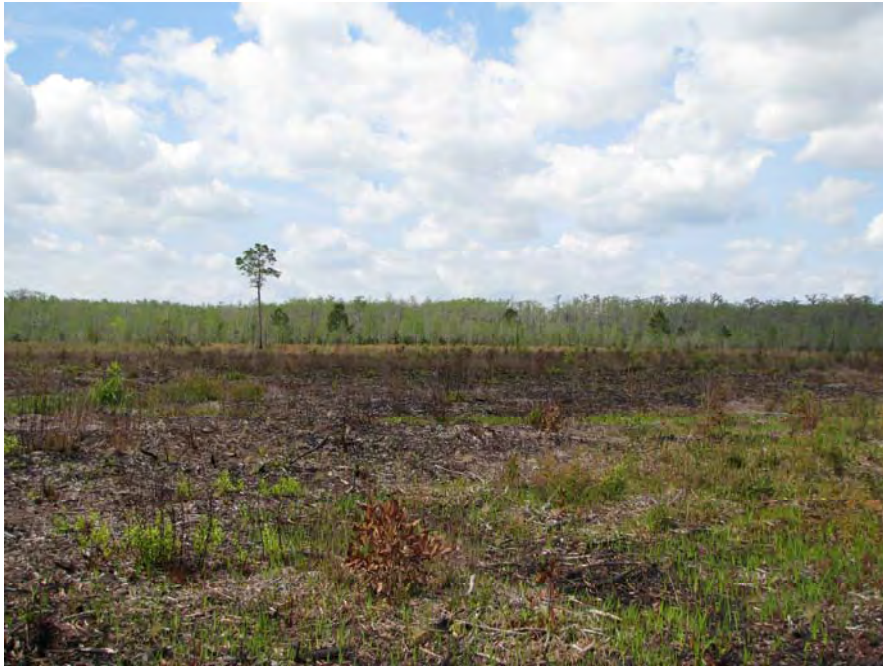
Gyrotrack and Burned Area Near Green Ponds (Island) and Wire Grass Planting 040308

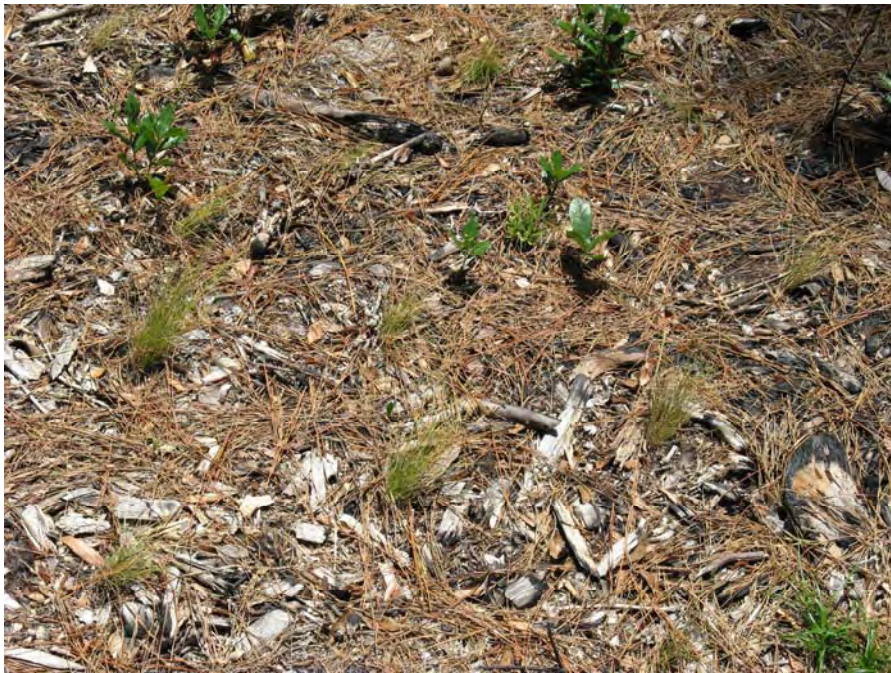
Wiregrass Plugs on Island 040308 (Good Survival)
