TREASURE ROAD MITIGATION SITE

2014 Annual Monitoring Report

(13 October 2014)

USACE Permit No.: SAJ-2012-02348 (SP-AWP), issued 3/11/2013

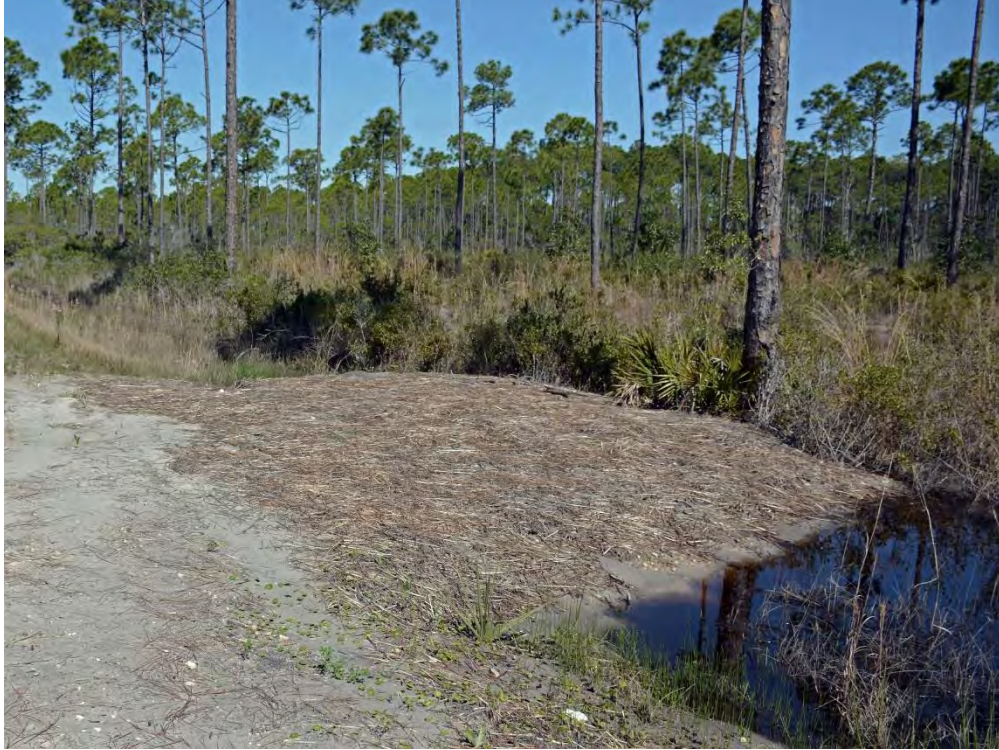
Typical Ditch Plug with Adjacent Hydric Pine Flatwoods in Background (4/1/2014)

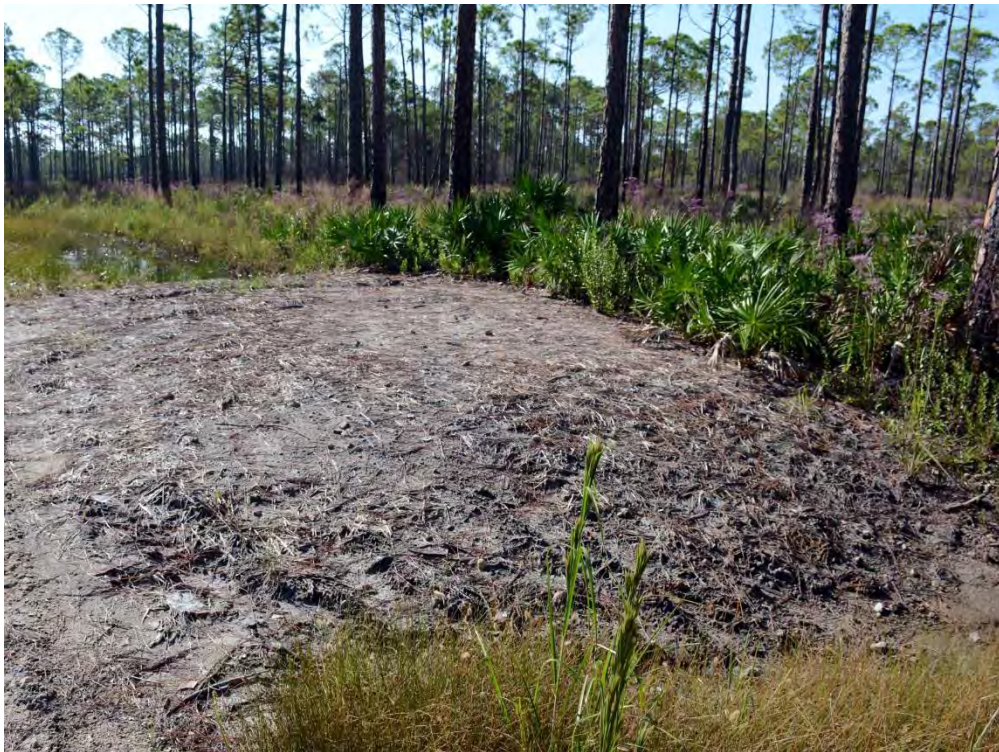
Typical Ditch Plug with Adjacent Hydric Pine Flatwoods in Background (10/10/2014)
