TREASURE ROAD MITIGATION SITE

Monitoring Report No. 1 (Time-Zero)

9 September 2013

USACE Permit No.: SAJ-2012-02348 (SP-AWP), issued 3/11/2013

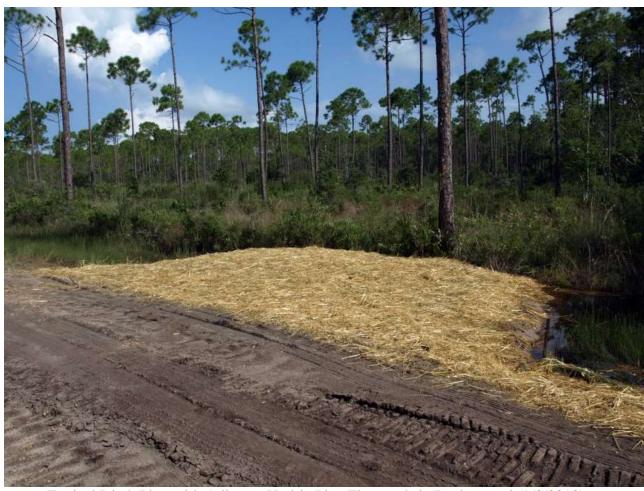
Typical Ditch Plug with Adjacent Hydric Pine Flatwoods in Background (9/3/2013)
