Northwest Florida Water Management District

Re: Progress Report 8

Please accept this submittal as the **semi-annual progress report** for the SHLMB.

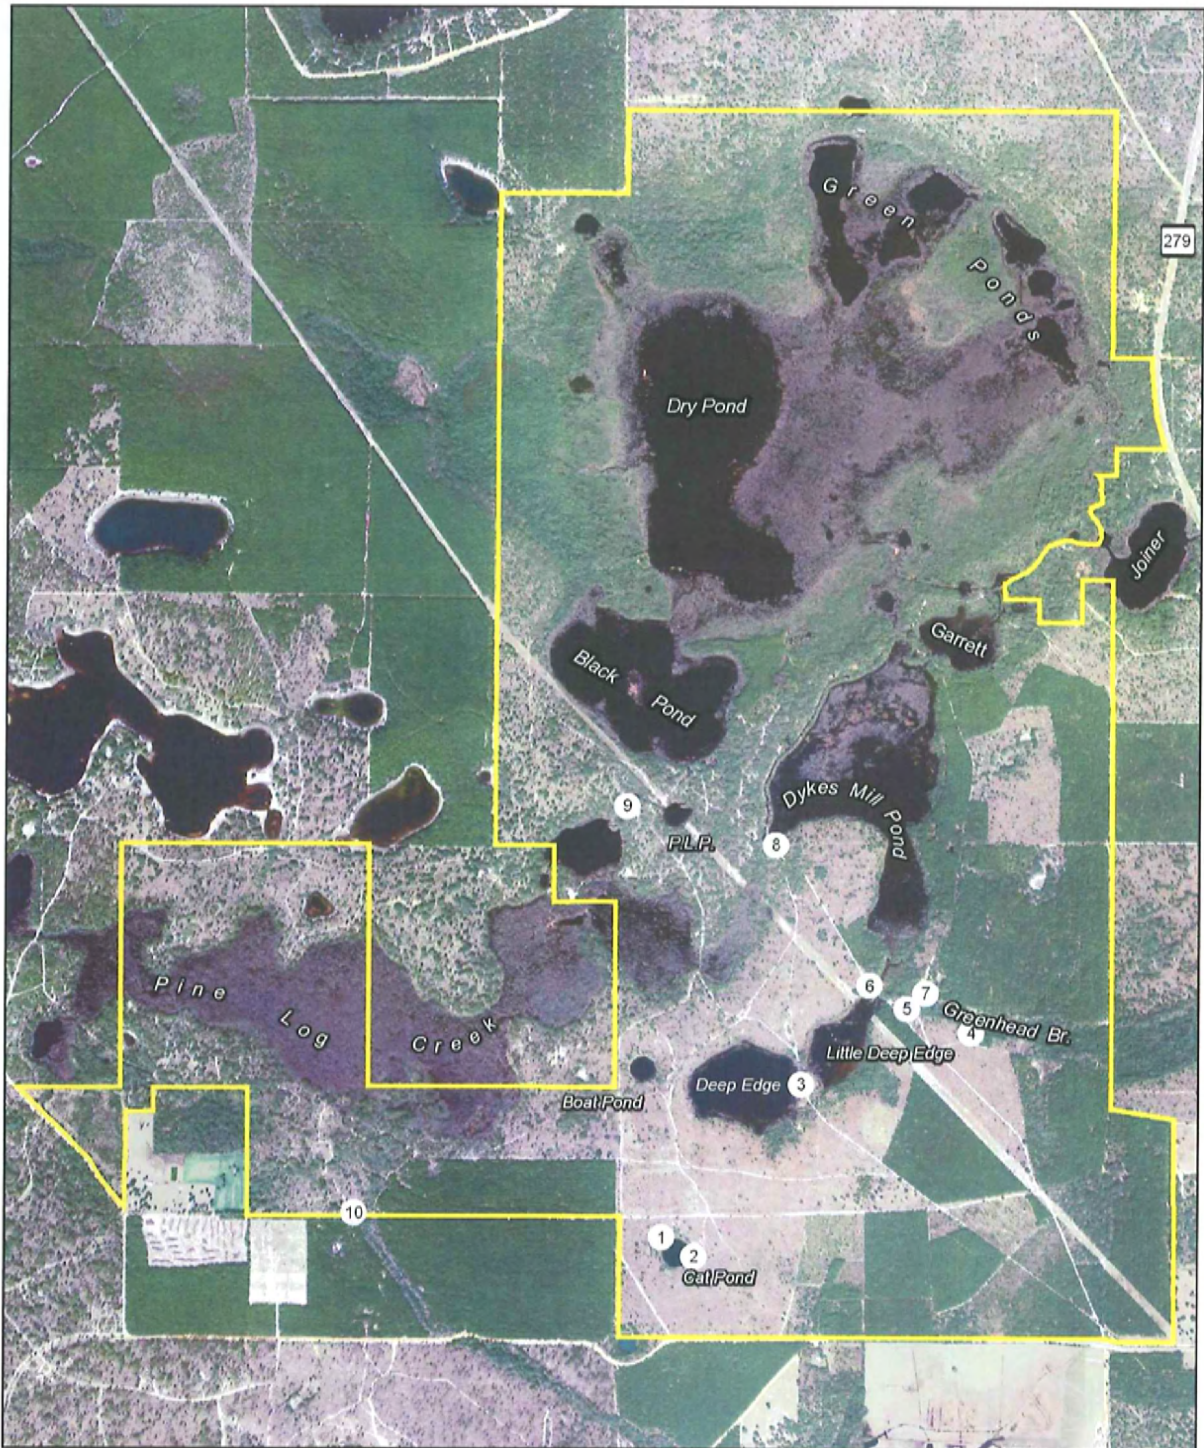
Figure 4 - Erosion Stabilization Sites

3. Due to inappropriate mulch used by the contractor, Bahia grass was observed within the erosion stabilization areas #1, #2, #3 and #10 in 2007. These areas were treated with herbicide by the contractor twice in 2007, until no living plant was observed. These areas were inspected in March and April of 2008 and small coverage of Bahia grass had re-sprouted. BRA has been contracted to treat the Bahia grass in June and August of 2008 (Figure 4).

8. Due to poor survival, wire grass, cypress and long leaf pine tublings were re-planted in erosion stabilization areas #1, #2, #3 and #10 in early spring 2008 in accordance with the planting plan. Follow up site inspection indicates excellent survival of the re-planted material (Figure 4).

3. Gyrotrack work will continue for an additional 38 acres adjacent to the Western portion of Dry Pond (Figure 14).
4. Erosion areas identified with Bahia grass cover (Figure 4) will be treated several times until eradicated.

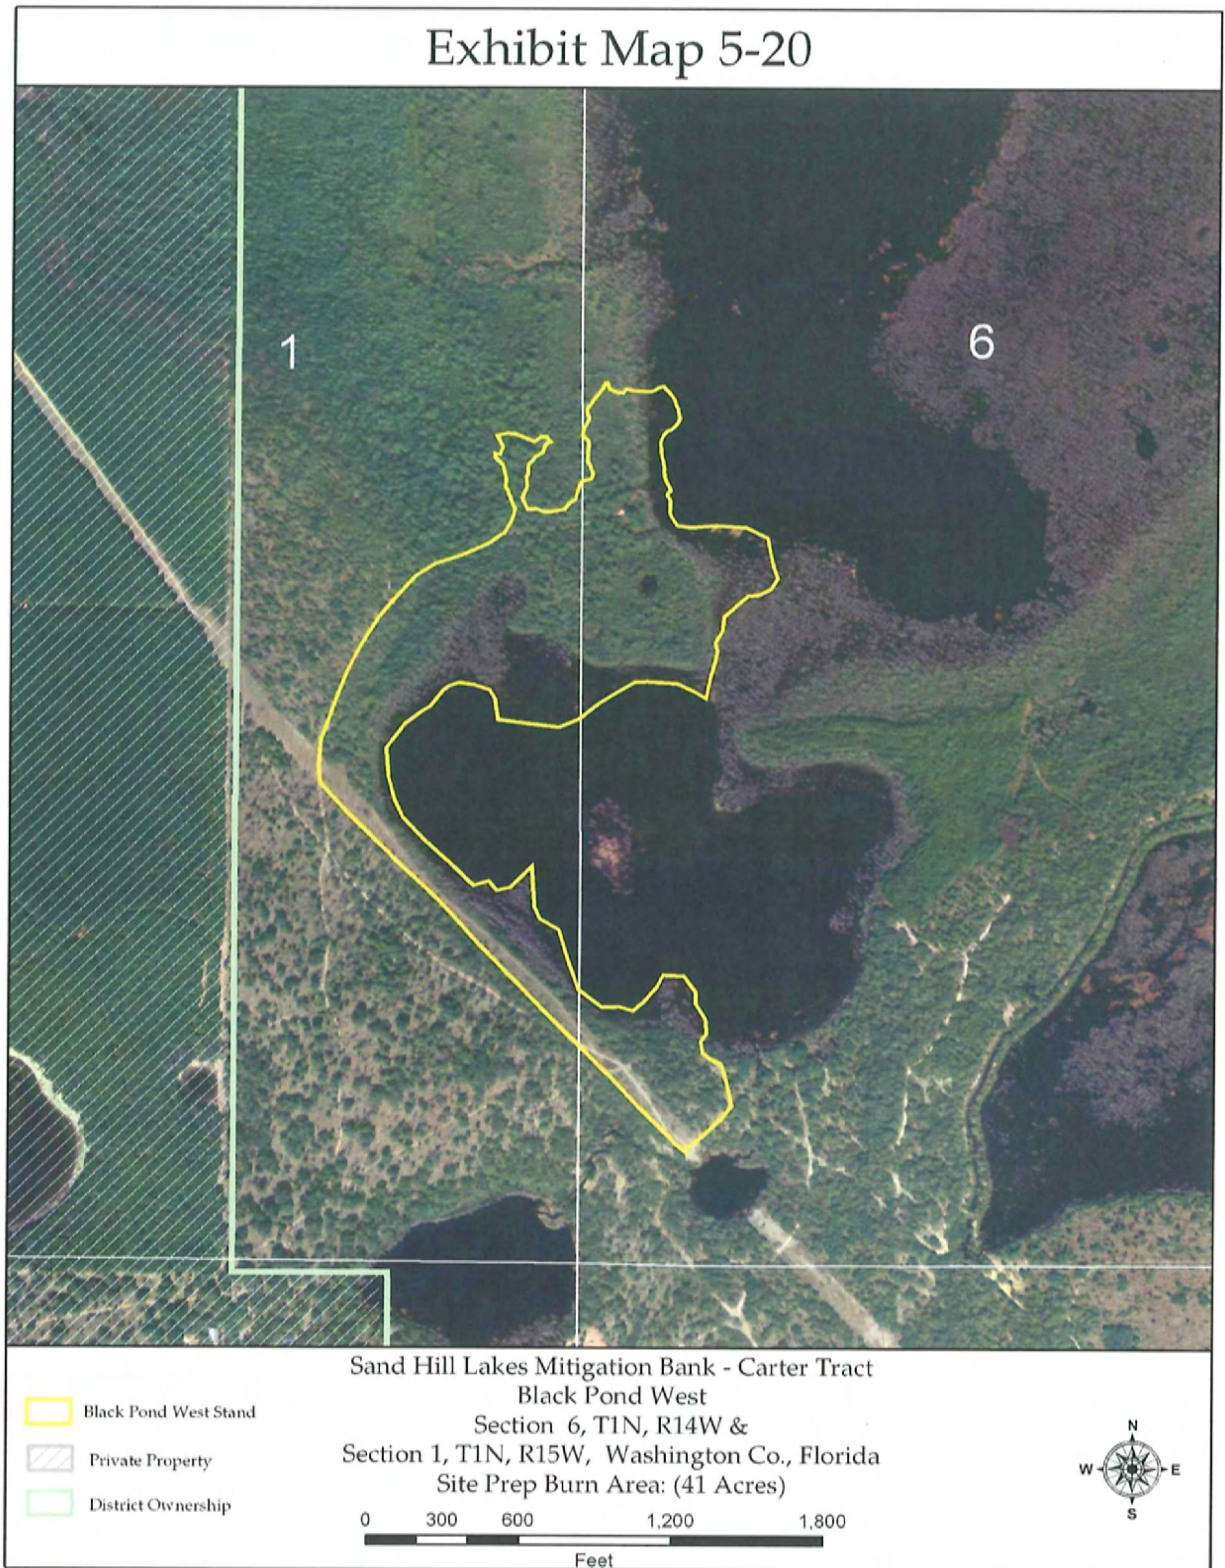
Figure 10. Spring SHLMB Dry and Black Pond Site Prep Burn

7. Remaining winter burns were completed by April of 2008. The area adjacent to Dry Pond and the back side of Black Pond that had been gyrotracked was burned with a very hot fire in late April. Some minor spot over occurred but were quickly extinguished. The end result was an excellent burn though a few pines were killed in the fire (Figure 10 and 11).

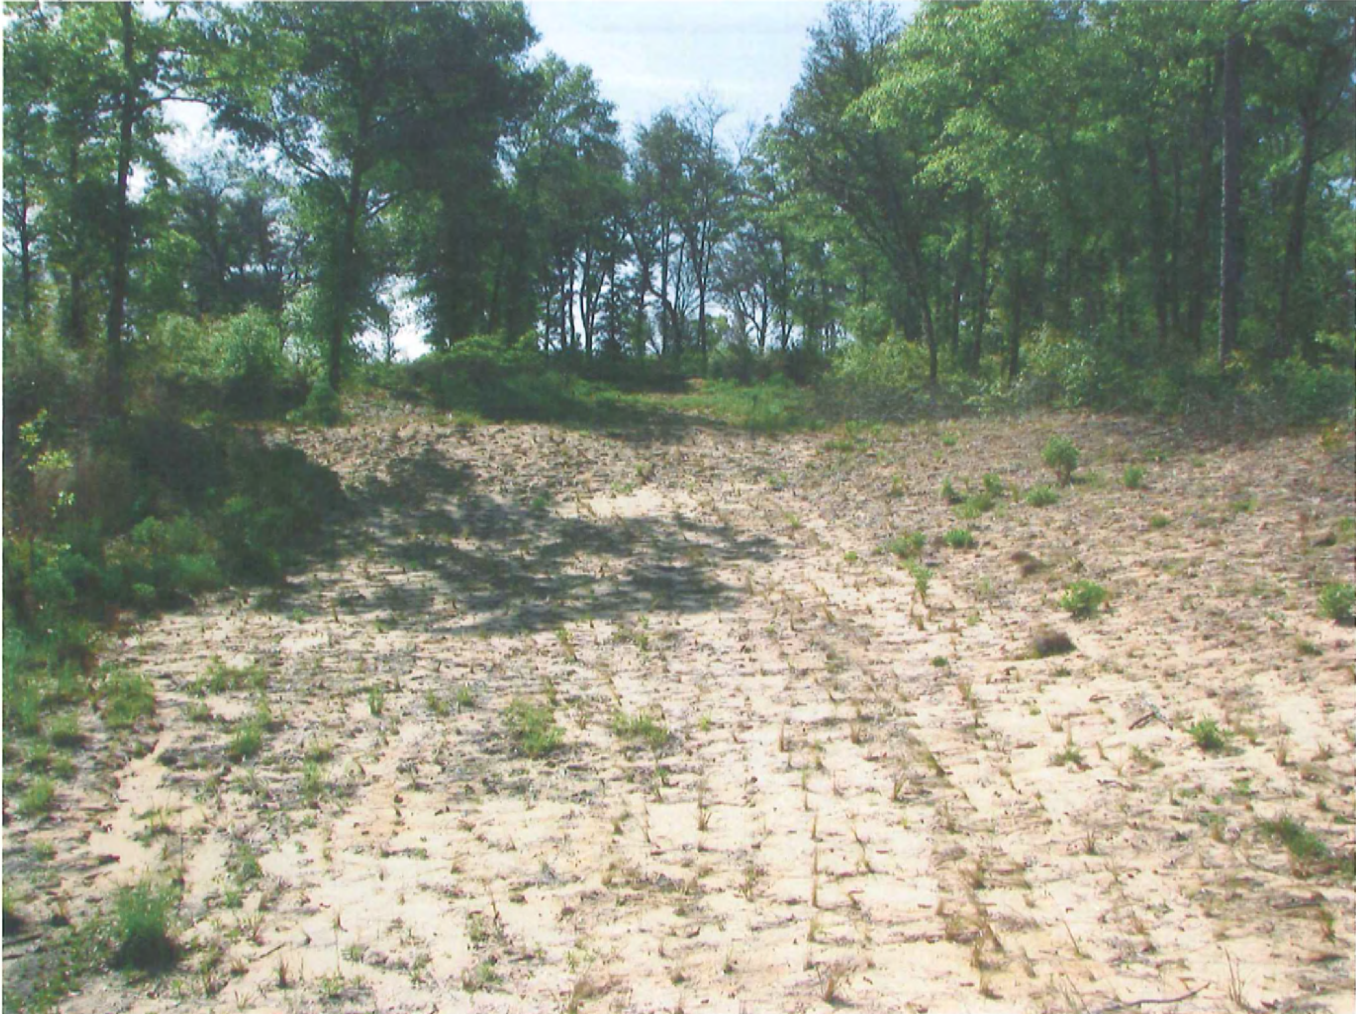
Re-planted Erosion Areas Showing Good Wire Grass Survival (040308)

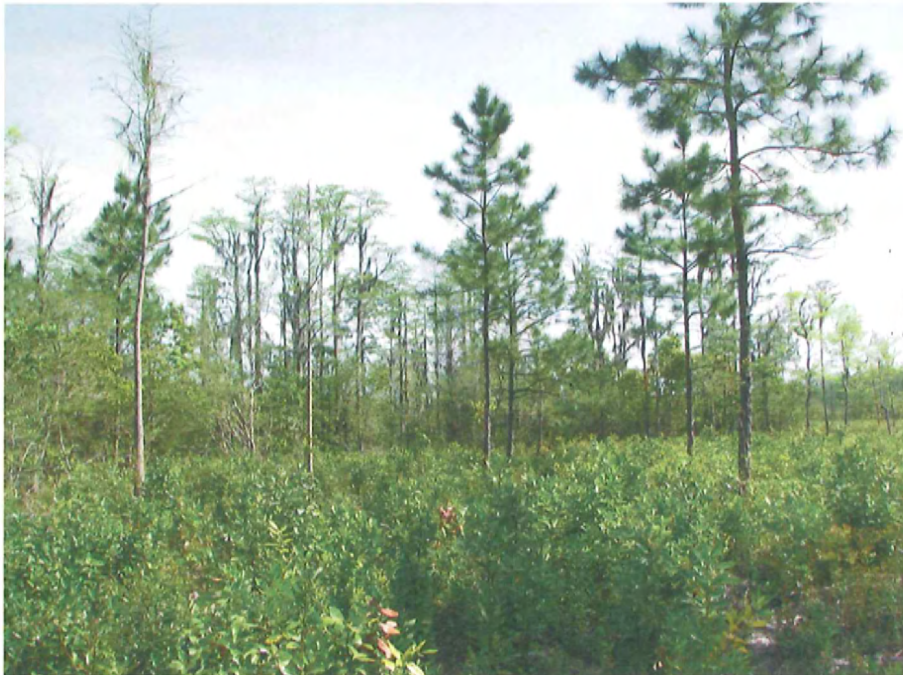
Gyrotrack Area Following Poor Burn Adjacent to Dry Pond and Pine Log Flow Way 040308
(Area will be burned this summer)

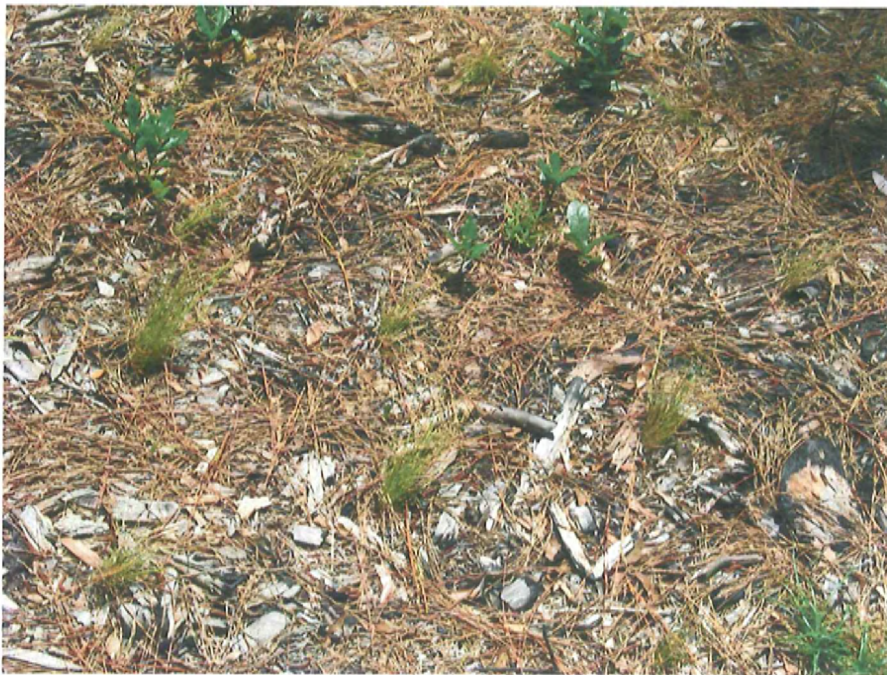
Wiregrass Plugs on Island 040308 (Good Survival)
