TATE’S HELL - DOYLE CREEK MITIGATION SITE
Annual Monitoring Report, 2011
February 8, 2012

PROJECT OVERVIEW

Impacts: SR 65, Franklin County
USACE Permit No.: SAJ-2004-706 (NW-TLZ), issued 4/26/2004
Mitigation: Tate’s Hell – Doyle Creek, Franklin County
Permittee/Consultant: FDOT
Responsible Party for Monitoring: Northwest Florida Water Management District (NFWFMD)
81 Water Management Dr.
Havana, FL 32333
Date of Inspection: November 16, 2011
Inspectors: Leigh Brooks, Graham Lewis

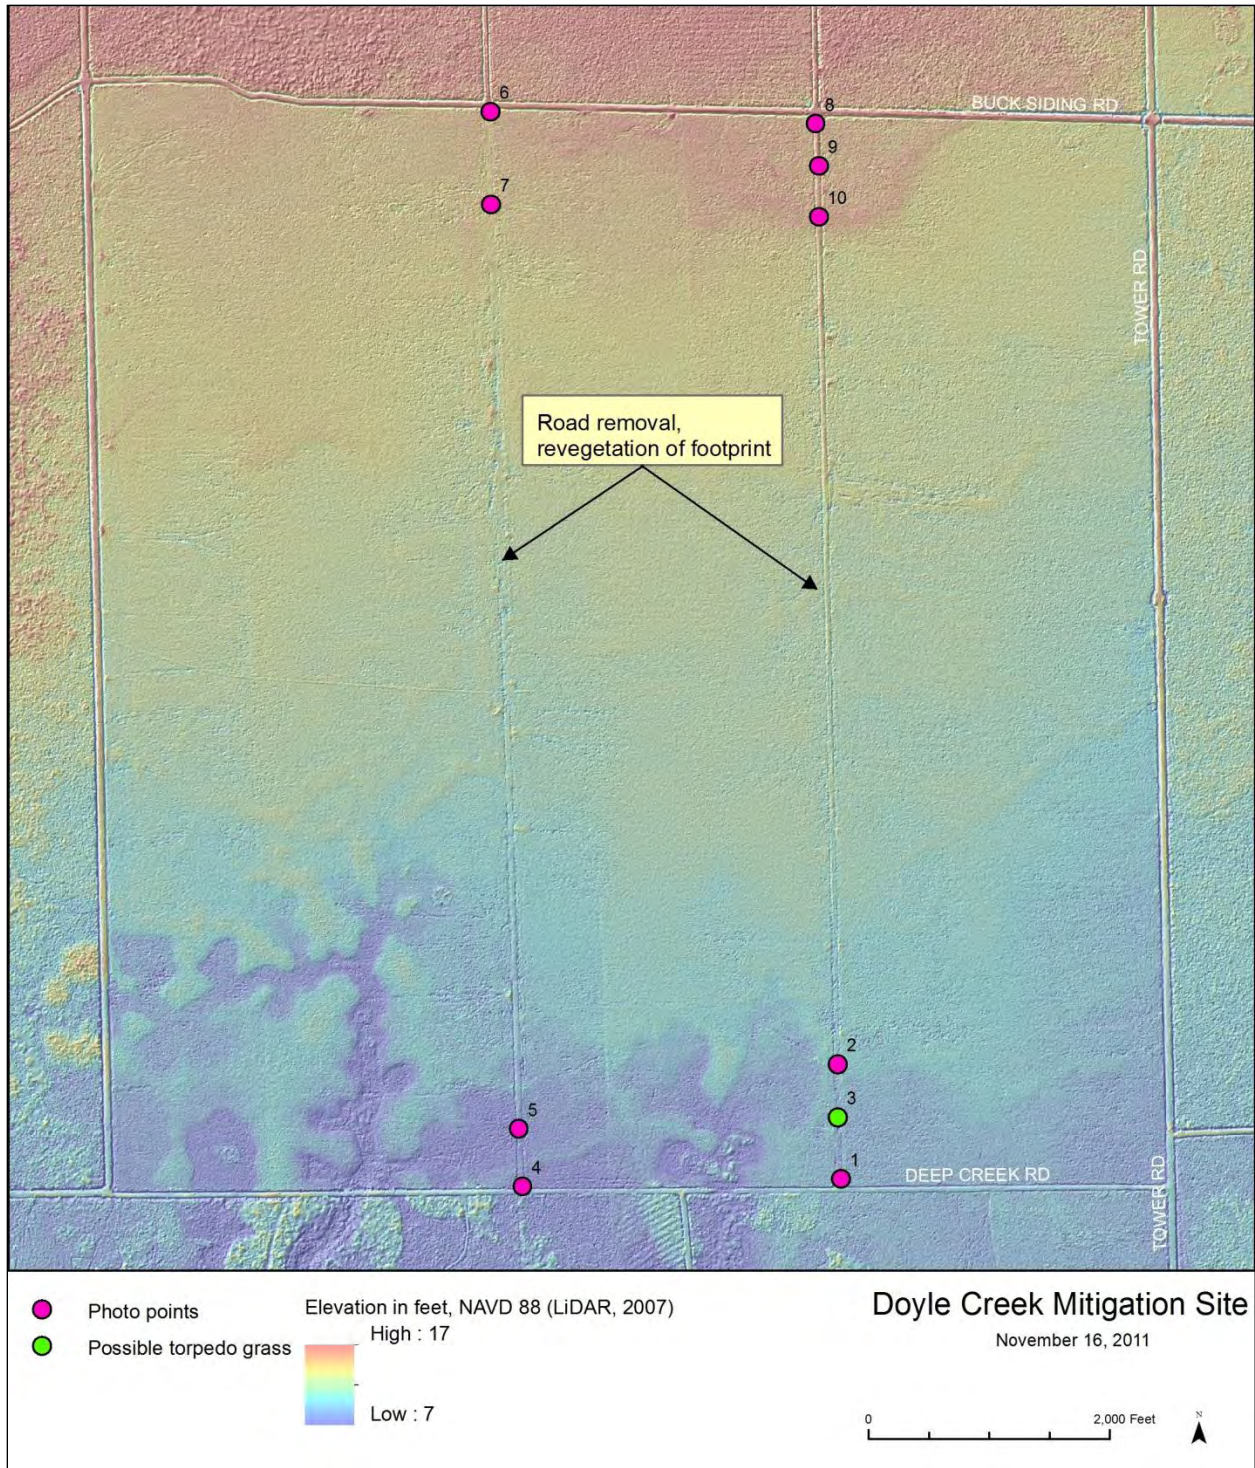
Survival of cypress was generally high. They were most robust at the southeast road segment ([Photo 1](#)); survival was not as good on the western segment and poor in the northeast. Young planted trees appeared to be bald cypress (*T. distichum*) and not pond cypress, as intended. The method of planting is readily apparent now that the trees are older; they were planted in straight lines down the old ditches. Some areas showed natural recruitment of pond cypress. Pine trees were also recruiting to some areas ([Photo 2](#)). Titi (*Cyrilla racemiflora*) was becoming established between Photo Points 1 and 2 on the east road segment (see [Figure 3](#)).

Figure 3. Topography after construction to regrade roads and ditches. Areas of uneven terrain are evident.

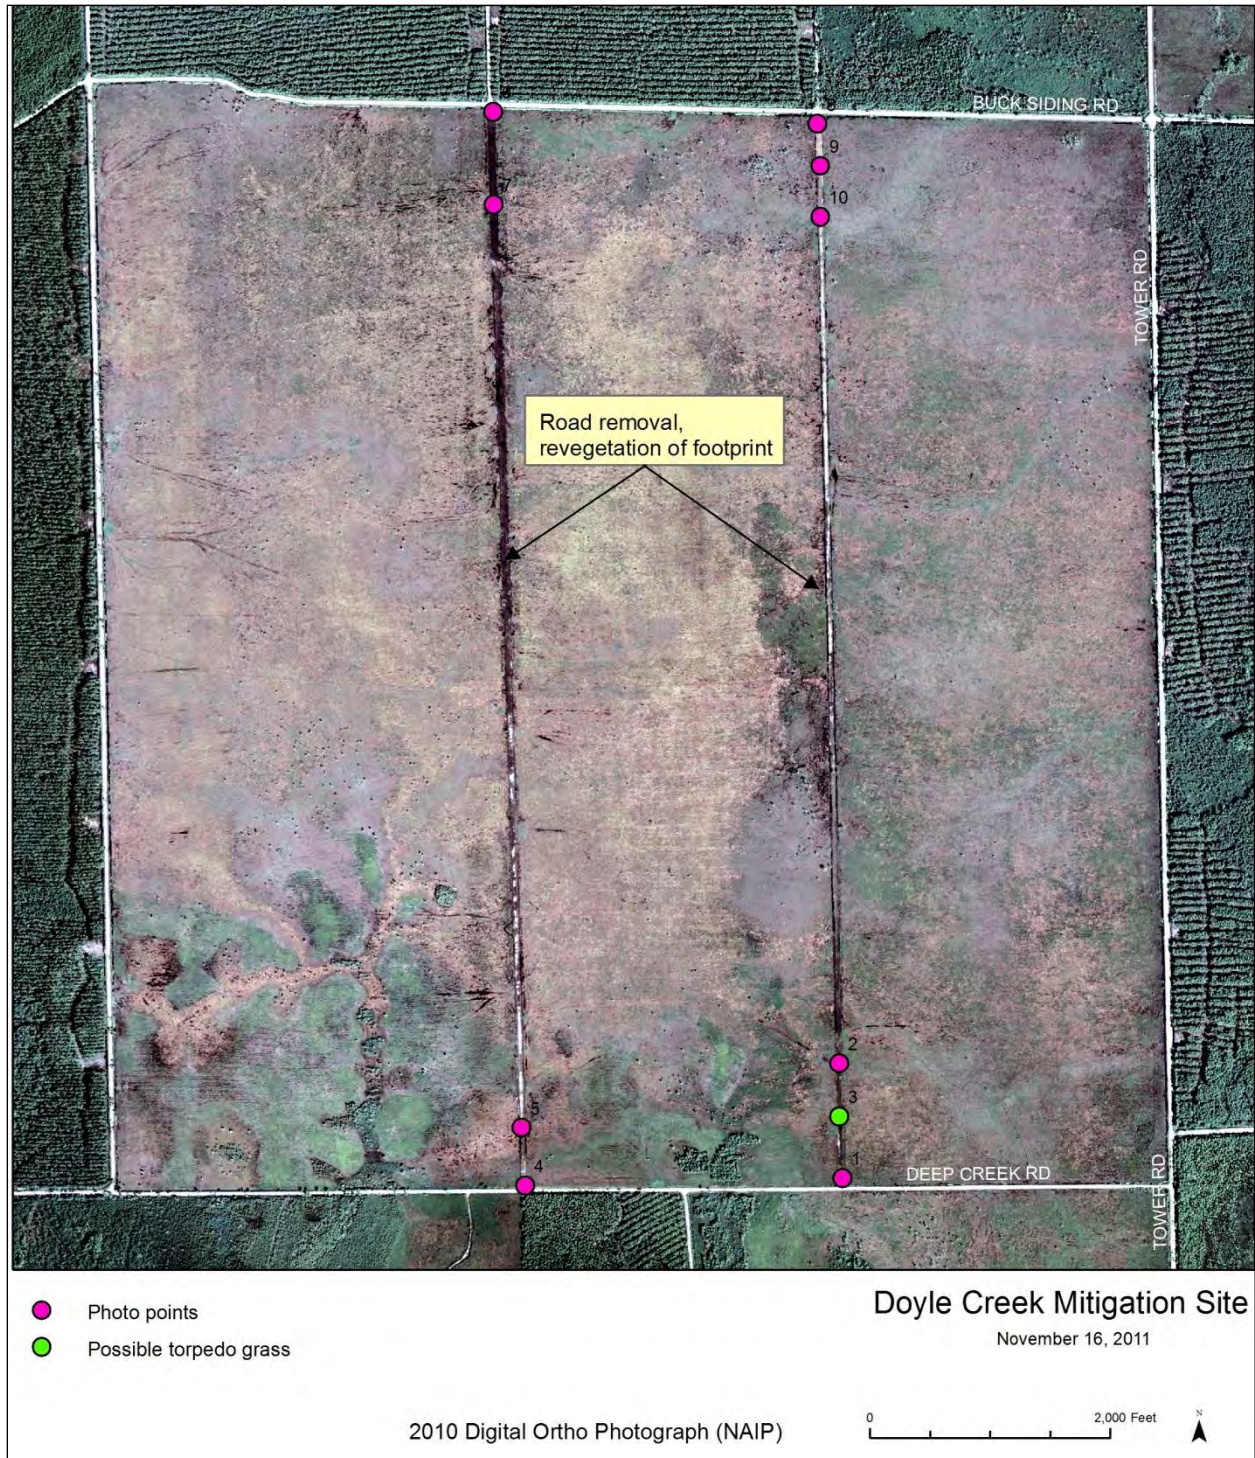
Figure 4. Aerial photograph after construction to regrade roads and ditches and revegetate. Areas of mostly bare ground appear white, areas of standing water appear dark. This photograph was likely taken after a rainy period. This amount of water was not standing during the current inspection. [RTN](#)

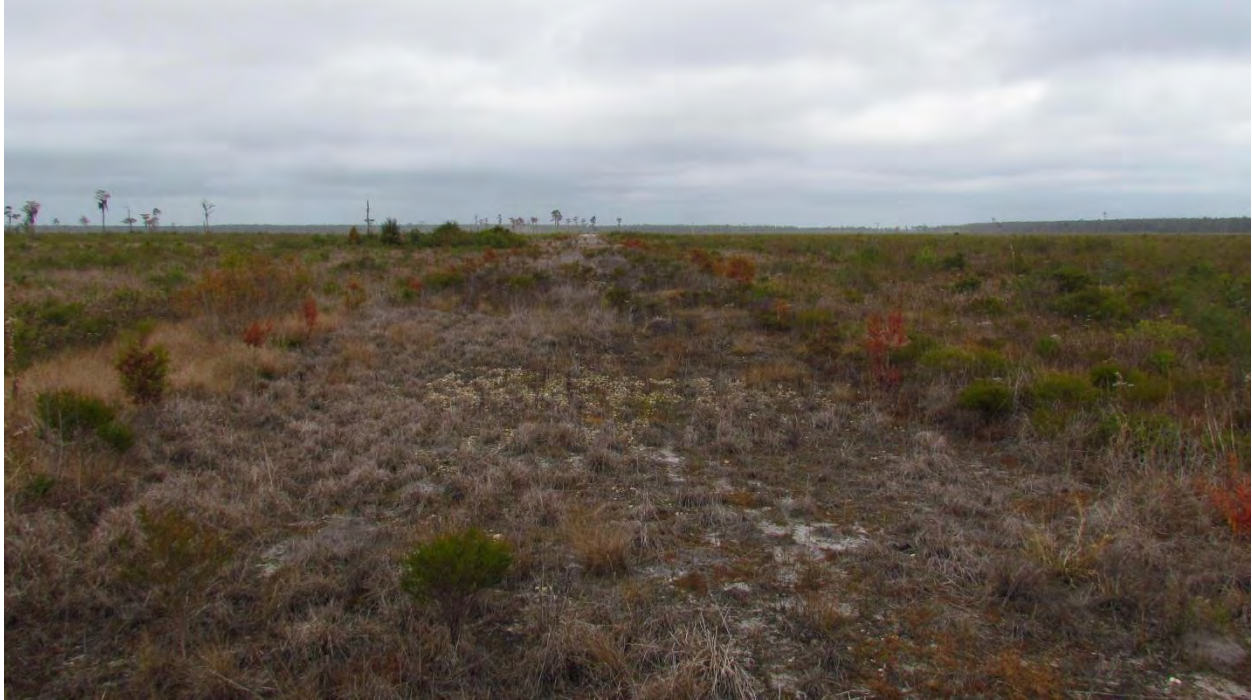
Photo 1. Road removal; roadway edges lined with planted cypress showing fall color. Photo Point 1, looking north. 11/16/2011

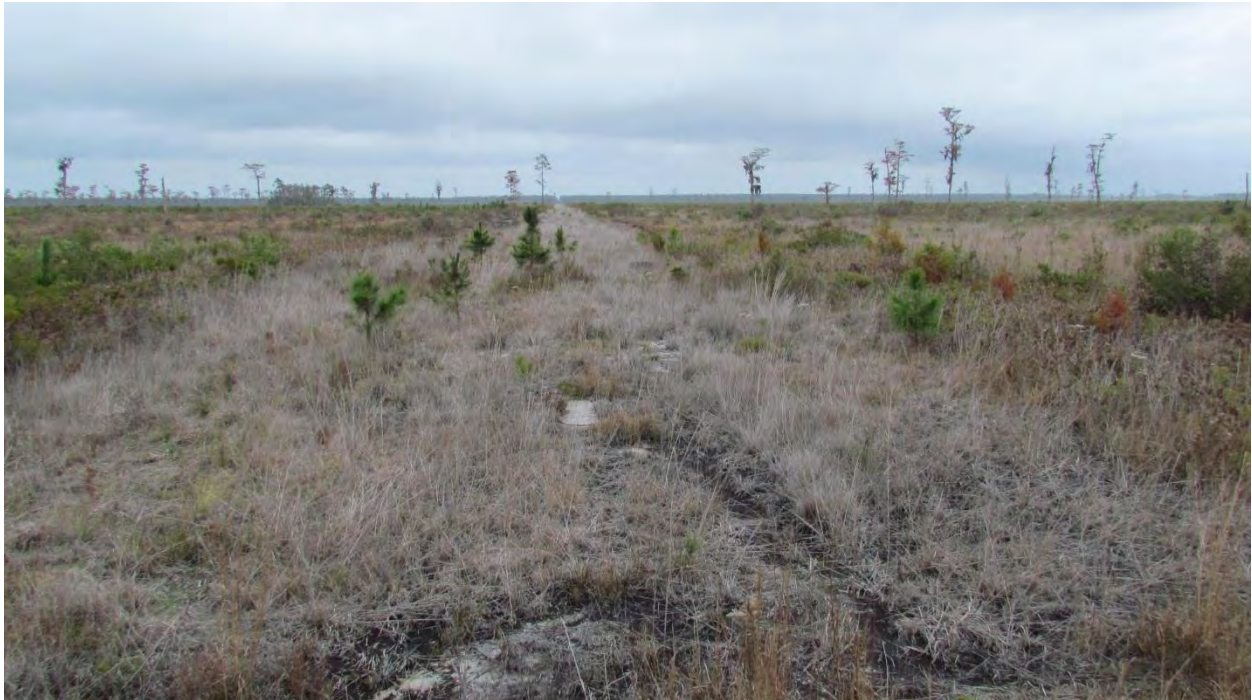
Photo 2. Road removal with natural pine recruitment. Photo Point 4, looking north. 11/16/2011. [RTN](#)

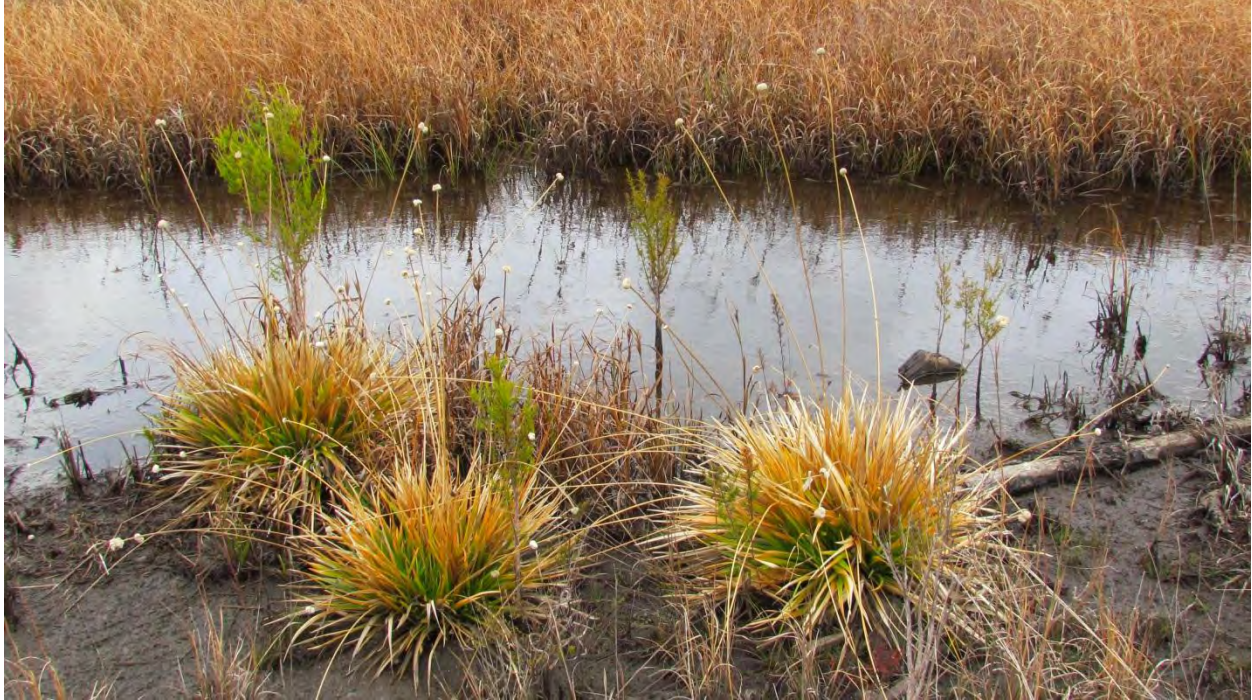
Photo 3. Road removal; *Eriocaulon decangulare* next to remnant ditch between Photo Points 4 and 5. 11/16/2011. [RTN](#)

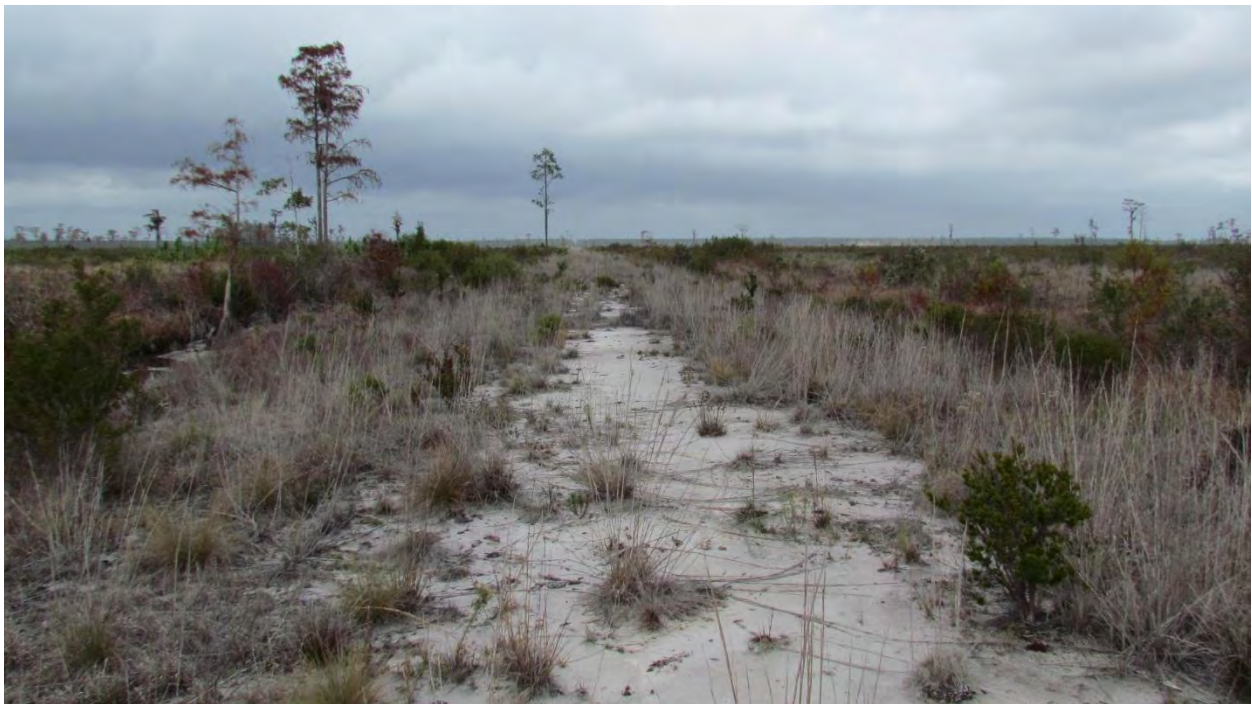
Photo 4. Road removal with bare patches. Photo Point 5, looking north. 11/16/2011. [RTN](#)

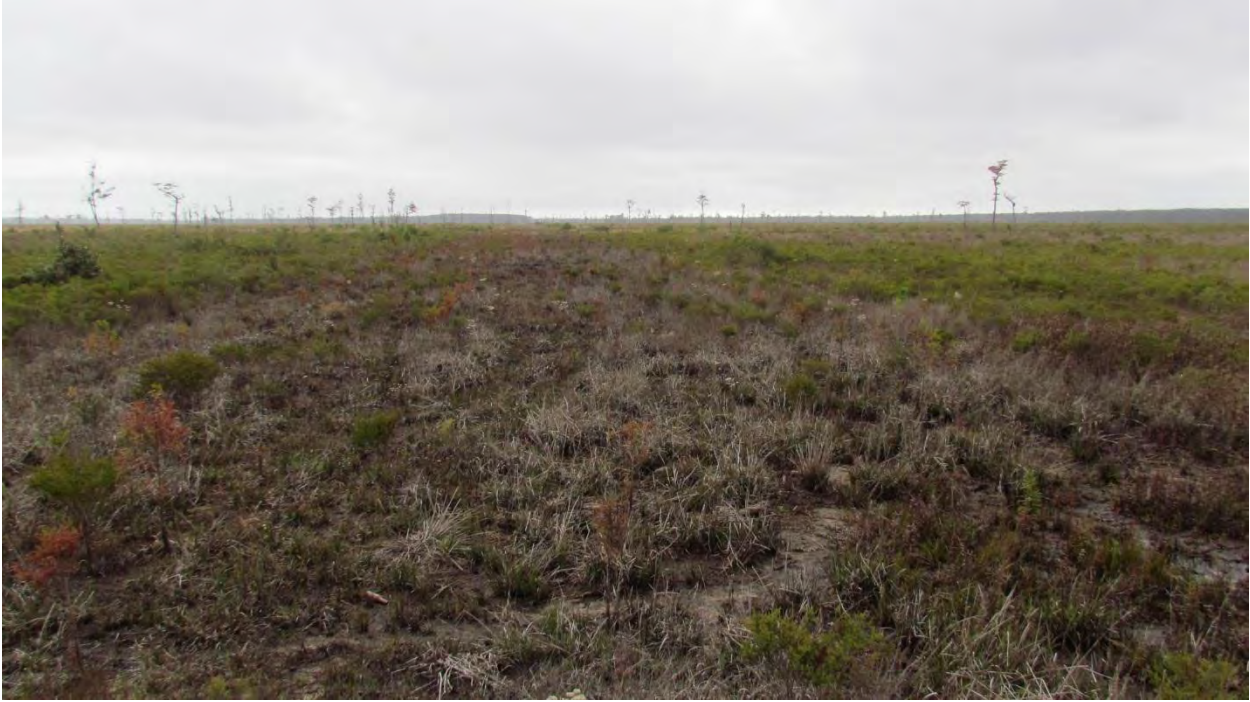
Photo 5. Road removal. Photo Point 6, looking south.11/16/2011.

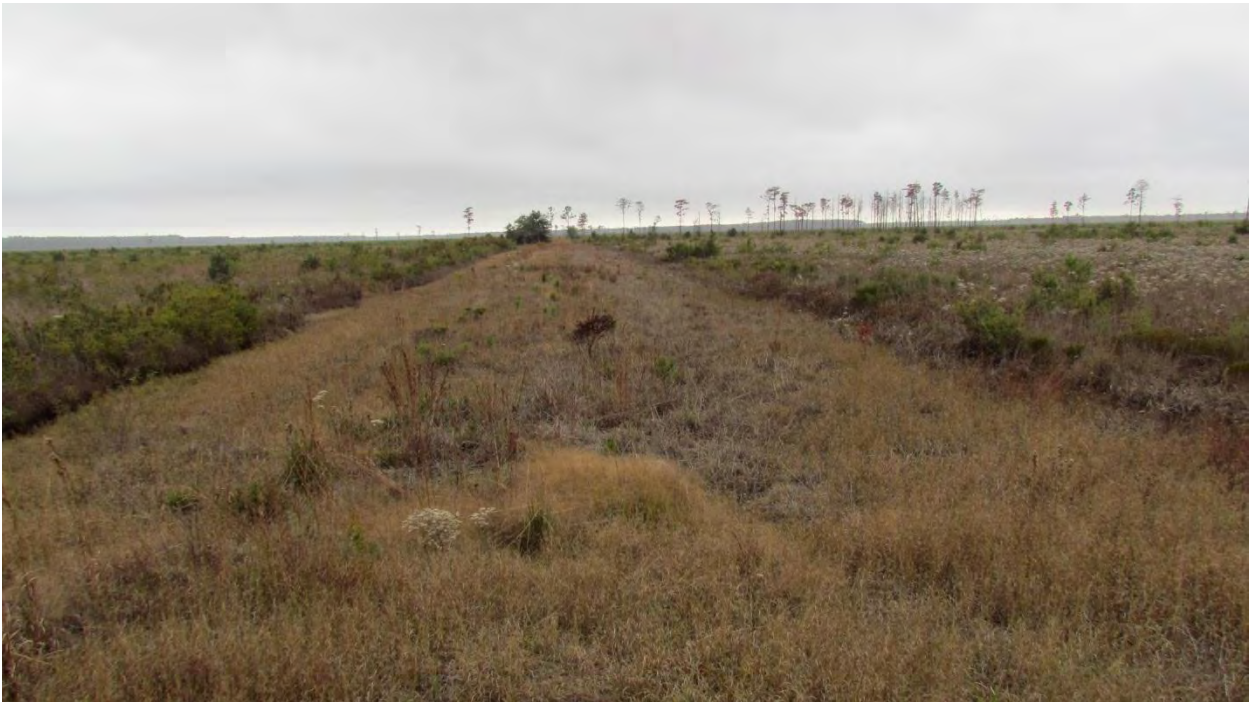
Photo 6. Road removal with remnant ditches evident. Photo Point 8, looking south.11/16/2011.
