Cat Point – 2007 Monitoring
CORPS Permit No. 200305450 (NW-JWS)

Project Description: The objective of this project is to mitigate for a 0.3-acre impact to seagrass beds in Apalachicola Bay associated with the replacement and realignment of the St. George Island Bridge (SR 300 – Bryant Patton Bridge). The approved mitigation plan included the restoration of approximately 0.8 acre of degraded shoreline. This involved removing old debris from 0.5 acres of shoreline, establishing a minimum marsh/breakwater area of 0.3 acre within the debris removal area, and restoring 0.3 acres of upland native habitat and vegetation on a strip landward of the created marsh. The marsh habitat includes the breakwater footprint, gaps in the breakwater, and areas of planted emergent vegetation. Planted marsh vegetation will enhance the amount of habitat along this section of shoreline. Gaps in the breakwater will allow flushing and ingress/egress of aquatic organisms utilizing the marsh area. The breakwater itself will provide valuable hard substrate for various forms of estuarine epifauna. This project is being carried out in accordance with U.S. Army Corps of Engineers Nationwide Permit 27, #200305450

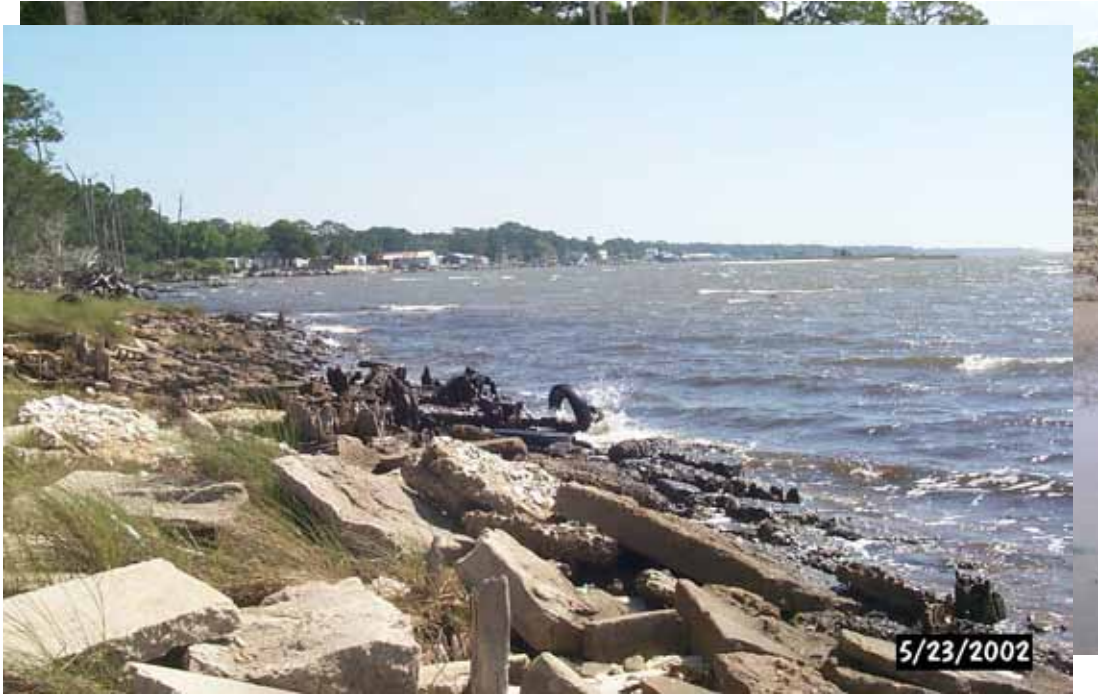
Figure 4. Preconstruction view of concrete construction material previously placed on site to control erosion of shoreline.

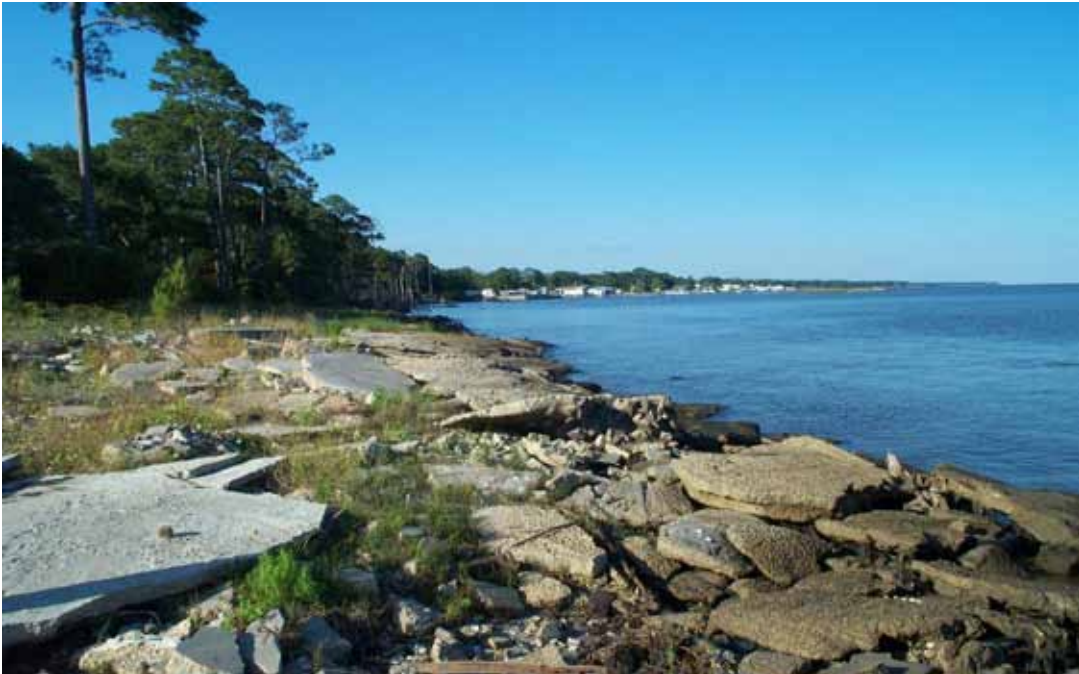
Figure 5. Preconstruction view of concrete construction material previously placed on site to control erosion of shoreline.

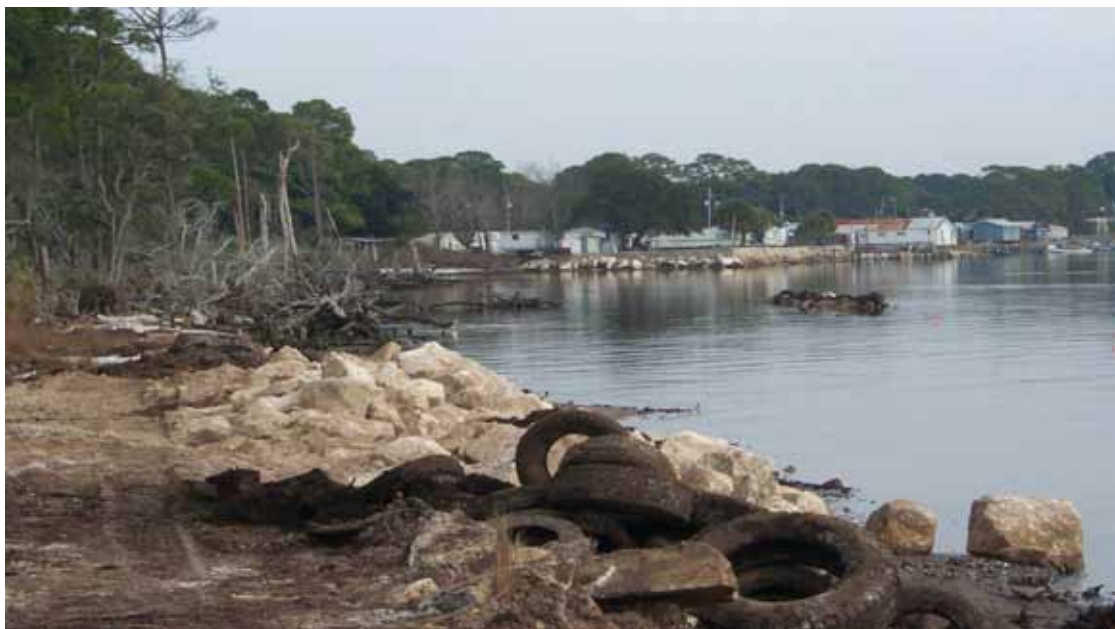
Figure 6. Preconstruction view at low tide showing concrete rubble and numerous old automobile tires scattered in the nearshore subtidal area at the project site.

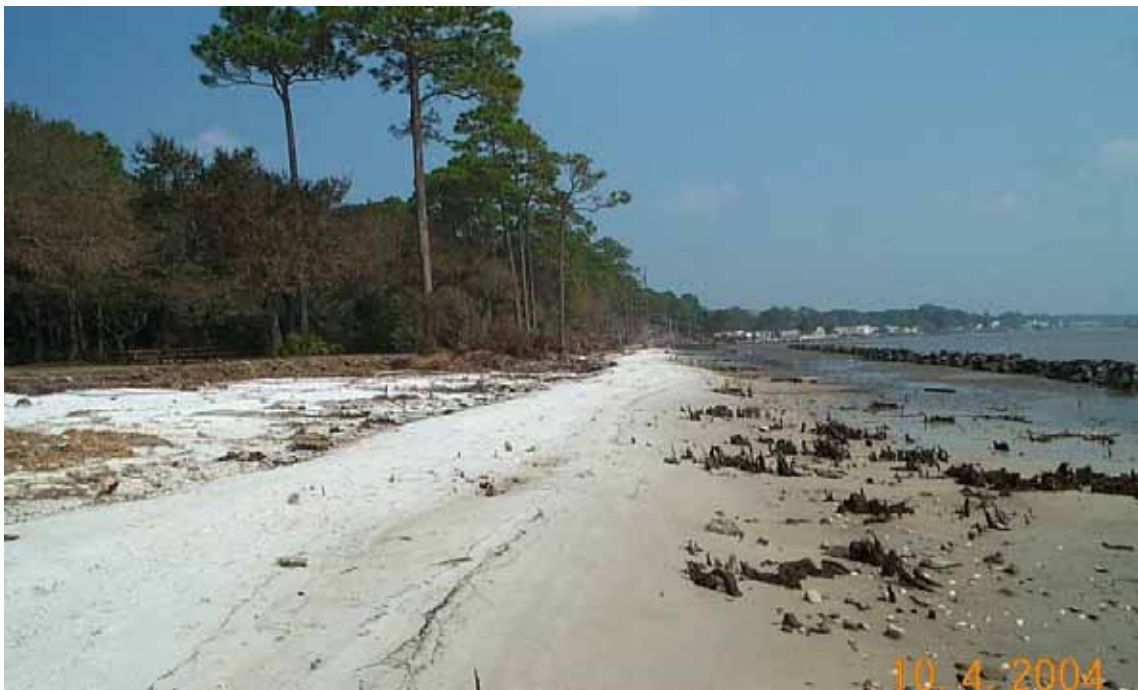
The success of our marsh plantings was affected significantly by the occurrence of several tropical storm events. During the late summer and early fall the shoreline along this section of coast was severely disturbed as three hurricanes passed through the Gulf, the most intense damage coming from Hurricane Ivan in late September (Figure 13). Although the breakwater itself was undamaged, wave action was significant, overtopping the rock structure by several feet at the height of the storm. Significant erosion occurred with landward movement of the demarcation line between beach slope and terrestrial upland occurred, as was noted by the newly formed erosion escarpment (Figure 14). Unfortunately, a substantial portion of the planted cord grass along with significant amounts of upland vegetation was scoured.

Figure 13. View of breakwater and adjacent eroded shoreline after Hurricane Ivan. Beach erosion was significant, extending at least 50 feet landward of previous beach/upland demarcation line.

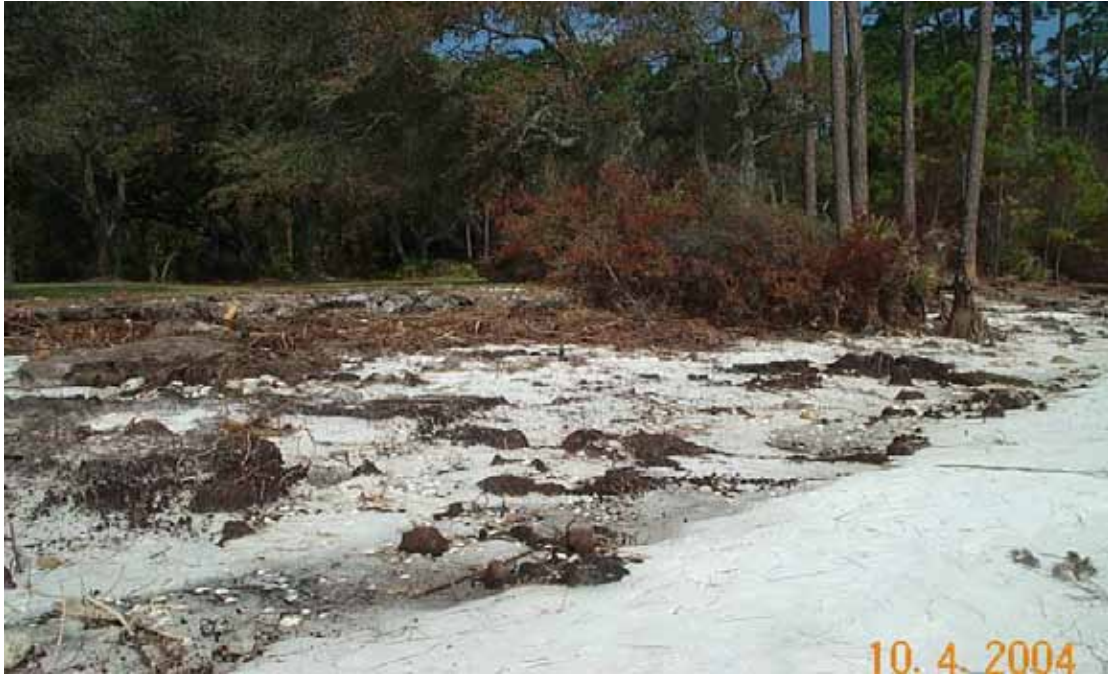
Figure 14. Close-up view of eroded shoreline after Hurricane Ivan. Erosion extended landward to newly formed escarpment, seen at center left in photo.

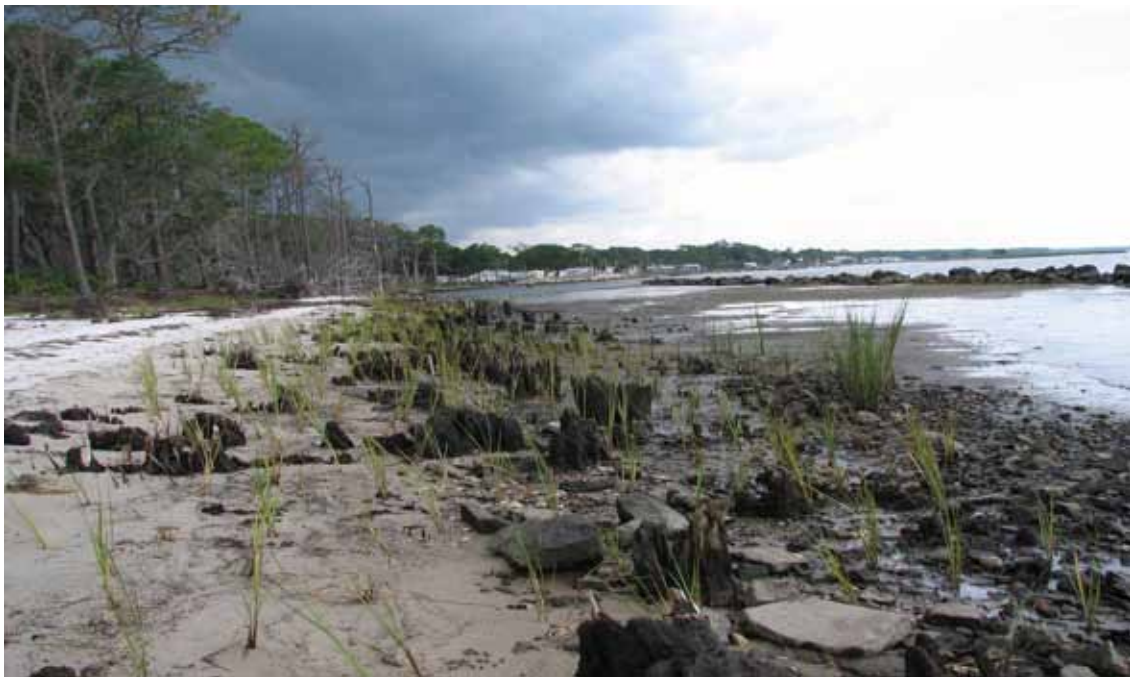
An active tropical storm season precluded additional replanting in 2005. Hurricane Dennis, although landfall occurred near Pensacola in July 2005, resulted in an extreme storm surge in the Apalachicola area and again damaged the marsh. A series of new plantings was completed in August 2006 with over 3000 new *Spartina* tublings interspersed among the remaining shoots (Figure 15). Mortality was high on these tublings and replanting of approximately 1500 plants took place in January 2007 (Figure 16). In September 2007, 6000 upland plants of seven species (including saltmeadow cordgrass, railroad vine, Muhly grass, sea purslane, dune elder, salt bush and beach panic grass) were planted in the transition zone between the beach and the upland at the site (Figures 17 and 18); an additional 500 *Spartina* were planted at this time to supplement the existing marsh zone. Both marsh and transition zone vegetation will be monitored in the spring of 2008 for survival success (minimum of 80% survival).

Figure 15. Revegetation of *Spartina alterniflora* after hurricane damage in 2004 and 2005. Approximately 3000 *Spartina* tublings were planted in the nearshore zone interspersed among existing shoots in August 2006.

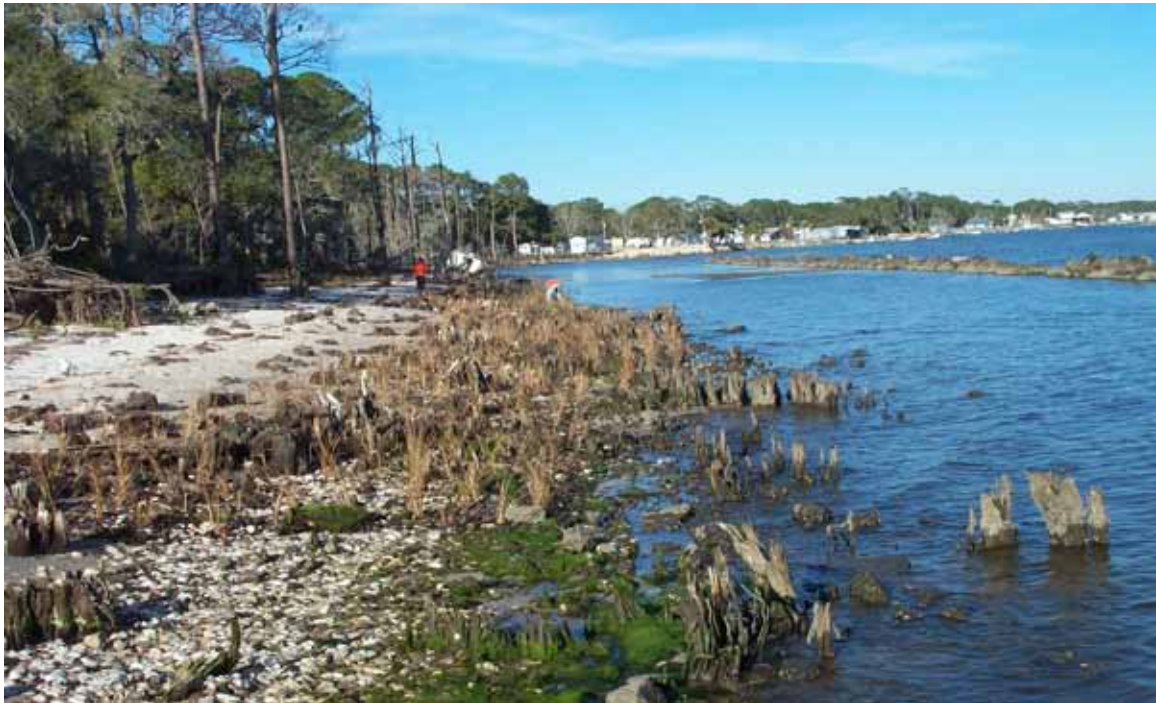
Figure 16. Supplemental planting of marsh during January 2007. Approximately 1500 plants were added after relatively high mortality was experienced.
