TATE'S HELL – WHISKEY GEORGE/SUMATRA MITIGATION SITES
Annual Monitoring Report, 2011, Year 2 of 5
December 15, 2011

USACE Permit No.: SAJ-2008-04457 (NW-RLT), issued 3/10/2010

Mitigation: Tate's Hell – Whiskey George and Sumatra Savannas
Hydrologic Restoration Project, Franklin County

Date of Inspection: November 16 & 17, 2011

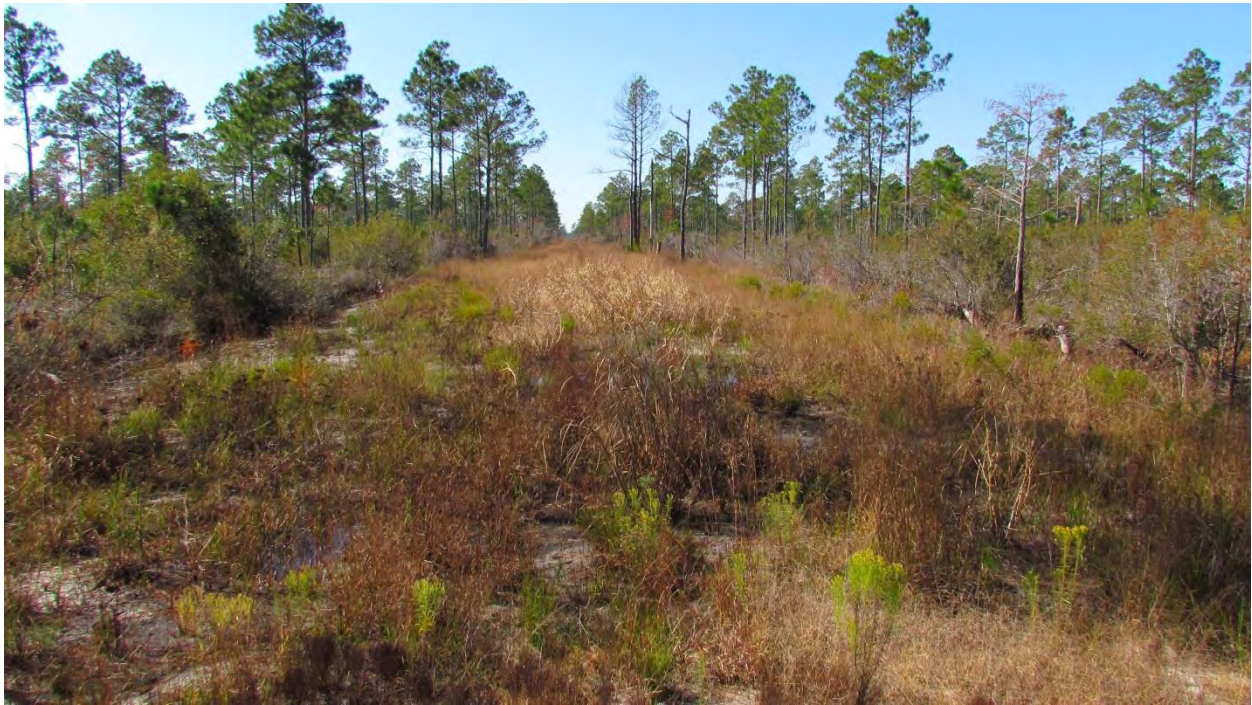
In the Whiskey George restoration area, roadside ditches were remaining at several locations. At Photo Point 1 the north side ditch was evident ([Photo 1](#)) although groundcover showed good recolonization. Other area had similar recruitment despite occasional low, wet areas ([Photo 2](#)). At Photo Point 3, ditches remained intact and the ditch plugs not very effective, with water bypassing the plug on one side and flowing in the ditch. The old roadway was relatively bare for several hundred feet eastward, then had encroachment by titi, then was relatively bare again to and beyond Photo Point 4 ([Photo 3](#)).

Photo 1. Whiskey George road removal, Photo Point 1, looking west. 11/17/2011.

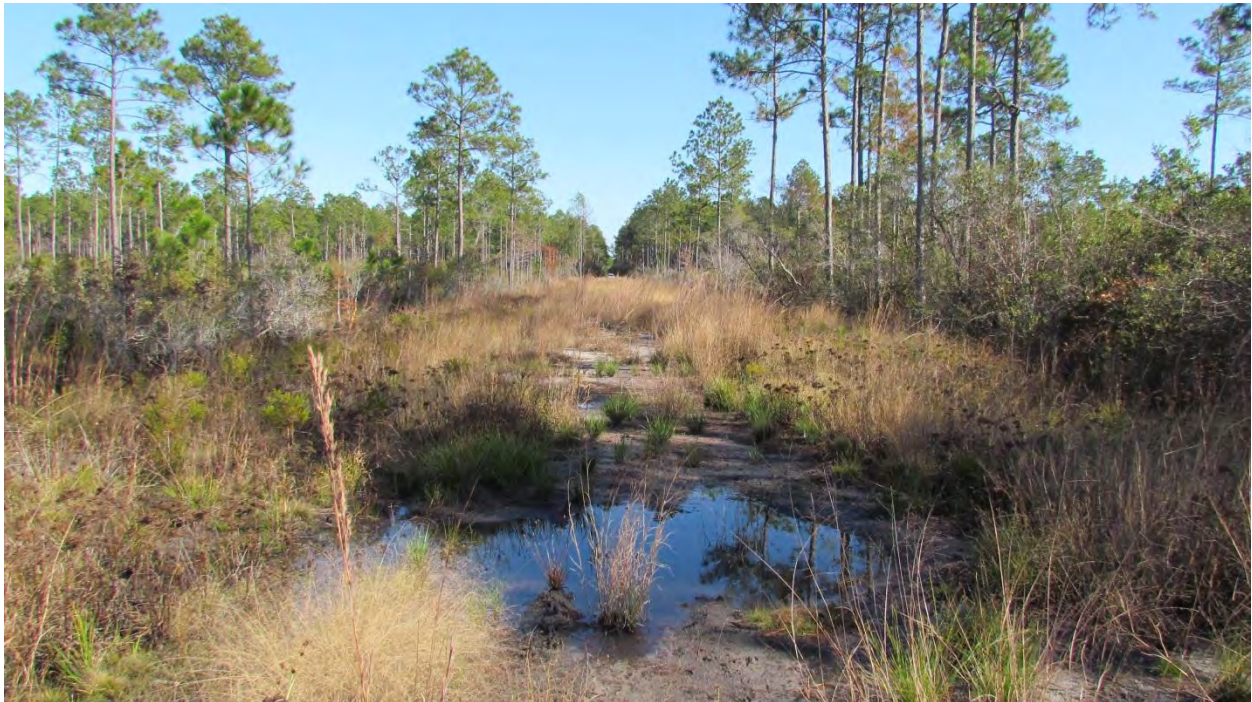
Photo 2. Whiskey George road removal, Photo Point 2, looking east. Low, wet area. 11/17/2011.

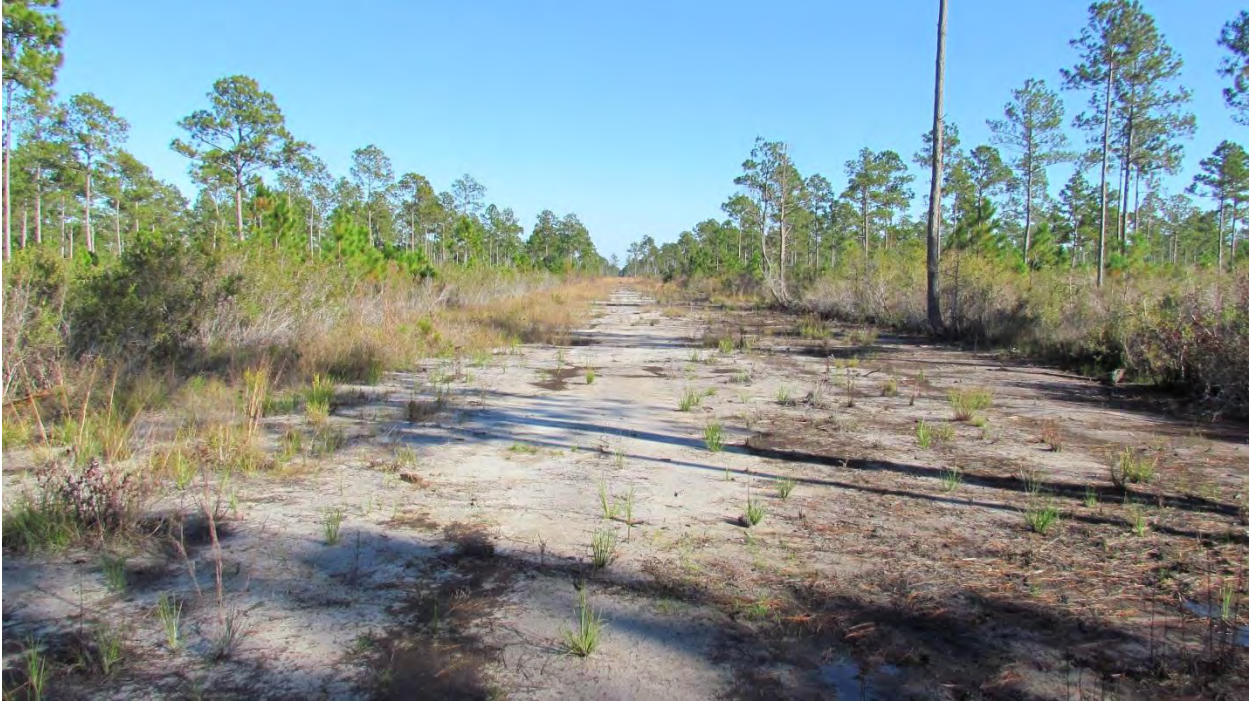
Photo 3. Whiskey George road removal with extensive patch of bare ground. Photo Point 4, looking east. 11/17/2011. [RTN](#)

Extensive linear patches of bare ground or wet depressions can impede the sweep of fire across the landscape. FFS will need to take that into account when conducting prescribed fire and plan a firing strategy accordingly. It is hoped that re-graded areas will not be used as fire breaks, scraping vegetation to bare ground. These areas need fire to stimulate continued colonization and control undesirable shrubs. A possible benefit could come, however, if fire lines are plowed that improve the natural grade, smoothing out differences between elevated old roadways and incompletely filled ditches.

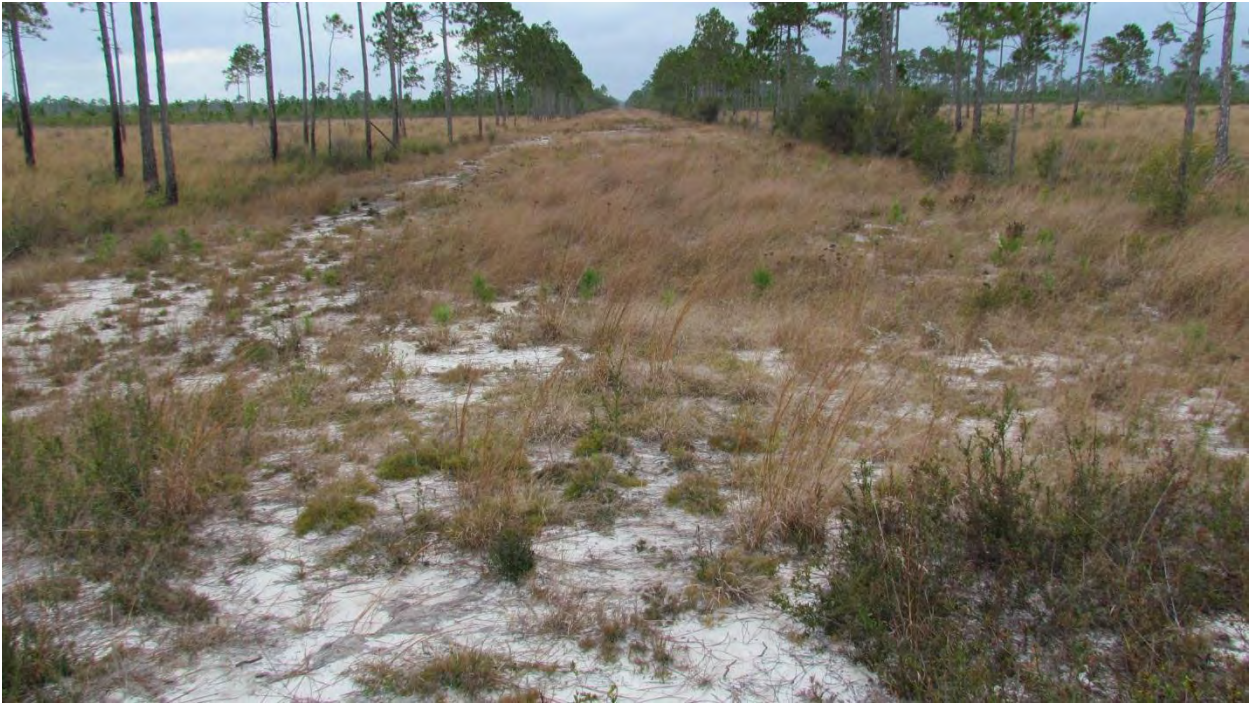
In the Sumatra restoration area, the western low water crossing was problematic in that the roadbed was at a lower elevation than the drainages on the sides of the road, causing ponding in the road. Some areas where roads and ditches had been removed had a thick, continuous ground cover ([Photos 4](#) and [5](#)), while other areas were patchy or had very little cover. Ditches were still evident in some areas and served as ponds with water lilies ([Photo 6](#)). Extensive ditching remained from Photo Point 9 east to Photo Point 10 and even a good distance further east, and at Photo Point 11 southward. The ditch plugs at the end of the road removal at Photo Point 11 were not intact; functioning ditch plugs were found further south. Several large bare areas ([Photos 7](#) and [8](#)) were still evident. Near Photo Point 9 an old tire was noted in the north ditch. Just south of Photo Point 11, titi was encroaching onto the old roadway ([Photo 7](#)).

Photo 4. Sumatra Savannas road removal with good tie in with surrounding landscape. Photo Point 3, looking west. 11/16/2011. [RTN](#)

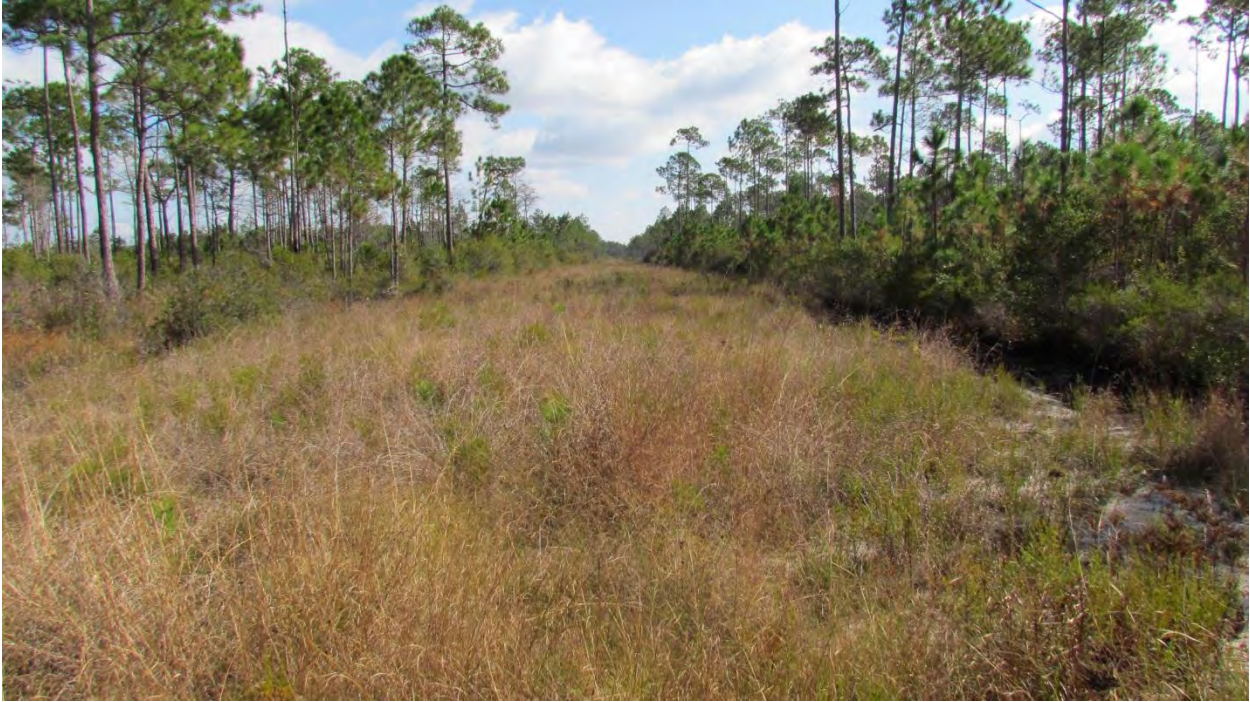
Photo 5. Sumatra Savannas road removal; ditch remains on right. Photo Point 6, looking east. 11/17/2011. [RTN](#)

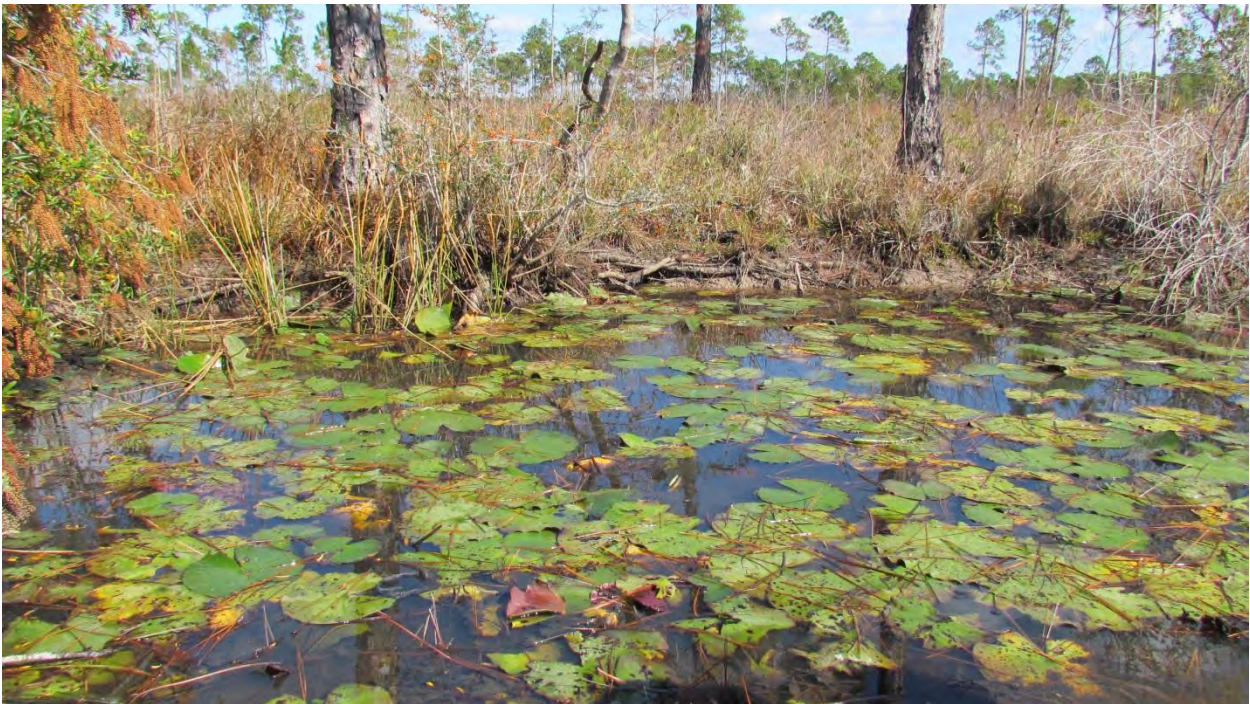
Photo 6. Sumatra Savannas road removal; remnant ditch with water lilies and small fish. Photo Point 8, northeast corner. 11/17/2011. [RTN](#)

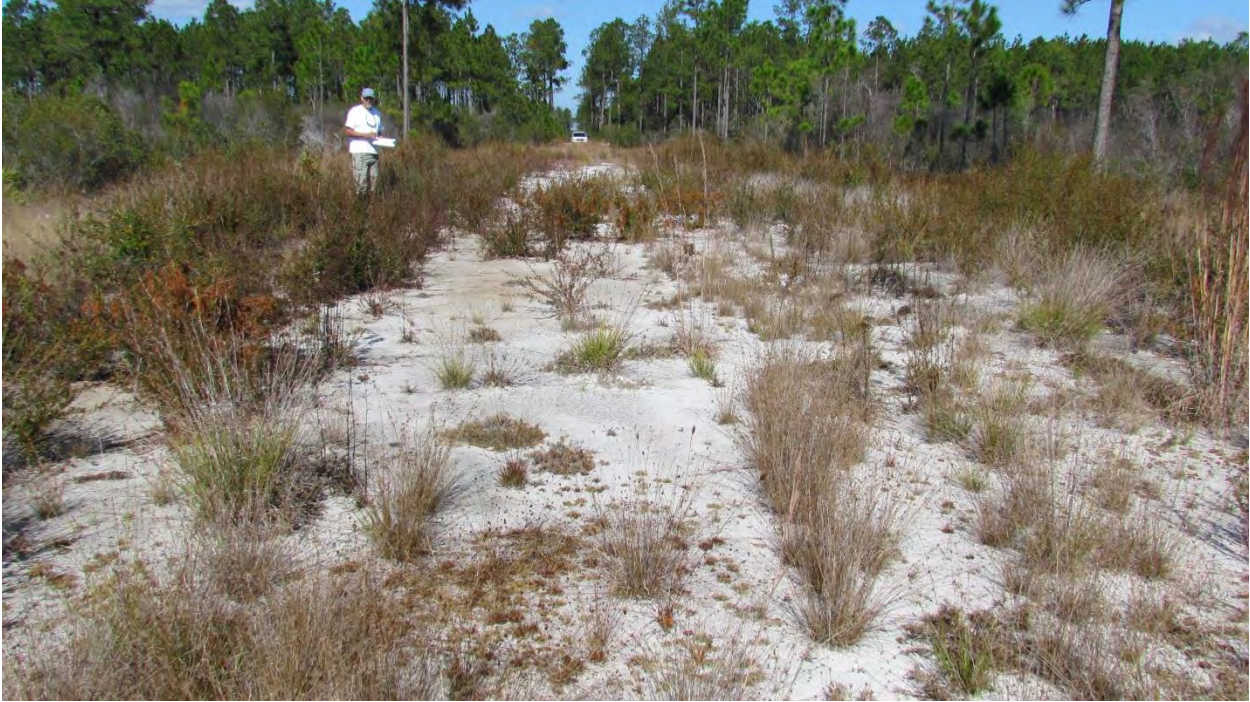
Photo 7. Sumatra Savannas road removal with titi encroaching. Between Photo Points 11 & 12, looking north. 11/17/2011. [RTN](#)

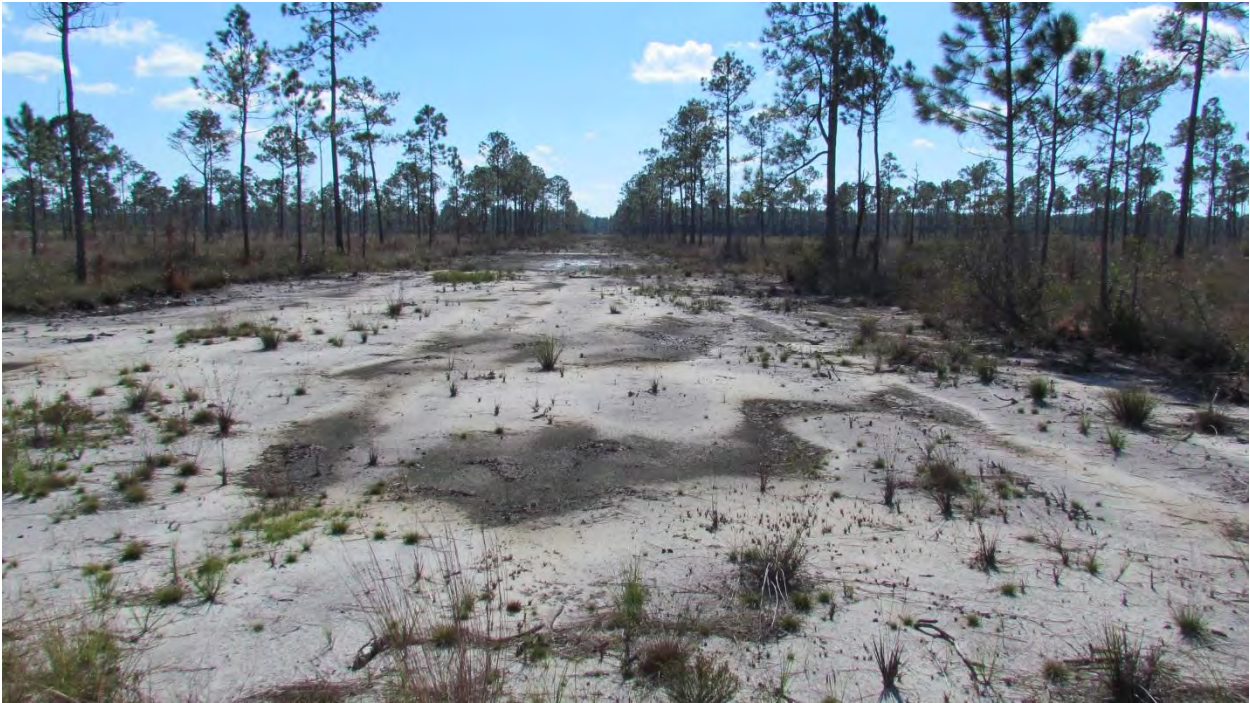
Photo 8. Sumatra Savannas road removal with extensive patch of bare ground. Photo Point 12, looking south. 11/17/2011. [RTN](#)
