WHISKEY GEORGE AND SUMATRA SAVANNAS - FIRST ANNUAL MONITORING REPORT (2010)
Franklin County

Monitoring date: February 23 and March 4, 2010

Tate's Hell State Forest
Hydrologic Improvement Monitoring: Whiskey George and Sumatra Tracts
Appendix B. Photographic Documentation

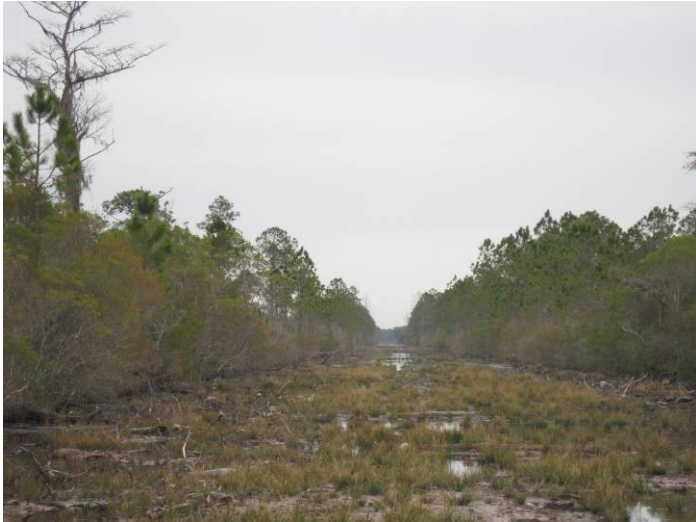
- **Segment 5:** The majority of this segment has been under-excavated by 3-4 inches. There are occasional pockets of inundation within the road interior; however, the majority of the segment (60%) remains exposed. Vegetative coverage comprises nearly a third of the segment; see **Appendix B, Photograph 1**, and consists of early successional species, *i. e.*, various rushes, sedges, wetland grasses, and titi (*Cliftonia* and *Cyrilla*), typical to the area. No nuisance or exotic species were observed. Approximately 75% of ditching remains visible. Portions of these ditches provide deep and persistent pockets of standing water as evidenced by the presence of water lilies (*Nuphar* sp.); see **Appendix B, Photograph 2**.

1. Sumatra Tract. Segment 5. Under-excavated road segment

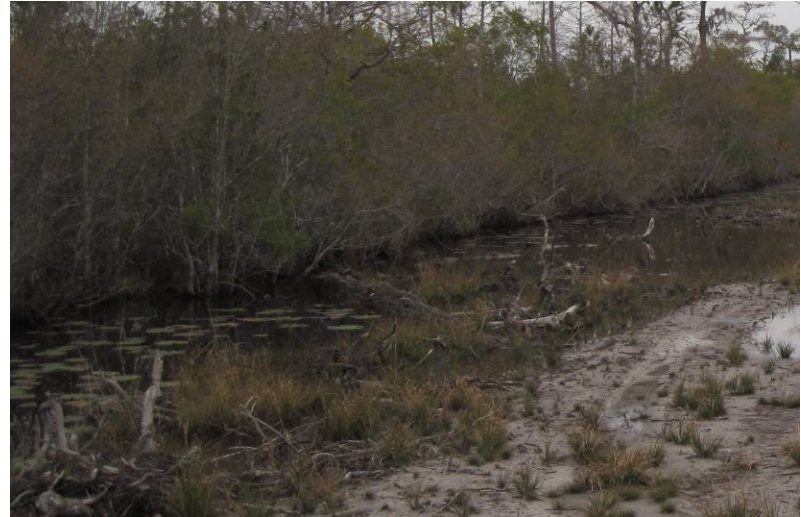
2. Sumatra Tract. Water lilies sustained in unfilled ditches.

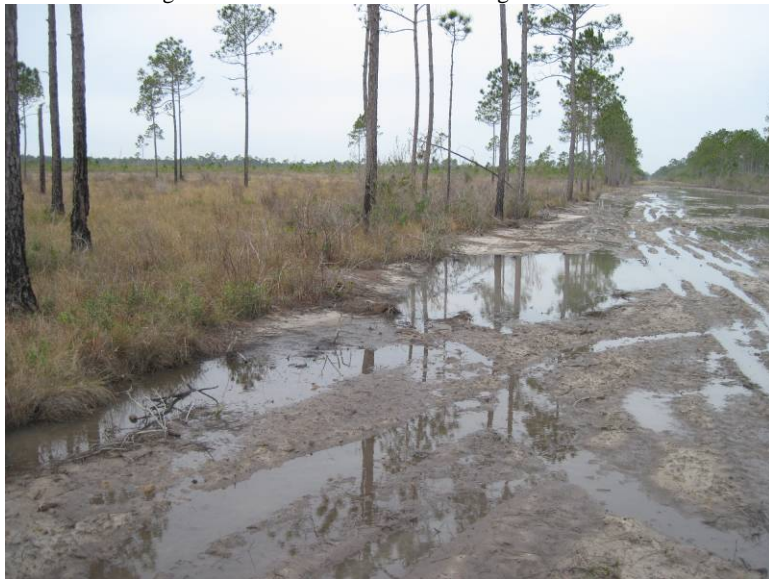
- **Segment 6:** Excavation grade is appropriate throughout most of Segment 6; see **Appendix B, Photograph 3**. An exception is an approximately 200 feet over-excavated section in the eastern reach; see **Appendix B, Photograph 4**. Road edges have 90-95% vegetative cover while recruitment remains sparse within the interior portions; see **Appendix B, Photograph 5**. Vegetation consists of early successional species, *i. e.*, rushes, sedges, wetland grasses, and titi (*Cliftonia* and *Cyrilla*), typical to the area. No nuisance or exotic vegetation was observed. All ditching within this segment has been filled. Minor erosion was observed in places along the barren roadway and highly turbid water was noted in the adjacent roadside ditches. The road access crossbar has not been installed at the eastern terminus (intersection with Tower Road).

3. Sumatra Tract. Segment 6. Appropriate grading

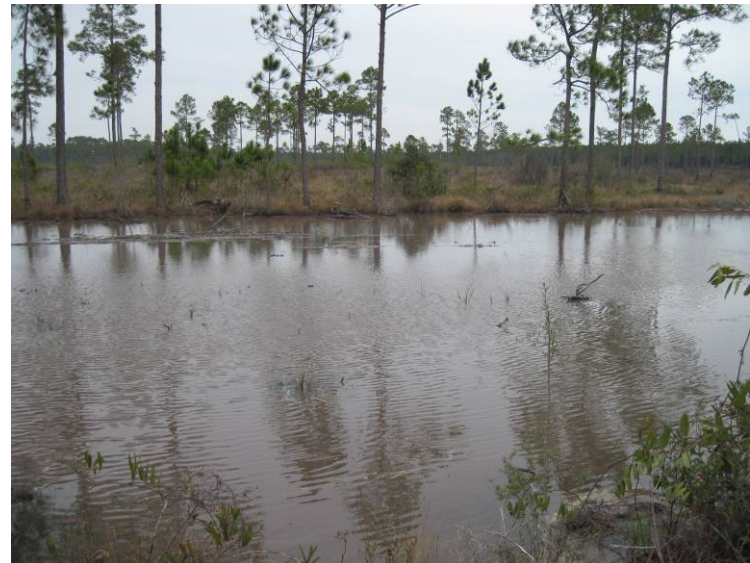
4. Sumatra Tract. Road Removal 16-3. Over-excavation

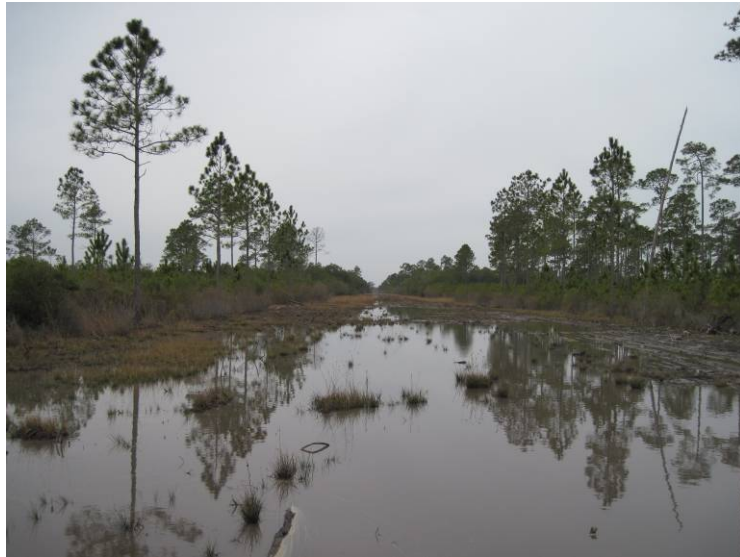
5. Sumatra Tract. Segment 6. Vegetative growth along road margins and interior.

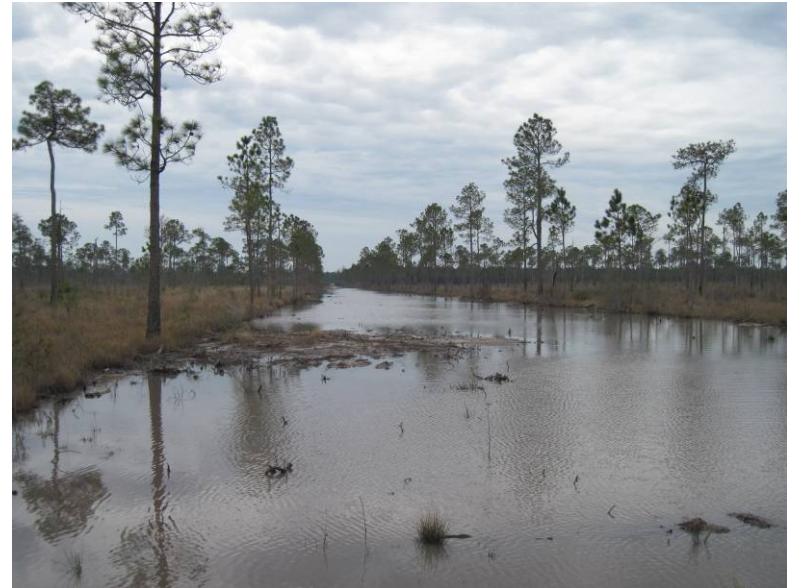
- **Segment 7:** The portion of this segment occurring south of the Segment 5/6 intersection is generally over-excavated and characterized by widespread inundation (2-3 inches) and 10-20% aerial coverage by herbaceous and/or woody shrub recruitment; see **Appendix B, Photograph 6**. By contrast, the segment occurring north of the intersection is largely exposed (non-inundated), yet also poorly vegetated; see **Appendix B, Photograph 7**. What vegetation exists consists of early successional species, *i. e.*, rushes, sedges, wetland grasses, and titi (*Cliftonia* and *Cyrilla*), typical to the area. No nuisance or exotic vegetation was observed. Approximately 5% of ditching remains throughout the segment. Minor erosion was observed along the earthen berm and turbid pockets of standing water were common within the decommissioned roadway.

6. Sumatra Tract. Segment 7. Over-excavation

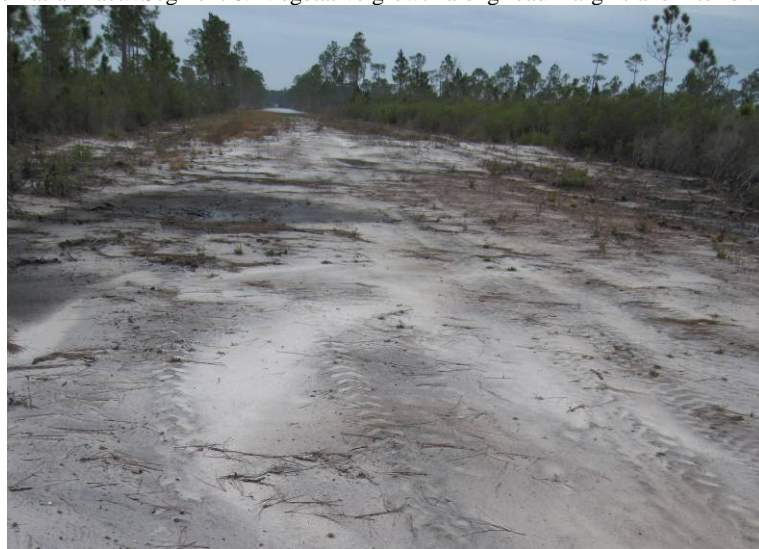
7. Sumatra Tract. Segment 7. Non-inundated segment.

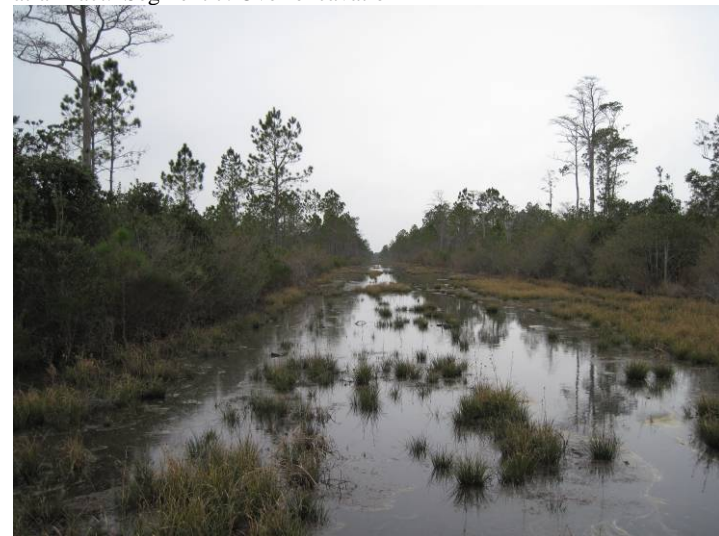
- **Segment 8:** The eastern half of this segment has been appropriately excavated, and the grade of the road matches adjacent communities; see **Appendix B, Photograph 8**. Nearly two-thirds of this reach is vegetated with early successional herbaceous species. The western half of this segment has been slightly over-excavated by 3-4 inches. This reach was fully inundated with little to no vegetative cover; see **Appendix B, Photograph 9**. Less than 5% of ditching remains throughout this segment. No nuisance or exotic vegetation was observed.

8. Sumatra Tract. Segment 8. Appropriate grading throughout eastern half.

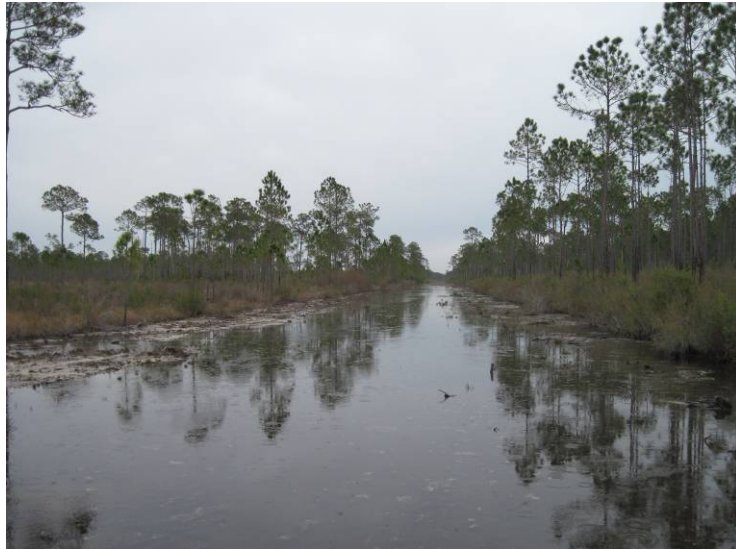
9. Sumatra Tract. Segment 8. Over-excavation throughout western half.

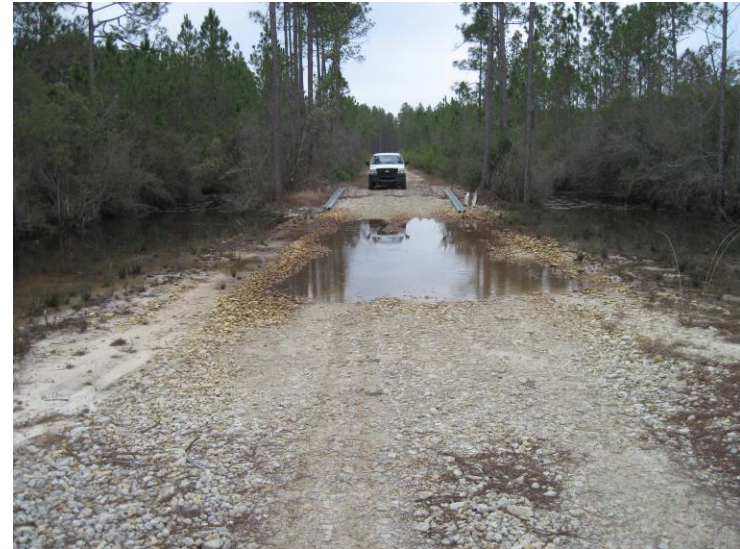
10. Sumatra Tract. WGS5.

- **WGS5:** This crossing has been appropriately graded and allows water movement from east to west with little-to-no sign of erosion; see **Appendix B, Photograph 10**. The side slopes appear to be properly stabilizing as sand accretion and herbaceous colonization are occurring over the stone-aggregate apron. Deep and persistent pockets of ponded water, as evidenced by the presence of water lilies, are present together side of the crossing. Off-highway vehicle (OFW) access barriers had not been installed at the time of survey.

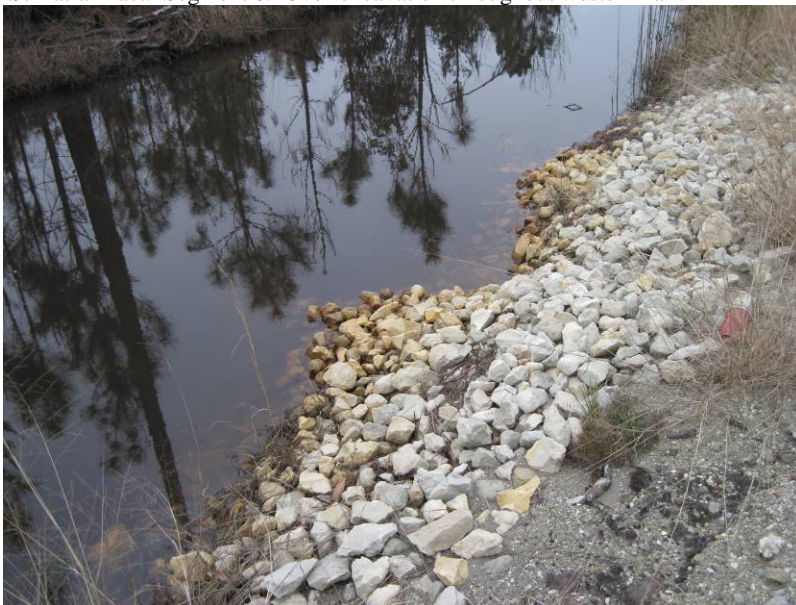
11. Sumatra Tract. Culvert Improvement – C4

- **C4:** Both culverts at this location are fully submerged; see **Appendix B, Photograph 11**. Banks are stabilizing with appropriate vegetation. No nuisance or exotic species were observed. Erosional areas were not observed and road integrity has been properly maintained. Water clarity in and around the culverts is appropriately tannic and non-turbid.

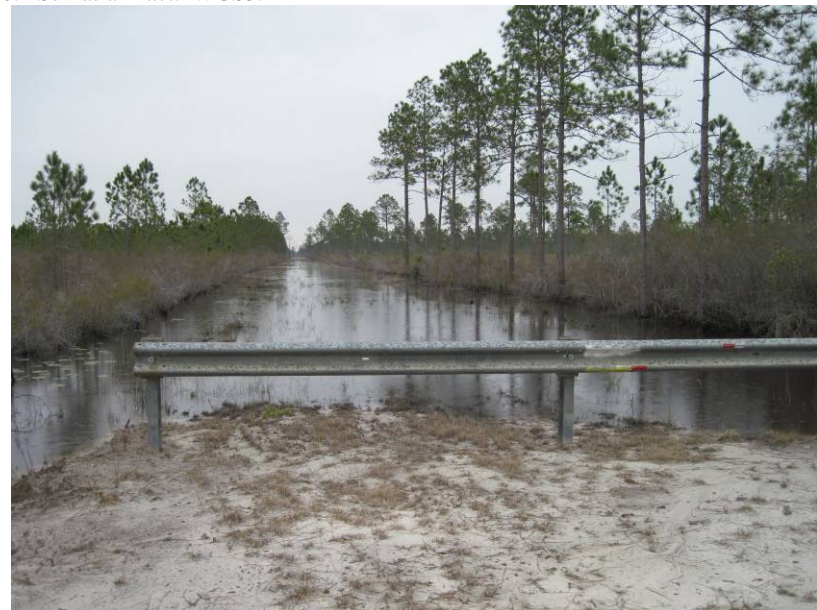
- **Segment 1:** The western third of this segment, occurring between Segment 2 and the western terminus, appears to have been properly excavated so that road grade matches adjacent wetlands. At the time of survey, this reach was fully inundated (2-3 inches) and recruitment of herbaceous and woody shrubs remained sparse; see **Appendix B, Photograph 12**. Moderate erosion and bank instability was apparent surrounding a vehicle turnaround area at the western terminus. The remaining two-thirds of Segment 1 is best characterized as an undulating mix of deeply inundated (>4"), shallowly inundated (1-3"), and fully exposed wetland habitats; see **Appendix B, Photographs 13 and 14**. Vegetation consists of early successional species, *i. e.*, rushes, sedges, wetland grasses, and titi (*Cliftonia* and *Cyrilla*), typical to the area. No nuisance or exotic vegetation was observed. Approximately 5% of ditching remains throughout the segment. No significant erosion was observed.

12. Whiskey George Tract. Segment 1. Full inundation along western reach

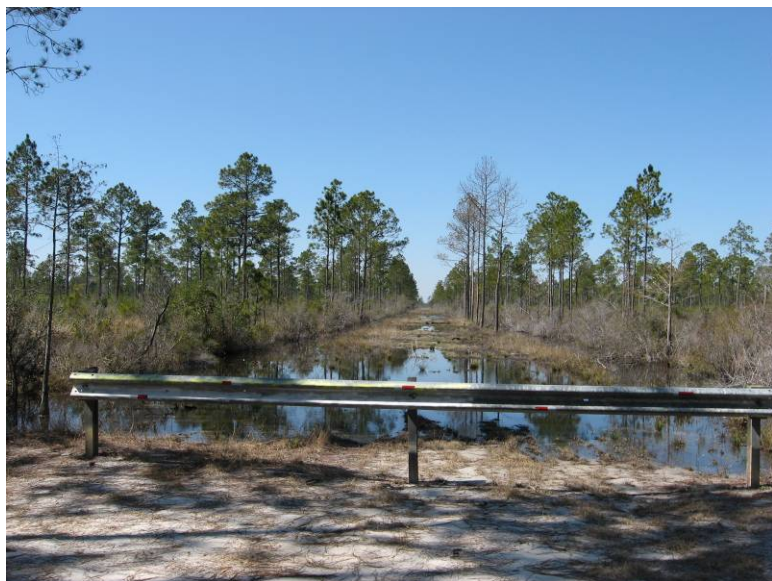
13. Whiskey George Tract. Segment 1. Eastern terminus

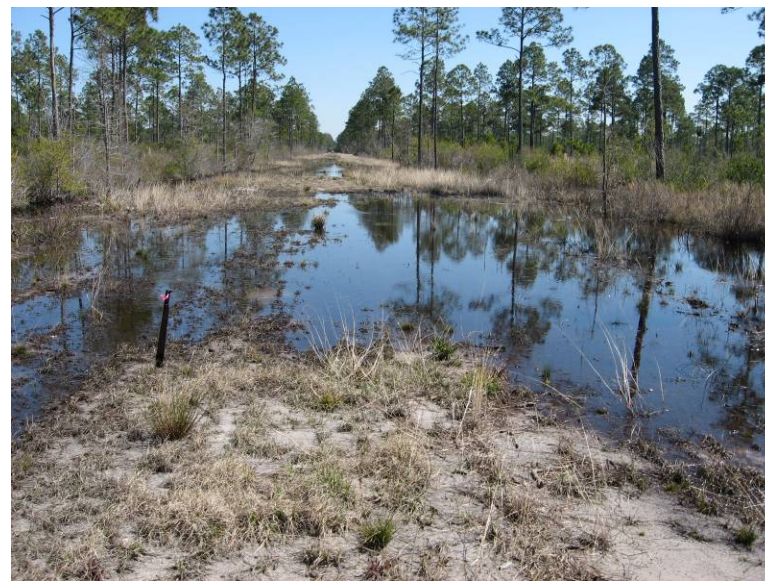
14. Whiskey George Tract. Segment 1. Undulating grade

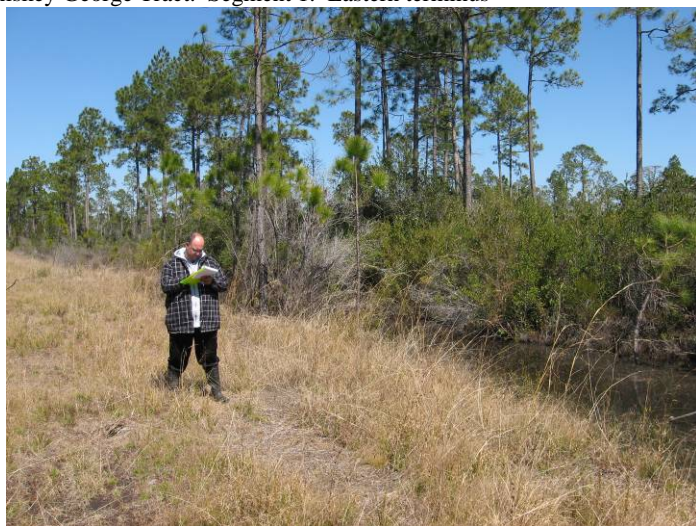
- **Segment 2:** Nearly two-thirds of Segment 2 appears under-excavated with approximately 75% of ditching remaining visible. Interior road segments exist as dry sandy uplands, fully vegetated with a mix of upland and facultative species; see **Appendix B, Photograph 15**. An exception is a 100-foot stretch at the southern extent of the segment which has been appropriately graded to match adjacent wetlands. This area is shallowly inundated (1-2") and has approximately 75% cover by rushes, sedges, and wetland grasses; see **Appendix B, Photograph 16**. Flowering wetland plants such as redroot (*Lachnanthes* sp.), yellow-eyed grass (*Xyris* spp.), and meadowbeauty (*Rhexia* spp.) are also common within the southern reach. No nuisance or exotic vegetation was observed.

15. Whiskey George Tract. Segment 2. Under-excavated interior. Ditching remains

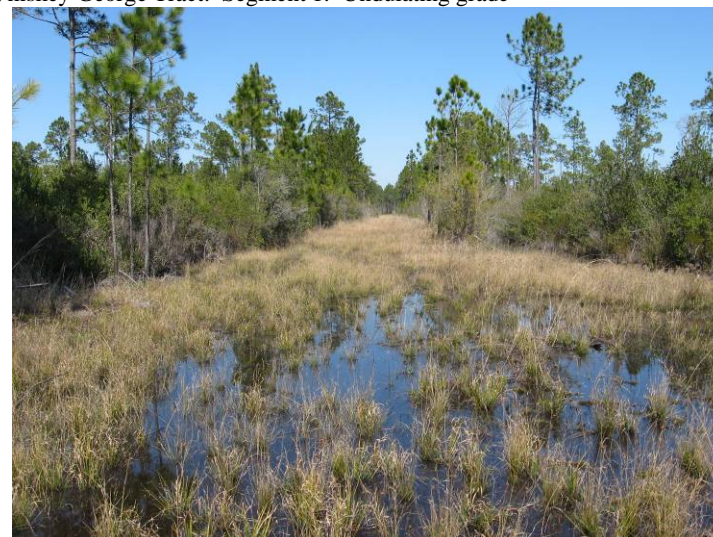
16. Whiskey George Tract. Segment 2. Appropriate grade at southernmost reach.

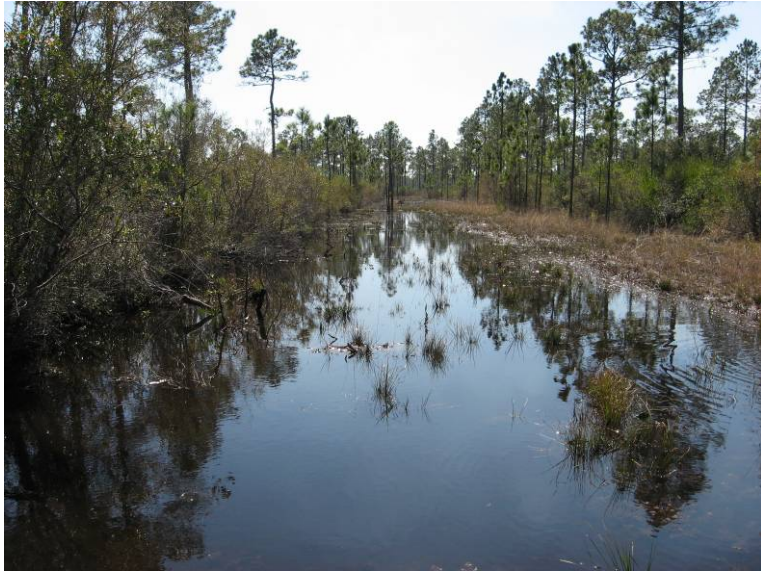
- **Segment 3:** The southern half of this segment is deeply inundated (4-6 inches) with little to no vegetative cover; see **Appendix B, Photograph 17**. Bladderwort (*Utricularia* sp.) is common throughout the deeper inundated portions. By contrast, the northern half of this segment exists as a shallowly inundated (≤ 3 ") wetland with approximately 75% herbaceous groundcover; see **Appendix B, Photograph 18**. Vegetation within this reach consists of early successional species, *i. e.*, various rushes, sedges, wetland grasses, and titi (*Cliftonia* and *Cyrilla*), typical to the area. Approximately 5% of ditching remains. No nuisance or exotic vegetation was observed.

17. Whiskey George Tract. Segment 3. Southern half, deep inundation (4-6")

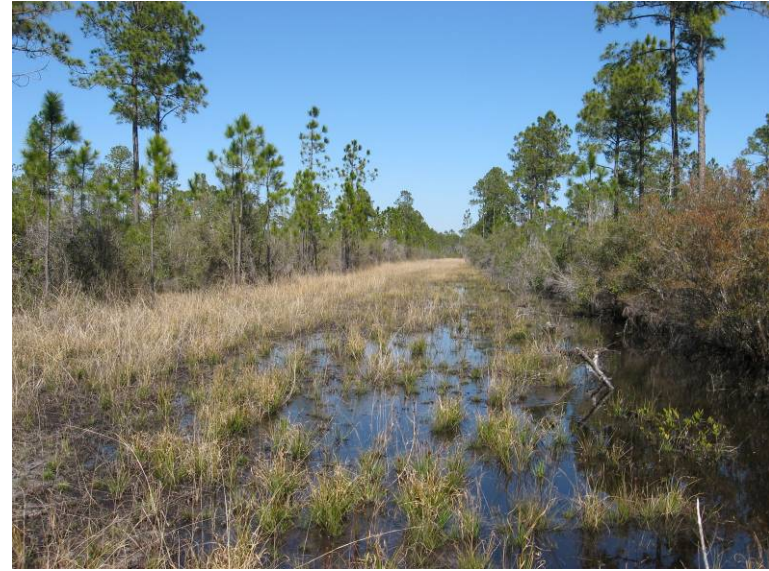
18. Whiskey George Tract. Segment 3. Northern half, shallow inundation (0-3")

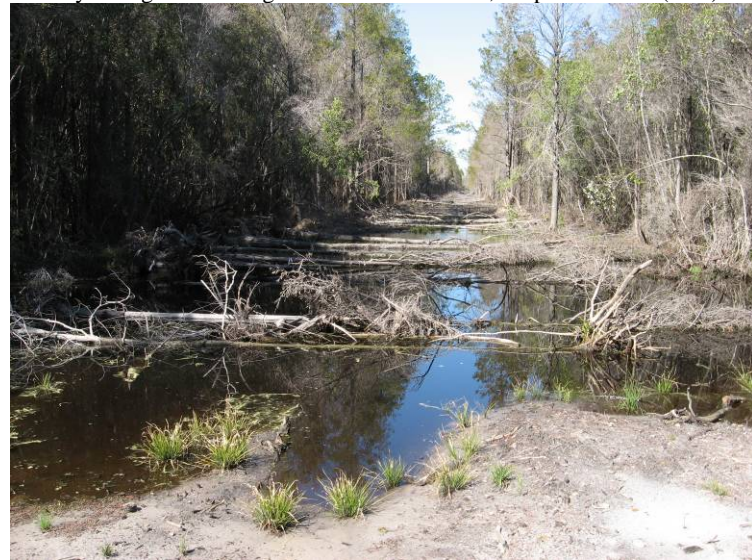
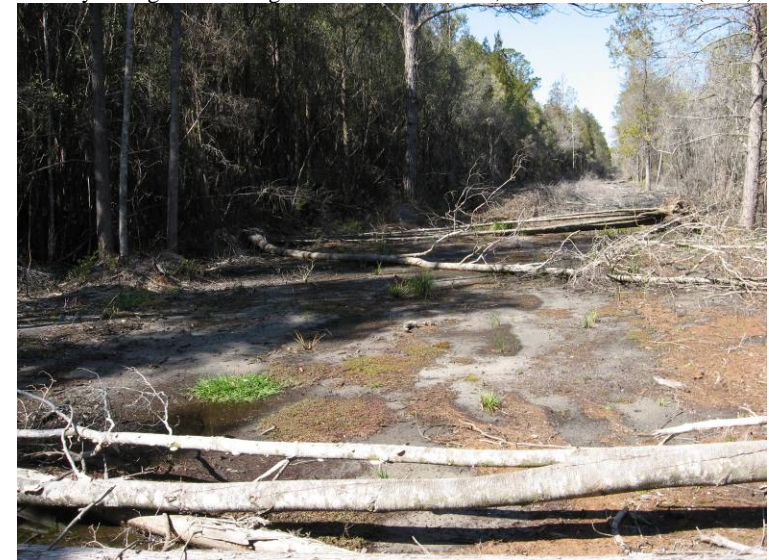
- **Segment 4:** This segment is best characterized as an undulating mix of deep inundated (>6"), shallow inundated (1-3"), and fully exposed wetland habitats; see **Appendix B, Photographs 19 and 20**. Large woody debris is abundant throughout the segment. Vegetative cover is generally sparse (<25%) and is mostly comprised of various sedges, rushes, and wetland forbs. No

19. Whiskey George Tract. Segment 4. Undulating wetlands w/ woody debris

20. Whiskey George Tract. Segment 4. Exposed wetland flats

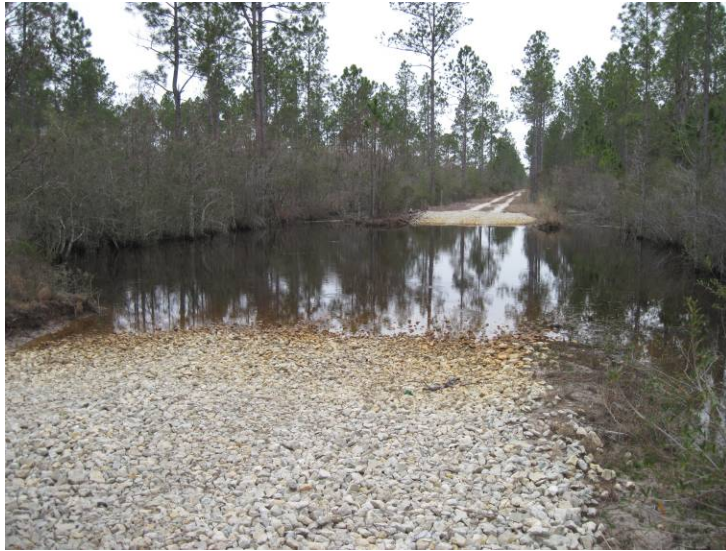
21. Whiskey George Tract. WGS1

- **WGS1:** This crossing has been appropriately graded to allow water movement from west to east with little-to-no sign of erosion; see **Appendix B, Photograph 21**. Sand accretion and herbaceous colonization are actively occurring over the stone-aggregate apron. No significant erosion was observed.

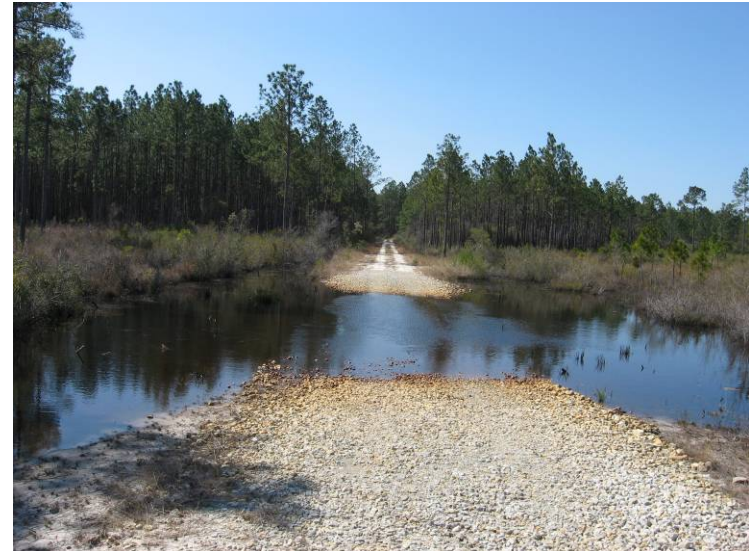
22. Whiskey George Tract. WGS2

- **WGS2:** This crossing has been appropriately graded to allow water movement from west to east; see **Appendix B, Photograph 22**. A one-inch rain event had occurred within 24 hours of this survey. Water velocity was approximately 0.5 feet/second (f/s) through the crossing and maximum depth at the midpoint measured 0.4 feet. No erosion, bank instability, or shifting/washout of the stone apron was evident. Deep and persistent pockets of ponded water, as evidenced by the presence of water lilies, are present to either side of the crossing.

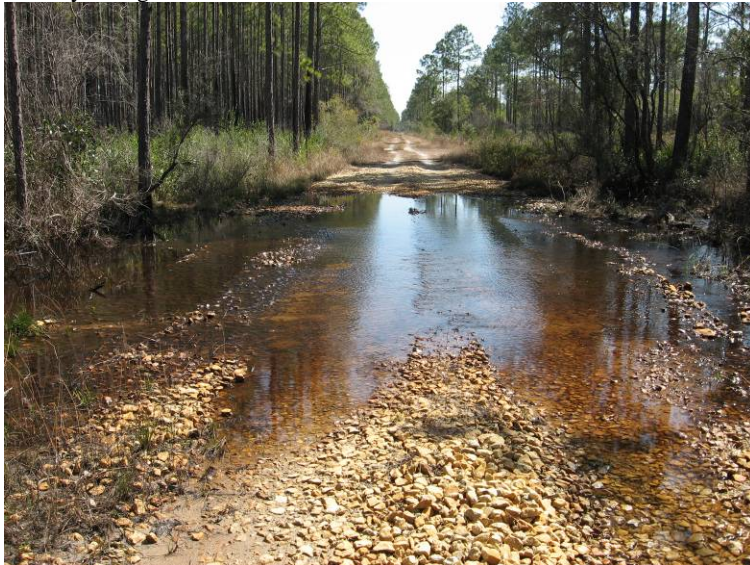
23. Whiskey George Tract. WGS3

- **WGS3:** This crossing has been appropriately graded to allow water movement from north to south with little-to-no sign of erosion; see **Appendix B, Photograph 23**. Sand accretion and herbaceous colonization are actively occurring over portions of the stone-aggregate apron. A one-inch rain event had occurred within 24 hours of this survey.

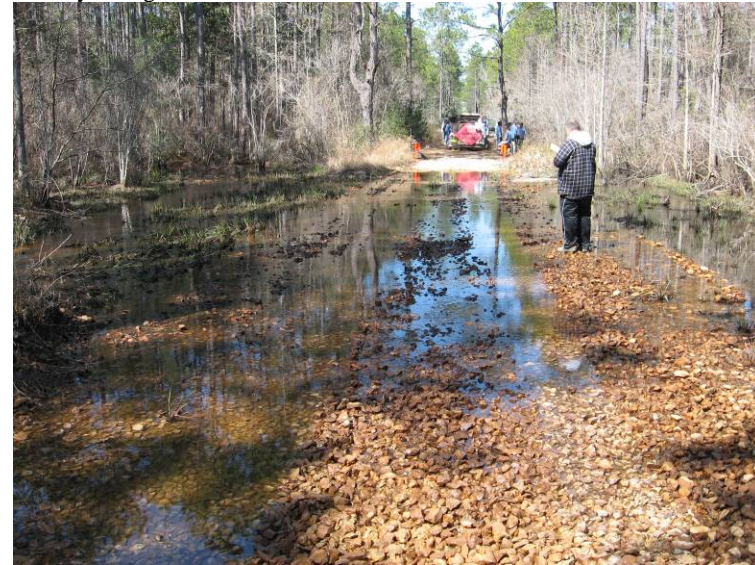
24. Whiskey George Tract. WGS4

- **WGS4:** This is the shallowest crossing of the four assessed within the Whiskey George Tract. A one-inch rain event had occurred within 24 hours of this survey, and despite the shallow grade the crossing did not appear to encumber hydrology which flows north to south; see **Appendix B, Photograph 24**. However, the hydrologic connection may become interrupted during drier periods due to the shallow nature of the grade. Sand accretion and herbaceous colonization are actively occurring over portions of the stone-aggregate apron.

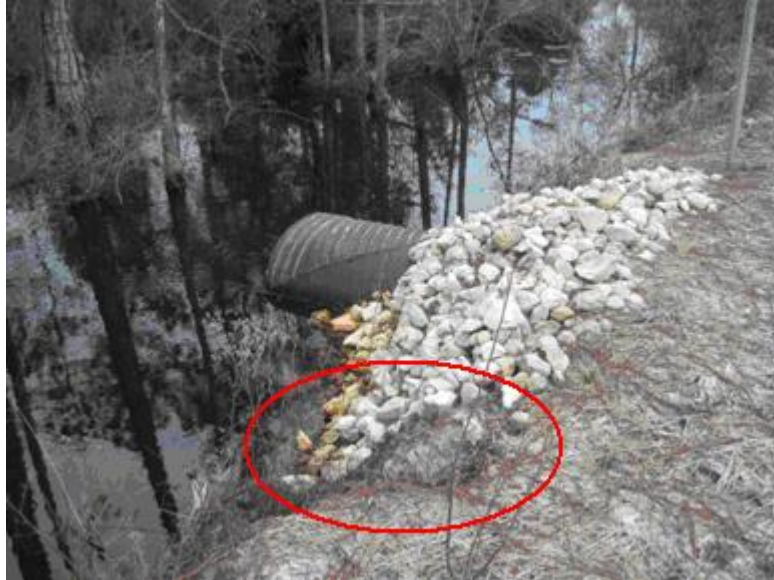
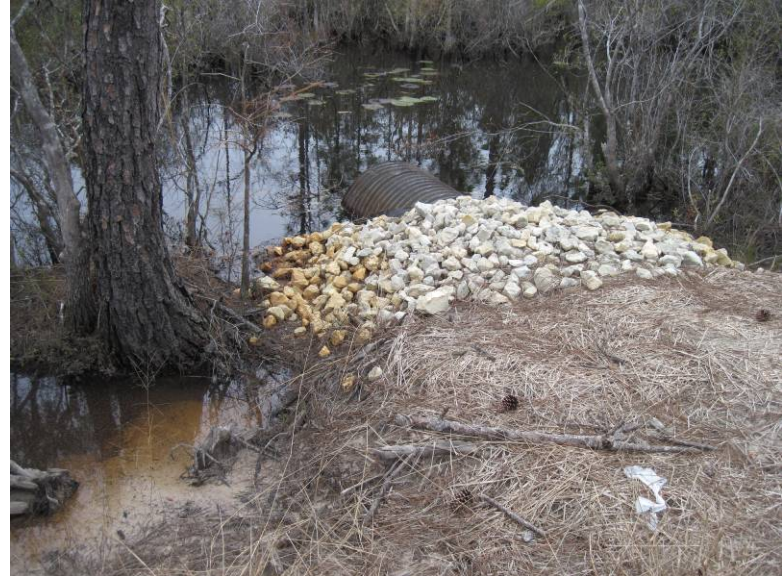
- **C1:** Invert elevation at C1 is appropriate for maintaining a persistent hydrologic connection; see **Appendix B, Photographs 25-26**. Evidence of mulching is apparent; however, vegetation remains sparse along the banks and some erosion/sedimentation is occurring to either side of the rip-rap apron. No nuisance or exotic vegetation was observed.

25. Whiskey George Tract. C1. Circled area highlights minor bank erosion.

26. Whiskey George Tract. C1. Opposing side

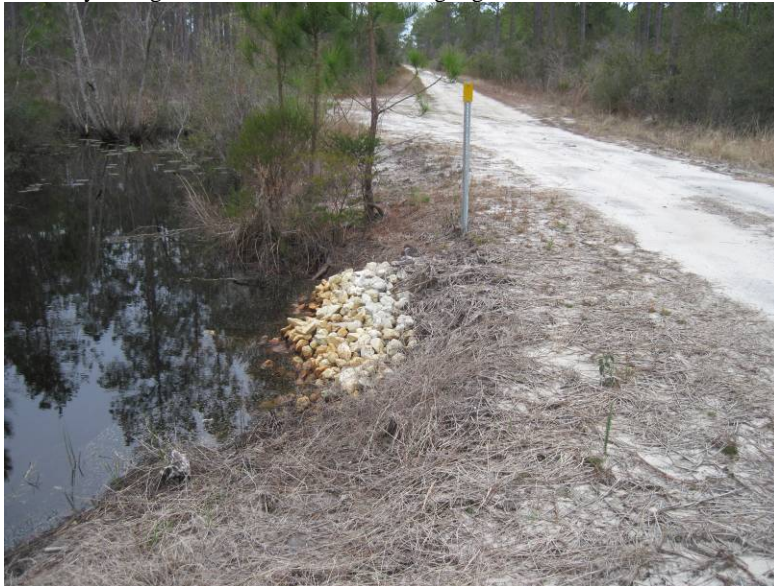
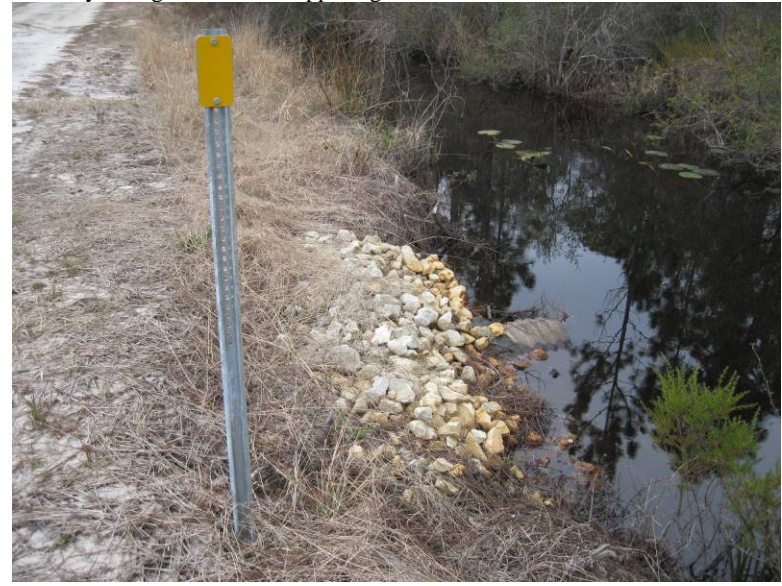
- **C2:** Invert elevation at C2 is appropriate for maintaining a persistent hydrologic connection; see **Appendix B, Photographs 27-28**. Evidence of mulching is apparent; however vegetation remains sparse along the banks. No significant erosion was recorded. No nuisance or exotic vegetation was observed.

27. Whiskey George Tract. C2. South-facing culvert

28. Whiskey George Tract. C2. North-facing culvert

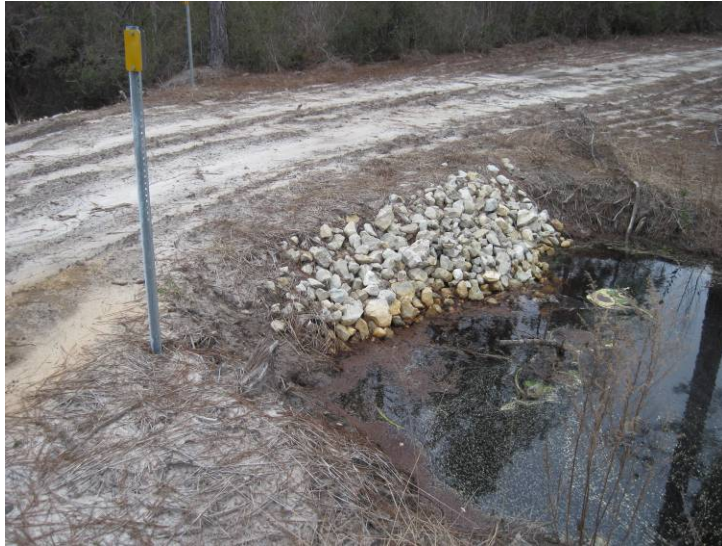
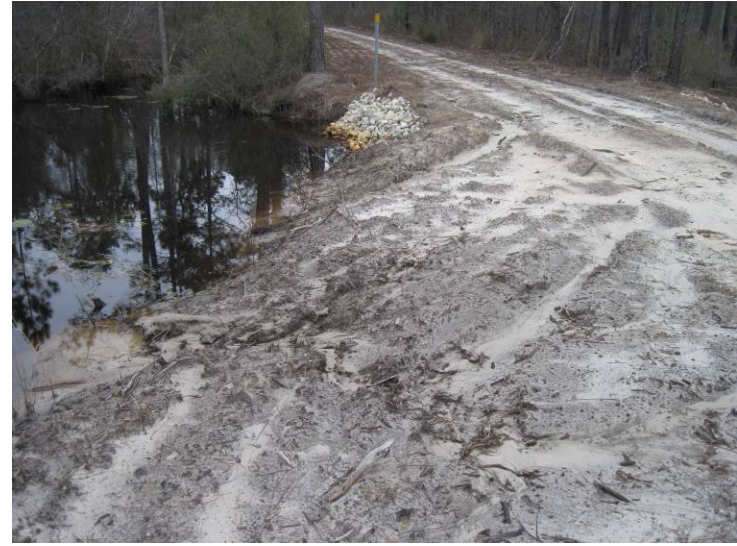
- **C3:** Invert elevation at C3 is appropriate for maintaining a persistent hydrologic connection; see **Appendix B, Photographs 29-30**. No evidence of mulching is apparent and there is considerable erosion along the earthen banks and roadway. While bank stability is currently poor with little to no re-vegetation occurring, in-stream turbidity was minimal. No nuisance or exotic vegetation was observed.

29. Whiskey George Tract. C3.

30. Whiskey George Tract. C3. Moderate erosion in foreground

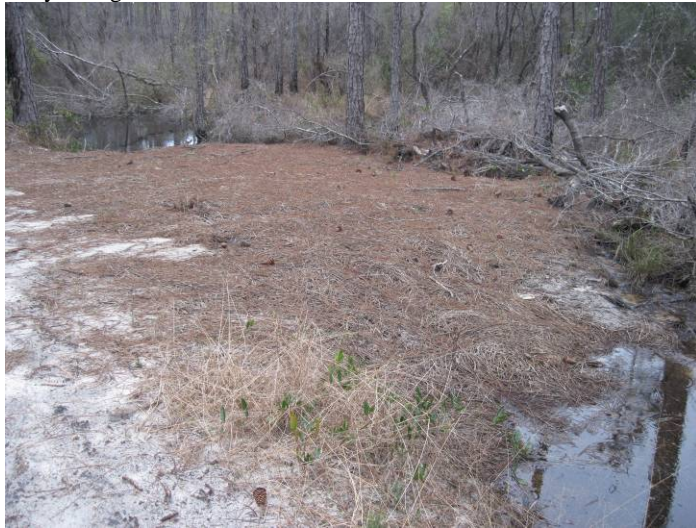
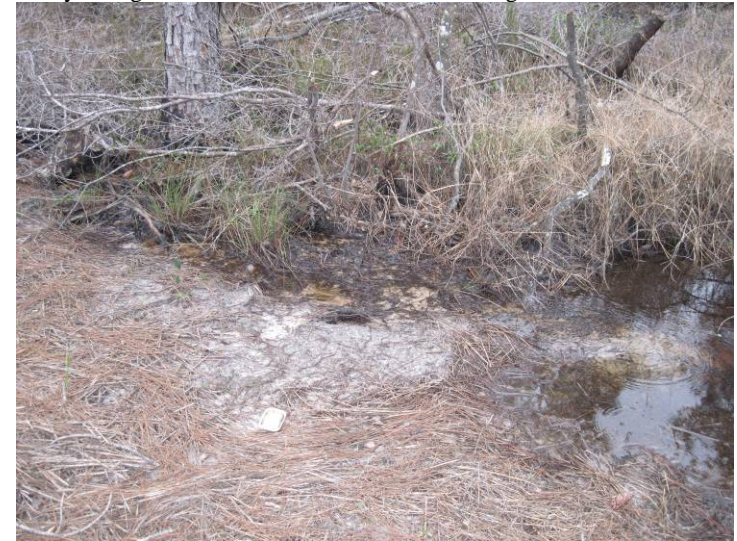
- **DB1:** Water level is approximately one foot higher on the north end of the ditch block (plug) than to the south (see **Appendix B, Photographs 31**) and water is bypassing the plug at the southeast corner; see **Appendix B, Photograph 32**. The plug appears to have been properly mulched; however, little to no revegetation is occurring. Reinforcement of the southeast corner will be necessary to prevent eventual failure of the structure. No nuisance or exotic species were observed.

31. Whiskey George Tract. DB1.

32. Whiskey George Tract. DB1. Water bypassing ditch plug

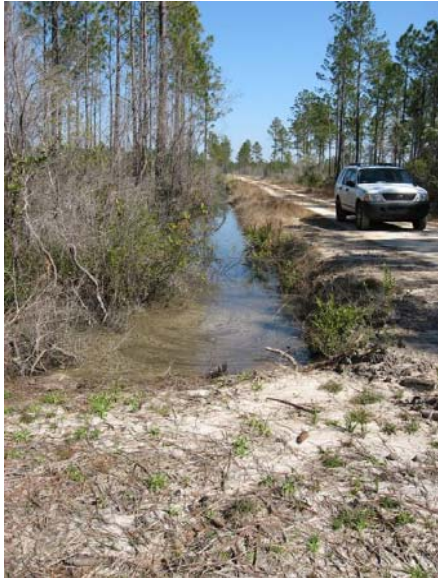
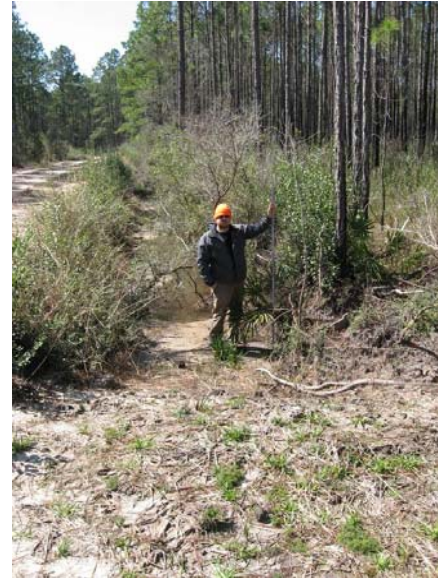
- **DB4:** This plug has effectively blocked water passage through the ditch segment. Ditching north of the plug is completely inundated with stagnant water while the southward ditch is completely dry; see **Appendix B, Photographs 33-34**. WGS2, located approximately one-tenth mile north, alleviates the hydrologic pressure on this plug by allowing flow to redirect into the adjacent wetland. The area has been properly mulched but little revegetation is occurring. No nuisance or exotic species were observed. No significant erosion was recorded.

33. Whiskey George Tract. DB4 facing north

34. Whiskey George Tract. DB4 facing south

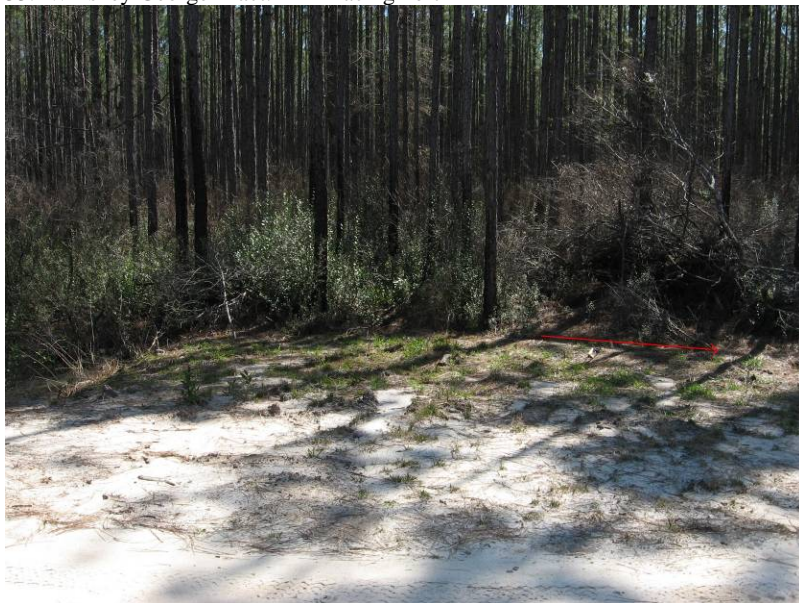
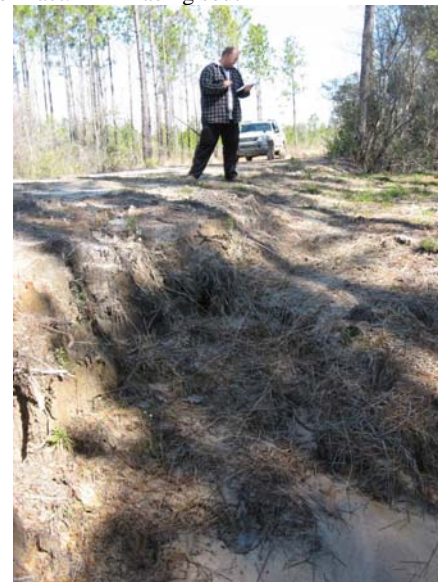
- **DB5:** This plug appears to have effectively blocked water passage through the ditch segment. However, a drift line of rafted debris along the east and southeast plug is suggestive of periodic water bypass during storm events. Some erosion, present along the southern end of the plug, is consistent with stormwater bypass. The area has been properly mulched moderate revegetation is occurring, mostly facultative grasses (*Dicanthelium* spp.) and minimal woody shrub recruitment (*Persea* sp.) Without more aggressive revegetation or earthen reinforcement this plug may be vulnerable to washout during an intense storm event. No nuisance or exotic species were observed.

35. Whiskey George Tract. DB5. Red line indicates water bypass potential

36. Whiskey George Tract. DB5. Erosion along southern bank.
