TREASURE ROAD MITIGATION SITE

2015 Annual Monitoring Report

(27 October 2015)

USACE Permit No.: SAJ-2012-02348 (SP-AWP), issued 3/11/2013

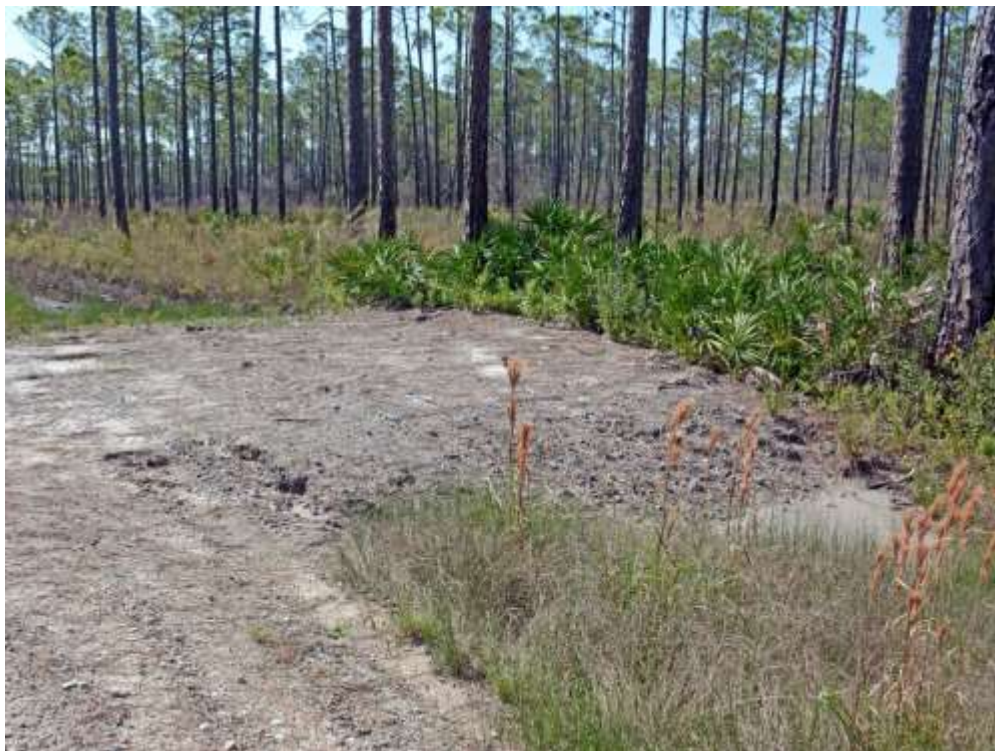
Typical Ditch Plug with Adjacent Hydric Pine Flatwoods in Background (4/8/2015)

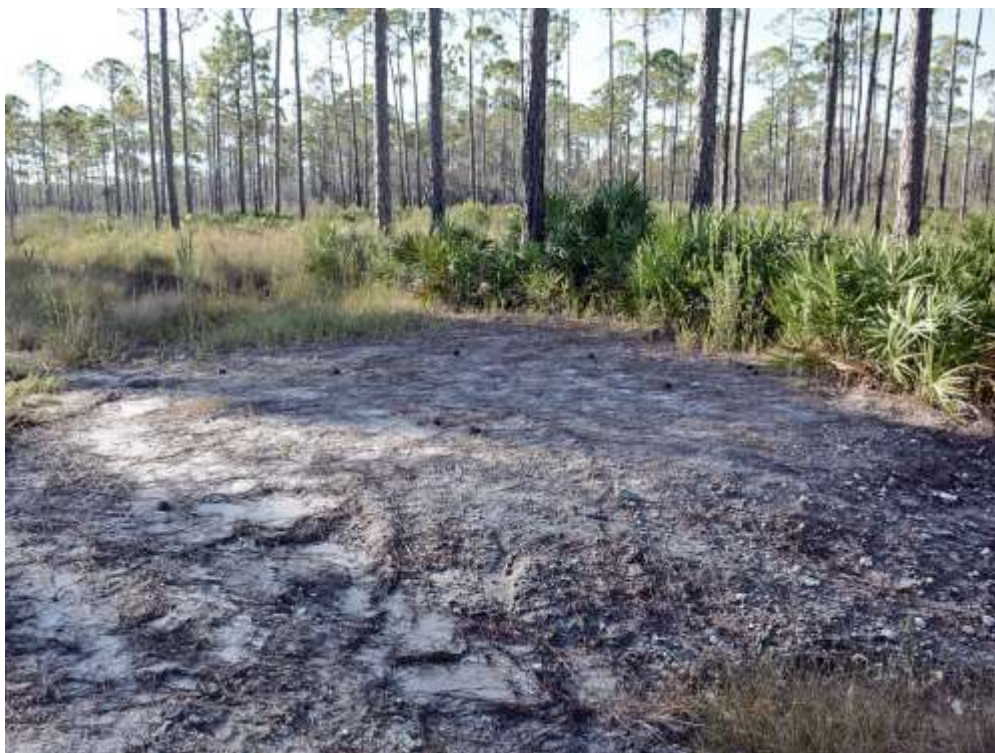
Typical Ditch Plug with Adjacent Hydric Pine Flatwoods in Background (10/15/2015)
