Northwest Florida Water Management District

Re: Semi-annual Report (Progress Report 4)

Please accept this submittal as the semi-annual progress report for the SHLMB.

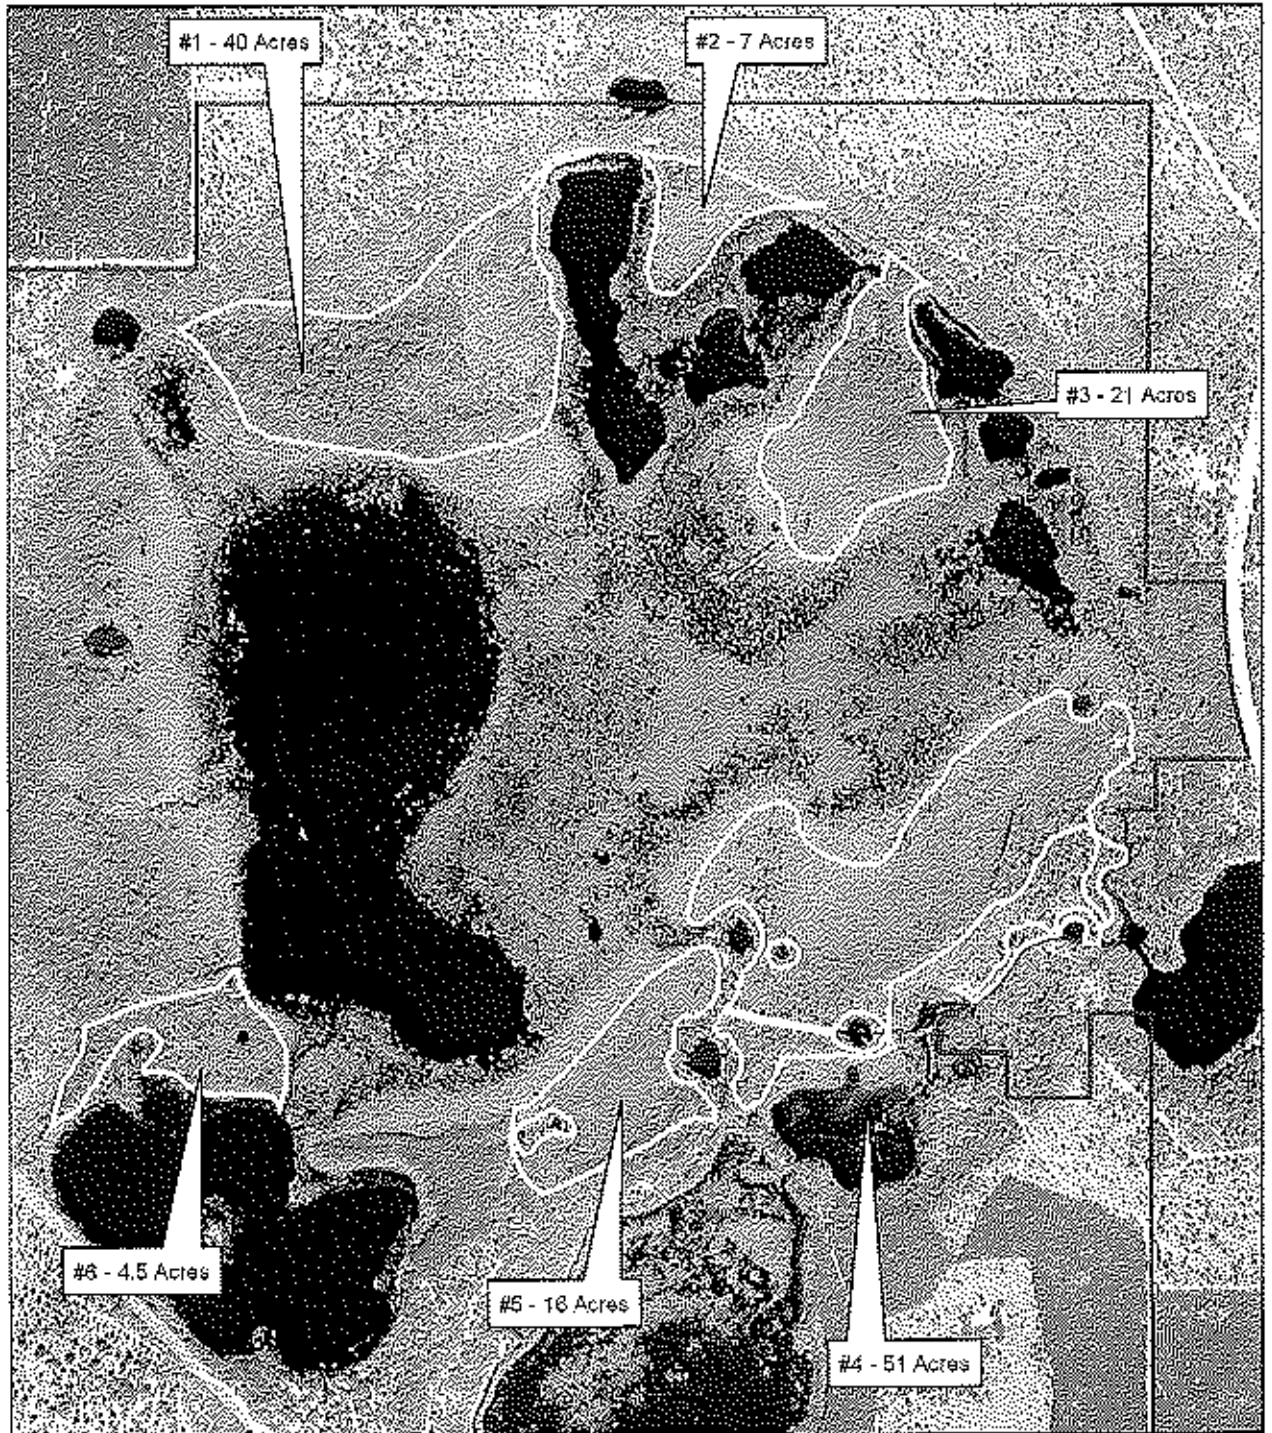
Figure 1. Brush Reduction Polygons

2. A Gyro-track has been used in the wet flatwoods area to reduce the shrub layer (Figure 1). Shrub reduction was initiated in February of 2007 and is expected to be completed by August of 2007. To date approximately 82.5 acres have had shrubs removed. An additional 58 acres will be gyro-tracked by August of 2007.

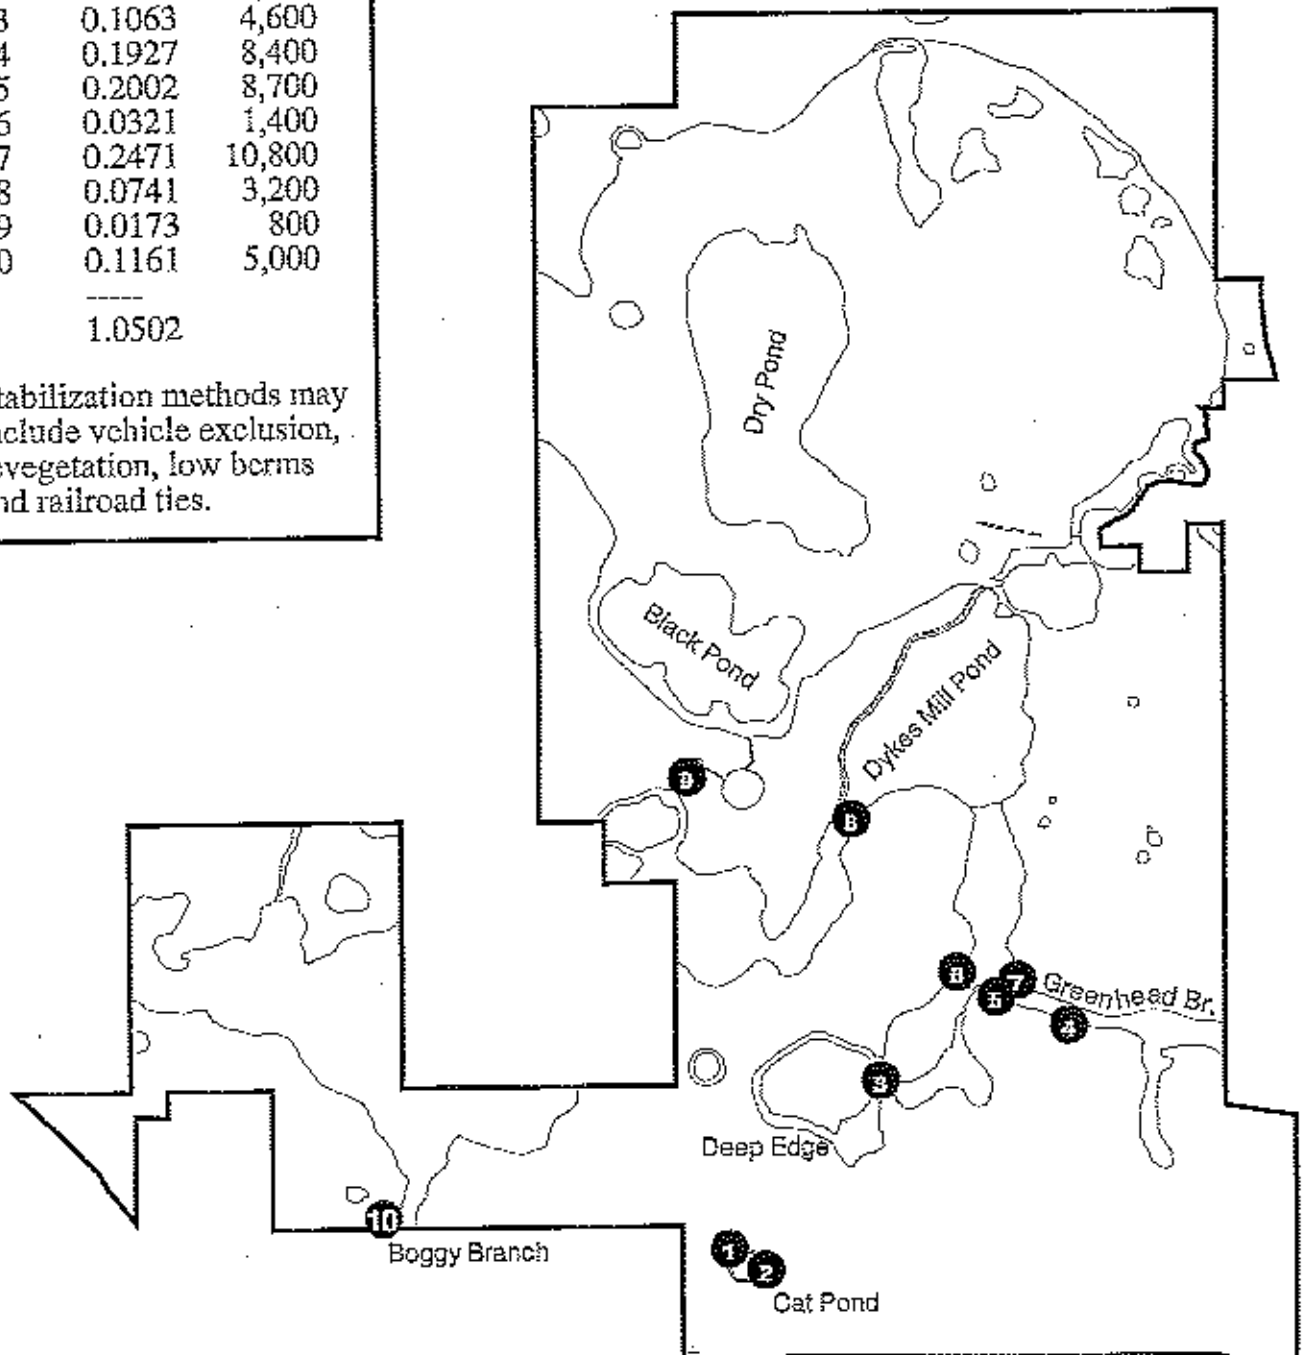
Figure 9 - Erosion Stabilization Sites

4. The remediation of erosion areas #6 occurred as part of erosion control in summer of 2006 (Figure 9). Remediation of three road-fill crossings and remaining 9 erosion areas was initiated January, 2007 and completed in March of 2007 (Figure 9 and 10 and Typical Road Cut Sheet 3 of 7). Silt fences and turbidity barriers were installed and maintained. Following earth moving annual rye grass was planted. Erosion areas were planted within 30 days in accordance with the planting plan (Attachment D). Wire grass was planted on 3' centers.

-Scattered Bahia grass seedlings have been observed within the erosion stabilization areas #1, #2, #3 and #10. Orange Hill Soil and Water Conservation District inadvertently applied mulch contaminated with Bahia grass seed to the sites listed above. Orange Hill has agreed to herbicide all Bahia grass within these areas using hand sprayers and appropriate chemicals as well as re-plant any damaged plant material.

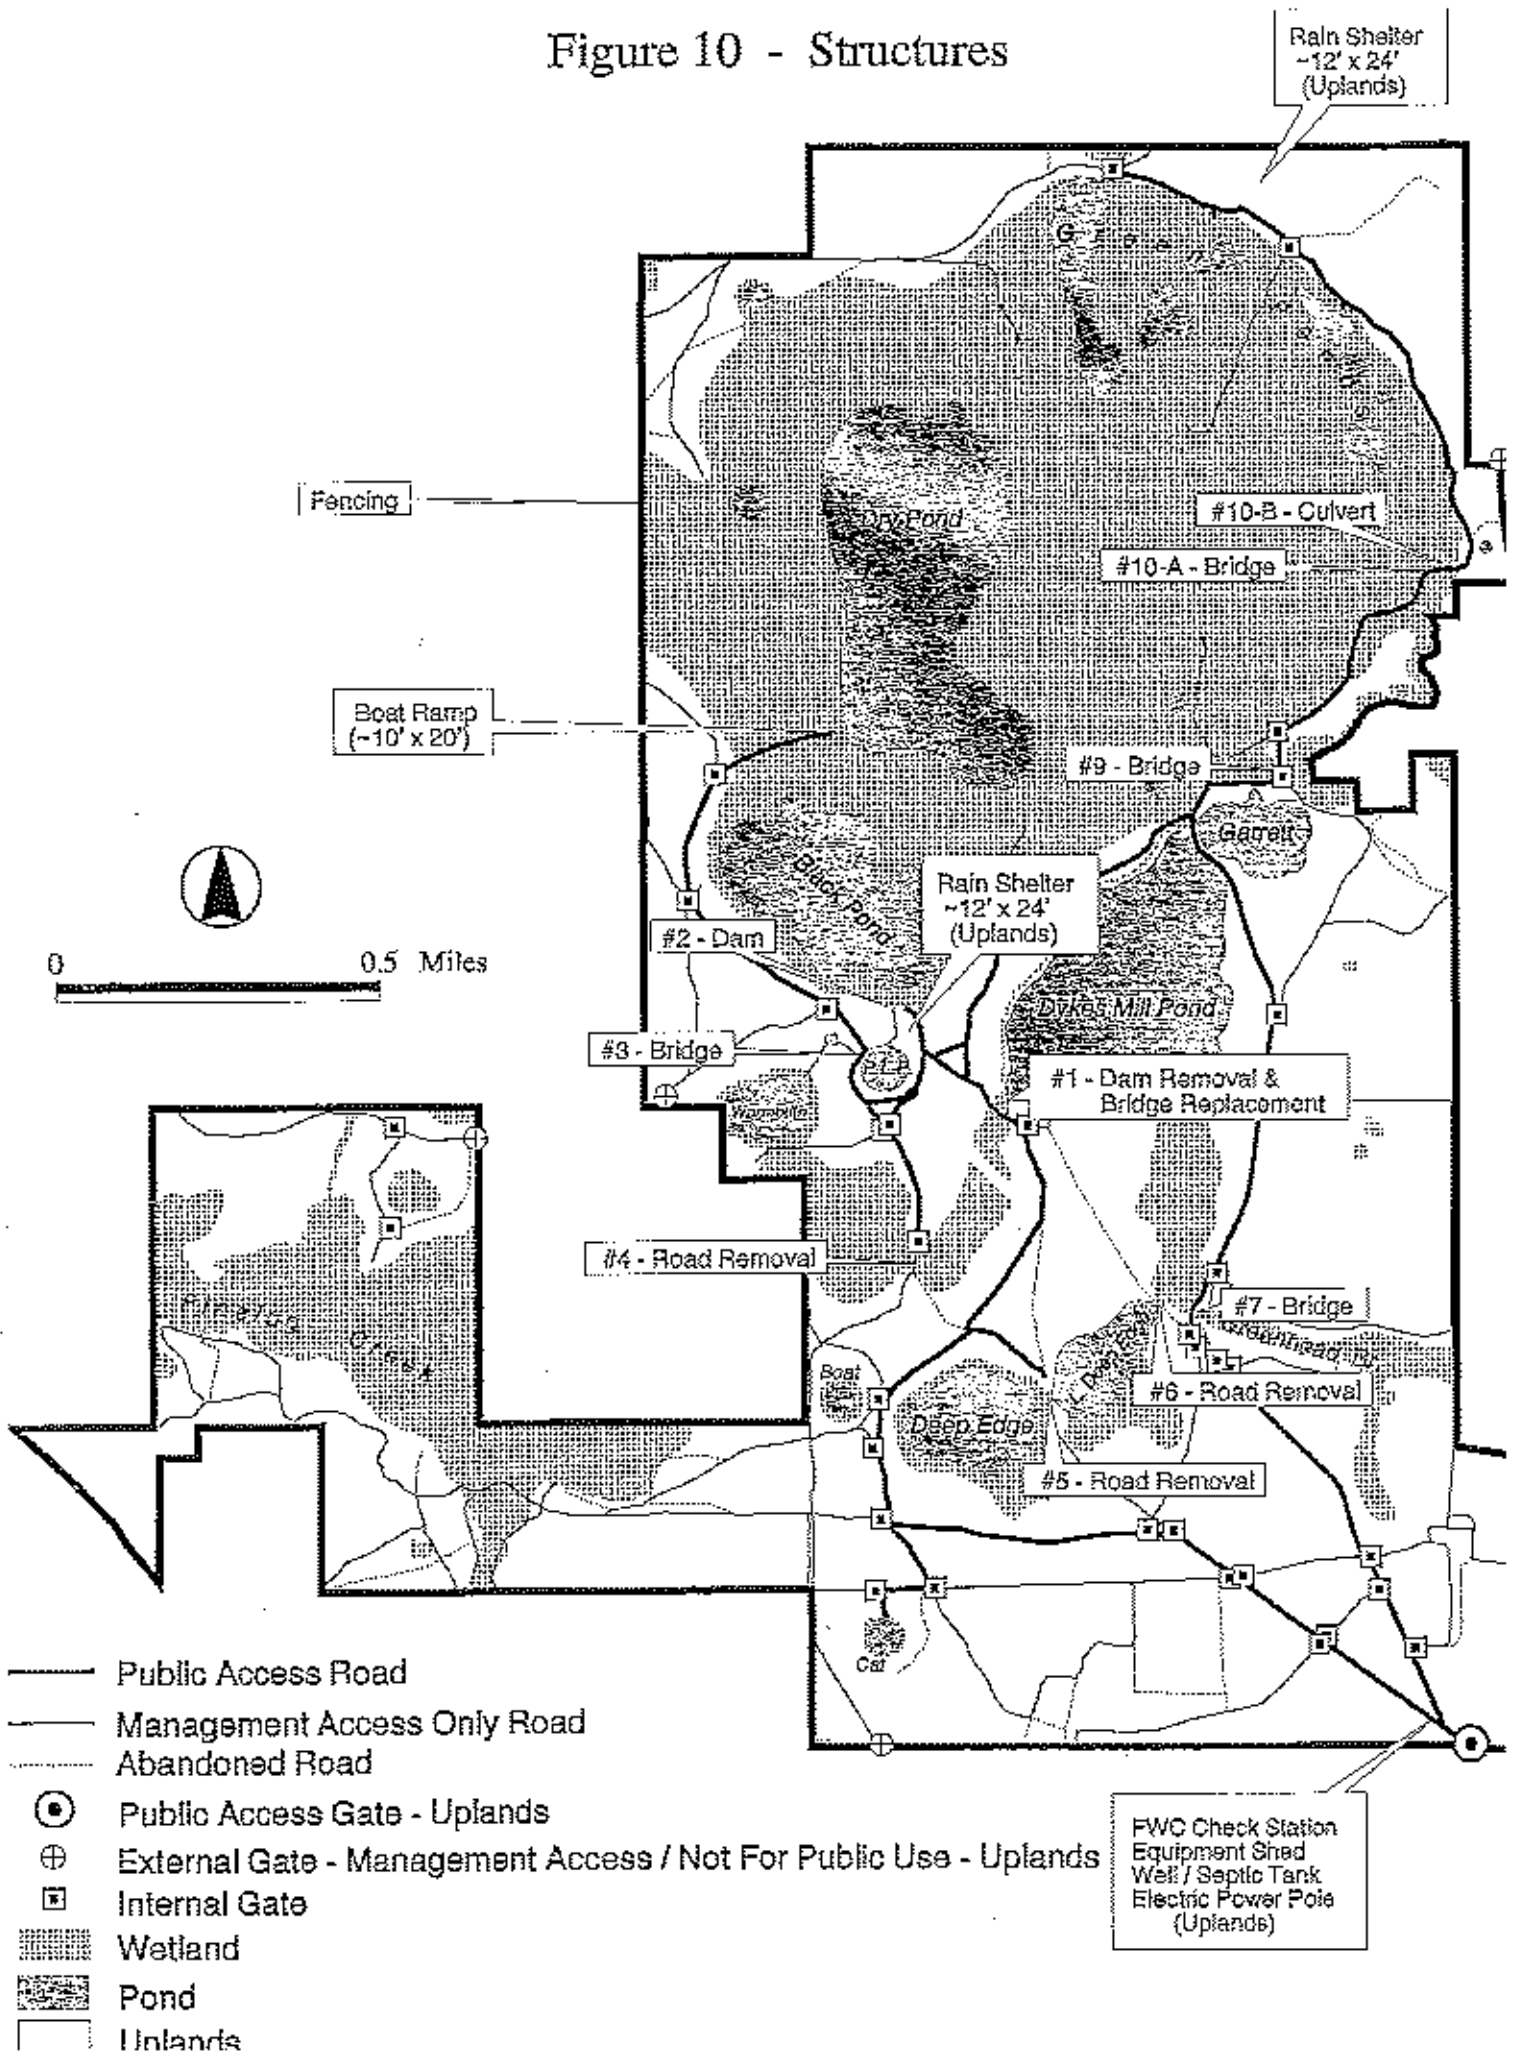
Figure 10 - Structures

3. Construction on three bridges and two culverts was completed in early April of 2007 (Figure 10, Typical Bridge Design Sheet 2 of 7, and Typical Culvert Installation Sheet 4 of 7). All construction was completed in compliance with permit drawings. Permit and as-built drawings have been included for your review (Appendix 1). Photos included in Appendix 2.

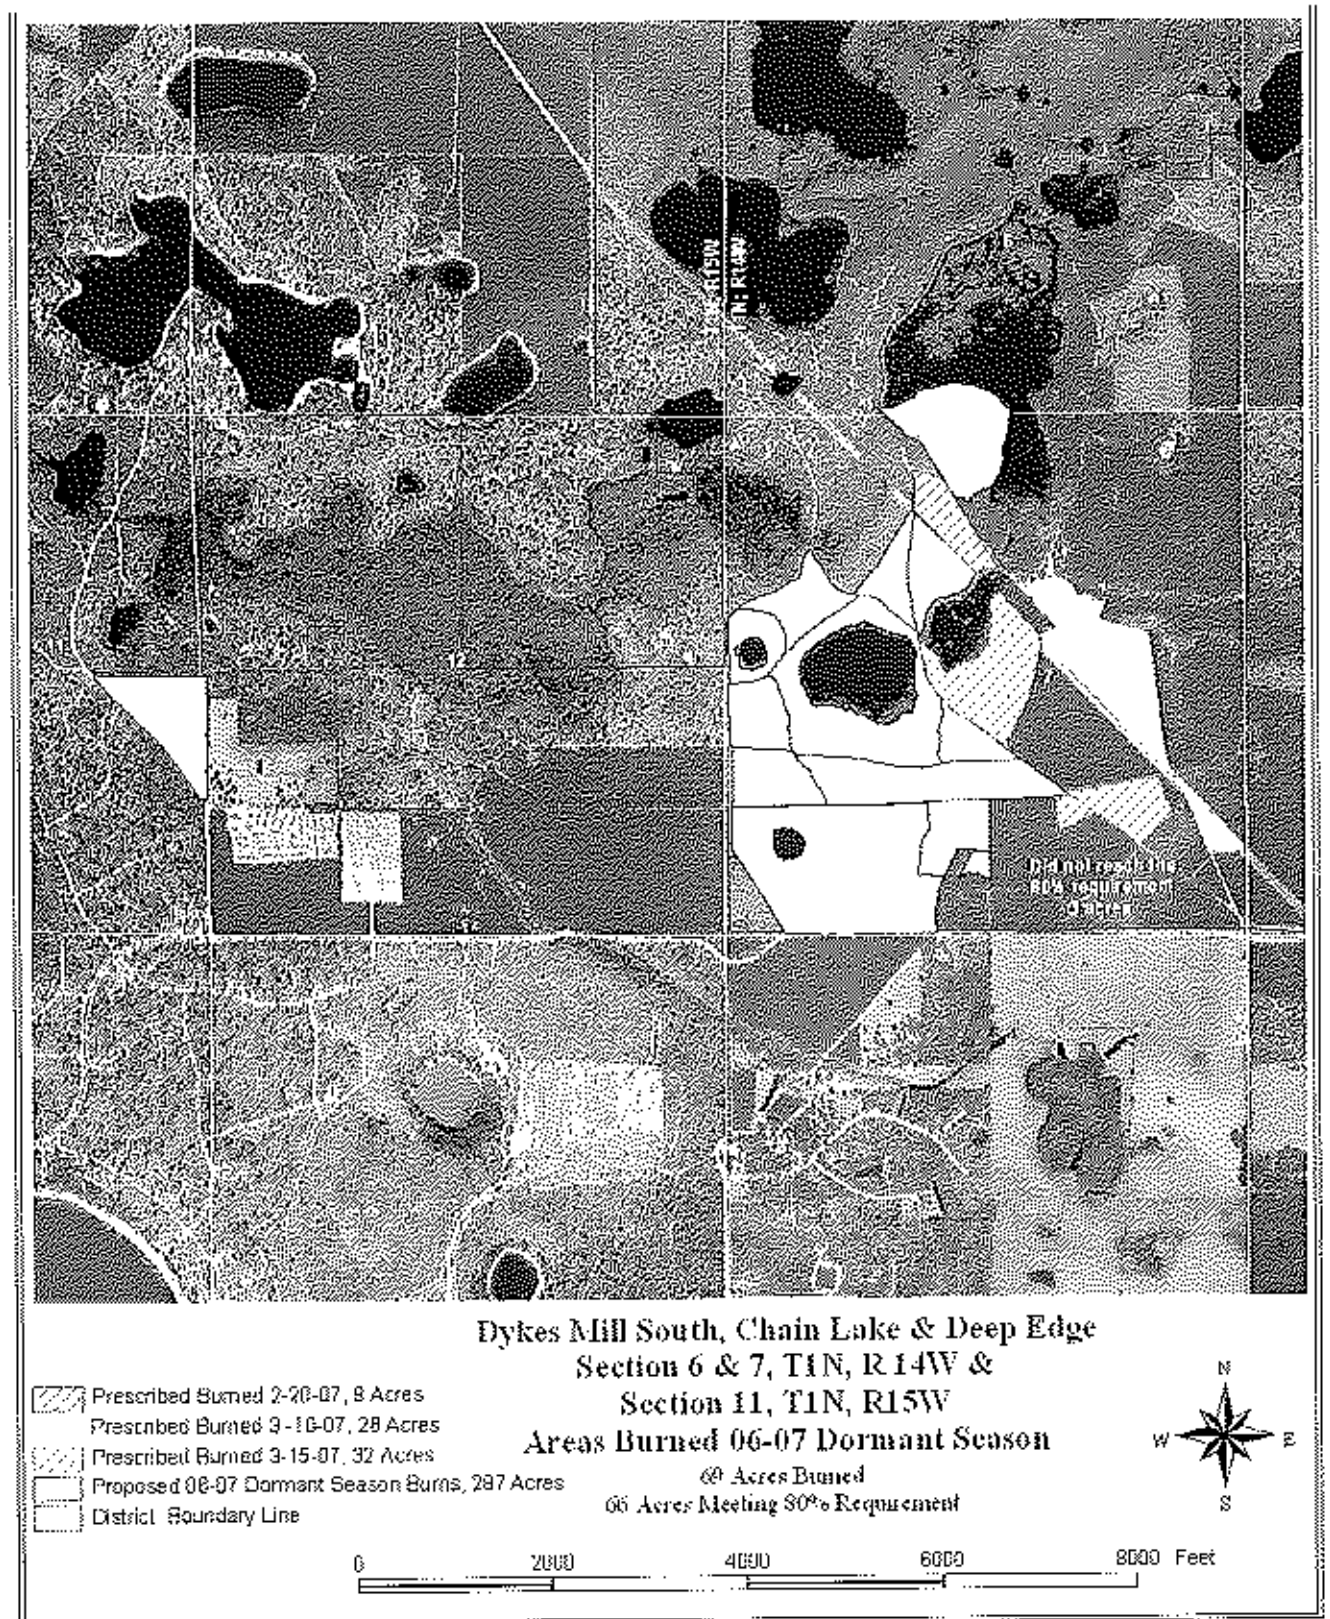
Figure 11. Winter burns at the SHLMB

8. Several winter burns were attempted in 2007. However, due to the drought, low humidity and higher winds than anticipated. Several of the planned burns were postponed due to the danger of wildfire. Completed, attempted or postponed winter burns are shown in Figure 11.

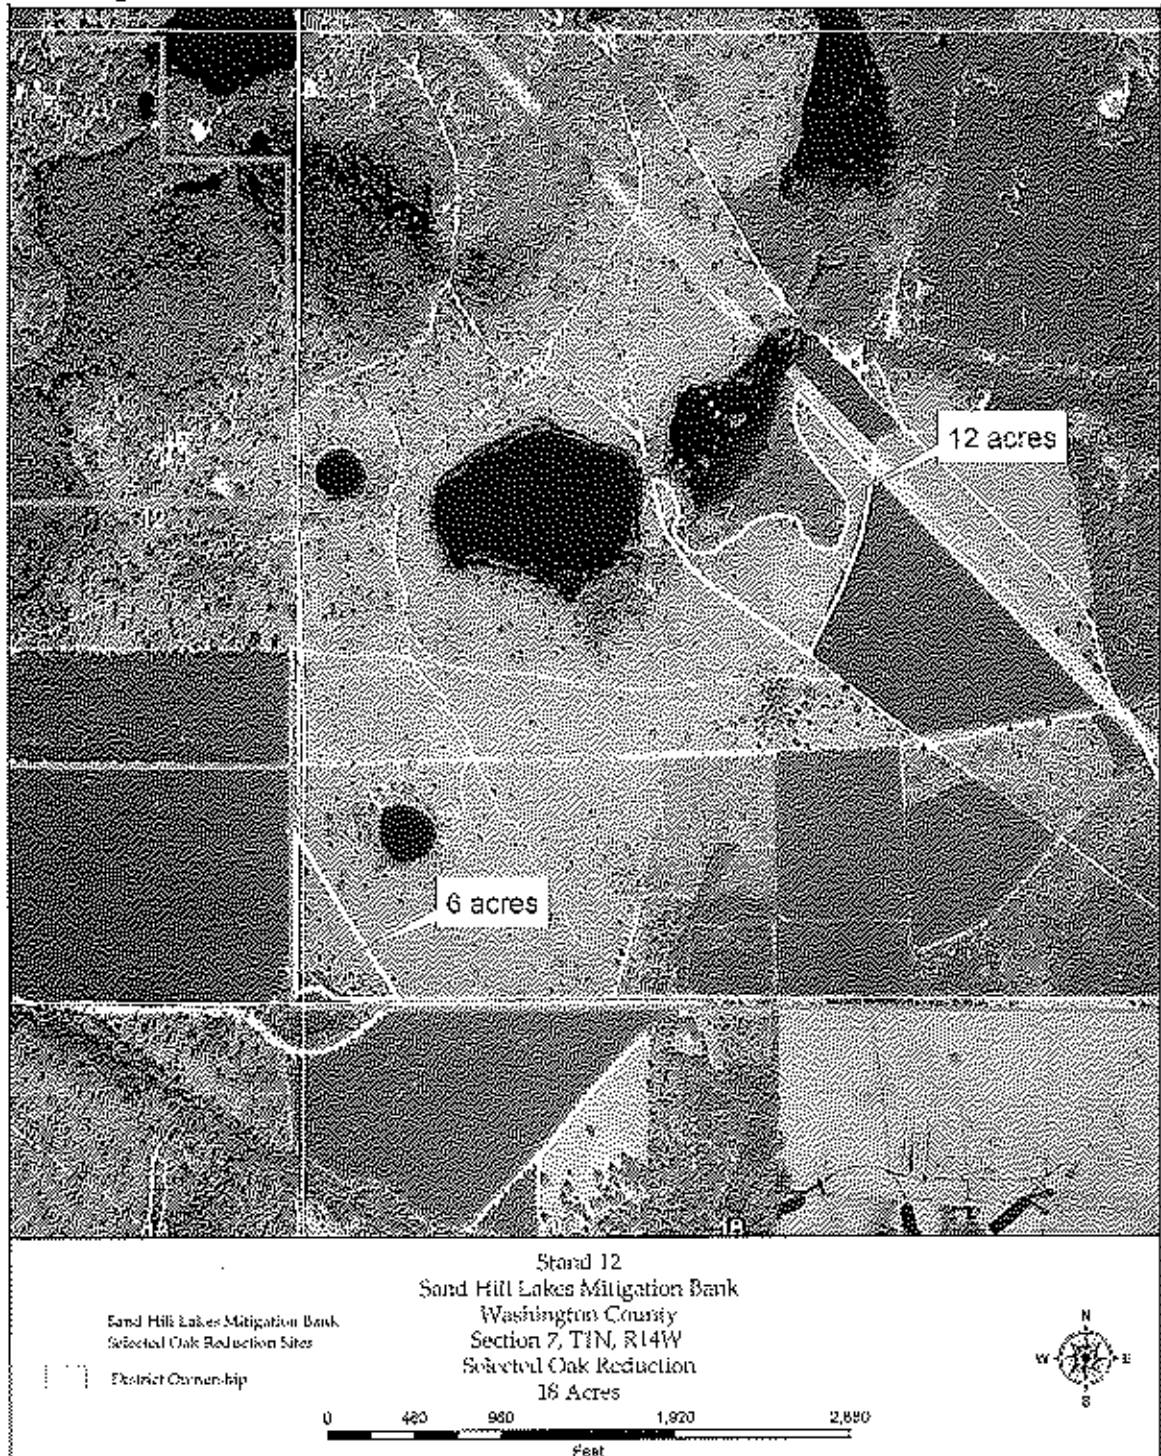
Figure 12. 2007 Oak Reduction: Adjacent to Little Deep Edge and Cat Pond

1. Oak trees will be thinned in approximately 6 acres surrounding Cat Pond and 18 acres adjacent to Little Deep Edge (Figure 12). These two areas contain high quality sand hill community that has been degraded by dense oak stands. Thinning of oaks within these areas should improve the quality of the sand hill habitat.

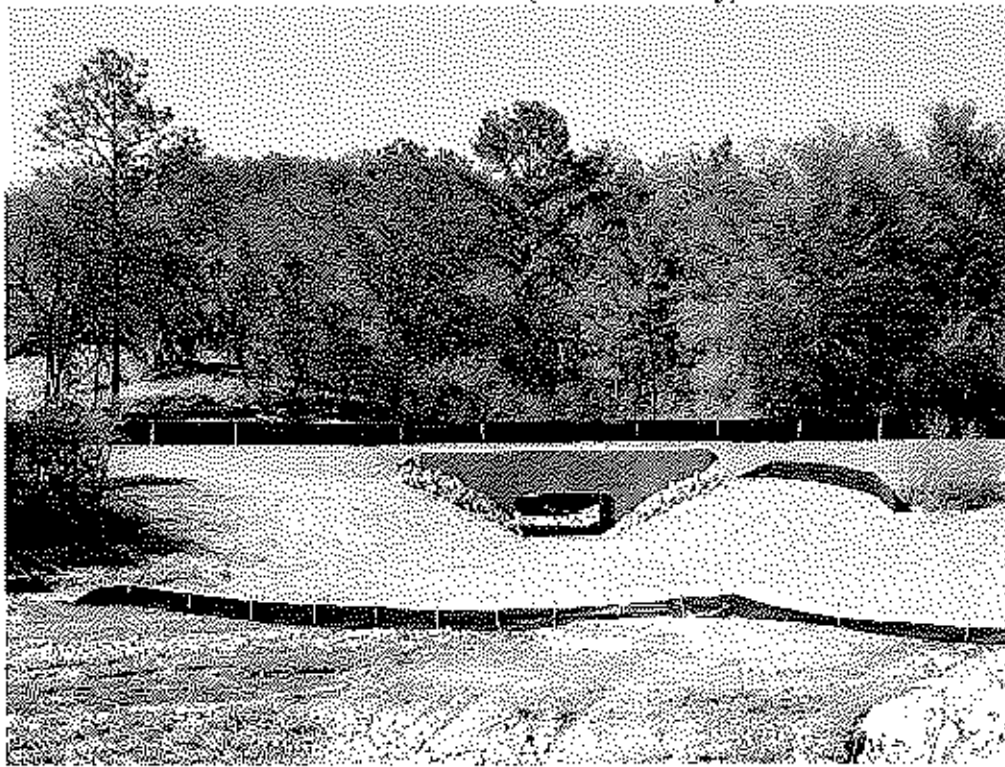
Culvert Construction at Powerline Pond (Pond Near Dry) March 2007

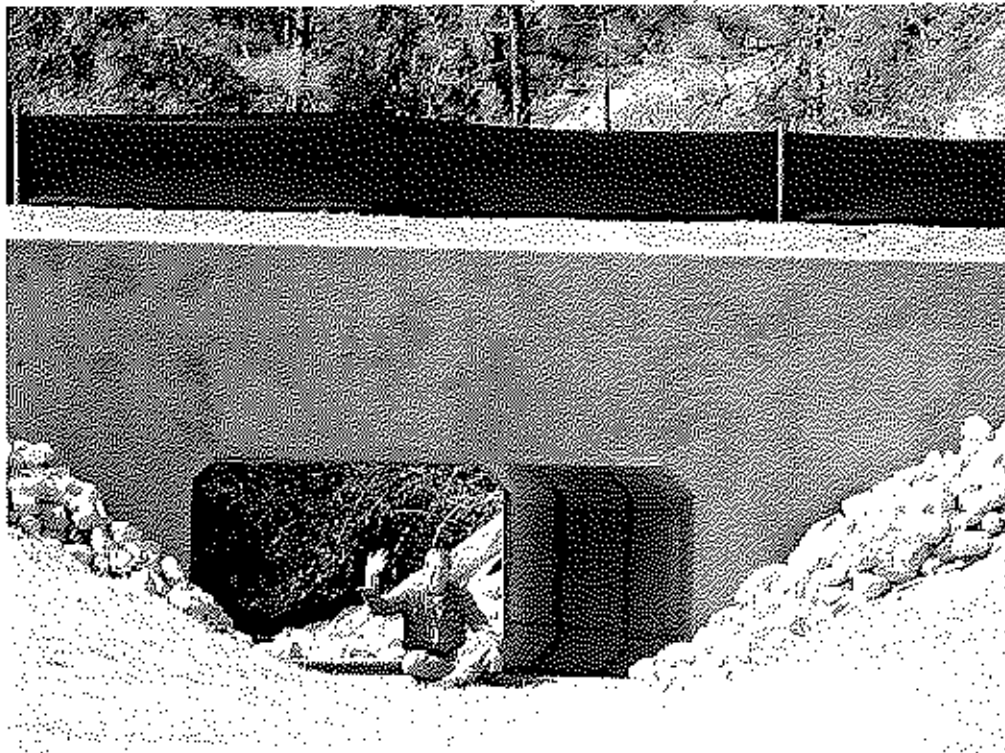
Culvert Construction at Powerline Pond (March 2007)

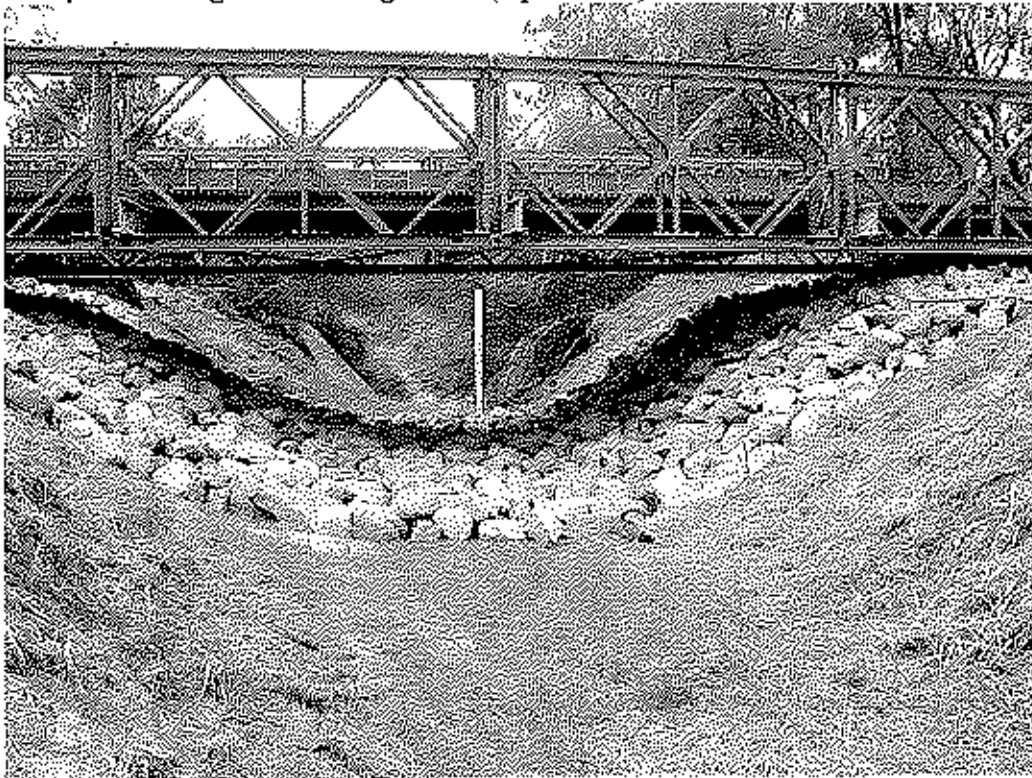
Completed Bridge at Pine Log Creek (April 2007)

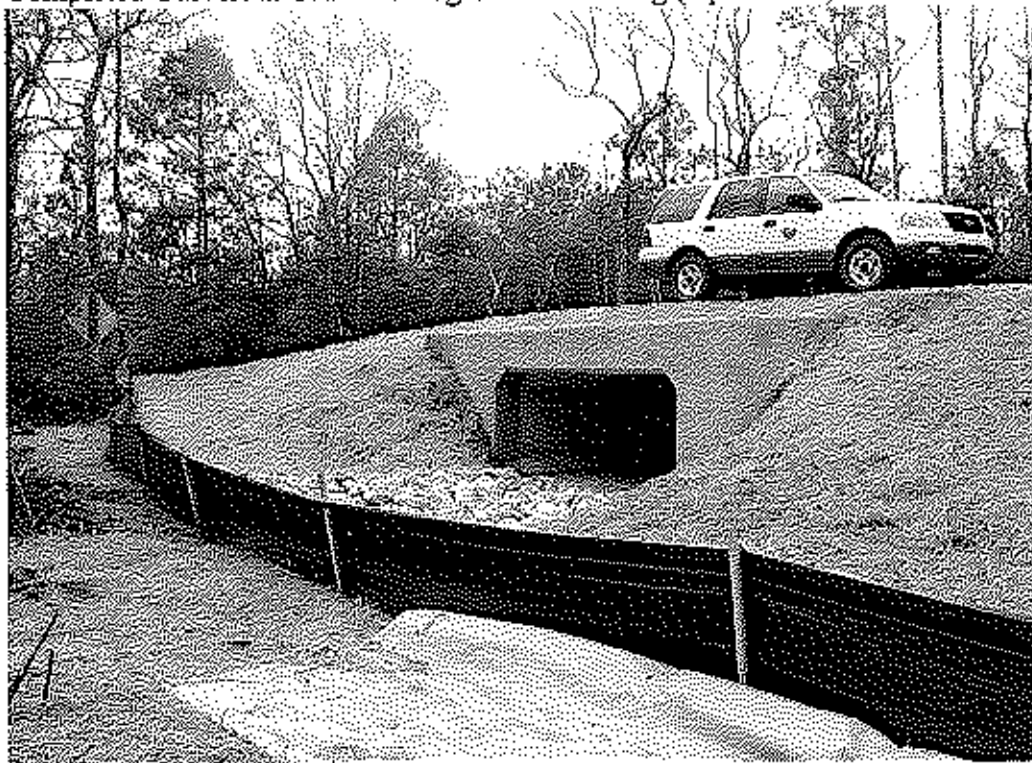
Completed Culvert at Old Pine Log Creek Crossing (April 2007)

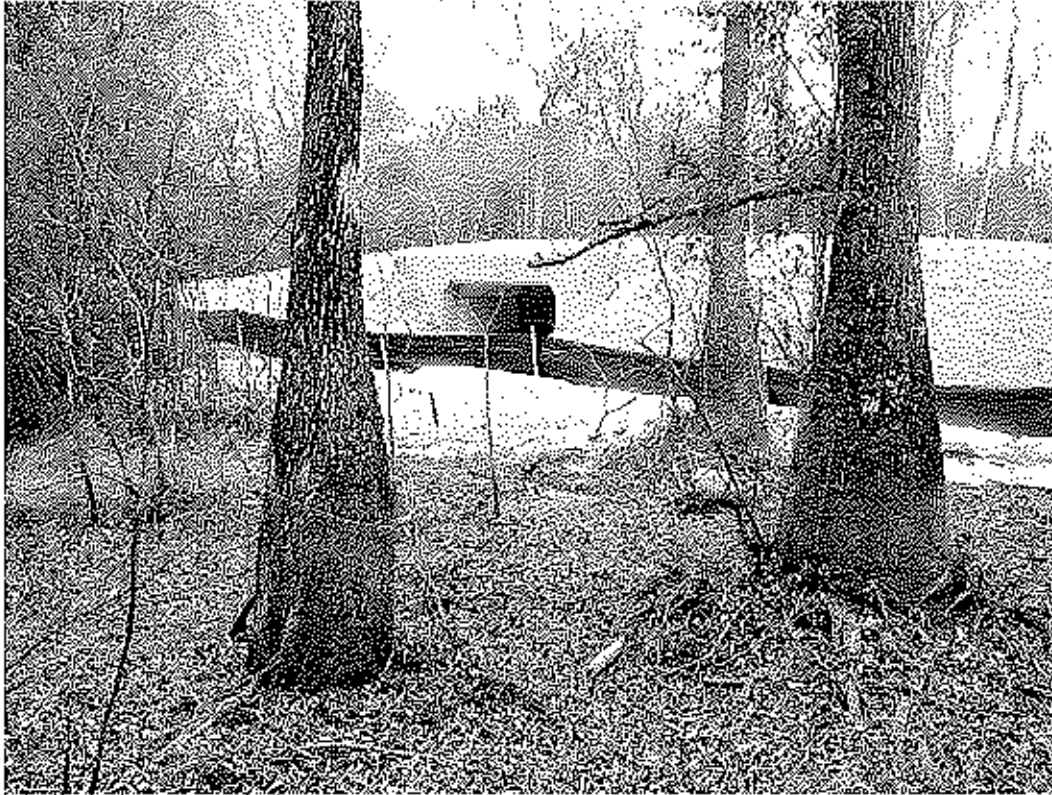
Culvert at Old Pine Log Creek (April 2007)

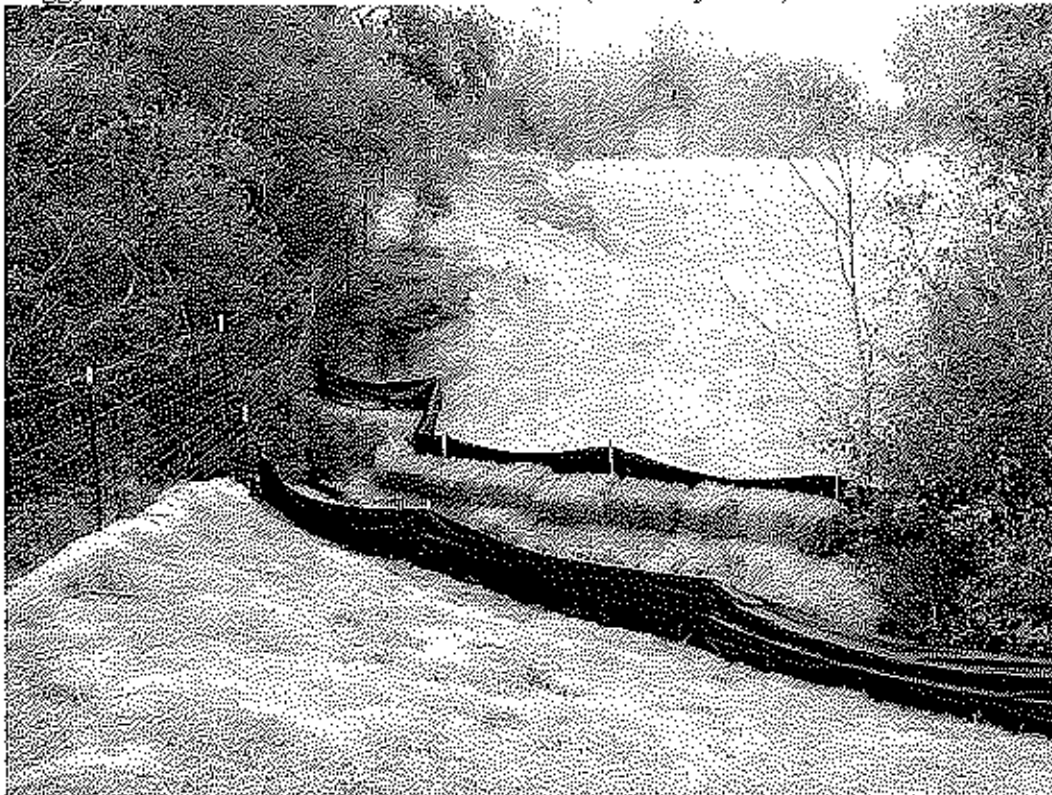
Boggy Branch Erosion Restoration Site #10 (February 2007)

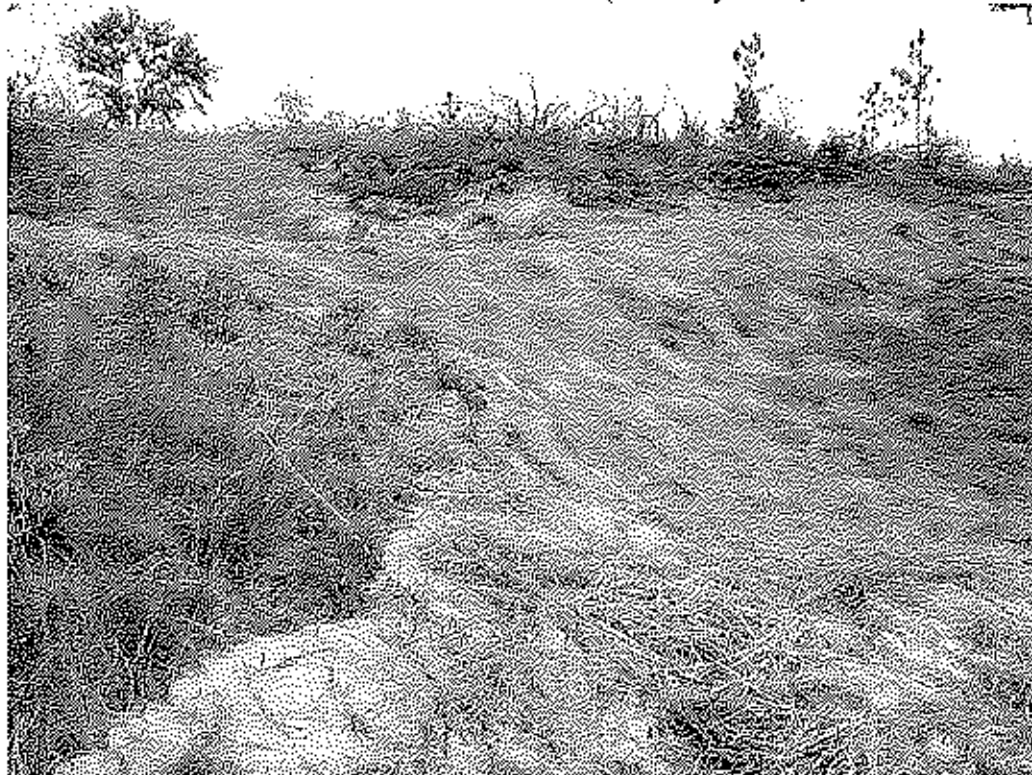
Cat Pond Erosion Restoration Sites #1 and #2 (February 2007)

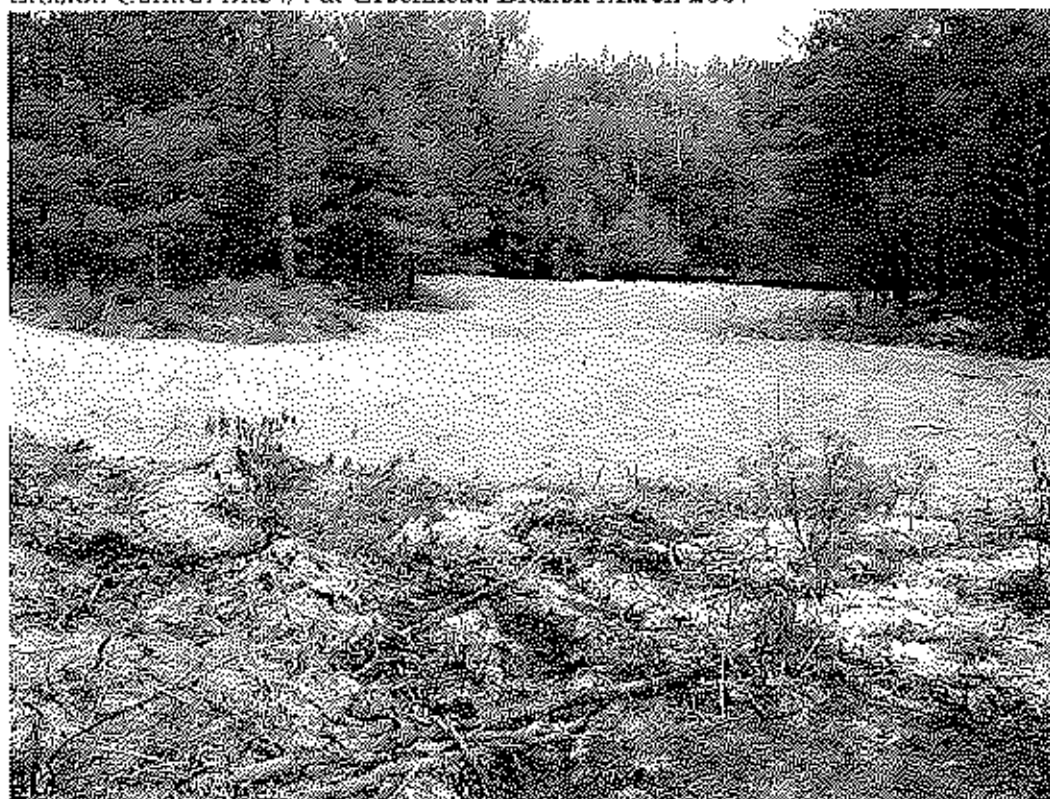
Erosion Control Site #4 at Greenhead Branch March 2007

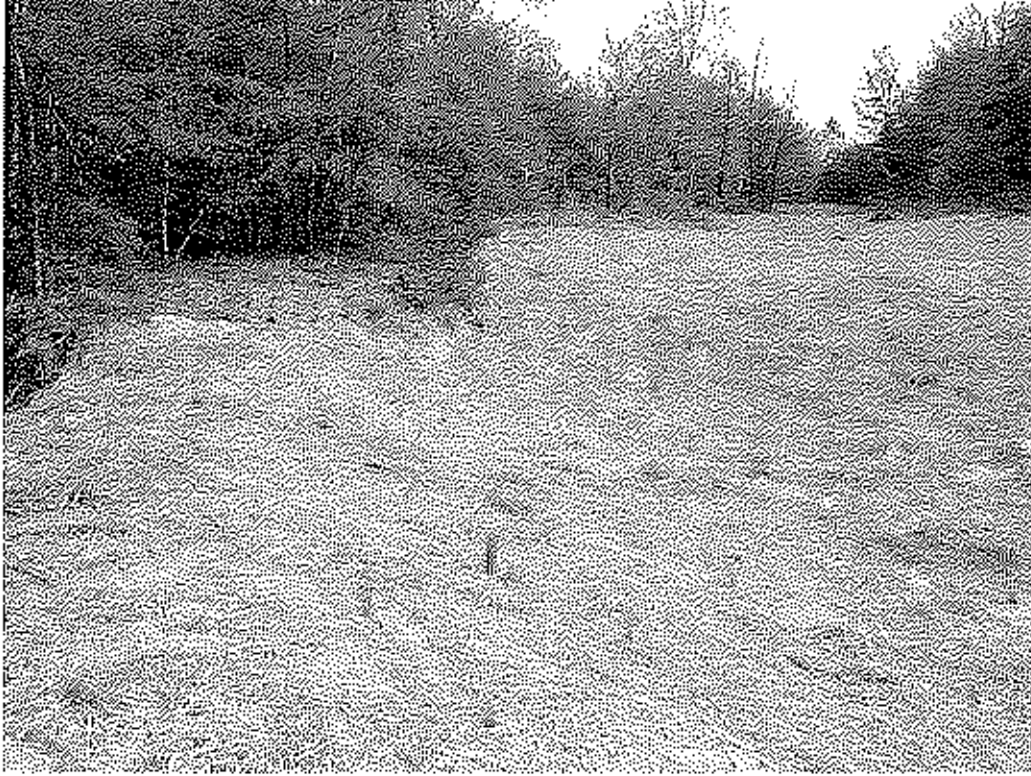
Erosion Control Site #7 at Greenhead Branch March 2007

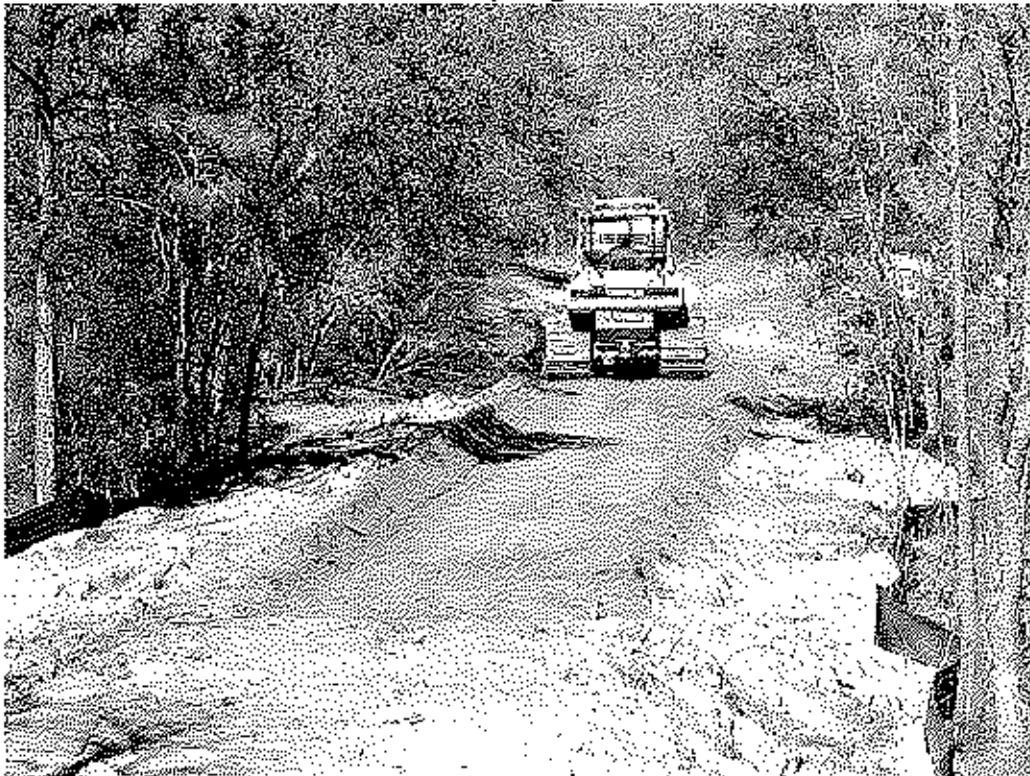
Roadfill Removal Between Little Deep Edge and Greenhead Branch (March 2007)

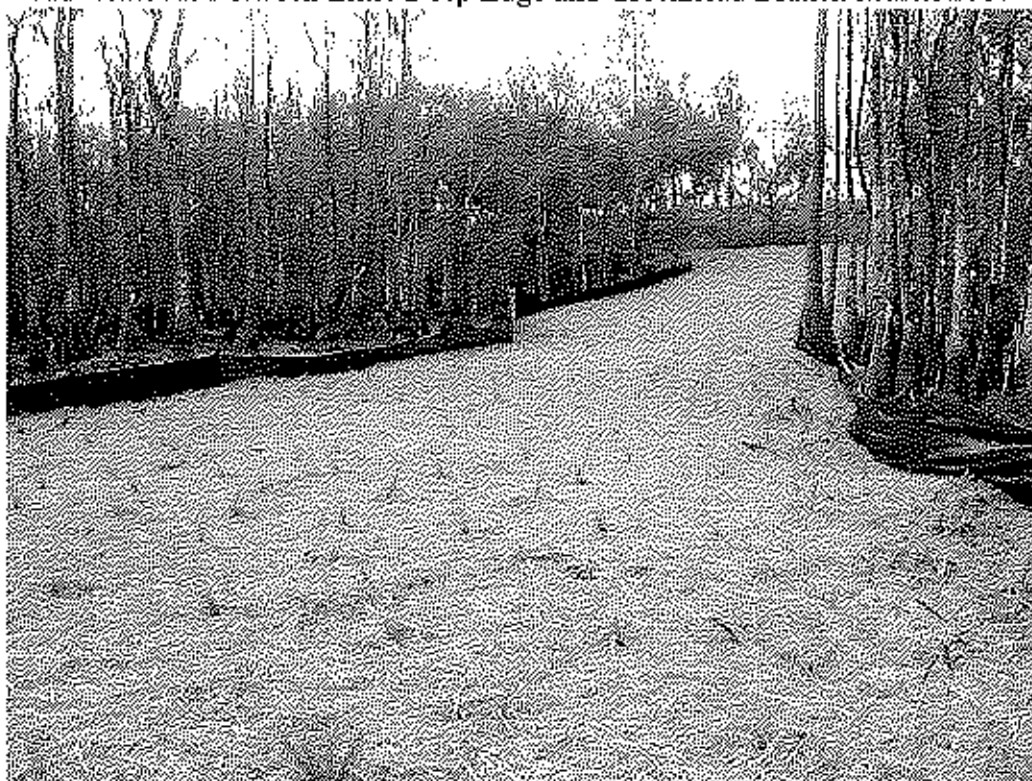
Road Removal Between Little Deep Edge and Greenhead Branch March 2007

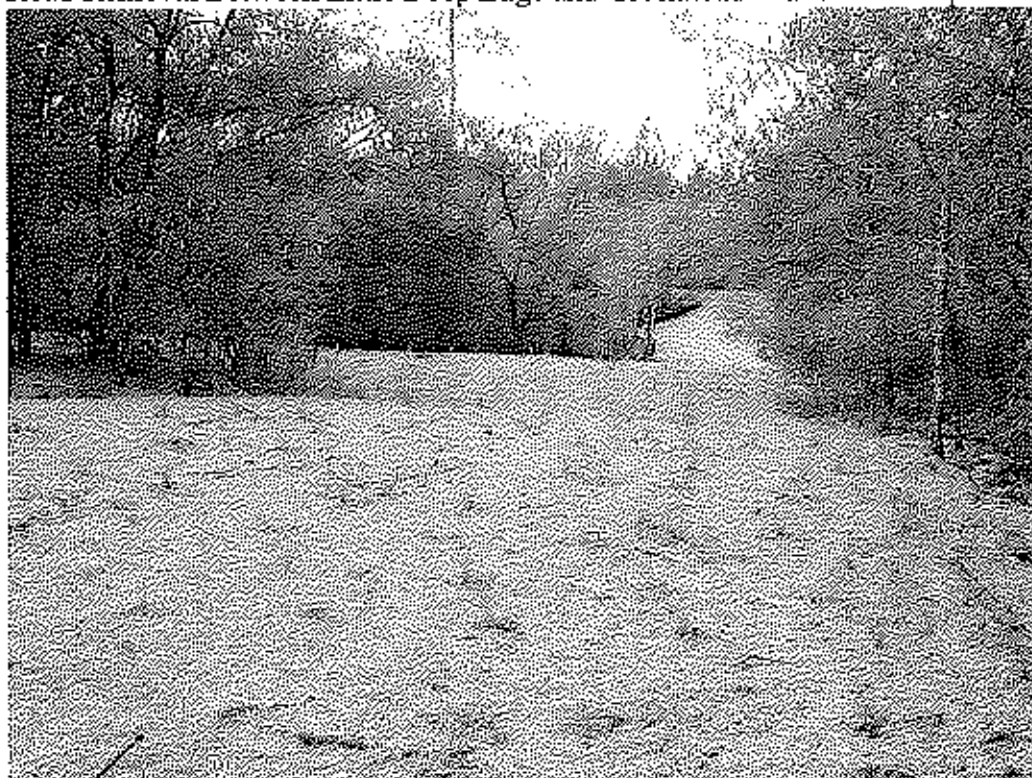
Road Removal Between Little Deep Edge and Greenhead Branch from Uplands

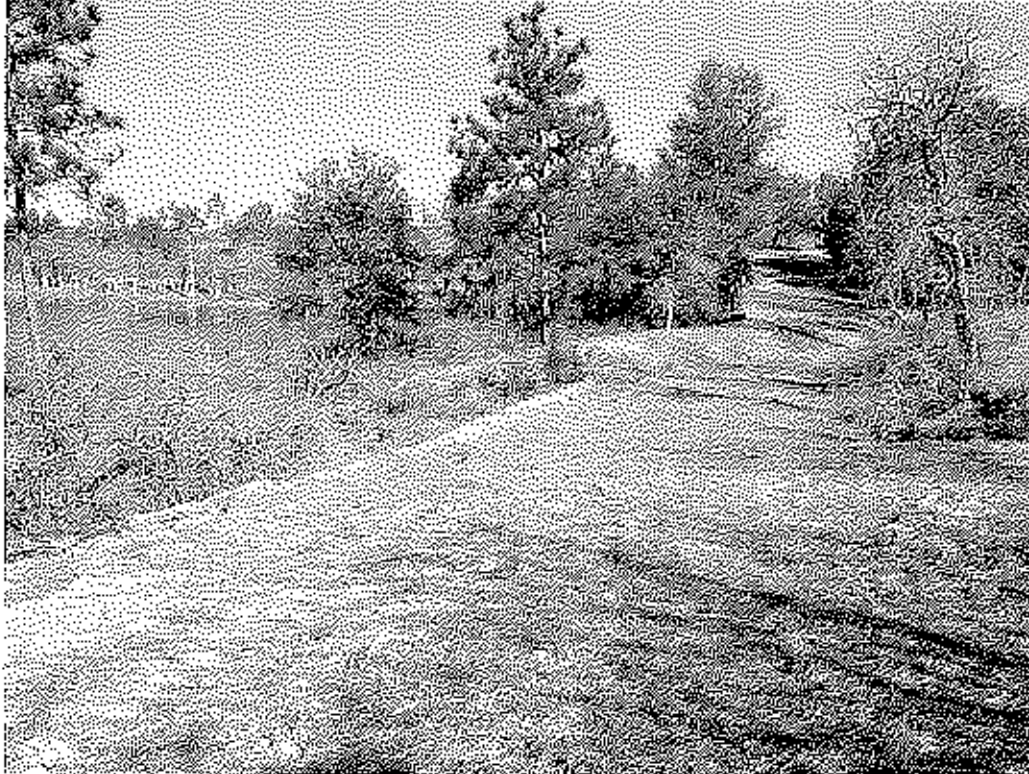
Road Removal Between Deep Edge and Little Deep Edge (February 2007)

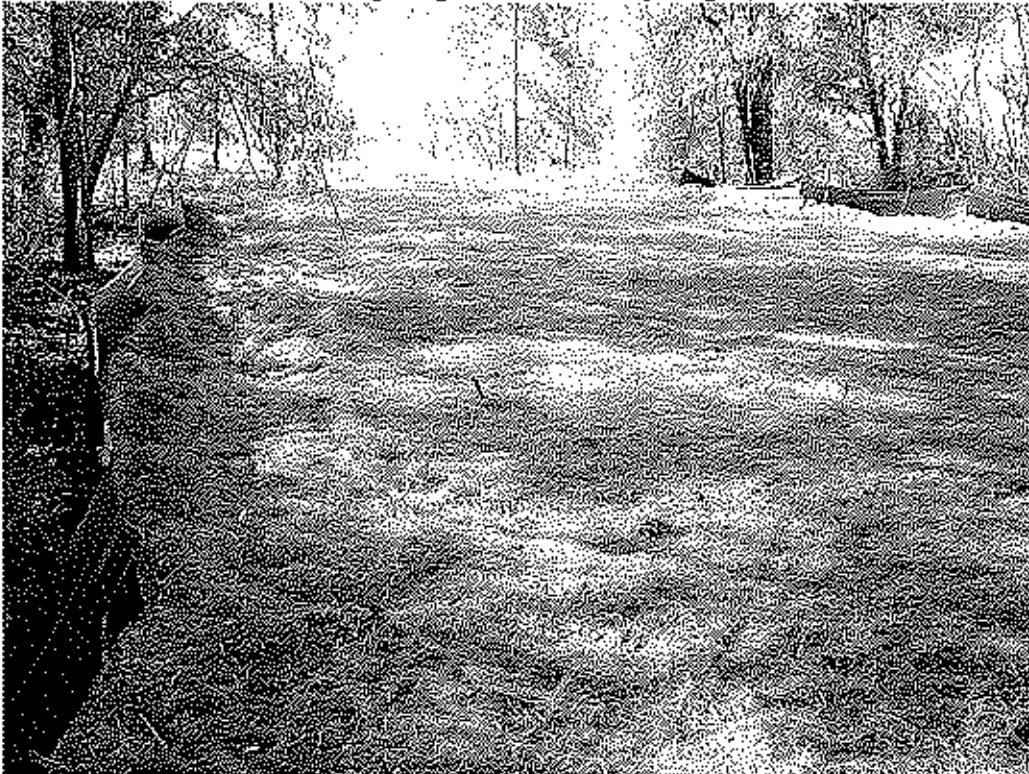
Road Removal Between Deep Edge and little Deep Edge (February 2007)
