Northwest Florida Water Management District

Re: Semi-annual Report (Progress Report 4)

Please accept this submittal as the semi-annual progress report for the SHLMB.

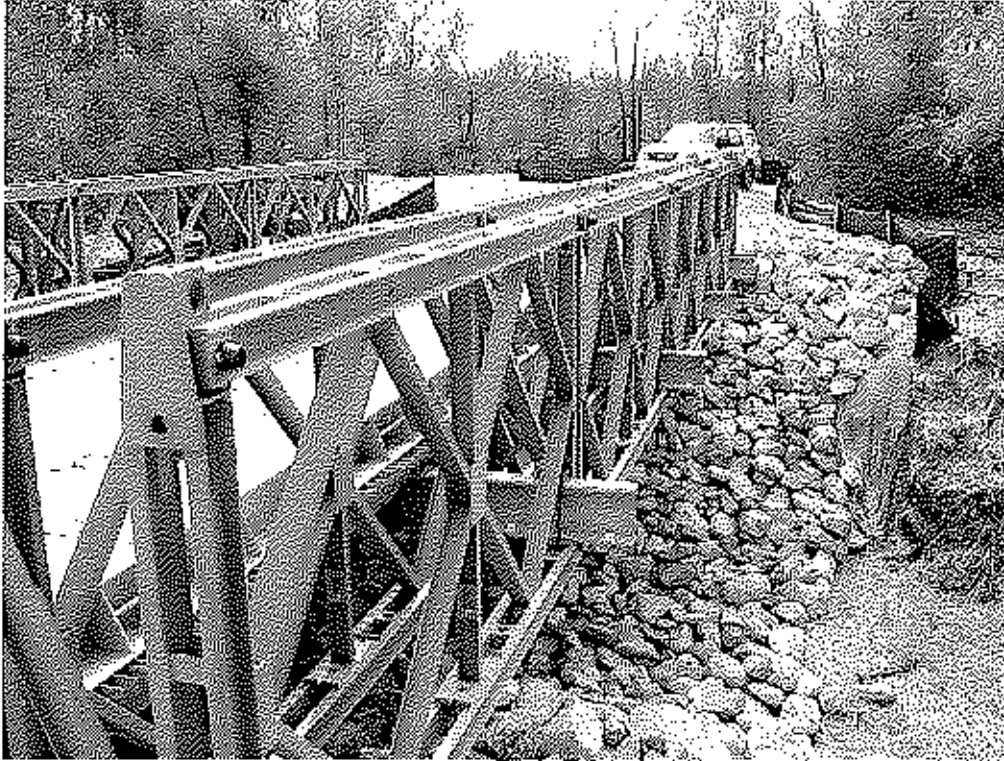
Bridge Construction at Greenhead Branch (February 2007)

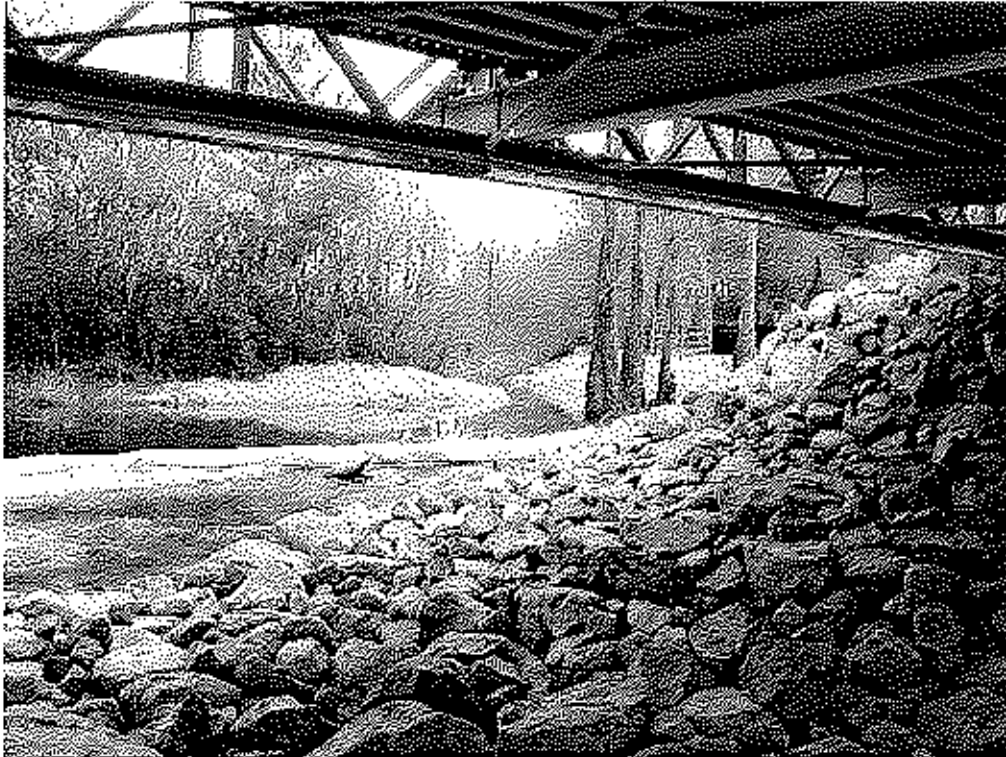
Bridge Construction at Greenhead Branch (February 2007)

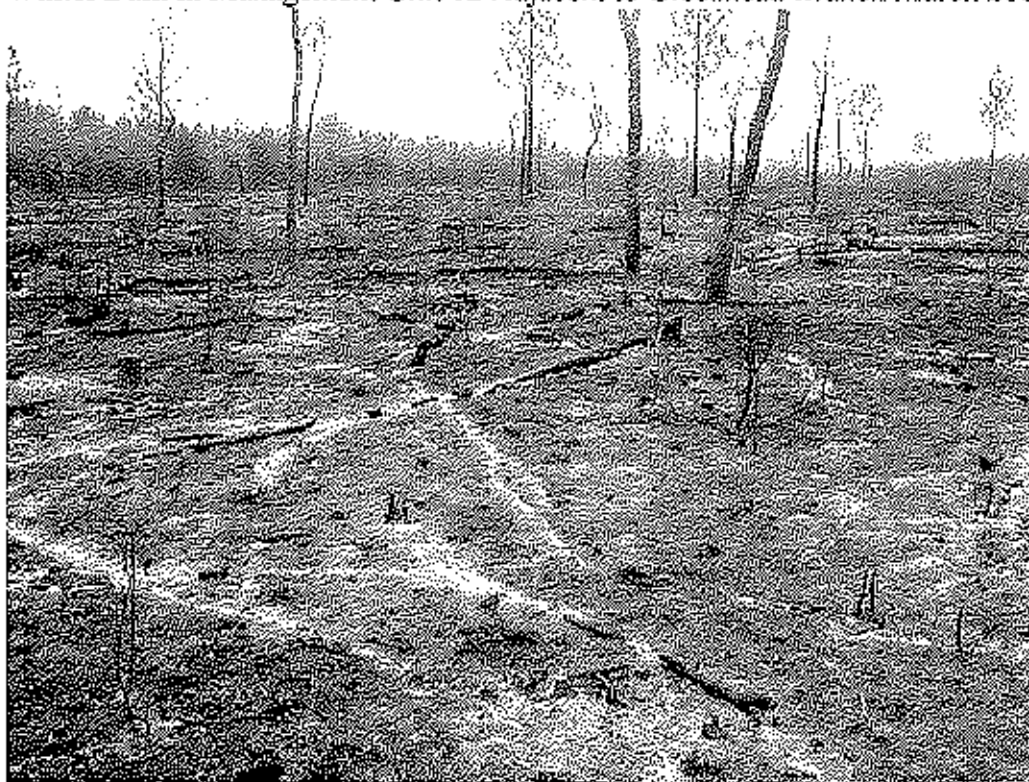
-An intense winter burn occurred adjacent to Greenhead Branch in Management Unit 12. Nearly all of the planted long leaf pine seedlings were destroyed. The site will be evaluated this fall for survivorship of long leaf pine. The area will be re-planted during the winter of 2007 if few to no long leaf pine trees survived.

Winter Burn in Management Unit 12 Adjacent to Greenhead Branch March 2007

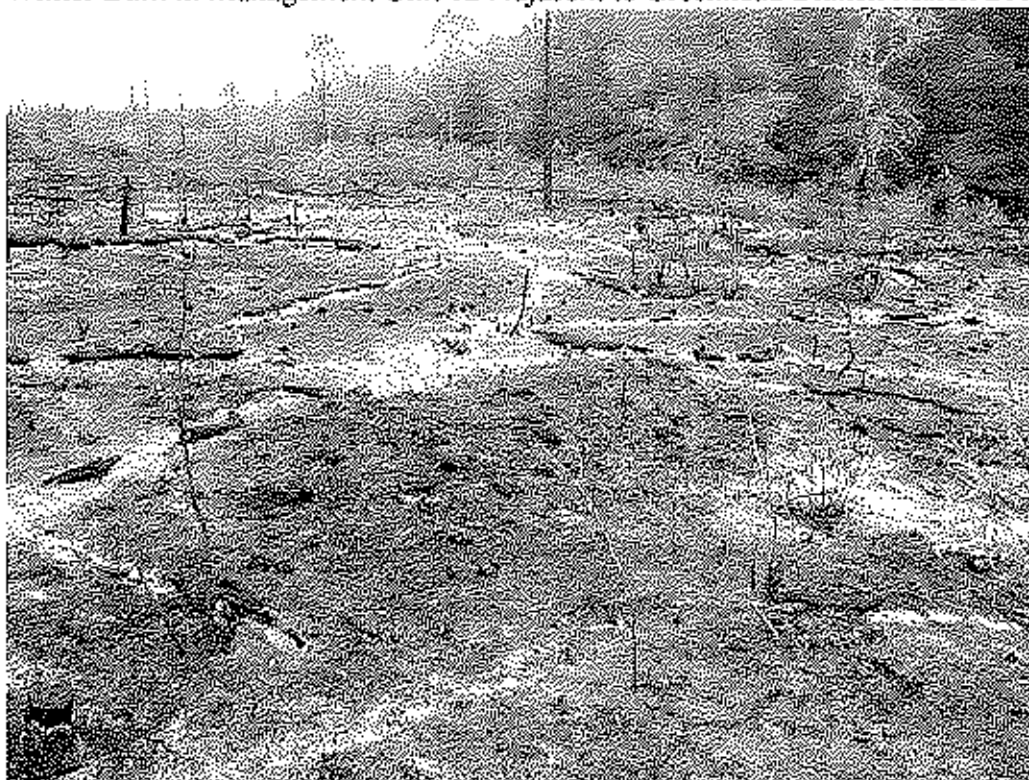
Winter Burn in Management Unit 12 Adjacent to Greenhead Branch March 2007
