## LIVE OAK PENINSULA MITIGATION FIRST ANNUAL MONITORING REPORT

### Woolley and Lee Properties Choctawhatchee Bay, Walton County

SAJ-2007-1175 IP-AWP, issued 3/3/08

**Mitigation:** Woolley and Lee Properties  
**Monitoring Date:** October 30, 2009

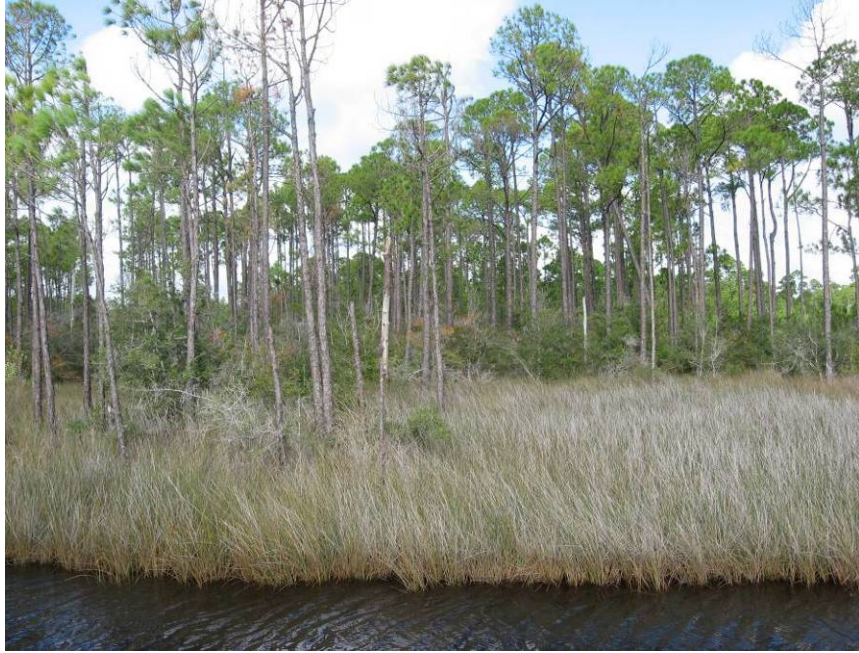
Polygon A (Photo 12)

<p><b>C: All construction areas for stabilization and re-vegetation, structure, operation, and integrity;</b> N/A</p>	
<p><b>D: Representative polygons for each UMAM community for fuel load, exotic or nuisance species, planted material survival, groundcover, and shrub condition.</b></p> <p>All three polygons (A, B, and C) are characterized by a relatively low fuel load, good overall vegetative condition, appropriate community structure and diversity, no exotic/invasives noted (notably no Chinese tallow tree observed).</p>

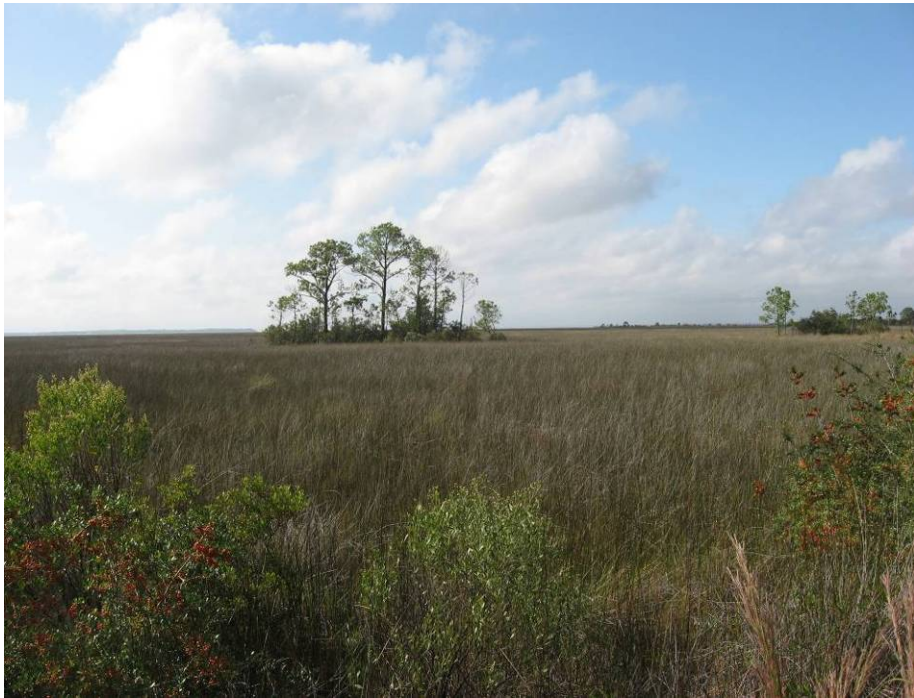
Woolley Parcel (Photo 13)

<b>Site Inspection Field Form</b>	
Project: Woolley-Live Oak	Date: October 30, 2009
Name(s) of Data Collectors: Brandon Tidwell	Weather: Mostly sunny; low-mid 80s; windy
Environmental Description: Photo #'s 14	
<p>Polygon: Entire parcel                  GPS Location: Photo 13 – looking west towards Woolley parcel from access road at N 30.41341,W 86.24838. Photo 14 – looking southeast down access road at <i>Panicum repens</i> on road (photo taken just southeast of Photo 13).                  Time: 1430</p>	
<p><b>On at least a yearly basis, the site will be inspected as follows:</b>                  A: Perimeter for signs of trespassing, fencing and signage integrity and infestation by exotic or nuisance vegetation;                  Locks cut on main access gate, no fence/signage noted, trash dumping off of access road. Significant amount of spent shotgun shells south of parcel along access road indicating waterfowl hunting in area.</p>

<p>B: Internal Roads (Both public and maintenance) for signs of dumping or trespassing, erosion, bridges and road integrity, and exotic or nuisance species infestations;                   Access road largely impassable, dumping/trespassing noted offsite along access road, two locks cut on main access gate.                   Minor amount of <i>Panicum repens</i> on access road – approximately 5% coverage overall. No other infestation noted.</p>	
<p>C: All construction areas for stabilization and re-vegetation, structure, operation, and integrity;                  N/A</p>

Potential Problems and solutions: Suggest better control of unauthorized access at gate. Do not improve road as it will provide unauthorized access.
