Cat Point Breakwater (Apalachicola Bay Breakwater and Salt Marsh Restoration) Fourth Annual Monitoring Report (2011)

Nationwide Permit – 200305450 (NW-JWS) issued 6/6/2003; Impact: SR 300 St. George Island Bridge, Franklin County; Impact: 0.3 acre of seagrass in Apalachicola Bay

Monitoring Date: January 1, 2011

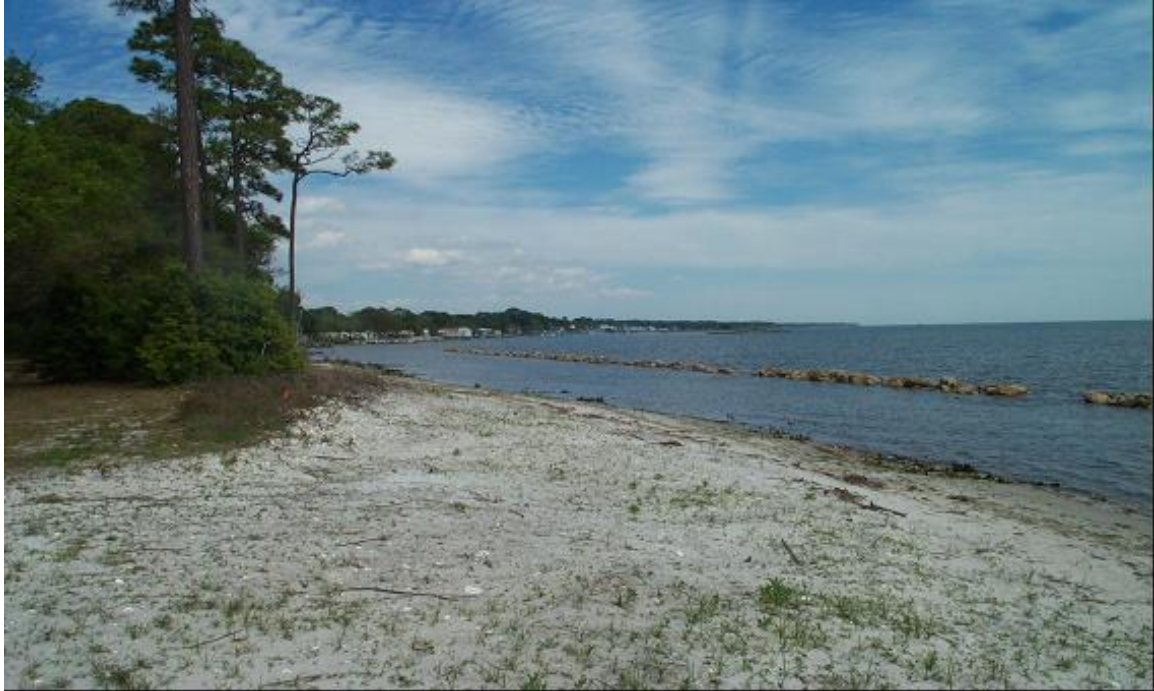
Construction was completed in March 2004 and the site was allowed to stabilize for about three months during which time the terrestrial portion of the shoreline began to re-vegetate (Figure 4). Marsh planting was initiated in Spring/Summer 2004 with plantings occurring on June 4 and July 6-7. Clumps of smooth cord grass (*Spartina alterniflora*) were collected from local marshes on the north side of Little St. George Island, transported intact to the site, and planted on 2-foot centers in the nearshore area. Initial plantings were accomplished in three to five rows just above and below the MHW line.

Figure 4. Post-construction view of breakwater showing rubble removed, shoreline contoured, and initial recovery of beach vegetation (June 2004).

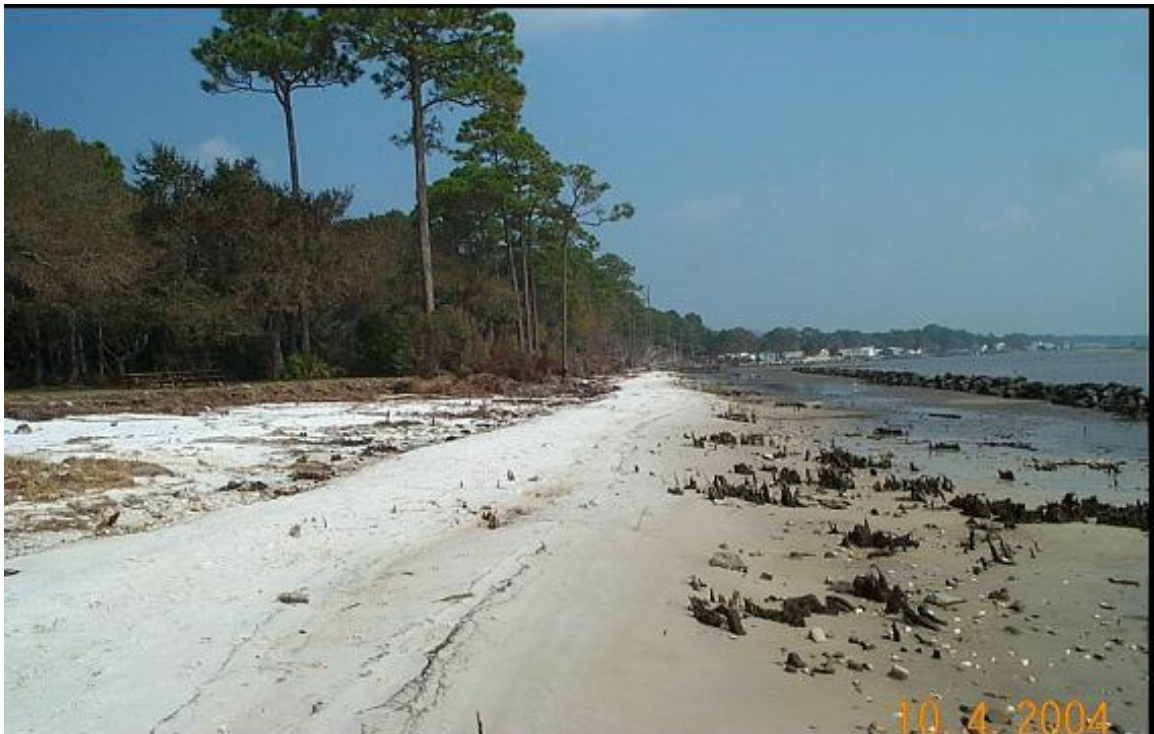
The success of our marsh plantings was affected significantly by the occurrence of numerous tropical storm events over the next few years. During the late Summer and early Fall 2004 the shoreline along this section of coast was severely disturbed as three hurricanes passed through the Gulf; the most intense damage coming from Hurricane Ivan in late September 2004 (Figure 5). Although the breakwater itself was undamaged, wave action was significant overtopping the rock structure by several feet at the height of the storm. Significant erosion occurred (Figure 6); a substantial portion of the planted cord grass along with significant amounts of upland vegetation was scoured.

Figure 5. View of breakwater and adjacent eroded shoreline after Hurricane Ivan (September 2004). Beach erosion was significant, extending at least 50 feet landward of previous beach/upland demarcation line.

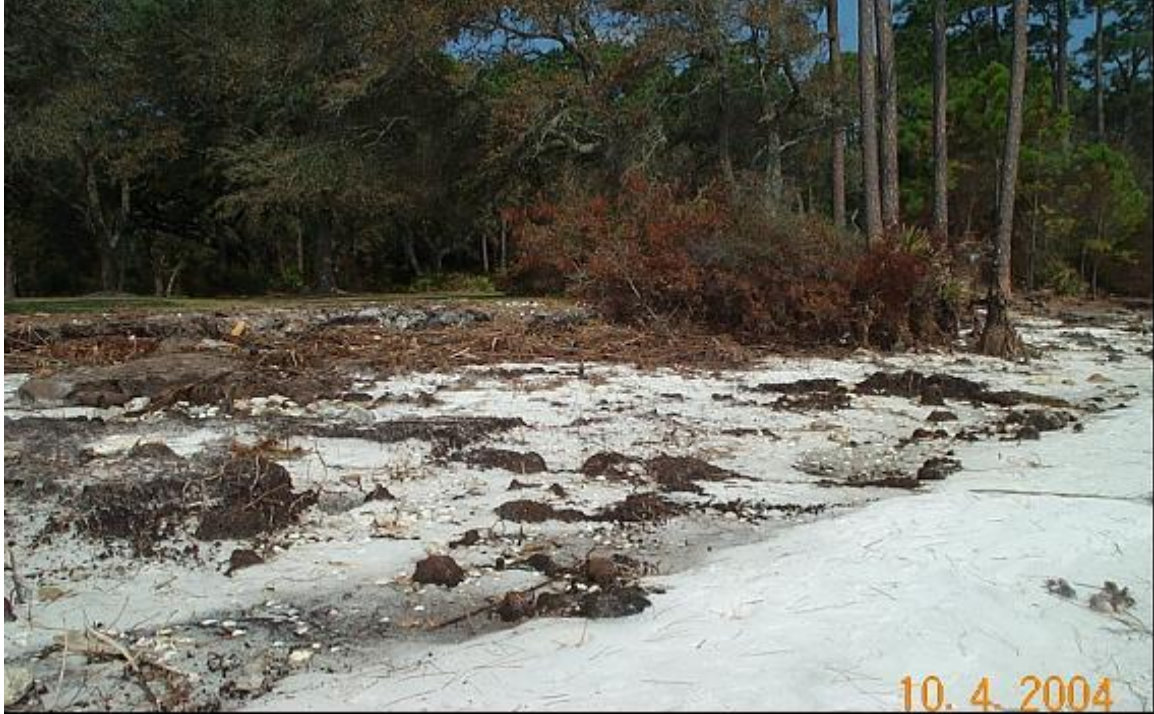
Figure 6. Close-up view of eroded shoreline after Hurricane Ivan (fall 2004). Erosion extended landward to newly formed escarpment that is seen at center left in photo.

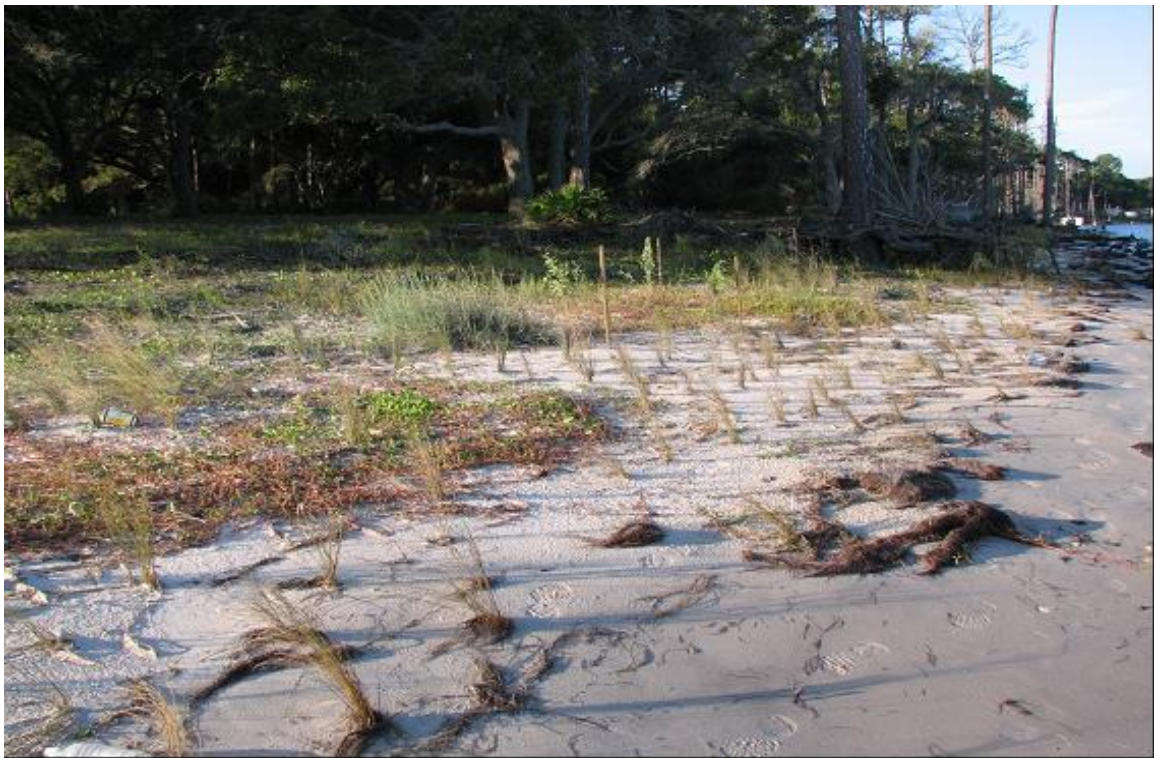
Figure 7. Vegetation planted in the transition zone between the beach and uplands (Fall 2007). See text for list of planted species. Compare with Figure 6.

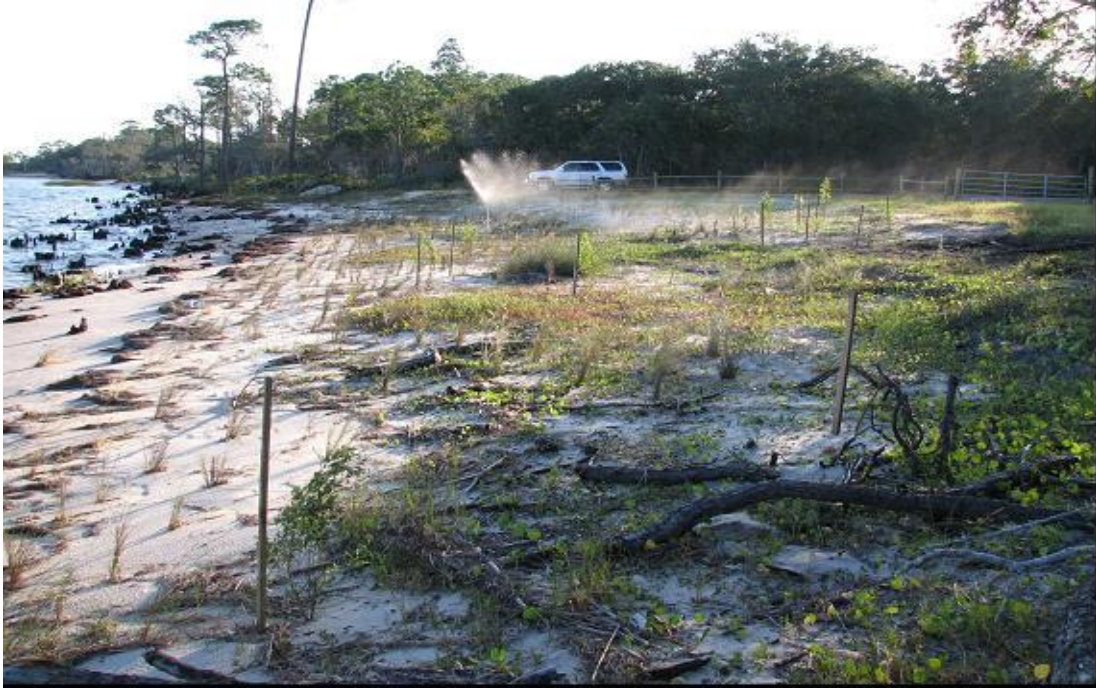
Figure 8. Vegetation planted in the transition zone between the beach and uplands (Fall 2007).

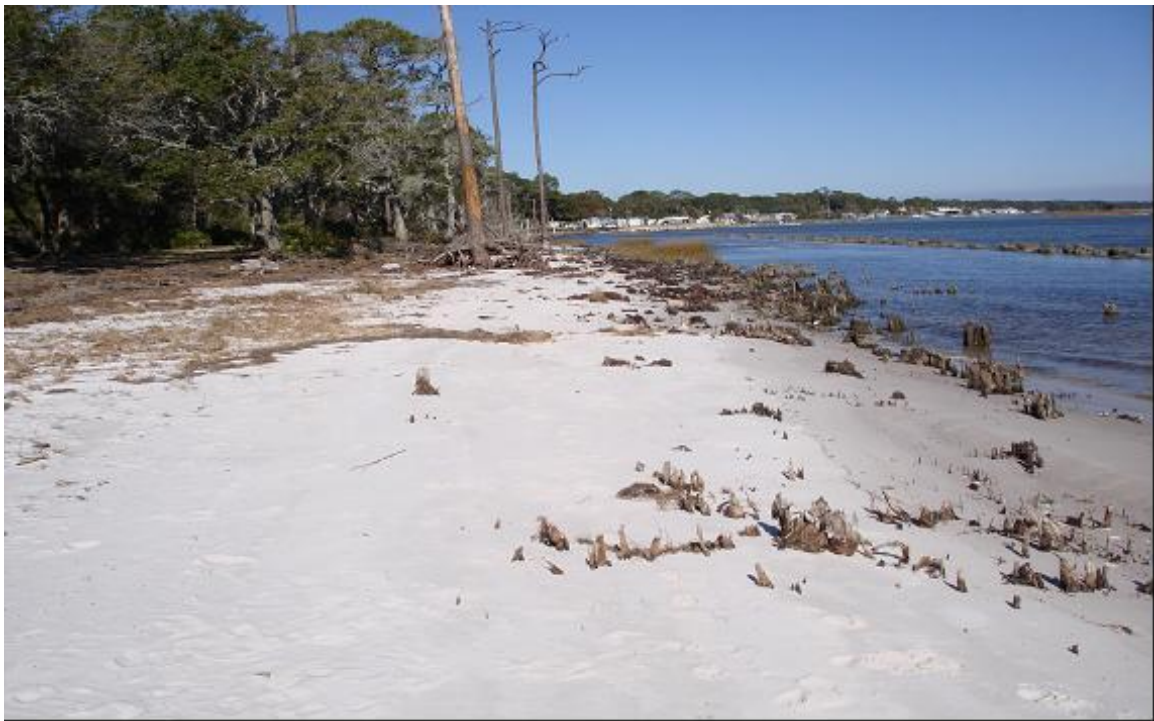
Figure 9. Overall condition of site after the storm activity in summer 2008 as noted during annual monitoring. The salt marsh has expanded despite significant erosion and loss of upland buffer vegetation.

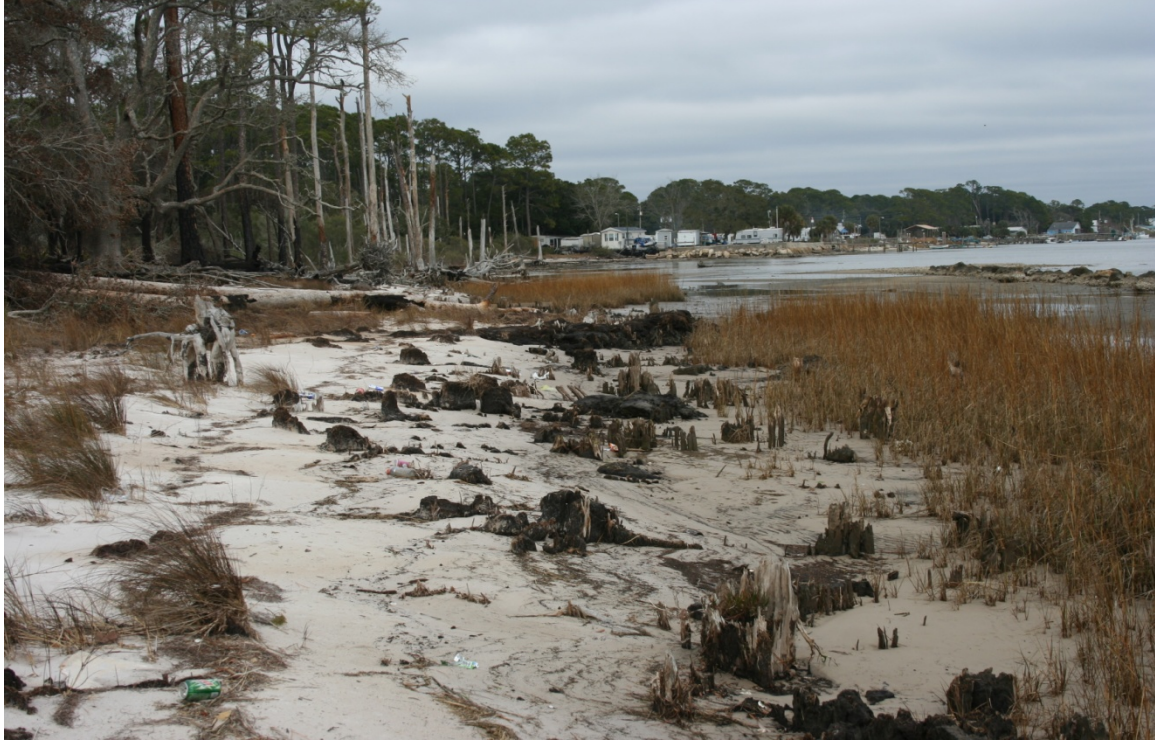
Figure 10. 2011 *Spartina alterniflora* and *Spartina patens* survival in restoration area. Beach erosion from previous hurricanes is evident. Facing NE from center of site.

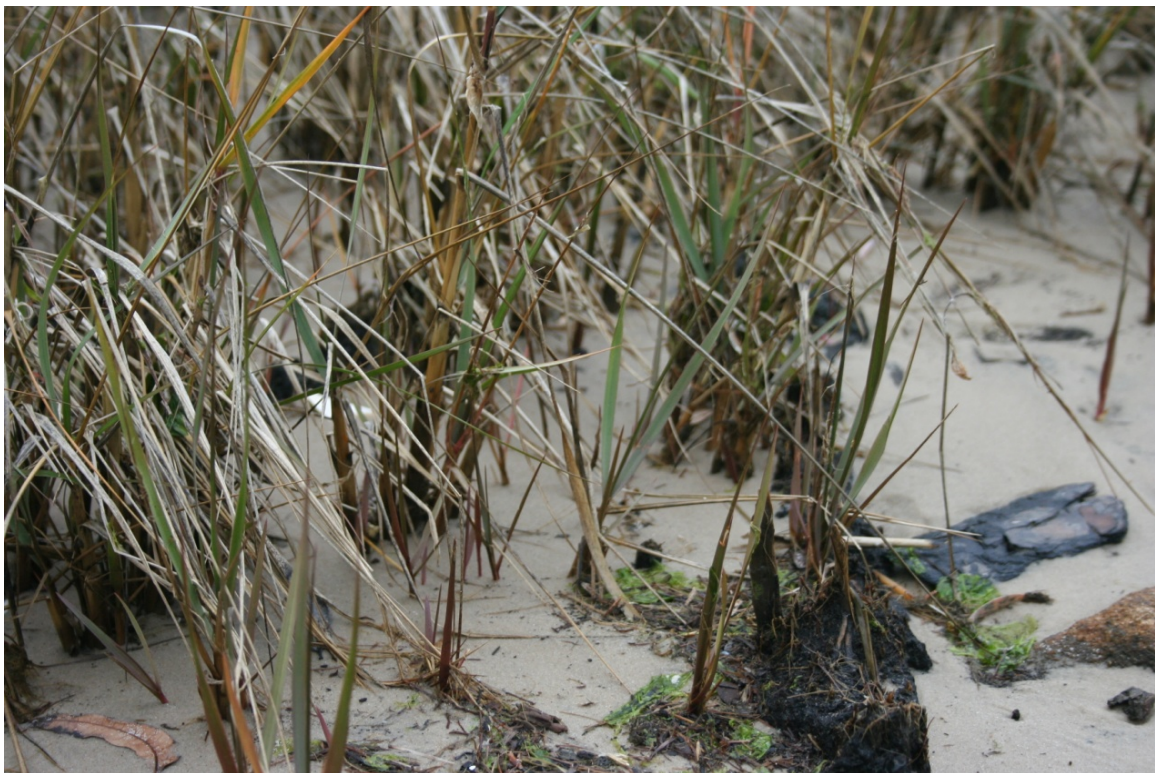
Figure 11. *Spartina alterniflora* vegetative and sexual (not pictured) reproduction indicating the health of the planted material and a trend toward increasing cover.

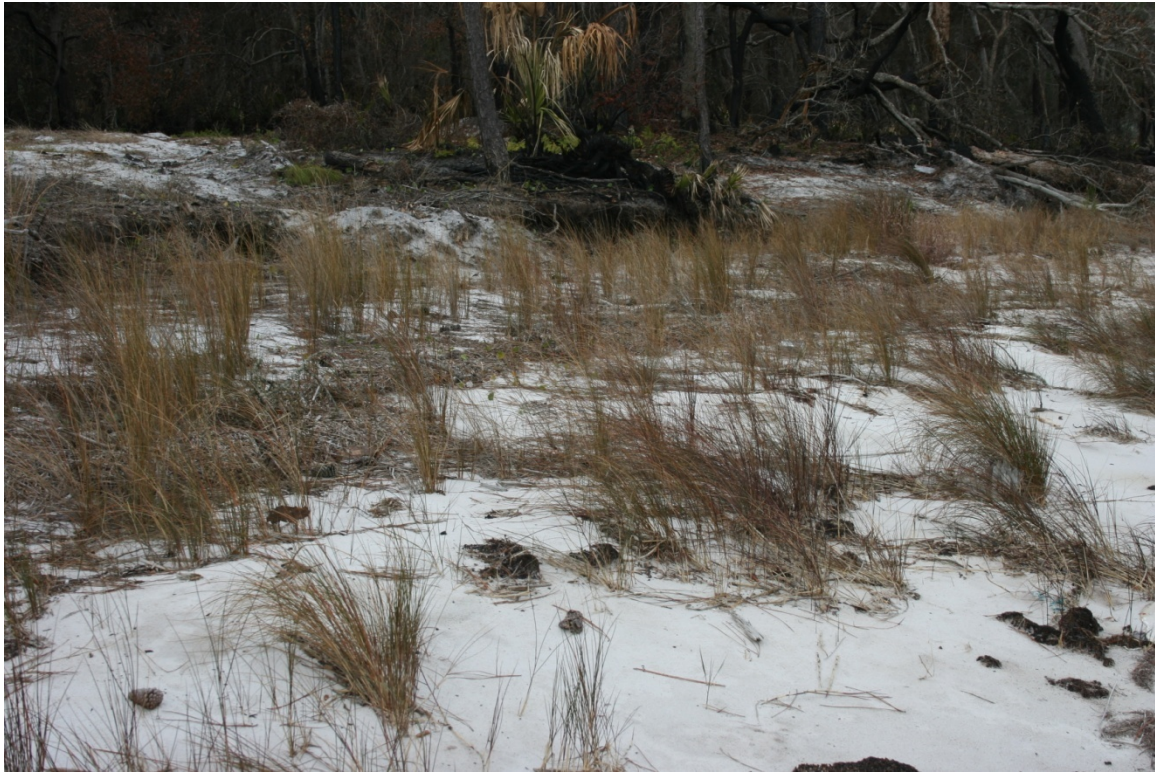
Figure 12. 2010 Spring *Spartina patens* planting survival.

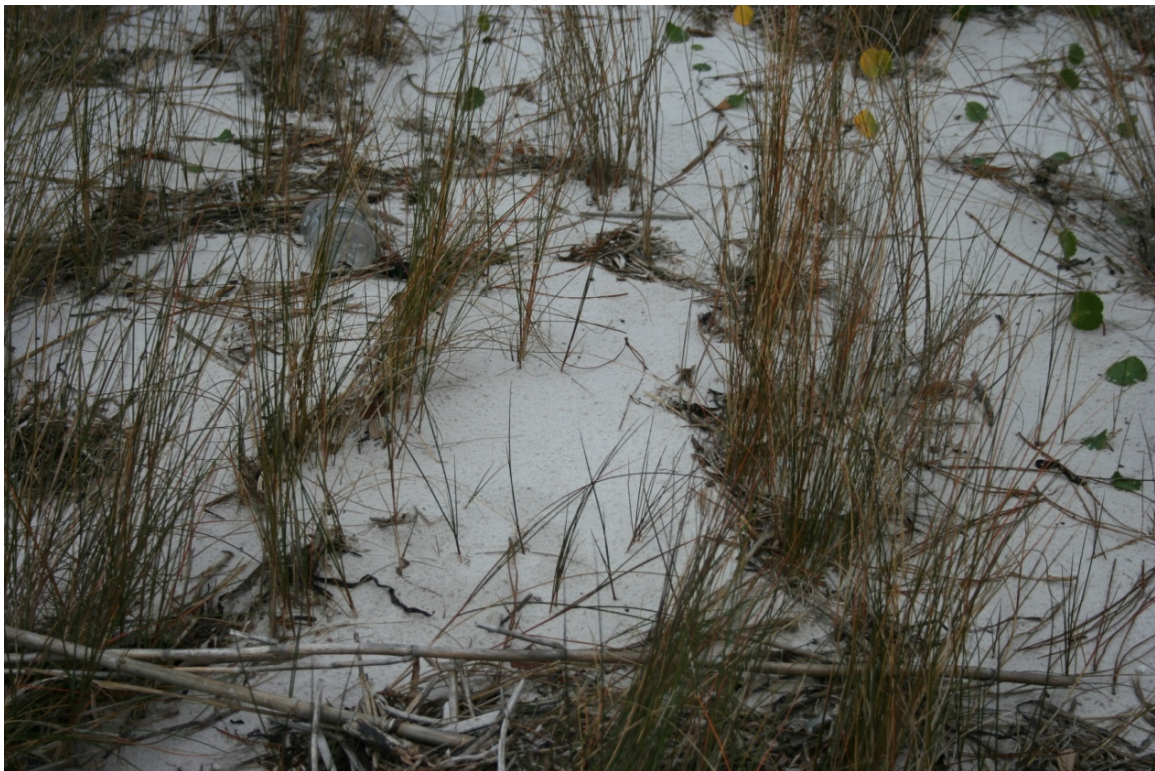
Figure 13. *Spartina patens* vegetative and sexual (not pictured) reproduction indicating the health of the planted material and a trend toward increasing cover.
