Impact: SR 300 Bryant Patton Bridge in Franklin County, 0.3 acre of seagrass in Apalachicola Bay

Mitigation: Cat Point/Apalachicola Bay breakwater and salt marsh

Monitoring Date: 11/25/08

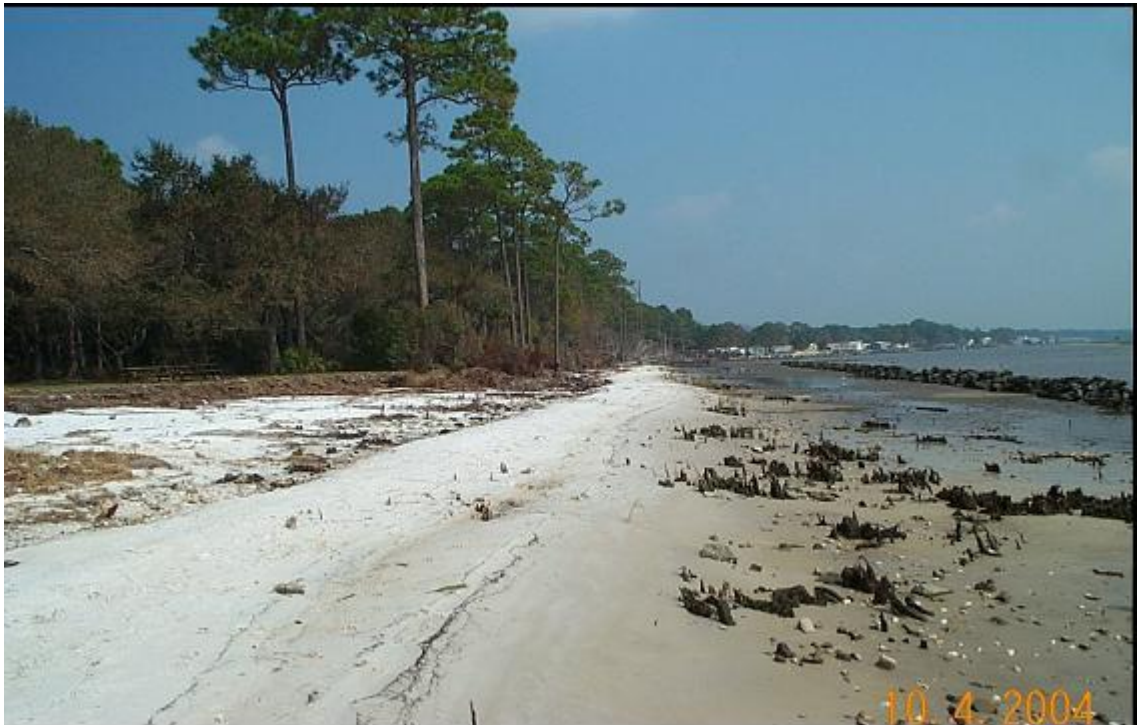
Figure 4. Post-construction view of breakwater showing rubble removed, shoreline contoured and initial recovery of beach vegetation (June 2004).

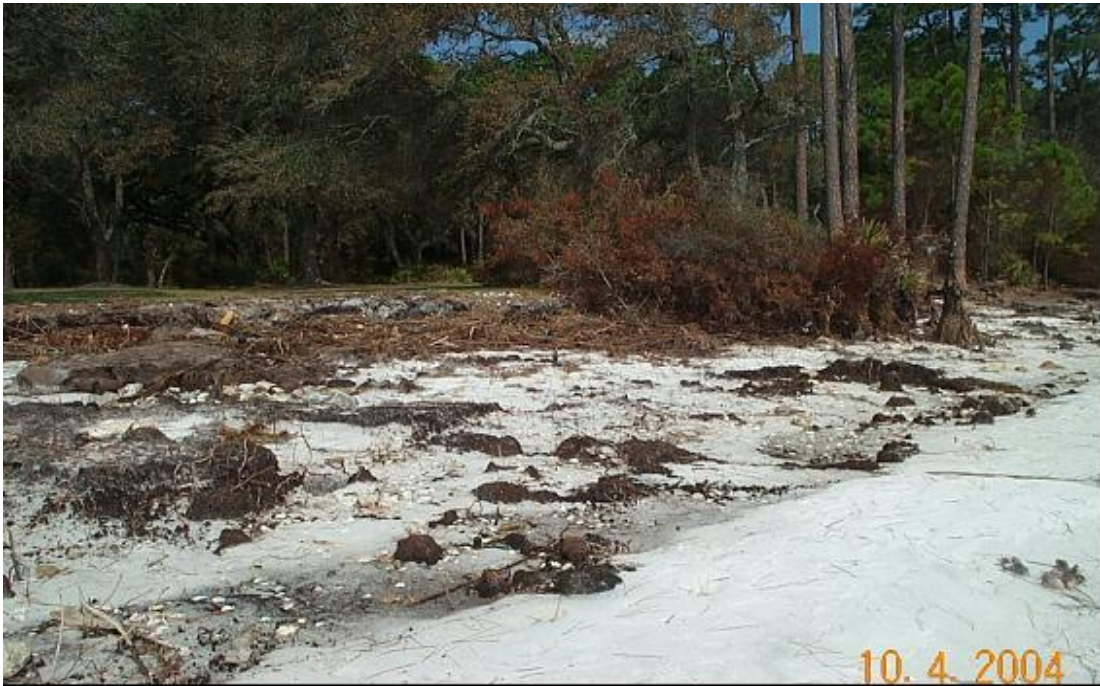
The success of our marsh plantings was affected significantly by the occurrence of numerous tropical storm events over the next few years. During the late summer and early fall 2004 the shoreline along this section of coast was severely disturbed as three hurricanes passed through the Gulf, the most intense damage coming from Hurricane Ivan in late September 2004 (Figure 5). Although the breakwater itself was undamaged, wave action was significant, overtopping the

Figure 5. View of breakwater and adjacent eroded shoreline after Hurricane Ivan (September 2004). Beach erosion was significant, extending at least 50 feet landward of previous beach/upland demarcation line.

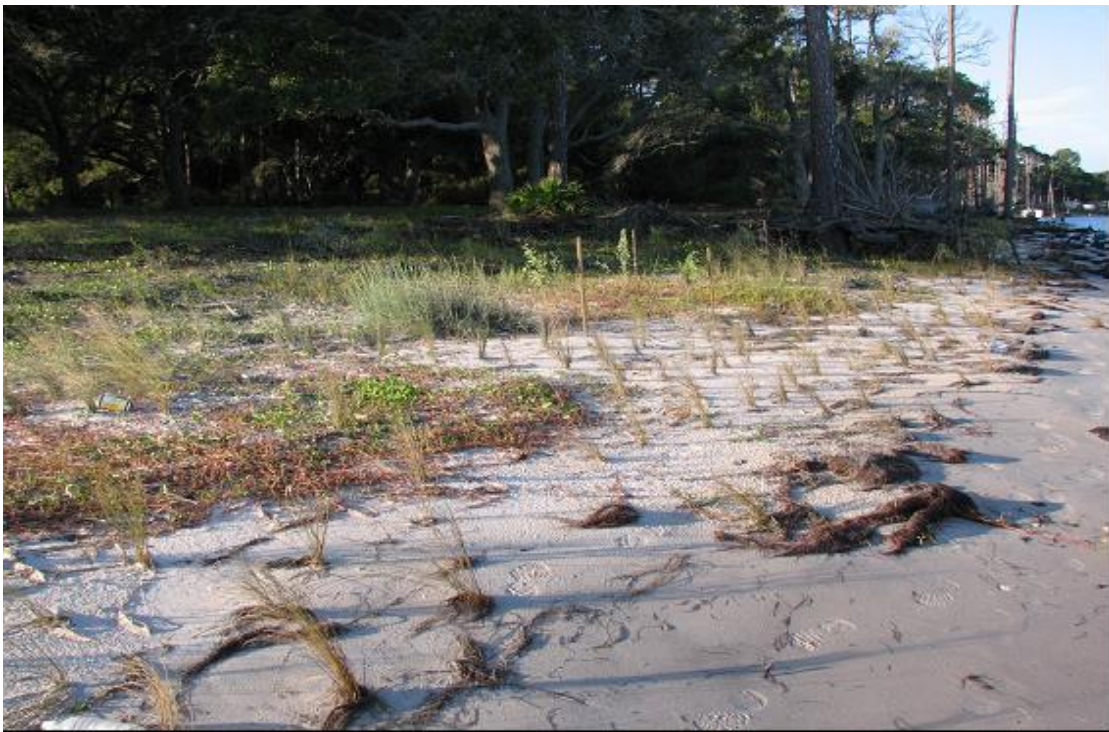
rock structure by several feet at the height of the storm. Significant erosion occurred (Figure 6); a substantial portion of the planted cord grass along with significant amounts of upland vegetation was scoured.

Figure 6. Close-up view of eroded shoreline after Hurricane Ivan (fall 2004). Erosion extended landward to newly formed escarpment, seen at center left in photo.

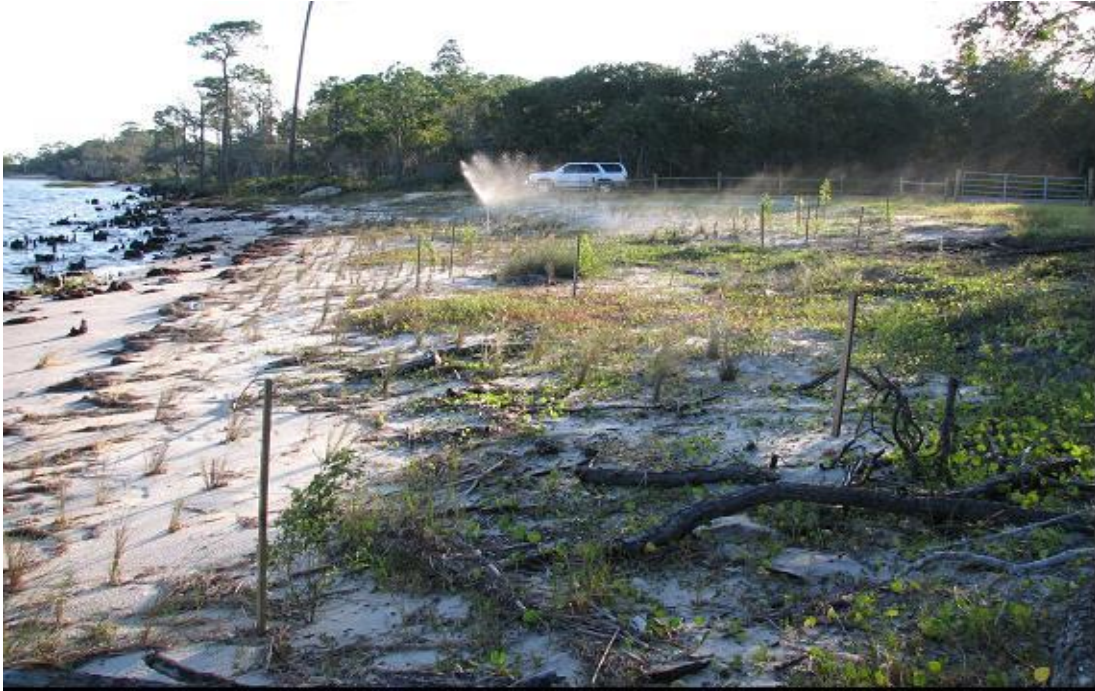
Figure 7. Vegetation planted in the transition zone between the beach and uplands (fall 2007). See text for list of planted species. Compare with above photo (Figure 6).

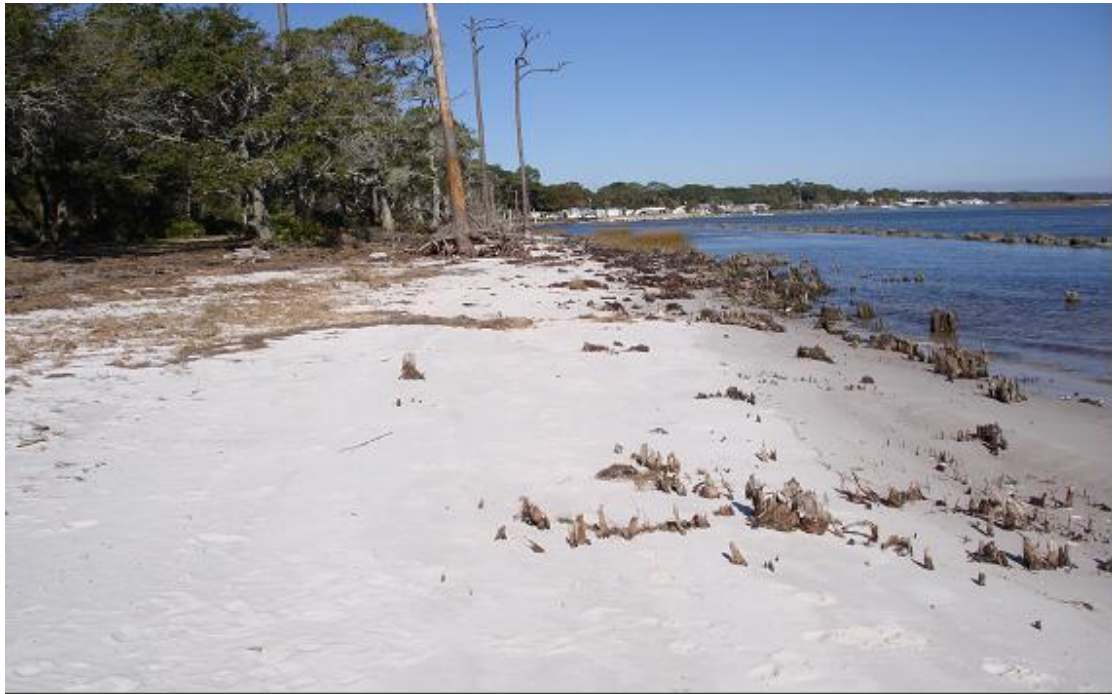
Figure 8. Vegetation planted in the transition zone between the beach and uplands (fall 2007). See text for list of planted species.

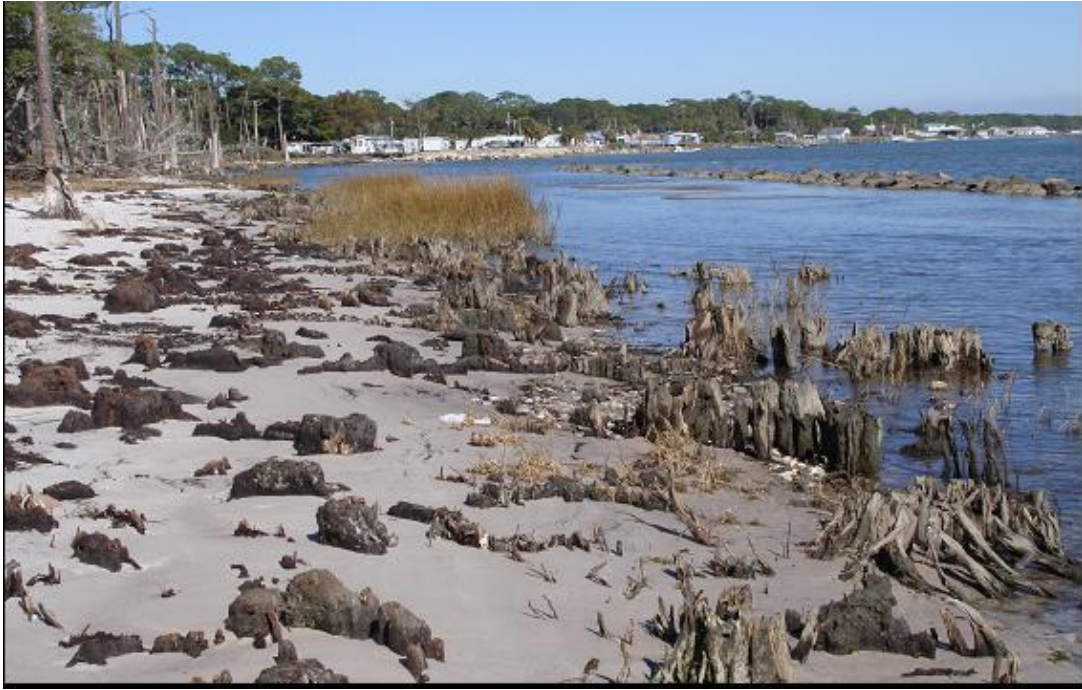
Figure 9. Overall condition of site after the storm activity in summer 2008 as noted during annual monitoring. The salt marsh has expanded despite significant erosion and loss of upland buffer vegetation.

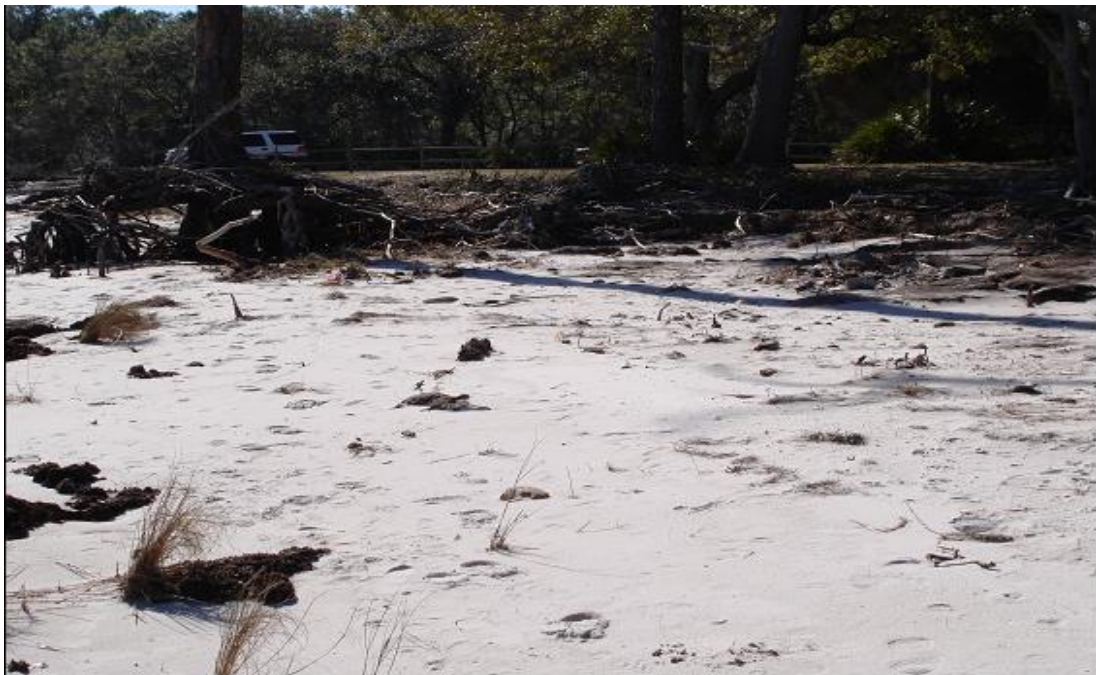
Figure 10. Erosion and scour in the nearshore/intertidal area noted during annual monitoring 2008; exposure of peat deposits that were covered prior to storm activity.

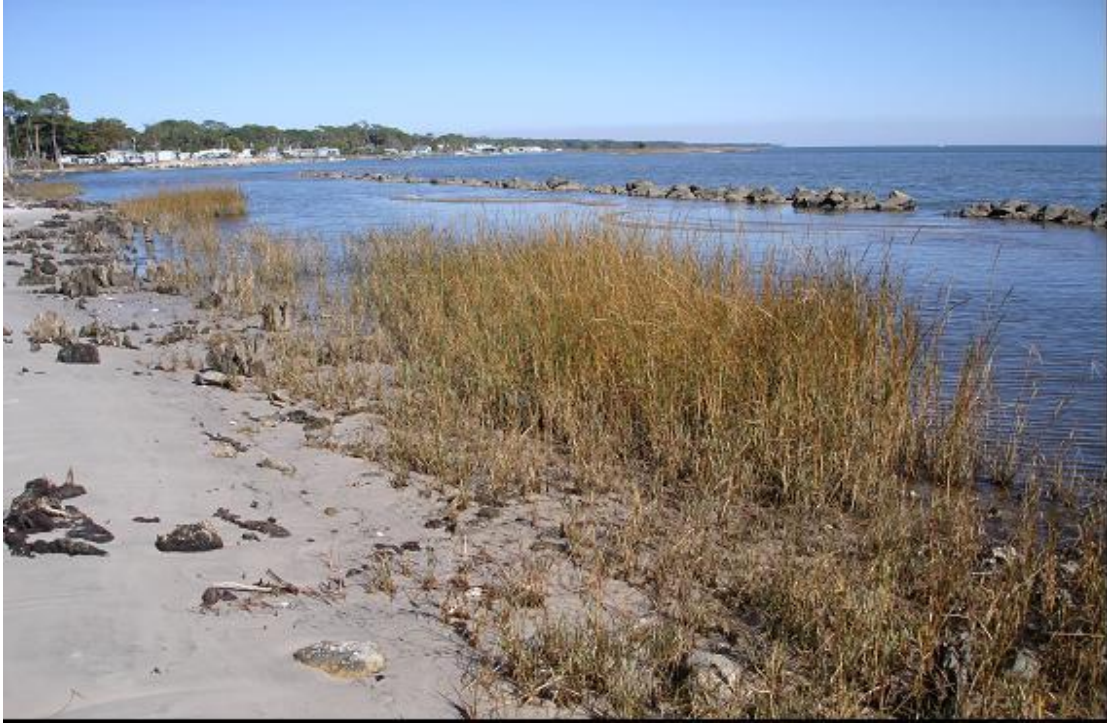
Figure 11. Erosion and scour in upland buffer zone in middle of site. Annual monitoring photo shows an additional loss of 15-20 feet of upland that occurred during the 2008 storm season.

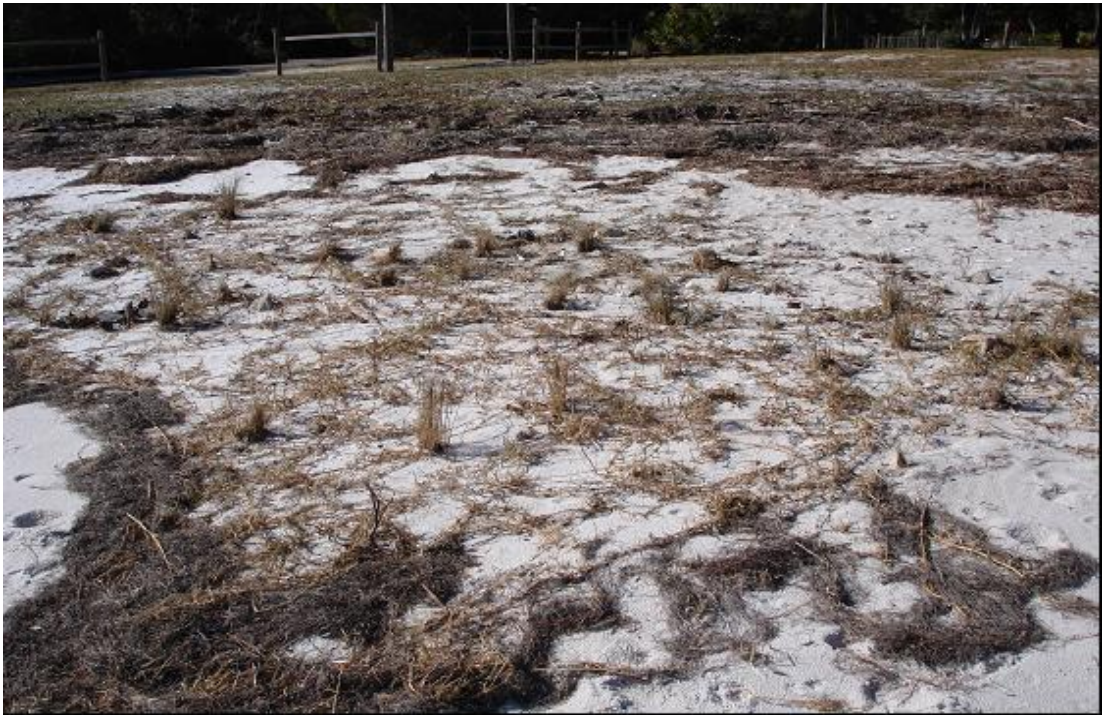
Figure 12. Spartina marsh has expanded into three large patches, the largest of which is shown in the foreground (noted in annual monitoring 2008).

Figure 13. Significant erosion and scour of upland resulting from high storm surge. Surviving saltmarsh cordgrass and sea purslane in southern portion of upland buffer (noted in annual monitoring 2008).

The second annual site monitoring was carried out on 25 November 2008. A late fall monitoring was chosen to assess the net result of propagation during the growing season coupled with any detrimental effects of tropical storm activity. Significant erosion and scouring occurred from multiple storms during the summer including Fay, Gustav and Ike, despite the fact that none made landfall in the immediate area (Figures 9-11). Survival of smooth cordgrass ranged from 65-90% depending on the section of shoreline planted (Figure 12); overall rate was about 75-80%. Upland buffer vegetation survival was poor with rates generally less than 5-10%; saltmarsh cordgrass (*Spartina patens*) and sea purslane (*Sesuvium portulacastrum*) had higher rates of survival (Figure 13). Upland buffer replanting will occur during spring 2009.
