LIVE OAK POINT LIVING SHORELINES

2024 (Fall) Project and Reference Site Monitoring Report

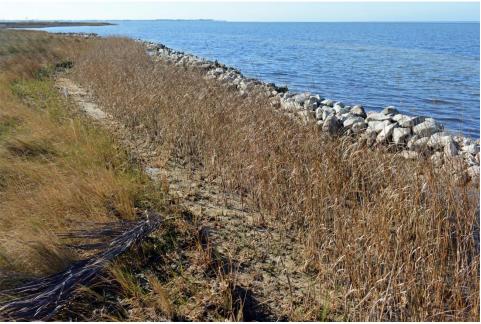
Figure 21. Expansion of Spartina alterniflora Behind Limerock Breakwaters (12/16/2024)

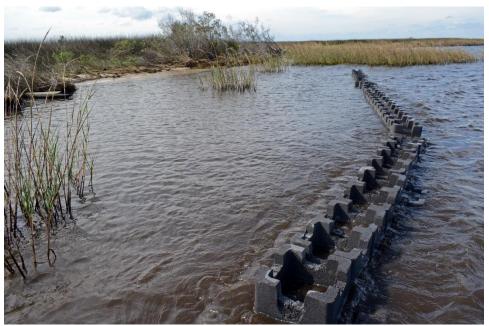
Figure 24. Newly Constructed Breakwater Segment Using "Oyster Castles" (11/13/2024)

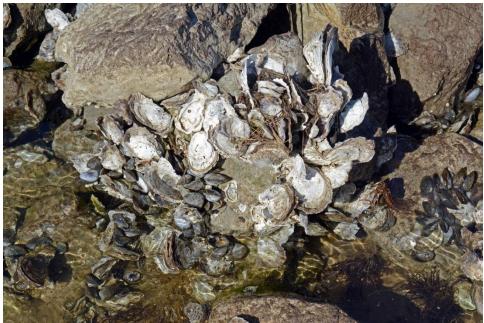
Figure 27. Oyster Colonization on Breakwater (12/16/2024)

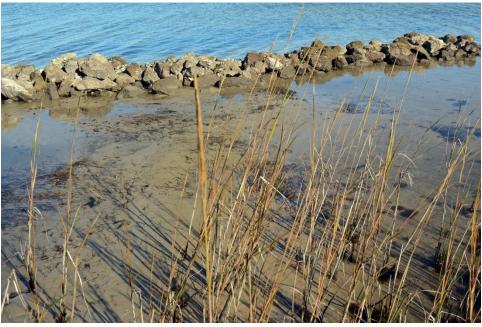
Initial monitoring of the PVC post pairs within the marsh expansion zone (Table 6) was conducted on 11/25/2025, with repeat measurements taken on 12/16/2024 (22 days apart). Although too short a time interval to establish trends with any degree of confidence, initial data strongly suggest accumulation of sediment in the marsh expansion zone behind constructed breakwaters.¹⁰ The average measured accretion of sediment, over 22 days (i.e., 11/25/2024 – 12/16/2024), for PVC post pairs placed behind existing breakwaters, was 1.8 cm (well above the rate of estimated sea level rise for northwest Florida). Over time, definitive trends within the marsh expansion zone are expected to be determined.

Figure 28. Sediment Accretion Behind Limerock Breakwater (12/16/2024)

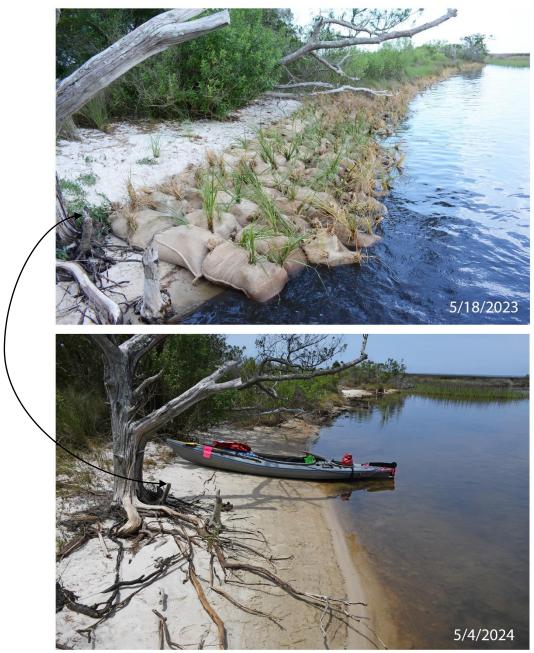
Planted vegetation has generally done well in locations protected by limerock breakwaters. However, where breakwaters are absent (i.e., where breakwaters were not constructed due to SAV-avoidance concerns), planted vegetation has generally washed out. Expectations that multiple rows of sandbag plantings (i.e., sandbags with three vegetation plugs per bag) would be sufficient to stop erosion where breakwaters were not constructed were not realized. Corrective measures are being implemented making use of "Oyster Castle" blocks along approximately 990± FT of shoreline where limerock breakwaters were not constructed.³

Figure 29. Washout of Planted Vegetation Not Protected by Breakwaters

³ Because of the geometries of "Oyster Castles," they can be positioned more precisely with less potential of disturbance to nearby SAV when compared to lose limerock. Breakwater construction using "Oyster Castle" blocks began October 2024 and is expected to be completed by Spring 2025.
