**TATE’S HELL - PINE LOG CREEK MITIGATION SITE**  
Annual Monitoring Report, Year 1 of 5  
February 21, 2012

**PROJECT OVERVIEW**

Mitigation: Tate’s Hell – Pine Log Creek  
Hydrologic Restoration Project, Franklin County

Date of Inspection: January 18, 2012

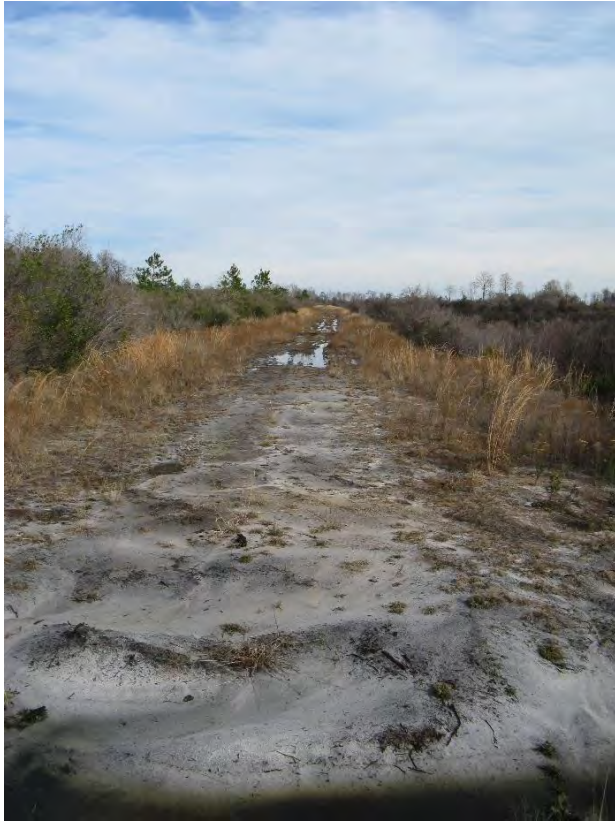
- Segment 1: Remnant roadside ditches were present at several locations but were more evident along the western portion of this segment ([Photo 1](#)) than at the eastern end ([Photo 2](#)). Bare areas varied in size throughout the segment with cover ranging only up to 35-40%. The eastern portion of the site appeared wetter than the western side with standing water observed to the south of the old road within the adjacent block ([Photo 3](#)). The guard rail at the eastern end of the segment has been removed and needs replacement. The ditch block at the western end, southern side of road, has been breached and it appears that vehicle traffic has entered the site bypassing the guard rail ([Photo 4](#)) at this end.

Photo 1. Western end of road removal Segment 1; taken at photo point 1 looking east, 1/18/12.

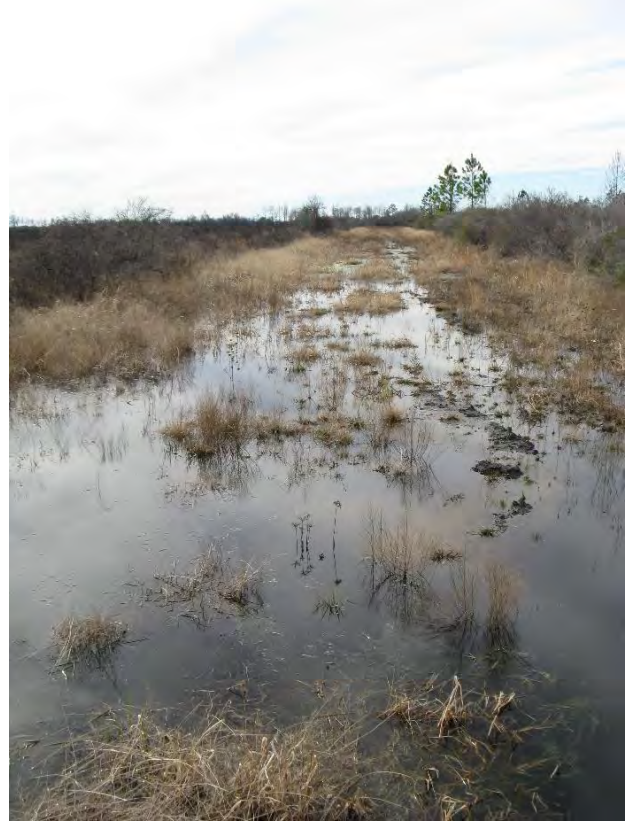
Photo 2. Eastern end of road removal Segment 1; taken at photo point 3 looking west, 1/18/12. [RTN](#)

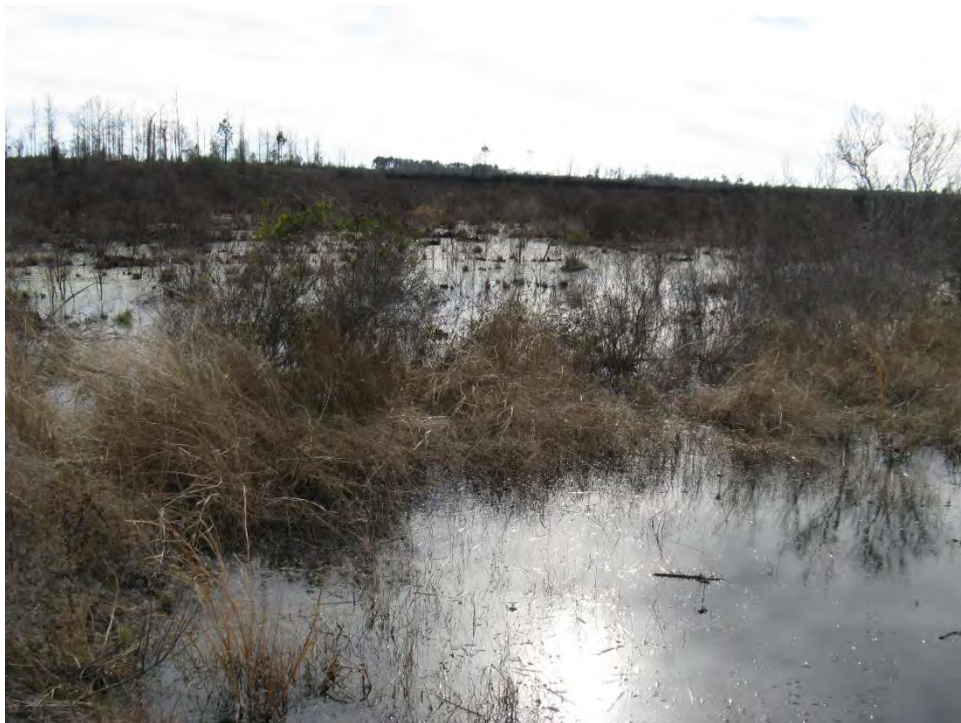
Photo 3. Standing water in adjacent block to the south of road removal Segment 1-eastern end; taken at photo point 3 looking south, 1/18/12. [RTN](#)

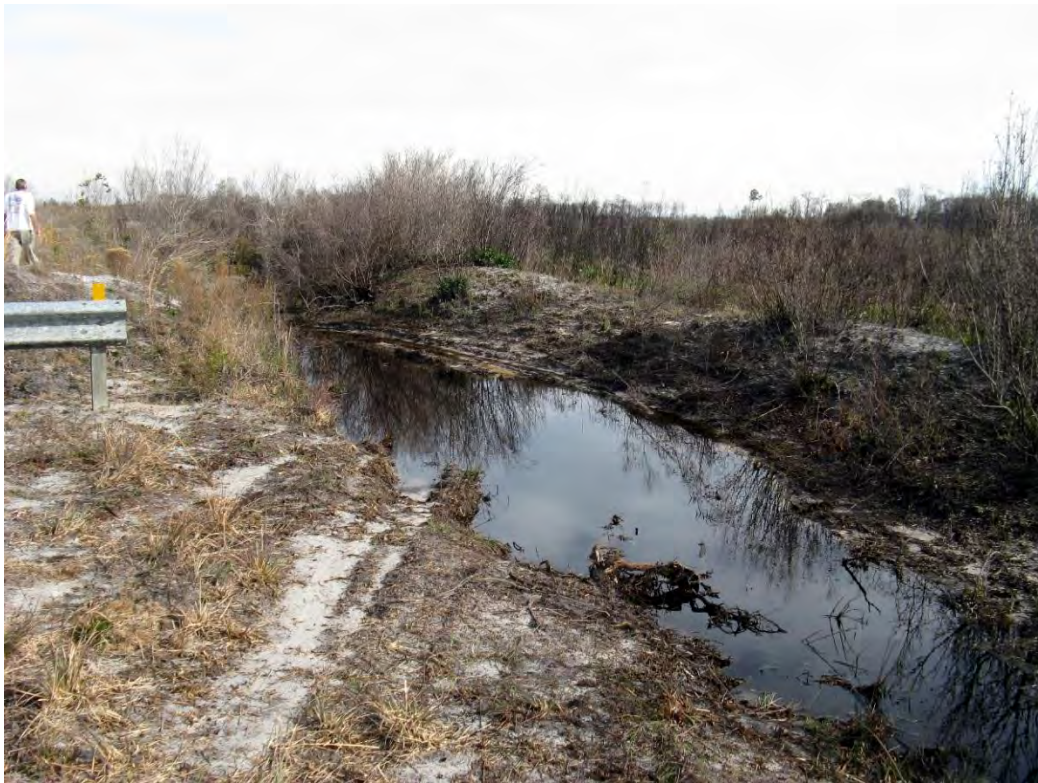
Photo 4. Western end of road removal Segment 1 indicating loss of ditch plug and possible vehicle tracks bypassing the guard rail and entering the site; taken at photo point 2 looking SE, 1/18/12. [RTN](#)

All other structures (i.e., low-water crossings, culvert improvements, flashboard riser, ditch blocks) were inspected and found to be functioning properly. Minor erosion was noted around some of the new culvert installations (e.g., C10; [Photo 10](#)) but was not excessive; sediment deposition was not accumulating in any of the adjacent ditches. All of the ditch plugs were intact and holding water; most had revegetated well (e.g., D11; [Photo 11](#)). One low-water crossing (L10) needs a staff gage, as water depth is relatively deep. A guard rail is missing at the east end of road removal Segment 1 and should be replaced.

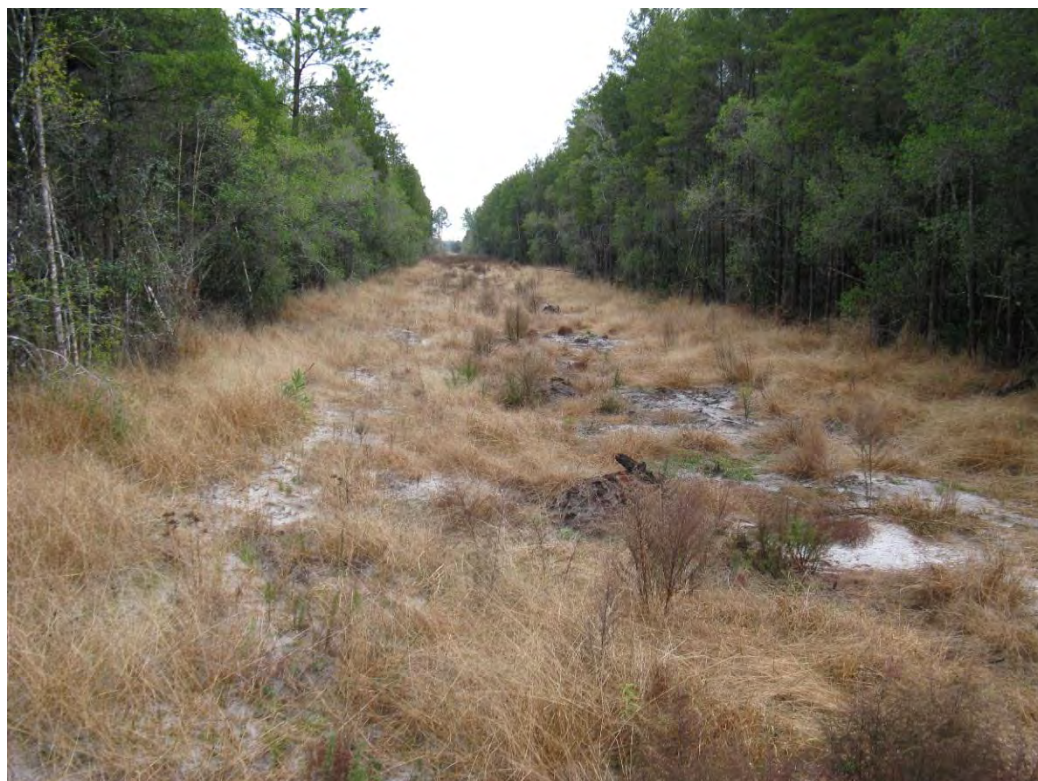
- Segment 2: Road recontouring was very effective throughout this segment and achieved a grade similar to the adjacent natural elevations. Vegetative cover ranged from 50-75% along the segment and consisted of a variety of early successional species of rushes, sedges and wetland grasses ([Photo 5](#)); several juvenile sweet bays were found sprouting in the southern portion of the segment.

Photo 5. Southern end of road removal Segment 2, note sprouting sweet bay just left of center; taken at photo point 4 looking north, 1/18/12. [RTN](#)

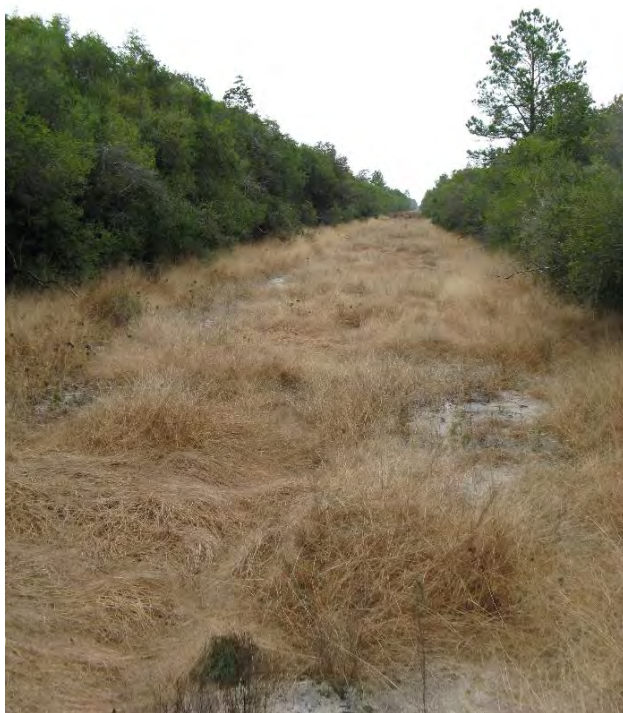
- Segment 3: Similar to segment 2, recontouring of this segment appeared to result in a good match to adjacent natural grade. Vegetation recolonization is proceeding well but patchy. Southern portions of the segment had up to 80% cover ([Photo 6](#)); northern sections were more heterogeneous, ranging from 25-75% ([Photo 7](#)). Here, as elsewhere, colonization by early successional species of wetland grasses and rushes was evident.

Photo 6. Southern end of road removal Segment 3; taken at photo point 5 looking north, 1/18/12. [RTN](#)

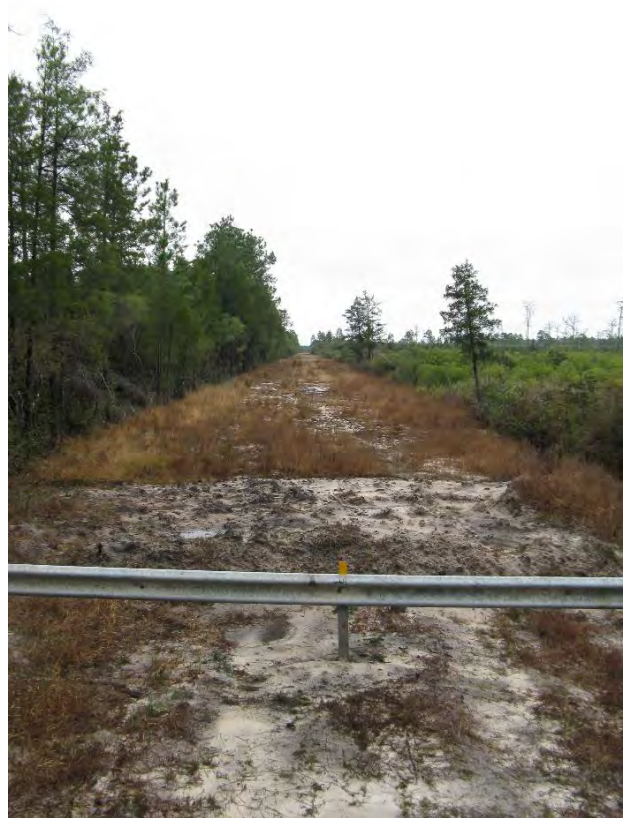
Photo 7. Northern end of road removal Segment 3; taken at photo point 6 looking south, 1/18/12. [RTN](#)

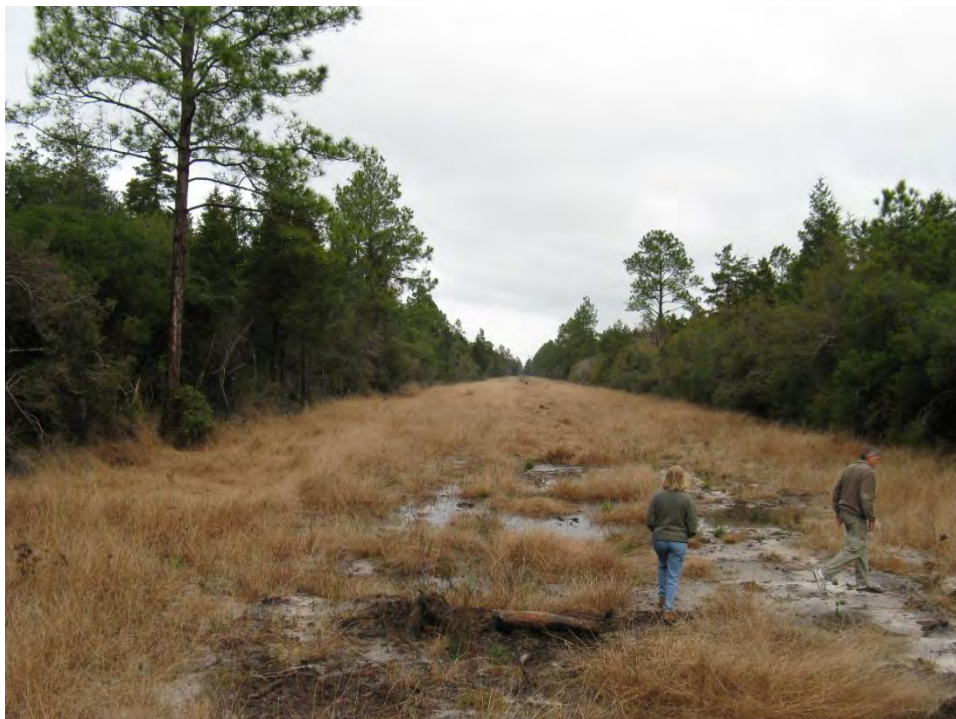
- Segment 4: Road and ditch recontouring in this segment matched well with existing natural grade; no remnant ditches were found. Vegetative recolonization was proceeding well also with groundcover ranging between 65-75% ([Photo 8](#)). A variety of wetland grasses, appropriate to the area, were recruiting to the site.

Photo 8. Southern end of road removal Segment 4; taken at photo point 7 looking north, 1/18/12. [RTN](#)

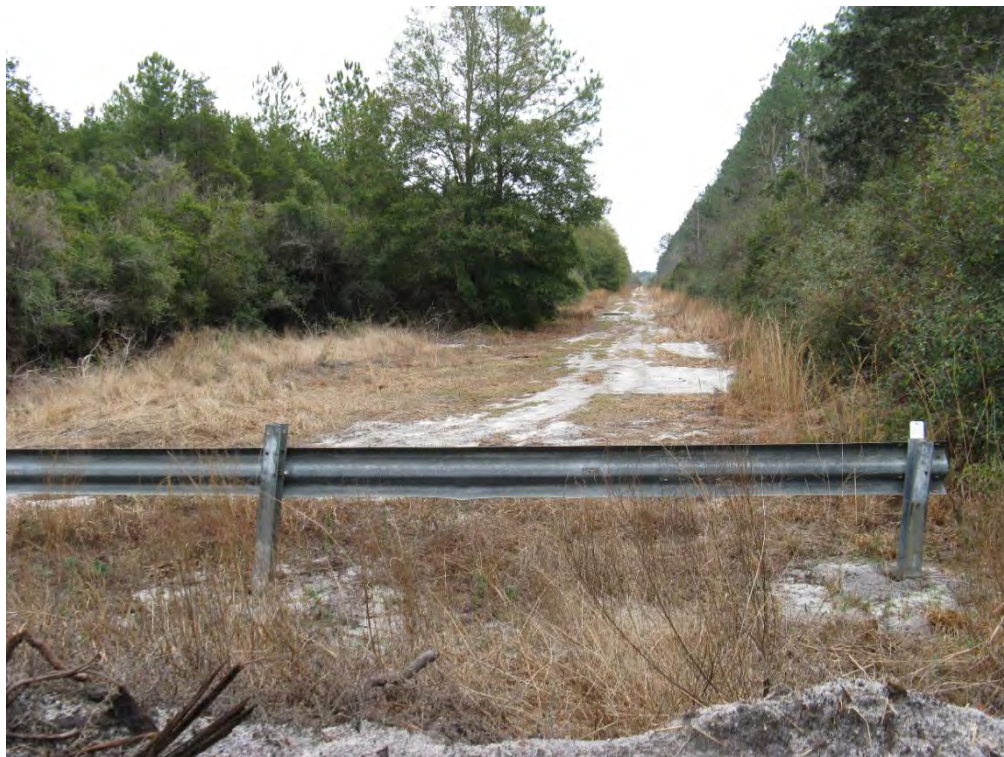
- Segment 6: A small section of road was removed abutting an existing removal section from a previous project ([Photo 9](#)). Ditching remains on north side of removal and water flows to the east in these ditches rather than south through the natural community. It is likely that this rerouting of water will not be successful until further recontouring can take place within the adjacent block to the south.

Photo 9. Western end of road removal Segment 6; taken at photo point 8, 1/18/12.

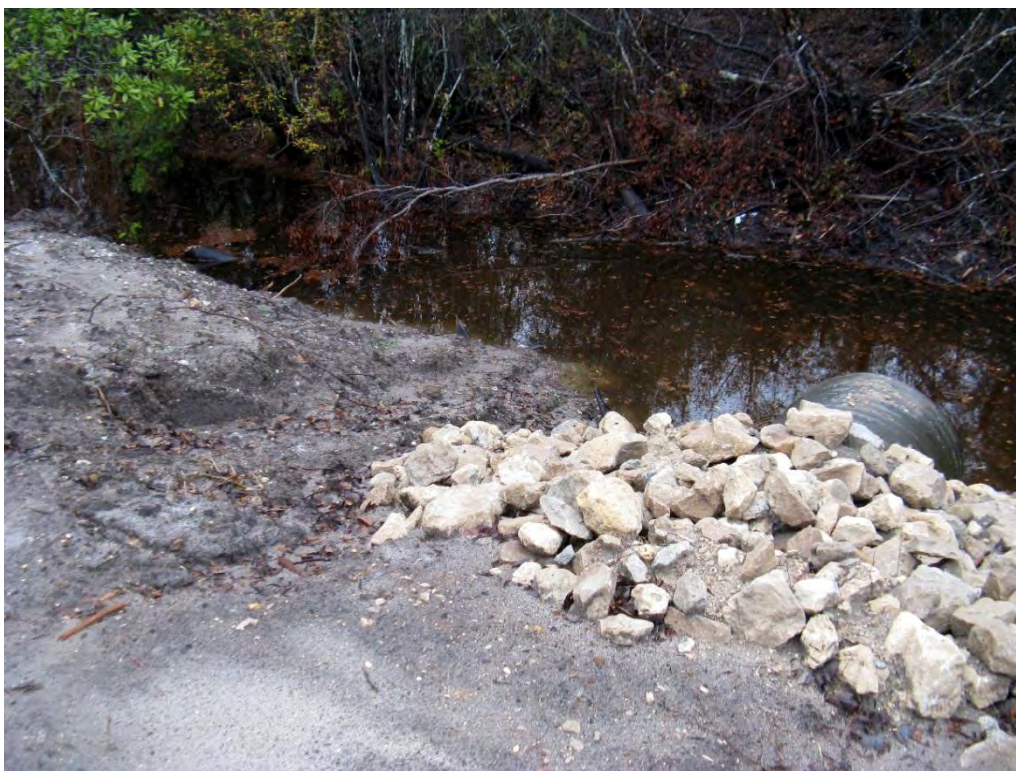
Photo 10. Minor erosion around side of newly installed culvert (e.g., C10); taken at photo point 9, 1/18/12.

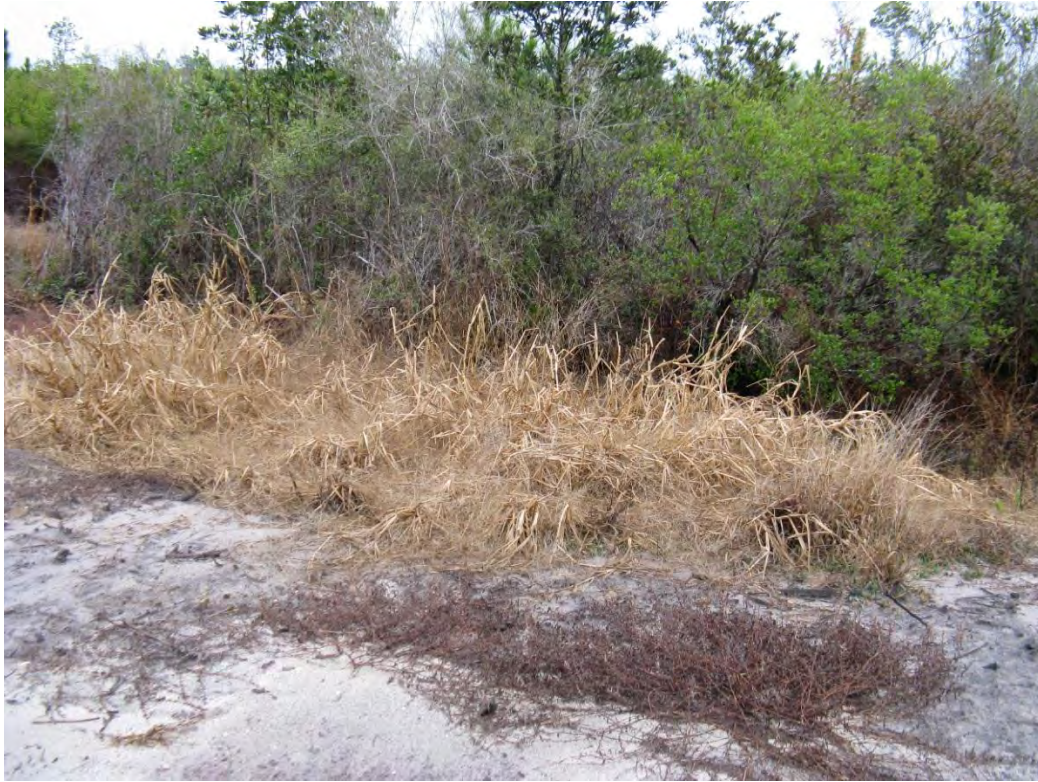
Photo 11. Typical ditch plug (e.g., D11) indicating relatively rapid revegetation; taken at photo point 10, 1/18/12. [RTN](#)

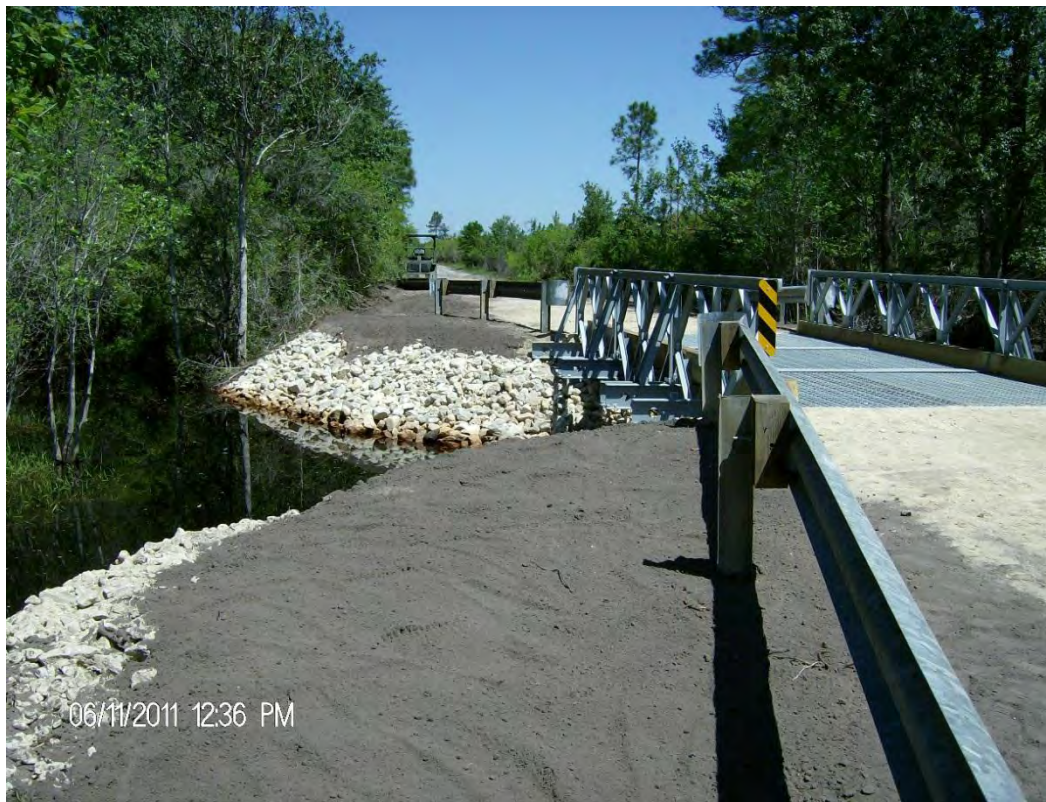
A 3-span Bailey bridge replaced inadequately sized culverts to improve flows under Pine Log Road ([Photo 12](#)). Bridge construction was completed in April 2011 prior to completion of the remaining hydrological improvements. The bridge was constructed by FFS staff and has received DOT inspection and approval.

Photo 12. Three-span Bailey bridge over a tributary of Pine Log Creek; taken at photo point 11, 6/11/11. [RTN](#)
