Juniper Creek Headwaters Preserve (UWRMP 5.5.7)

A site visit was conducted on November 12th, 2010 to monitor the condition of the site.

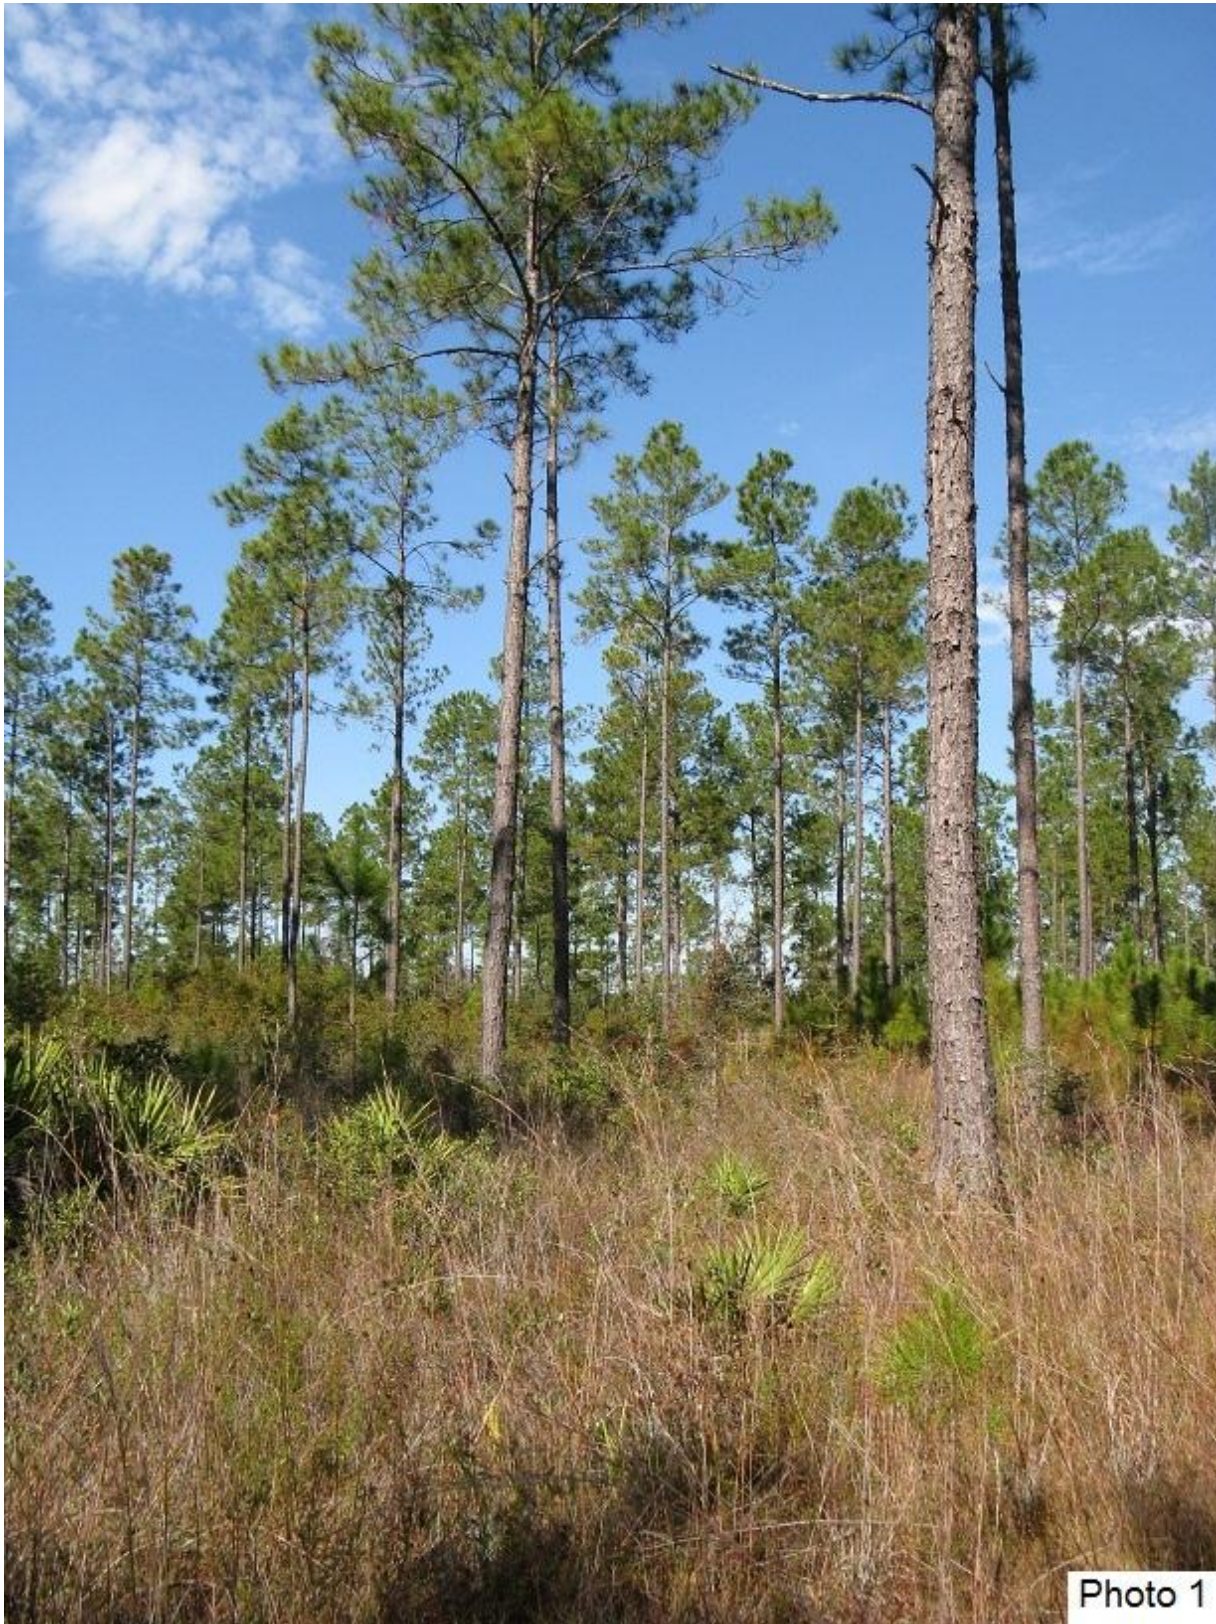
Based on structure and composition, the flatwoods are overall in moderate condition. There is a high level of herbaceous species diversity; however the entire area needs to be burned soon in order to maintain groundcover composition (Photo 1). It appears neighboring properties also conduct controlled burns, and therefore there may be opportunities for coordinated prescribed fire across several parcels.

Herbaceous groundcover in flatwoods. Photo taken along main road, facing west.

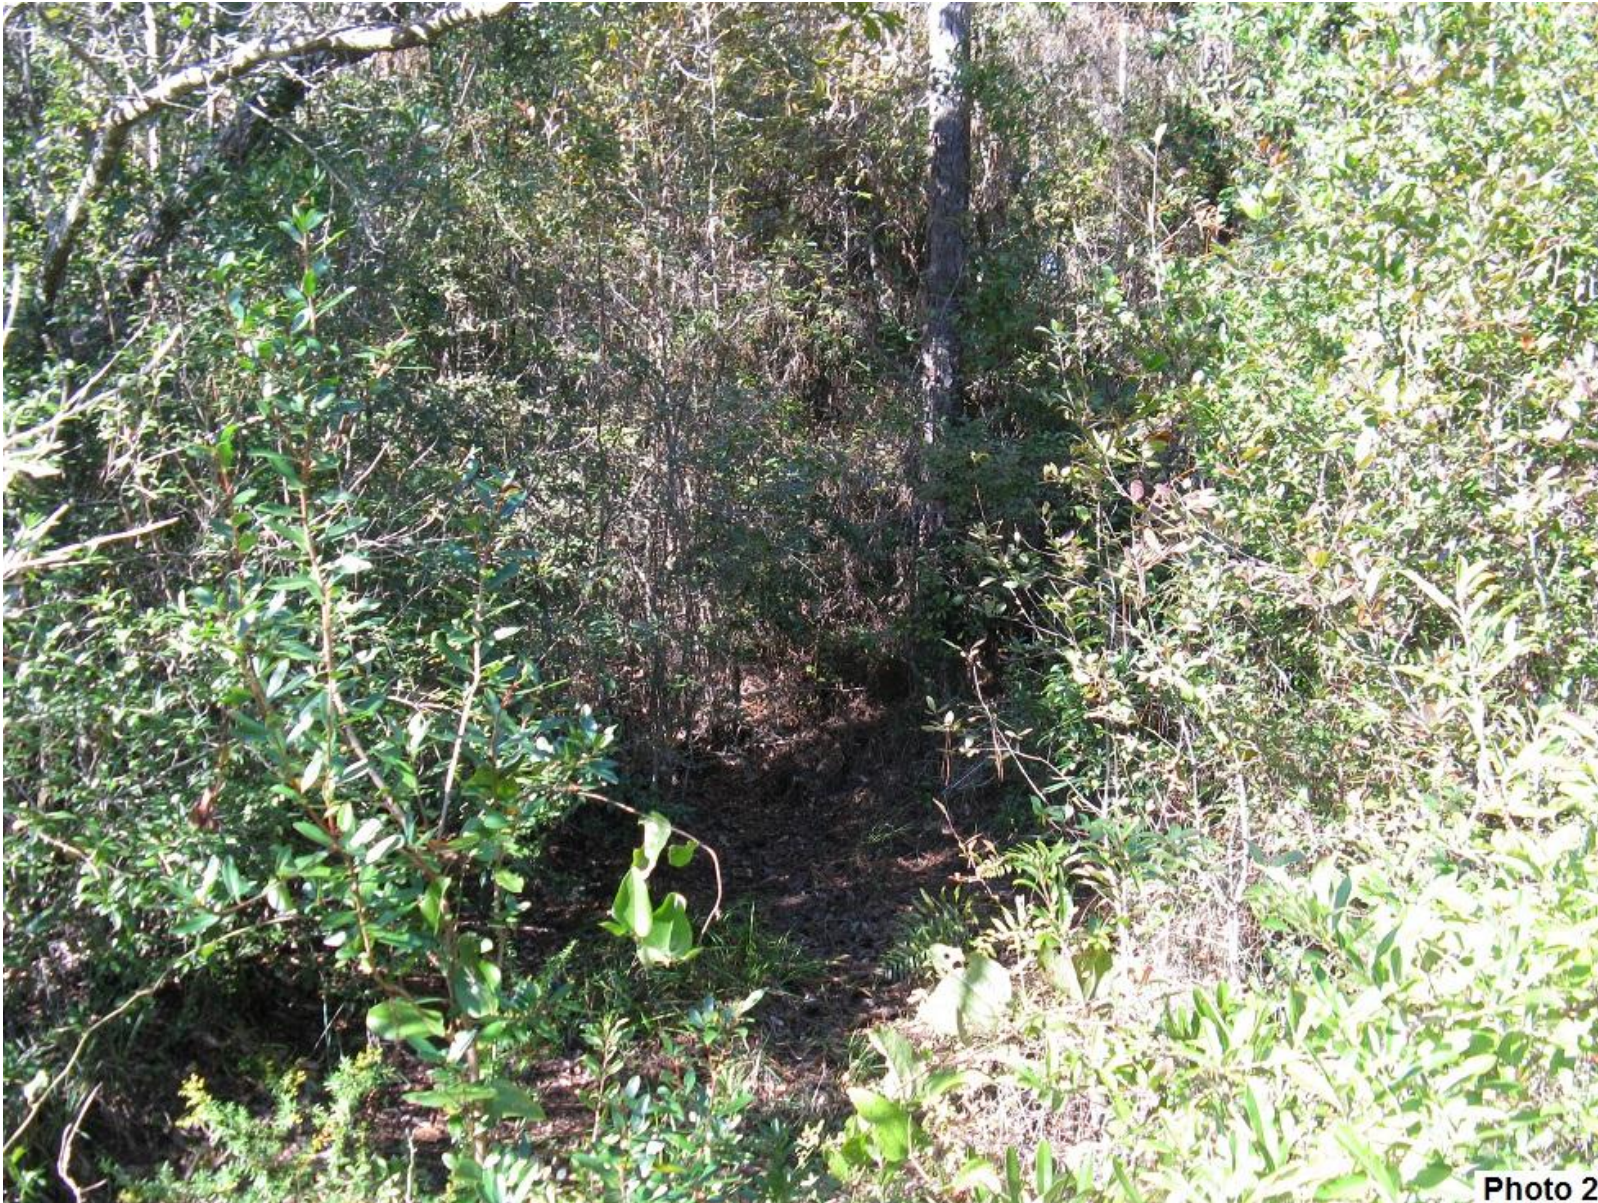
Photo 2

Across the property, vegetation is moderately dense. Along the natural drains that run through the center of the property, as well as along the outer boundary of the property, the vegetation is much denser (Photo 2, 3). Titi is approximately 6-9 feet tall along the main road (Photo 4) and much taller in other areas. In the forested and shrub wetlands along the northwestern and northeastern boundary, woody species are very dense and encroaching into the flatwoods area. In most of the flatwoods areas, woody species are becoming more prevalent where pines are established (Photo 5). Prescribed fire is essential in managing these habitats.

The main road that runs N-S through the property has been closed and there is minor evidence of erosion (Photo 7). However there was not water in main creek channel at the time of the site visit (Photo 2). The ditch on the western edge of the property had standing water on the northern end (Photo 8).

Vegetation is much denser along the natural drains. Note: Creek is dry. Photo taken along main road, facing west.

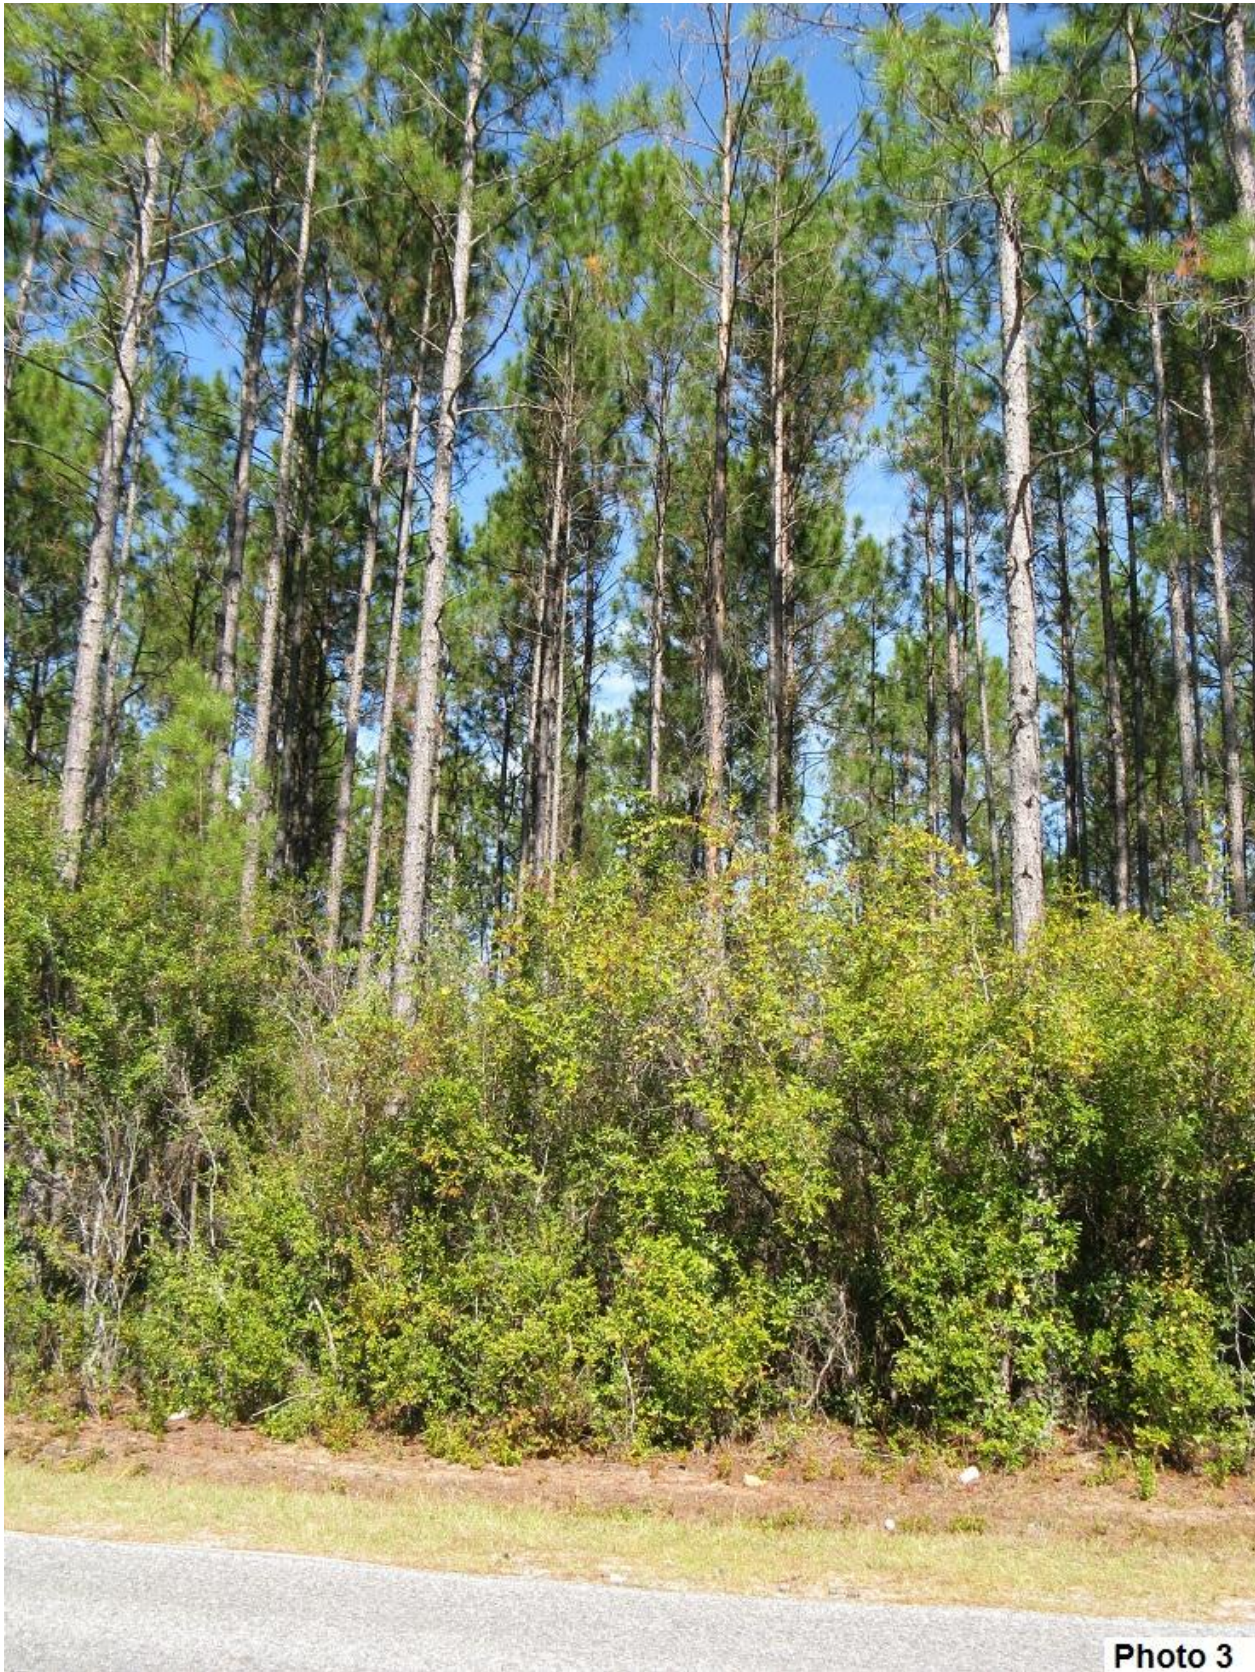
Photo 3

Vegetation is also much denser along property boundaries. Photo taken along Silver Lake Rd, facing north.

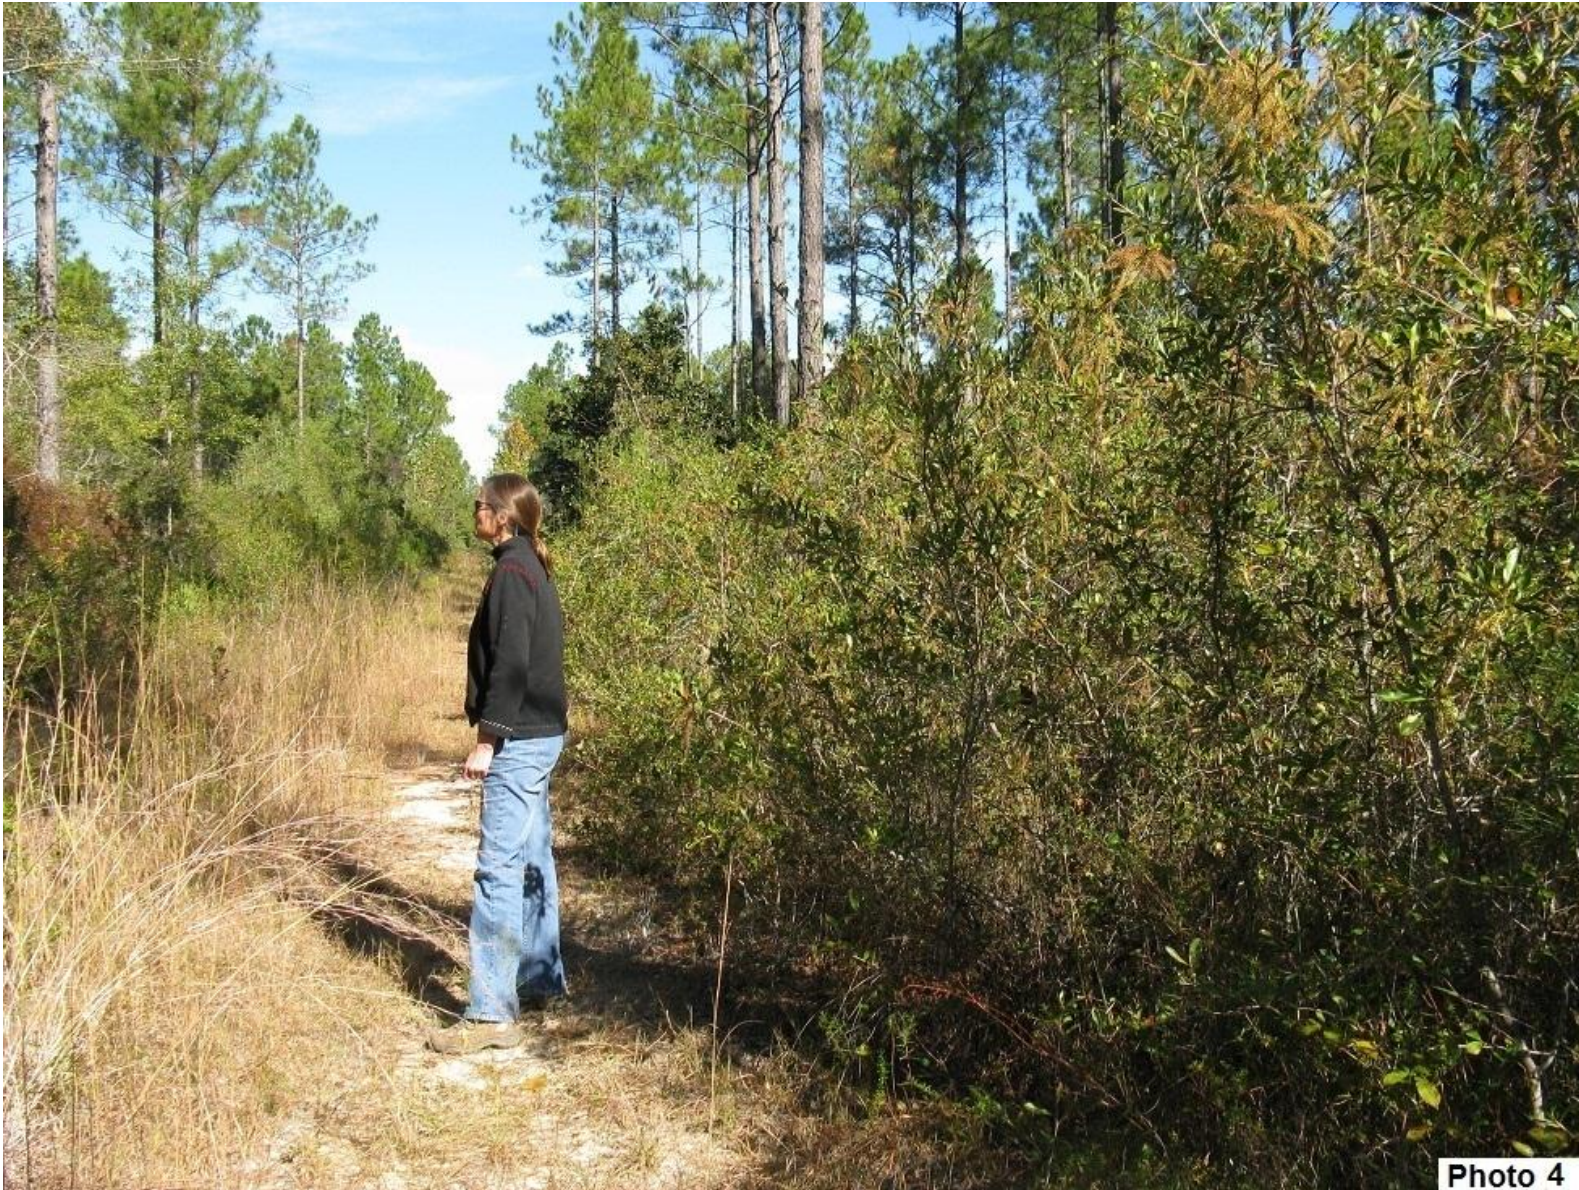
Photo 4

Titi along natural drains is 6-9 feet tall near the main road. Photo taken along main road, facing north.

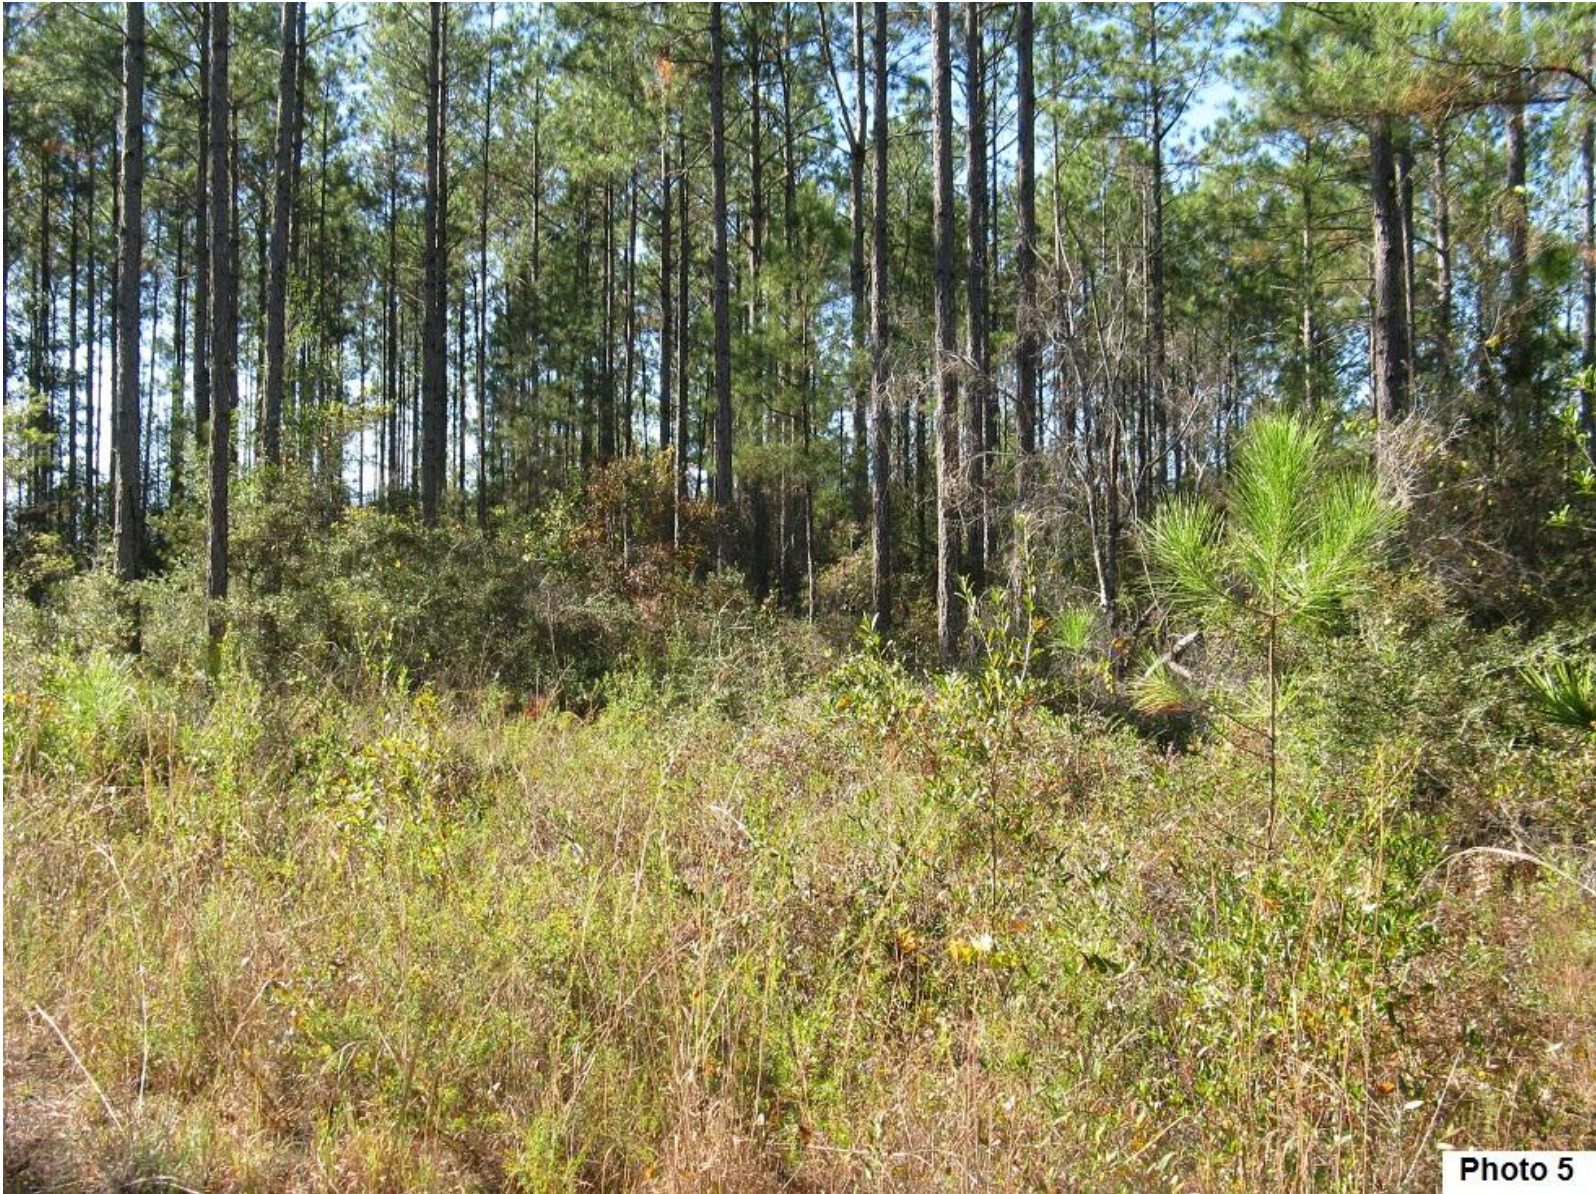
Photo 5

Hardwood encroachment into flatwoods areas. Photo taken along main road, facing west.

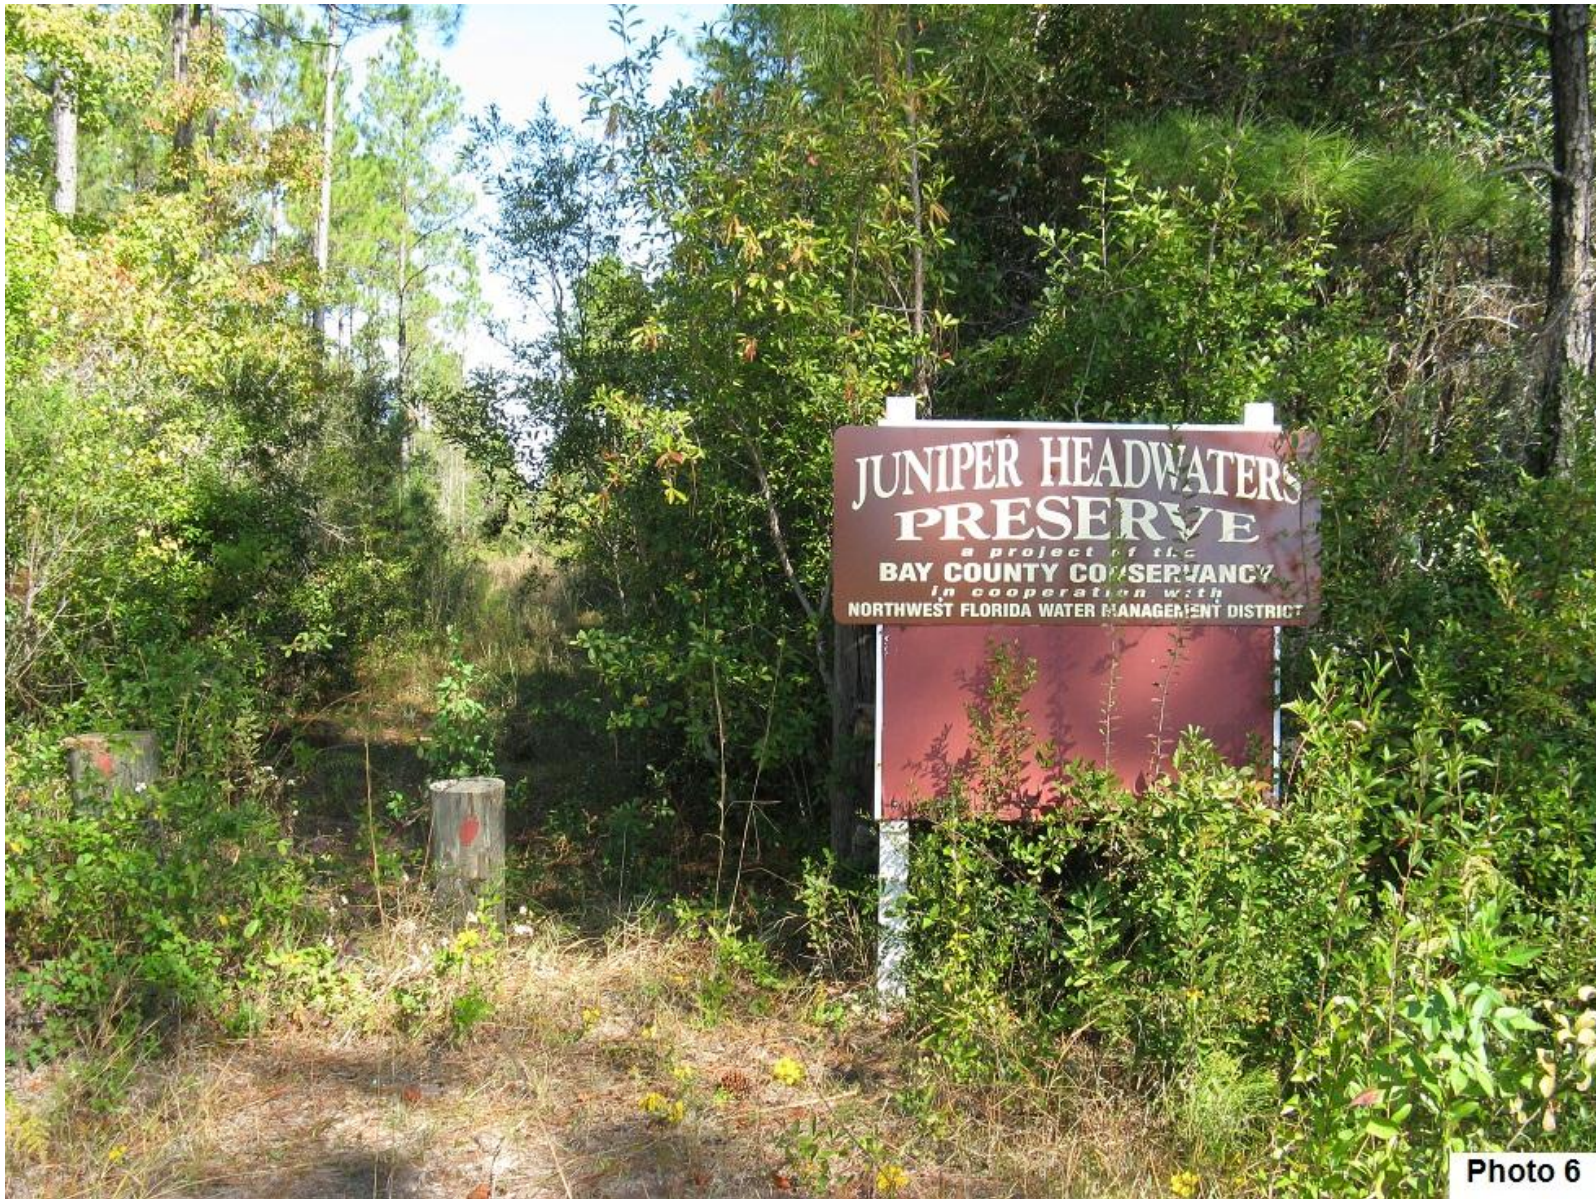
Photo 6

As stated in the mitigation plan, there are few exotic species on site; however Chinese tallow is still present along the southern property boundary near the main entrance (Photo 6).

Preserve entrance- note the Chinese Tallow on the left. Photo taken at main entrance, facing north.

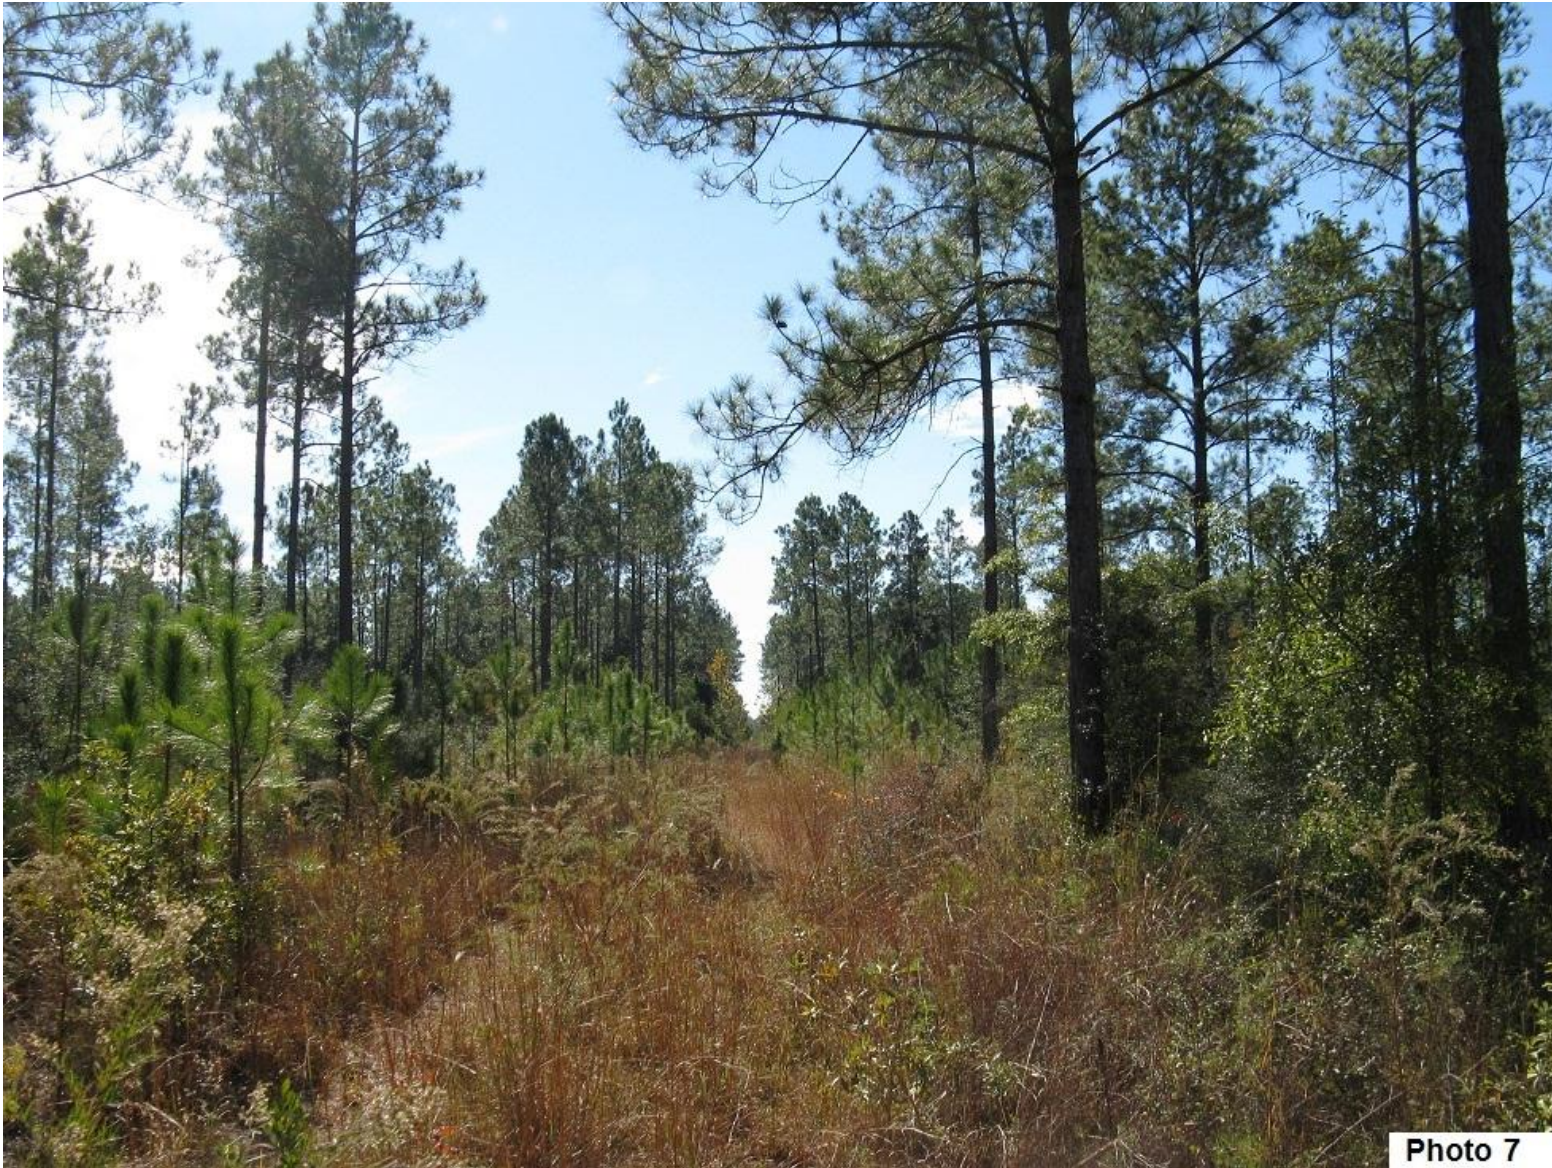
Photo 7

Herbaceous vegetation grows along the closed road. Photo taken along main road, facing south.

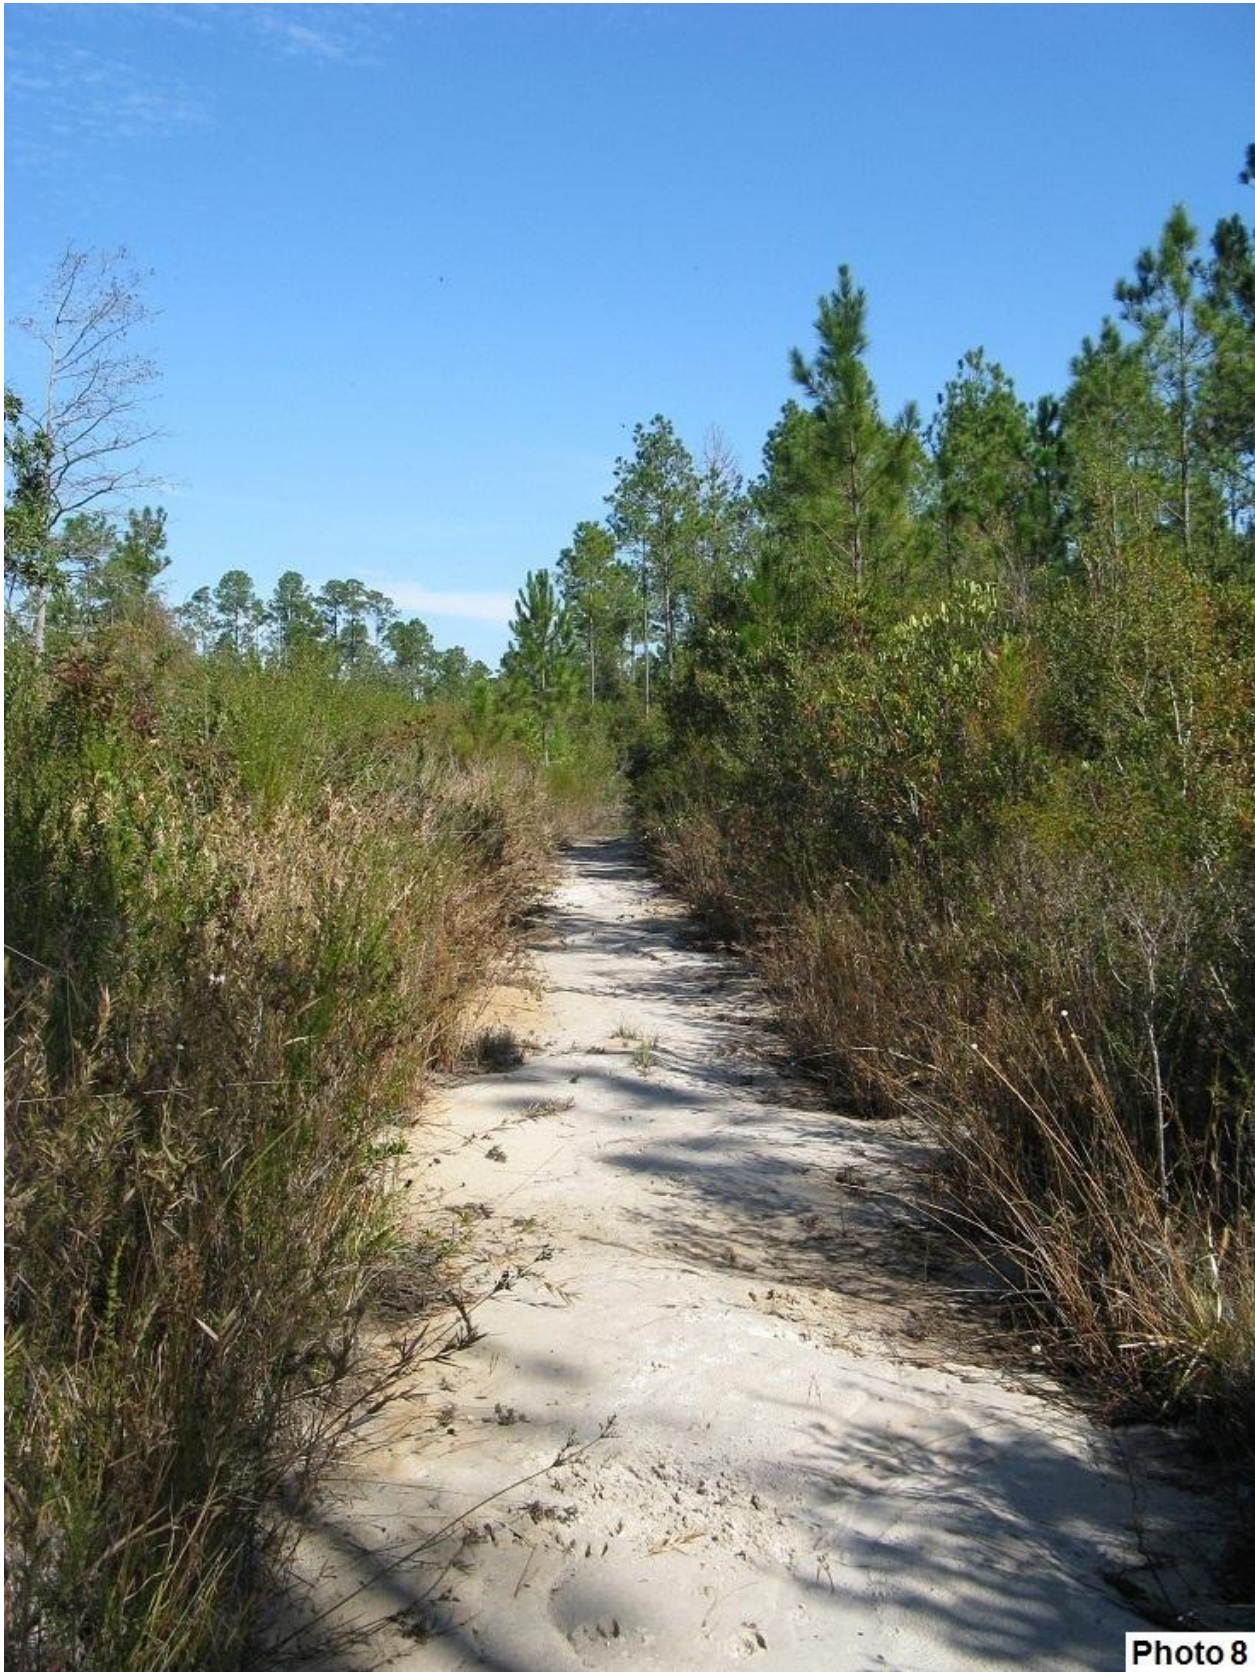
Photo 8

Ditch along the western boundary of the property. Photo taken near western property line, facing northeast.
