PLUM CREEK MITIGATION SITE

Annual Monitoring Report, Year 3 of 5 February 15, 2012

Date of Inspection: February 13, 2012

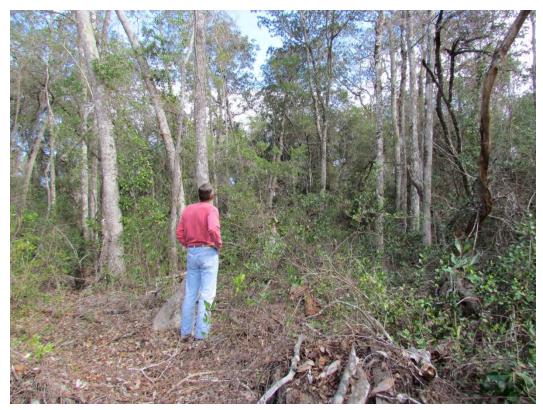
Forested wetlands (Polygon A, Figure 3) appeared in healthy condition with a diverse understory and canopy layer including many large bay, cypress and tupelo trees, typical of a high quality bottomland forest (Photo 1). The disturbed firebreak area at the ecotone edge between the wetland forest and the upland buffer, described in the previous annual monitoring (2010), was still observable but had revegetated well. Uneven grade, disturbed soil had recontoured naturally with only slight irregularities. Seepage was noticeable at the base of the slope with numerous rushes, sedges, sundew and other wetland groundcover colonizing within the old firebreak.

Photo 1. Forested wetland with tall, mature cypress, bay and tupelo. Old stump from historic harvest in foreground. Photo point 13 facing east. 2/13/12.

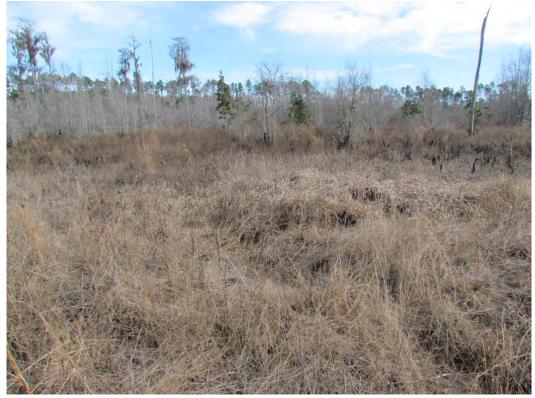
Photo 2. Non-forested wetland with diverse groundcover. Photo point 2 facing southeast. 2/13/12.

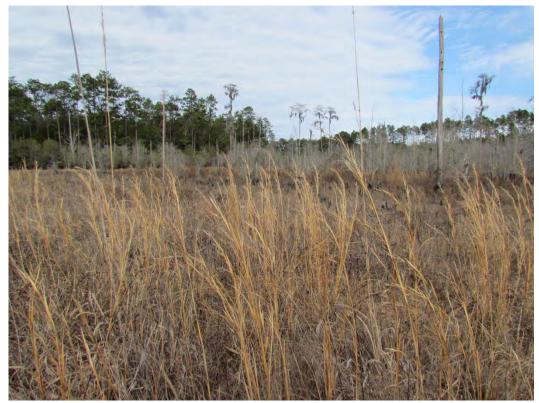
Photo 3. Non-forested wetland with diverse groundcover. Photo point 2 facing northwest. 2/13/12.

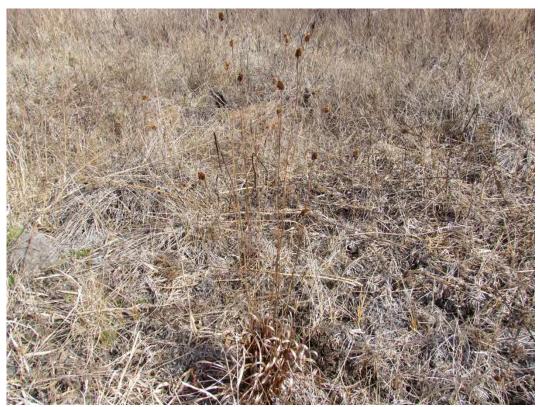
Photo 4. Non-forested wetland with close-up of diverse groundcover including *Xyris* sp. in center foreground. Near photo point 2. 2/13/12.

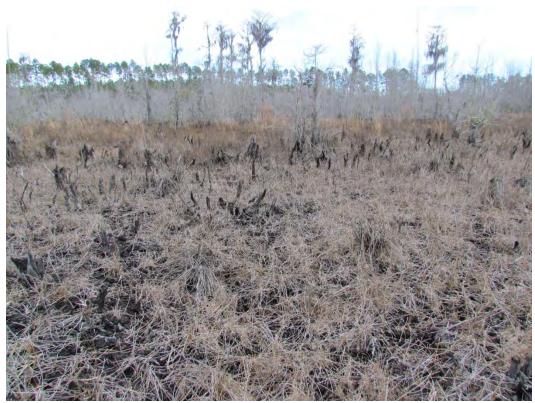
Photo 5. Non-forested wetland with cypress and gum in central portion (bare trees in the background. Note old stumps and snags in foreground. Photo point 1 looking northeast. 2/13/12.

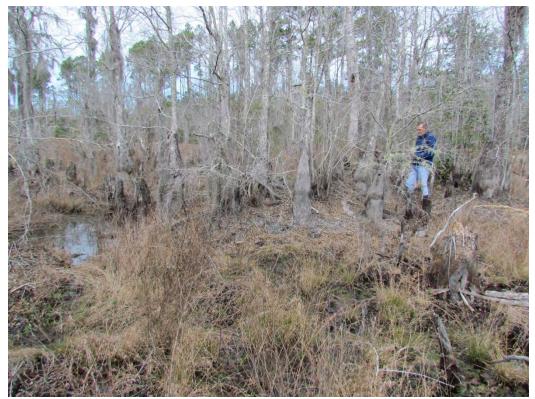
Photo 6. Non-forested wetland with stand of black gum and cypress on eastern side of area. Some small areas of standing water noted along this side of wetland. Photo point 8 facing north. 2/13/12.

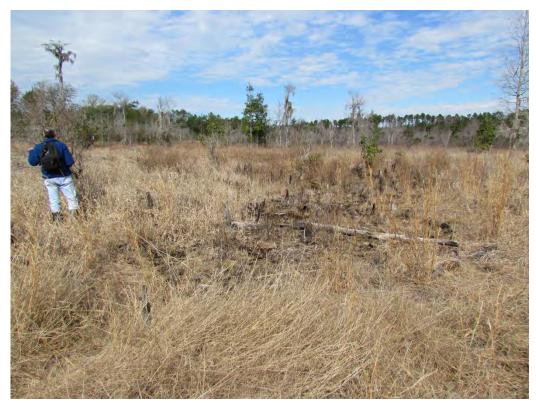
Photo 7. Non-forested wetland, southern end, with isolated sweetbay and titi. Photo point 6 facing north. 2/13/12. RTN

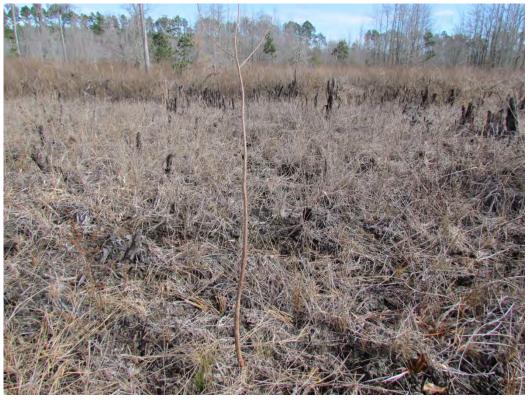
Photo 8. Non-forested wetland, western side, with surviving planted cypress in foreground. Near photo point 2 facing northeast. 2/13/12. RTN

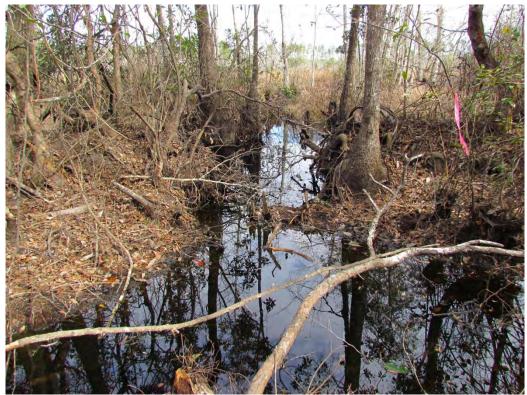
The current monitoring included an inspection of the beaver dam breaches (Photo 9) and the downstream culvert and low-water crossing (Photo 10) to determine if downstream flow remained unobstructed. Both were found to be in good shape with no signs of beaver activity. No noticeable rebuilding of the dams was observed and flow was noted through the culvert. Since flows were very low, no water was flowing over the low-water crossing.

Photo 9. One of several breaches in the beaver dams along the southern portion of the non-forested wetland; all remain open. Photo point 4 facing north. 2/13/12.

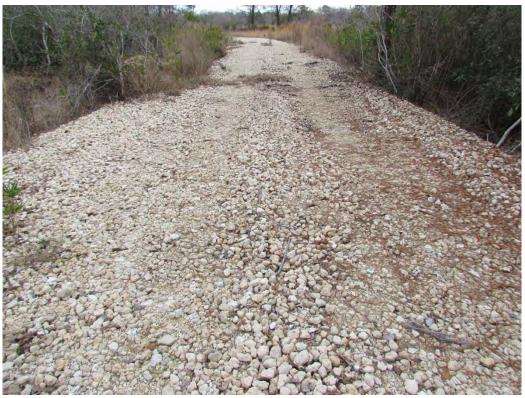
Photo 10. Low-water crossing and culvert (not visible in photo) that allow discharge from non-forested wetland. Photo point 3 facing east. 2/13/12.

The low water crossing and culvert downstream of the outfall of the old beaver pond looked good. The culvert was intact and appeared very sturdy; water was freely flowing through pipe with no obstructions.

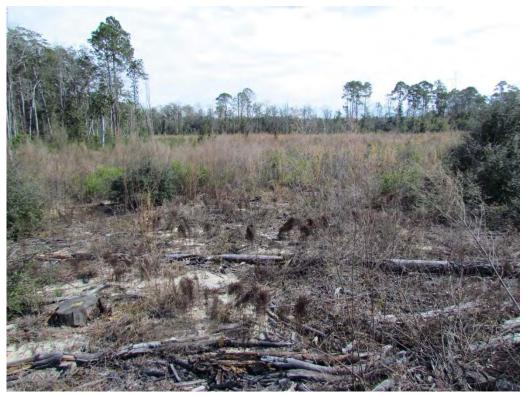
The upland forest areas (primarily Polygon E, Figure 3) remain in transition between a planted pine silviculture and a native sandhill community (Photos 11-12). Only a single line of large trees (oaks and pines) had been left after clearcutting the site, presumably to act as seed trees for recolonization, and longleaf were planted over most of the uplands. Longleaf seedlings were relatively common and appeared to be doing well particularly in open areas with little groundcover (Photo 13). Wiregrass was also observed but varied in abundance from none on the eastern side of the entry road to sparse on the western side moving upslope (Photo 14). Isolated clumps of yaupon, pineweed, gallberry, blackberry and Carolina jessamine were noted along with sparkleberry, deerberry and persimmon on the eastern side. Shiny and highbush blueberry, yaupon, wild indigo, bluejack and sand live oak, wild olive and American holly were observed on the western side along with broom sedge and witch grass. The site is trending toward a wiregrass-longleaf pine sandhill community but is in the early stage. Continued management with the inclusion of prescribed burns will assist this process. Future wiregrass planting may be necessary to establish adequate groundcover capable of carrying fire.

Photo 11. Upland sandhill community restoration in progress with diverse groundcover; patches of yaupon (dark green shrub) noted throughout. Photo point 9 facing east. 2/13/12.

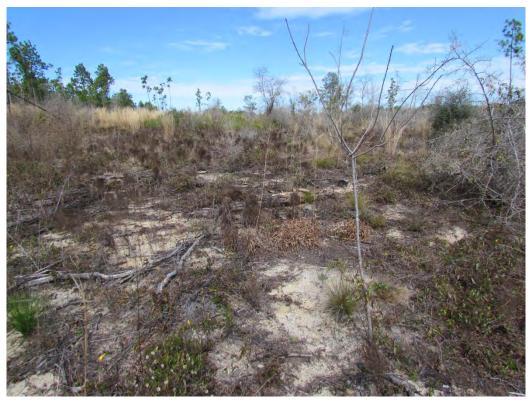
Photo 12. Upland sandhill community restoration. Photo point 12 facing north. 2/13/12. RTN

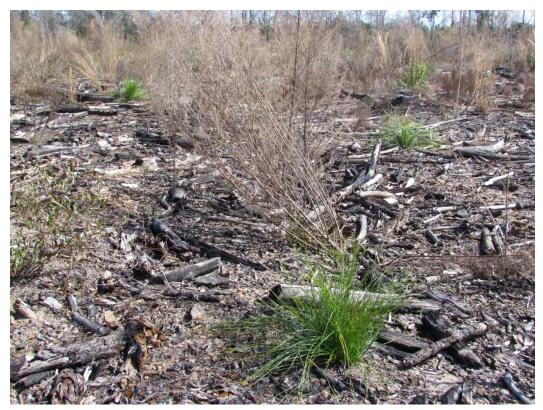
Photo 13. Upland restoration area; recently ploanted longleaf seedlings doing well in open areas. Near photo point 10. 2/13/12. RTN

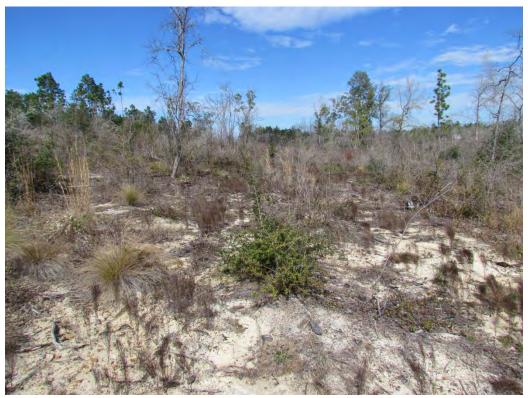
Photo 14. Upland restoration area; note scattered clumps of wiregrass. Photo point 11 facing north. 2/13/12.

- In upland buffers undergoing native pine restoration, shrubs will need to be kept in check with fire. Sparse wiregrass coverage and patchy bare soil may need to be augmented with planted wiregrass to carry fire.
- Restoration wetland area was planted in bald cypress instead of pond cypress. Bald
 cypress have not been documented to occur naturally on the site. Existing mature trees
 will serve as seed sources for natural regeneration. Planted off-site trees could be
 removed.

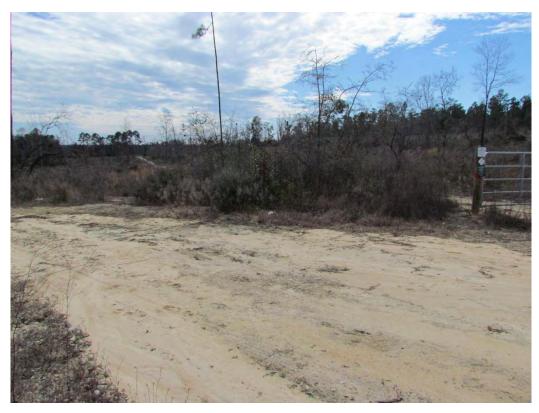
The main road through the property was in good shape with no signs of erosion or trash. There is a short extension of the entry road to the north and east of the main gate (Photo 15) that may allow entry into the site when the gate is locked. This may require some type of fencing or road blockage.

Photo 15. Potential gate bypass at main entrance on Johnson Road. Photo point 14 looking south. 2/13/12.

Fencing needs to be replaced to left of entrance gate on Johnson Road where a road has been created to bypass the gate. There is a hunt blind facing into the property next to the western fence line. No exotic or nuisance vegetation was observed.
