Sand Hill Lakes Mitigation Bank Combined DEP/USACE Thirteenth Annual Report

FDEP Permit # 0227351-001 Issued 9/6/2005, Washington County

**Northwest Florida Water Management District
Submitted by David Clayton
In support of Specific Conditions 26 and 28**

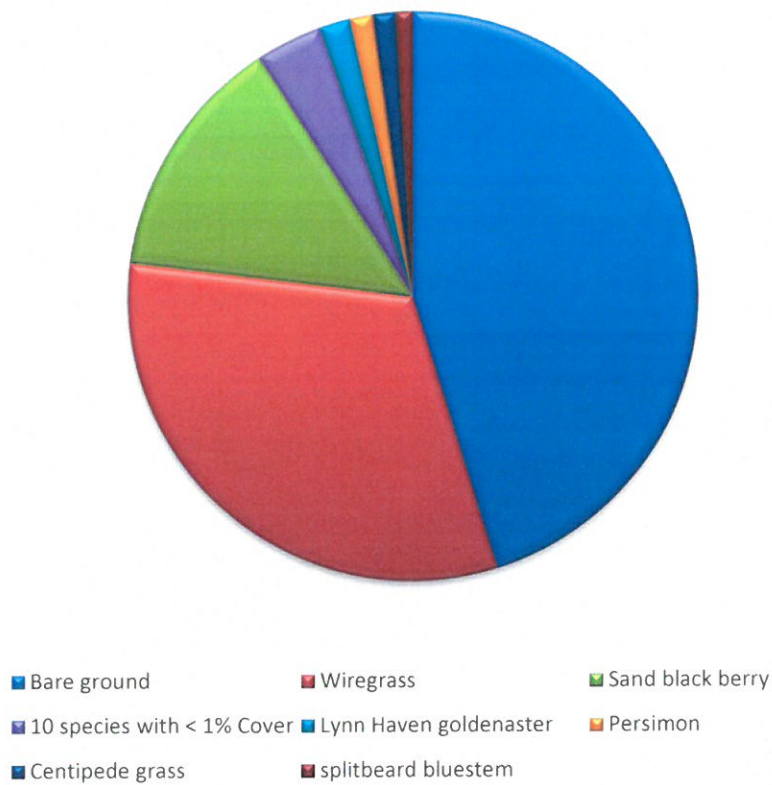
Figure 10. Transect 1: Sand pine plantation restored to sandhill

During the 2018 monitoring, 16 species were observed in Transect 1, 24 in Transect 2, and 26 in Transect 4. (Tables 3-5; Figures 10-12). Wiregrass had the greatest vegetative cover for each transect ranging from 32 percent in transect 1 to 30 percent in Transect 2 and 35 percent in Transect 4. Bare ground ranged from 51.3 percent in Transect 2 to 37.3 percent in Transect 2. The number of species observed was significantly lower and bare ground was greater due to a late August burn that removed annual species and reduced overall species cover.

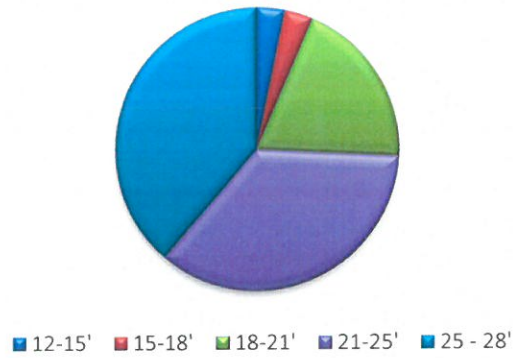
Figure 13. Planted longleaf pine seedlings (Transect 1)

per acre. Overall health of the planted seedlings was excellent. Most trees were 12-15 feet in height and the average diameter and breast height (DBH) is seven inches (Figures 13-15).

Long Leaf Pine (84 per acre)

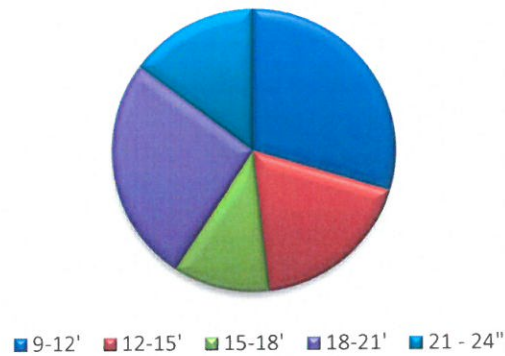
Figure 14. Planted longleaf pine seedlings (Transect 2)

Long Leaf Pine (98 per acre)

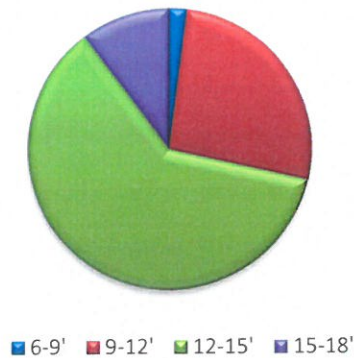
Figure 15. Planted longleaf pine seedlings (Transect 4)

Long Leaf Pine (178 per acre)

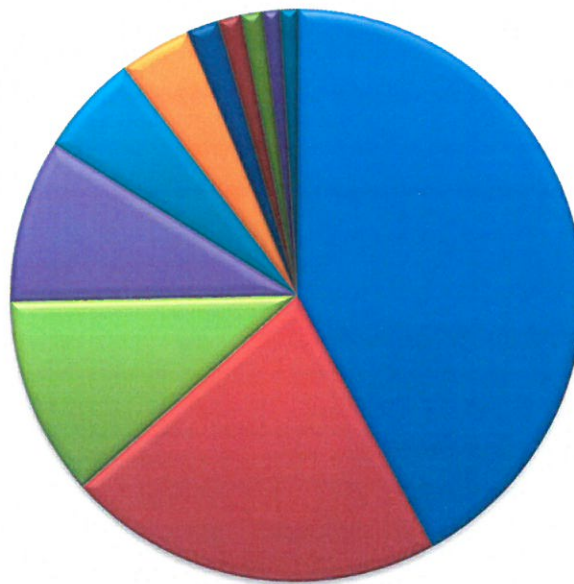
Figure 16. Transect 3: Species cover and occurrence (Sandhill Enhancement)

During the 2018 monitoring, 23 species were observed within Transect 3 a reduction of three species. Thirty species were observed within Transect 5 an increase of two species (Tables 6 and 7; Figures 16 and 17). Wiregrass cover was the greatest cover class observed for both transects with 21.3 percent cover observed within Transect 3, and 33.2 percent cover observed in Transect 5. Bare ground cover was 42 percent within Transect 3 and 30.5 percent within Transect 5. The reduced cover, species composition and increase in bare ground was due to a late season burn in early September.

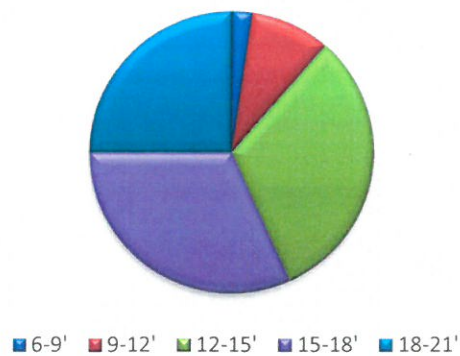
Figure 18. Planted longleaf pine seedlings (Transect 3)

In 2018, the survival of longleaf pine seedlings was 116 per acre in Transect 3 and 109 in Transect 5. Tree height was variable. Trees appear healthy and vigorous (Figure 20 and 21).

Long Leaf Pine (116 per acre)

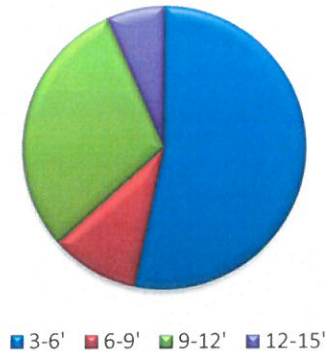
Figure 19. Planted longleaf pine seedlings (Transect 5)

Long Leaf Pine (109 per acre)

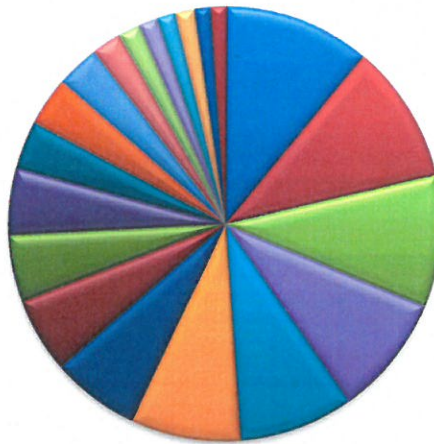
During the 2018 monitoring, 29 species were observed a slight decrease from the previous year. The diversity of the site continues to improve as the site develops. Bare ground remained low at 5.6 percent cover. Grasses and sedges dominated the vegetative cover (60.3 percent cover) (Table 8; Figure 20).

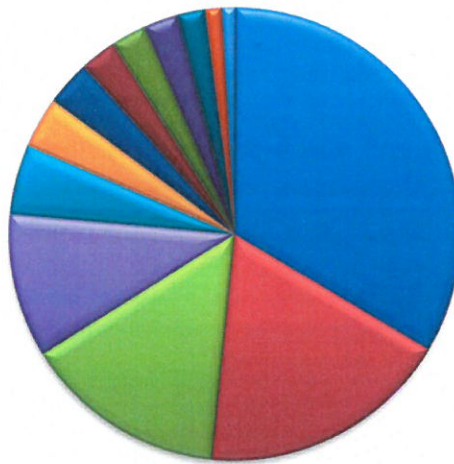
Figure 21. Transect 6. Species cover and occurrence (Hydric Pine Flatwoods Restoration)

During the 2018 monitoring, 26 and 17 species were observed within Transect 6 and 7, respectively, similar with the observations in 2017 (Table 9 and 10; Figure 21 and 22). Hydric pine flatwood species dominated both transects. Shrub cover was 0.33 percent for Transect 6 and 5.6 for Transect 7. Vegetative cover exceeds 85 percent for both transects.
