Sand Hill Lakes Mitigation Bank Combined DEP/USACE Fourteenth Annual Report

FDEP Permit # 0227351-001 Issued 9/6/2005, Washington County

**Northwest Florida Water Management District
Submitted by David Clayton
In support of Specific Conditions 26 and 28**

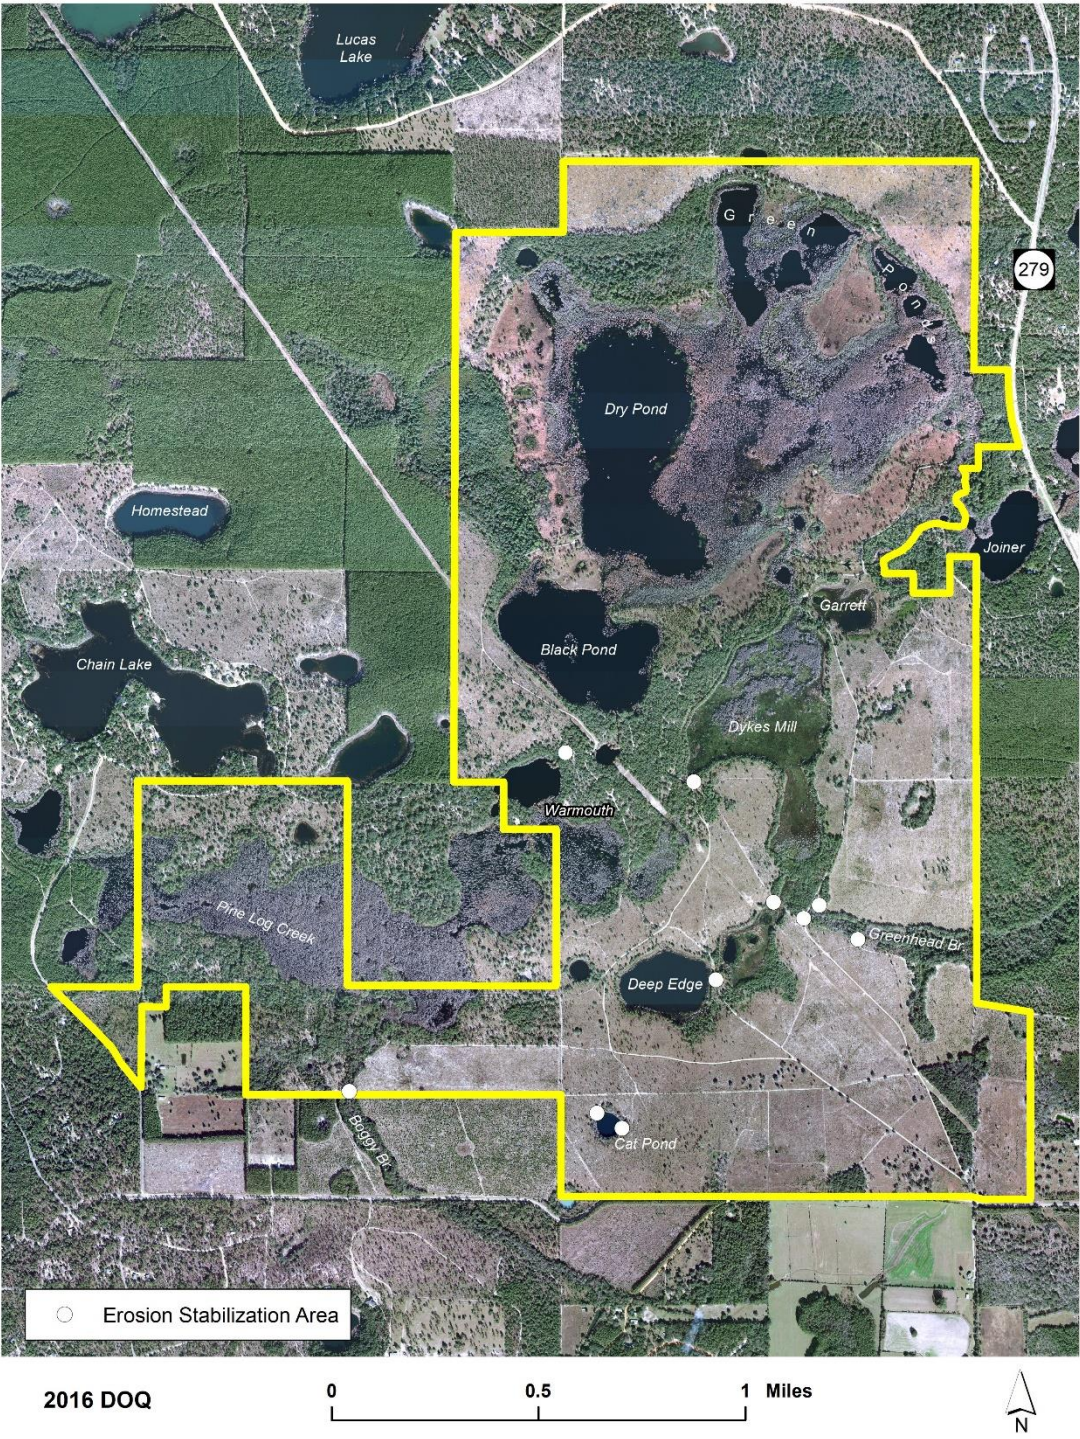
Figure 4. Erosion Stabilization Areas Restored at the SHLMB

Hydrologic enhancements included the removal of two fill-road crossings, installation of bridges at three crossings and two culverts and the removal or replacement of two failing water control structures, the remediation of ten erosion areas, and the stabilization of a boat launch (Figures 3 and 4). All water control structures, culverts and road removals and erosion stabilization areas continue to function as designed.

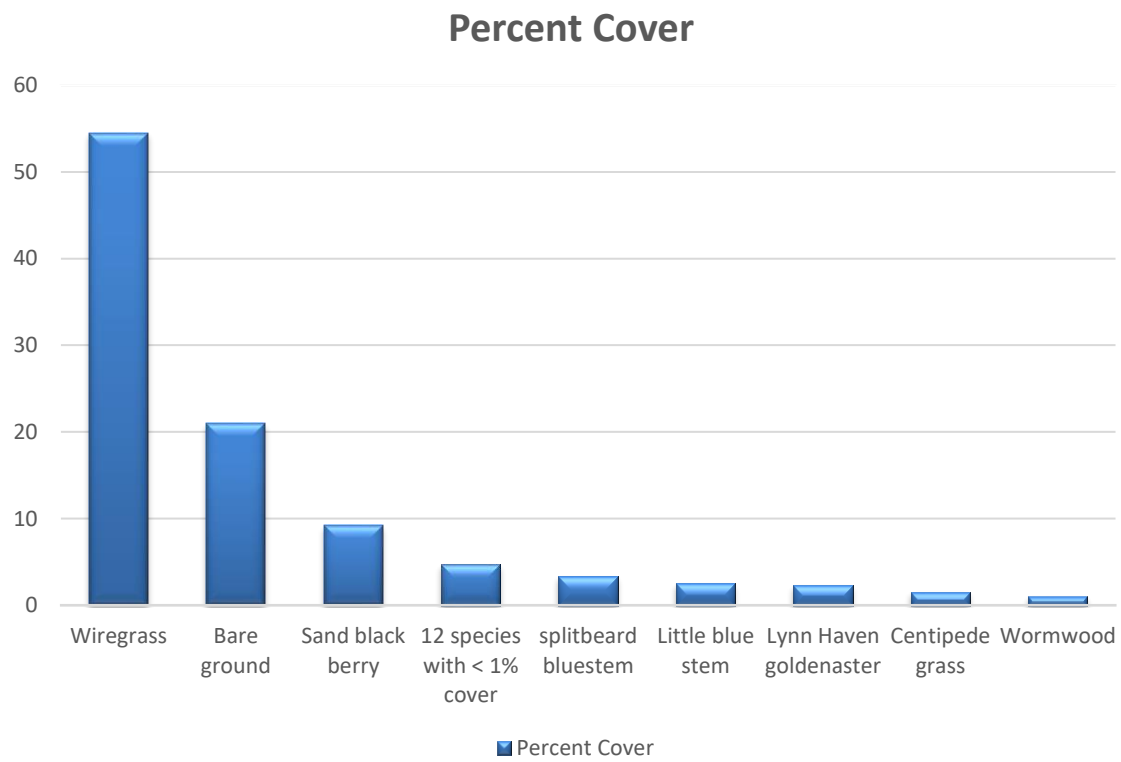
Figure 10. Transect 1: Sand pine plantation restored to sandhill

During the 2019 monitoring, 19 species were observed in Transect 1, 26 in Transect 2 (Tables 3-4; Figures 10-11). Transect 4, was burned in early October and was not sampled. Wiregrass had the greatest vegetative cover for each transect ranging from 46.2 percent in transect 1 to percent 41.5 percent in Transect 2. Bare ground ranged from 21 percent in Transect 1 to 28.1 percent in Transect 2. Species diversity increased from the previous year. Wiregrass cover significantly increased for each site, while bare ground decreased from the previous year.

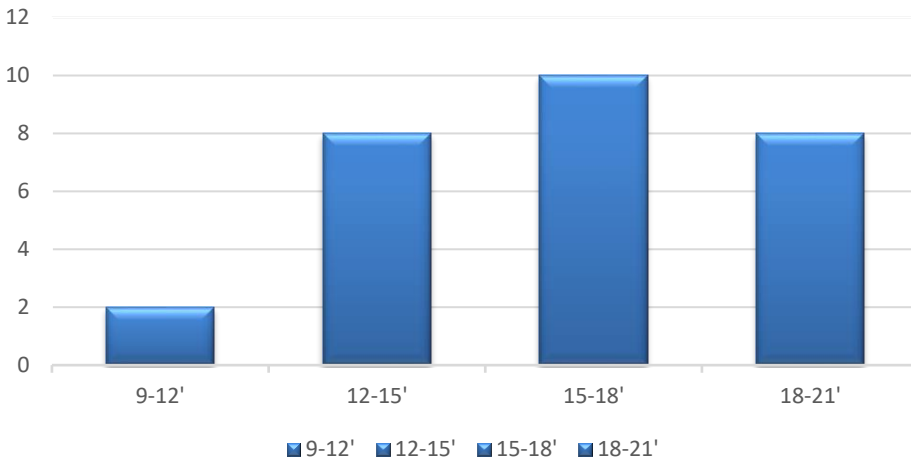
Figure 12. Planted longleaf pine seedlings (Transect 1)

Longleaf pine seedlings were planted in the sandhills at a rate of 436 trees per acre. Permit conditions require a maximum average of 200 longleaf pine trees per acre. Planted tree densities are determined by counting all the seedlings in a 30' X 600' plot co-located with each transect and converting to trees per acre. All tree seedlings counted and measured by size class and notes on tree condition are included. The survival of longleaf pine seedlings along each transect was observed to be trees between 102 and 178 trees per acre. Overall health of the planted seedlings was excellent. Most trees were 12-15 feet in height and the average diameter and breast height (DBH) is eight inches (Figures 13-15).

Long Leaf Pine (102) per acre

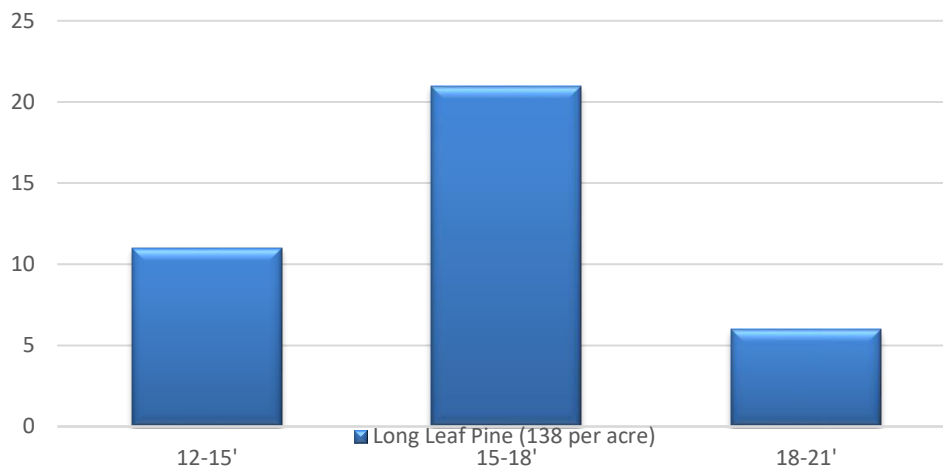
Figure 13. Planted longleaf pine seedlings (Transect 2)

Long Leaf Pine (138 per acre)

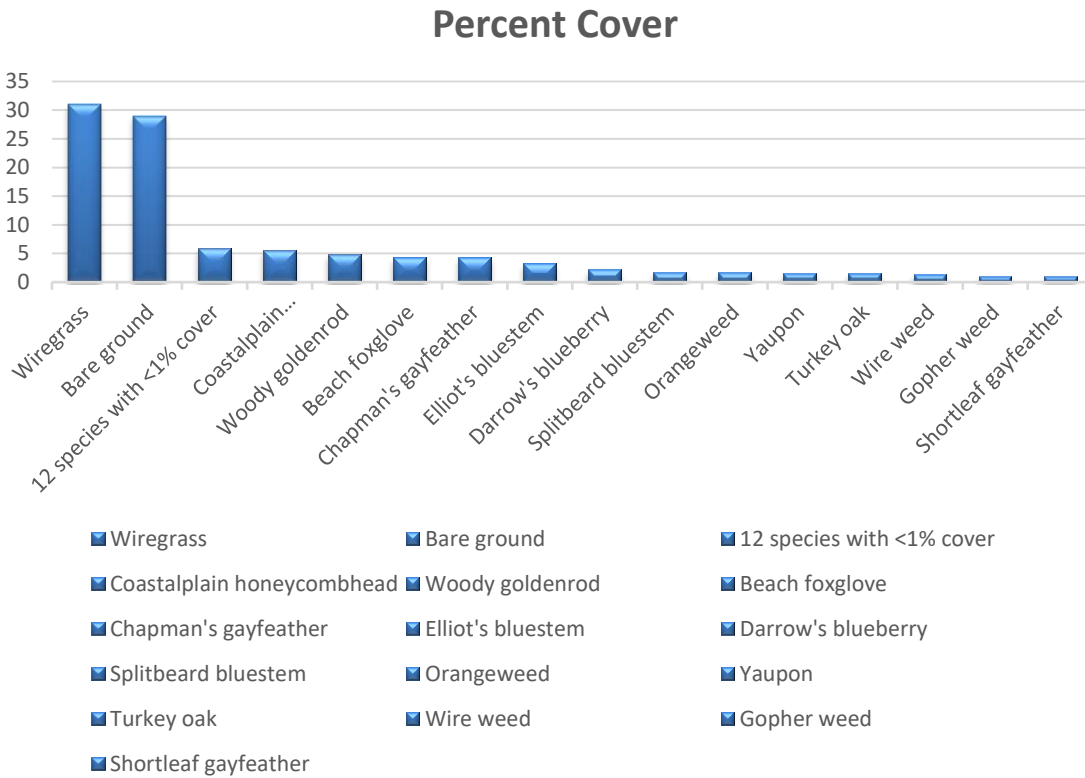
Figure 14. Transect 3: Species cover and occurrence (Sandhill Enhancement)

During the 2019 monitoring, 26 species were observed within Transect 3 an increase of three species. Transect 5 was not sampled due to a burn in early October. Wiregrass cover was the greatest cover class observed with 31 percent cover. Bare ground cover was 29 percent. Species observed, wiregrass cover increased over the last year while bare ground decreased significantly.

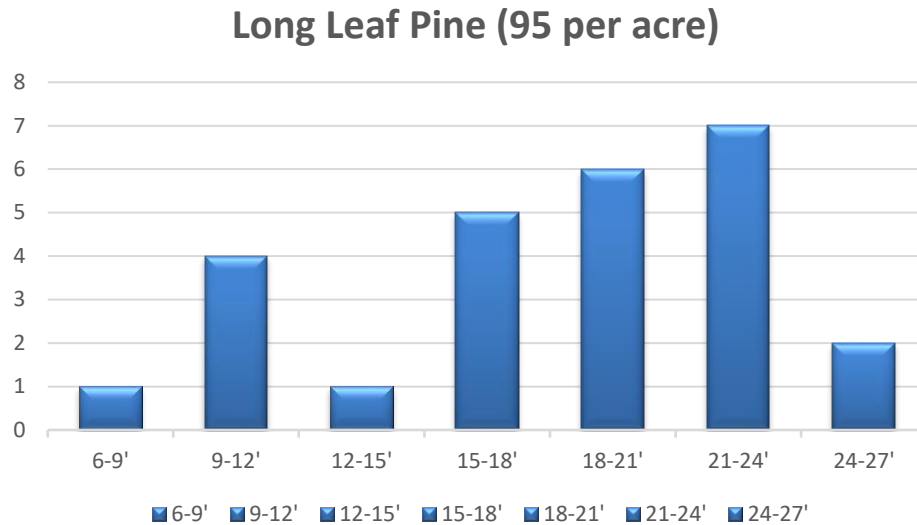
Figure 15. Planted longleaf pine seedlings (Transect 3)

In 2019, the survival of longleaf pine seedlings was 95 per acre in Transect 3. Tree height was variable but with the most trees in the 18-21' and the 21-24' class. Trees appear healthy and vigorous (Figure 20).

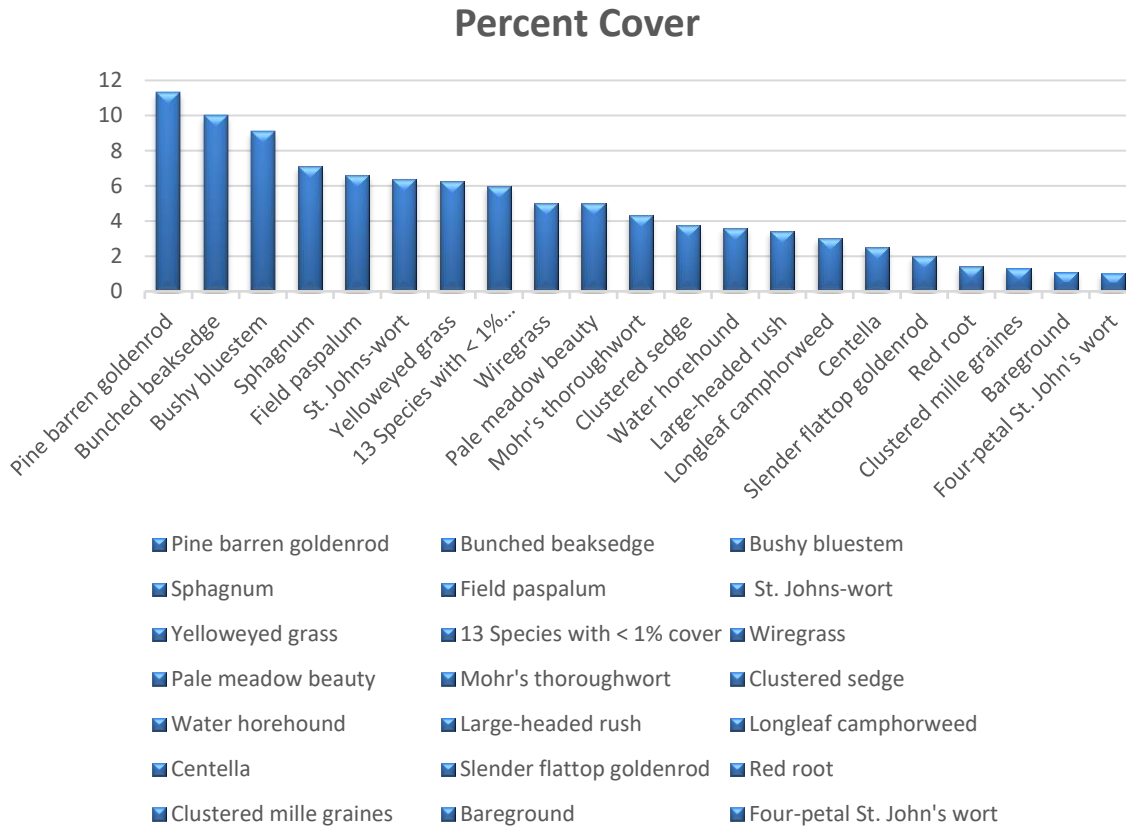
Figure 16. Transect 8: Species cover and occurrence

During the 2019 monitoring 32 species were observed a slight increase from the previous year. The site diversity continues to improve as the site develops. Bare ground was very low at 1.07 percent. Grasses and sedge cover was 39.5% cover.

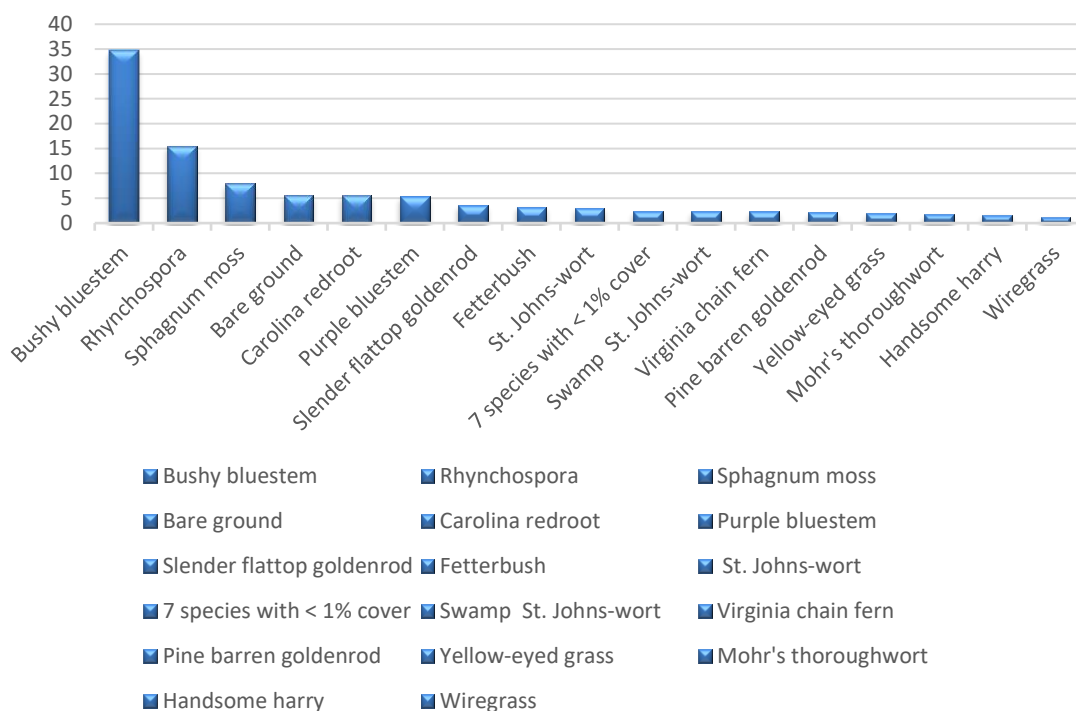
Figure 17. Transect 6. Species cover and occurrence (Hydric Pine Flatwoods Restoration)

During the 2019 monitoring, 22 and 18 species were observed within Transect 6 and 7, respectively, slightly lower for Transect 6 and an increase of one species for Transect 7. Hydric pine flatwood species dominated both transects. Shrub cover was 3.4 percent for Transect 6 and 8.9 percent for Transect 7. Transect 7 shrubs will be treated in 2020 to reduce cover. Vegetative cover exceeds 90 percent for each transect.

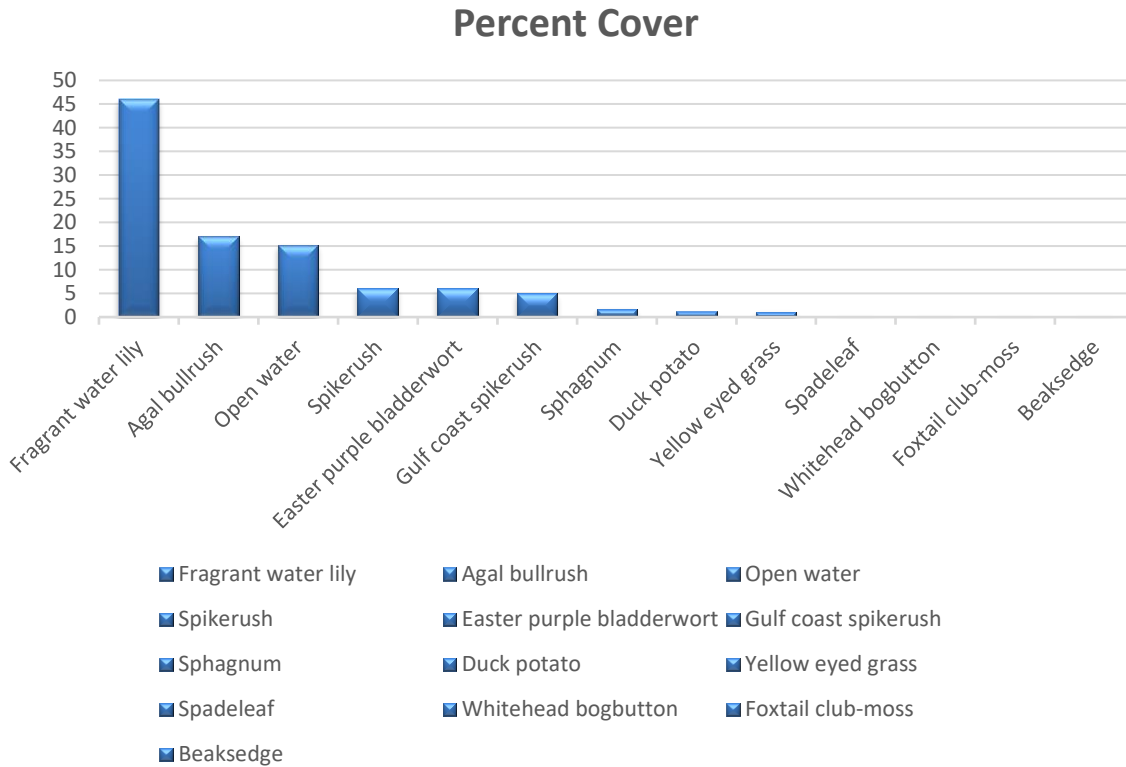
Figure 19. Transect 9. Species cover and occurrence (Dykes Mill Pond)

In 2019, a total of 12 species were observed along Transect 9 (Table 12, Figure 25). The aquatic vegetation is thriving providing important habitat for wildlife. Fragrant water lily represented the dominant cover class with 46 percent cover followed by algal bull rush with 17 percent cover. Open water has steadily decreased from 38 percent from baseline sampling to 15.2 percent in 2019. Water depth averaged 1.2 meters.
