BAYPORT MITIGATION

Fall 2020 Monitoring Report

USACE Permit No.:	SAJ-1997-07427 (SP-SWA), issued 7/9/2018
Permittee:	DJFO, Inc. c/o: Jay Odom P.O. Box 1735 Destin, FL 32540
Responsible Party for Monitoring:	Northwest Florida Water Management District 81 Water Management Drive Havana, FL 32333
Dates of Inspection:	10/30/2020; 11/4/2020; 11/10/2020

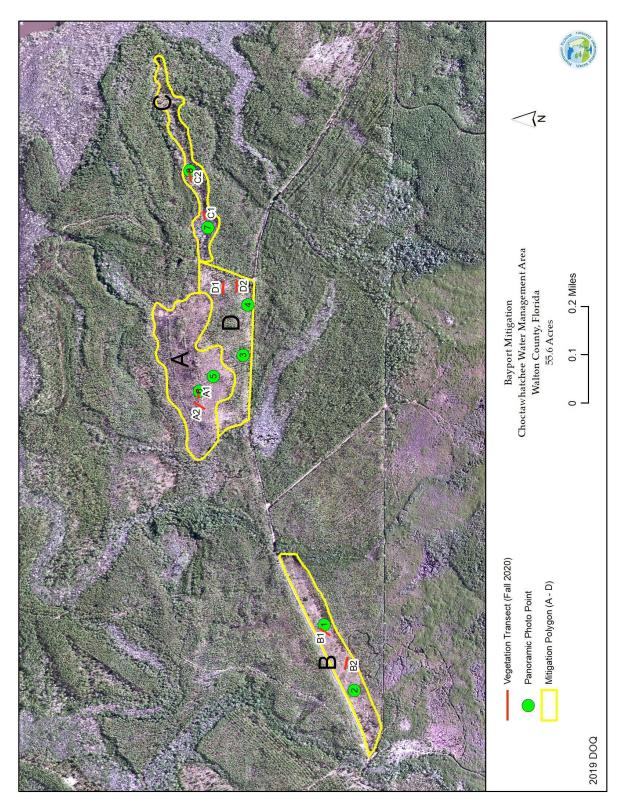
Figure 2. Fall 2020 Vegetation Transects

Percent vegetation cover was measured in 1 m² quadrats (10-foot intervals) along eight 150-foot transects in November 2020 (Figure 2). The percent coverage for each species was determined by adding all quadrat observations together and dividing the total coverage by the cover of each species within each transect. This represents a modified Daubenmire cover scale where vegetation species statistics are used to determine the percent cover by bare ground, water and plant species.

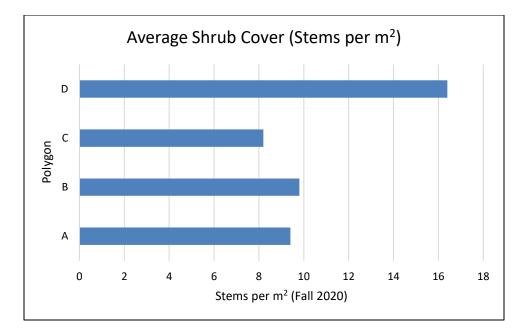
Figure 3. Average Rooted Shrub Stems per Square Meter (Fall 2020)

b.	Within Mitigation Area "B", reduce tree density to no more than 400 trees per acre and reduce shrub coverage to less than 5% cover, by January 2019.	 Fall 2020; target performance standard met. Tree density performance standard met. Shrub cover performance standard not met. Tree cover reduced to ≤ 400/Acre in 2017.
		Shrub cover reduced to <5% in 2017/2018 in accordance with performance standards. Shrub resprouting necessitated additional herbicide treatments in Fall 2019. Shrub cover in Polygon "B" varied from 8.6% to 15.5% (12% average) in Fall 2020 and did not meet the target performance standard. Additional herbicide treatments will be necessary to reduce shrub cover back to within the target performance standard.

d.	Within Mitigation Area "D", reduce tree density to no more than 200 trees per acre and reduce shrub coverage to less than 5% cover, by January 2019.	 Tree density performance standard met. Shrub cover performance standard not currently met.
		Tree cover reduced to \leq 200/Acre in 2017.
		Shrub cover reduced to <5% in 2017/2018 in accordance with performance standards. Shrub resprouting necessitated additional herbicide treatments in Fall 2019. Shrub cover in Polygon "D" varied from 12.4% to 22.7% (17.6% average) in Fall 2020 and did not meet the target performance standard. Additional herbicide treatments will be necessary to reduce shrub cover back to within the target performance standard.

Rooted shrub stem density was monitored within each mitigation polygon using five $1 m^2$ quadrats established at random (Figure 3).

Polygon A		Polygon B		Polygon C			Polygon D		
Shrub Quadrat	Shrub Stems per m ²	Shrub Quadrat	Shrub Stems per m ²	Shrub Quadrat	Shrub Stems per m ²		Shrub Quadrat	Shrub Stems per m ²	
1	23	1	9	1	0		1	9	
2	11	2	3	2	21		2	43	
3	7	3	25	3	15		3	24	
4	3	4	7	4	0		4	1	
5	3	5	5	5	5		5	5	
AVG Stems per m ²	9.4	AVG Stems per m ²	9.8	AVG Stems per m ²	8.2		AVG Stems per m ²	16.4

Performance standards, as specified in SAJ-1997-07427 (SP-SWA), were met as of early 2018. However, resprouting resulted in shrub cover targets exceeding performance standards (<5% cover) by Fall 2019. As remediation, all mitigation polygons were treated with herbicide in September 2019 to reduce shrub cover back to the target of <5%; results were mixed. Vegetation transects monitored in October 2020 indicated that shrub cover in the mitigation polygons varied from 3% to 23%, with an average shrub cover of approximately 9%. Although prescribed fire, rescheduled for 2021, will help reduce shrub cover, additional herbicide treatments will be necessary to bring shrub cover back to within the targeted range.
