## Northwest Florida Water Management District

Re: Progress Report 3

Please accept this submittal as the third progress report for the SHLMB. Since the last progress report, the main roads around Deep Edge and adjacent to the Green Ponds were improved to allow heavy equipment to travel to the work sites. This work continued into July and a limestone cap was placed over selected portions of the roadway. An eroding portion of road adjacent to Dykes Mill Pond was abandoned and restored in late June. Construction of three bridges and two culverts was initiated in July and is ongoing. Prior to the initiation of work, silt screens were installed and have been inspected regularly. No turbidity has been observed. Additional oak and sand pine removal was conducted on 325 acres in Management Unit 10 throughout September. Oblique aerials were taken for the SHLMB on October 23, 2006. The photographs are being processed now and will be included in the annual report. Fall monitoring for the annual report was conducted in October as well as the annual inspection for nuisance and exotic species.

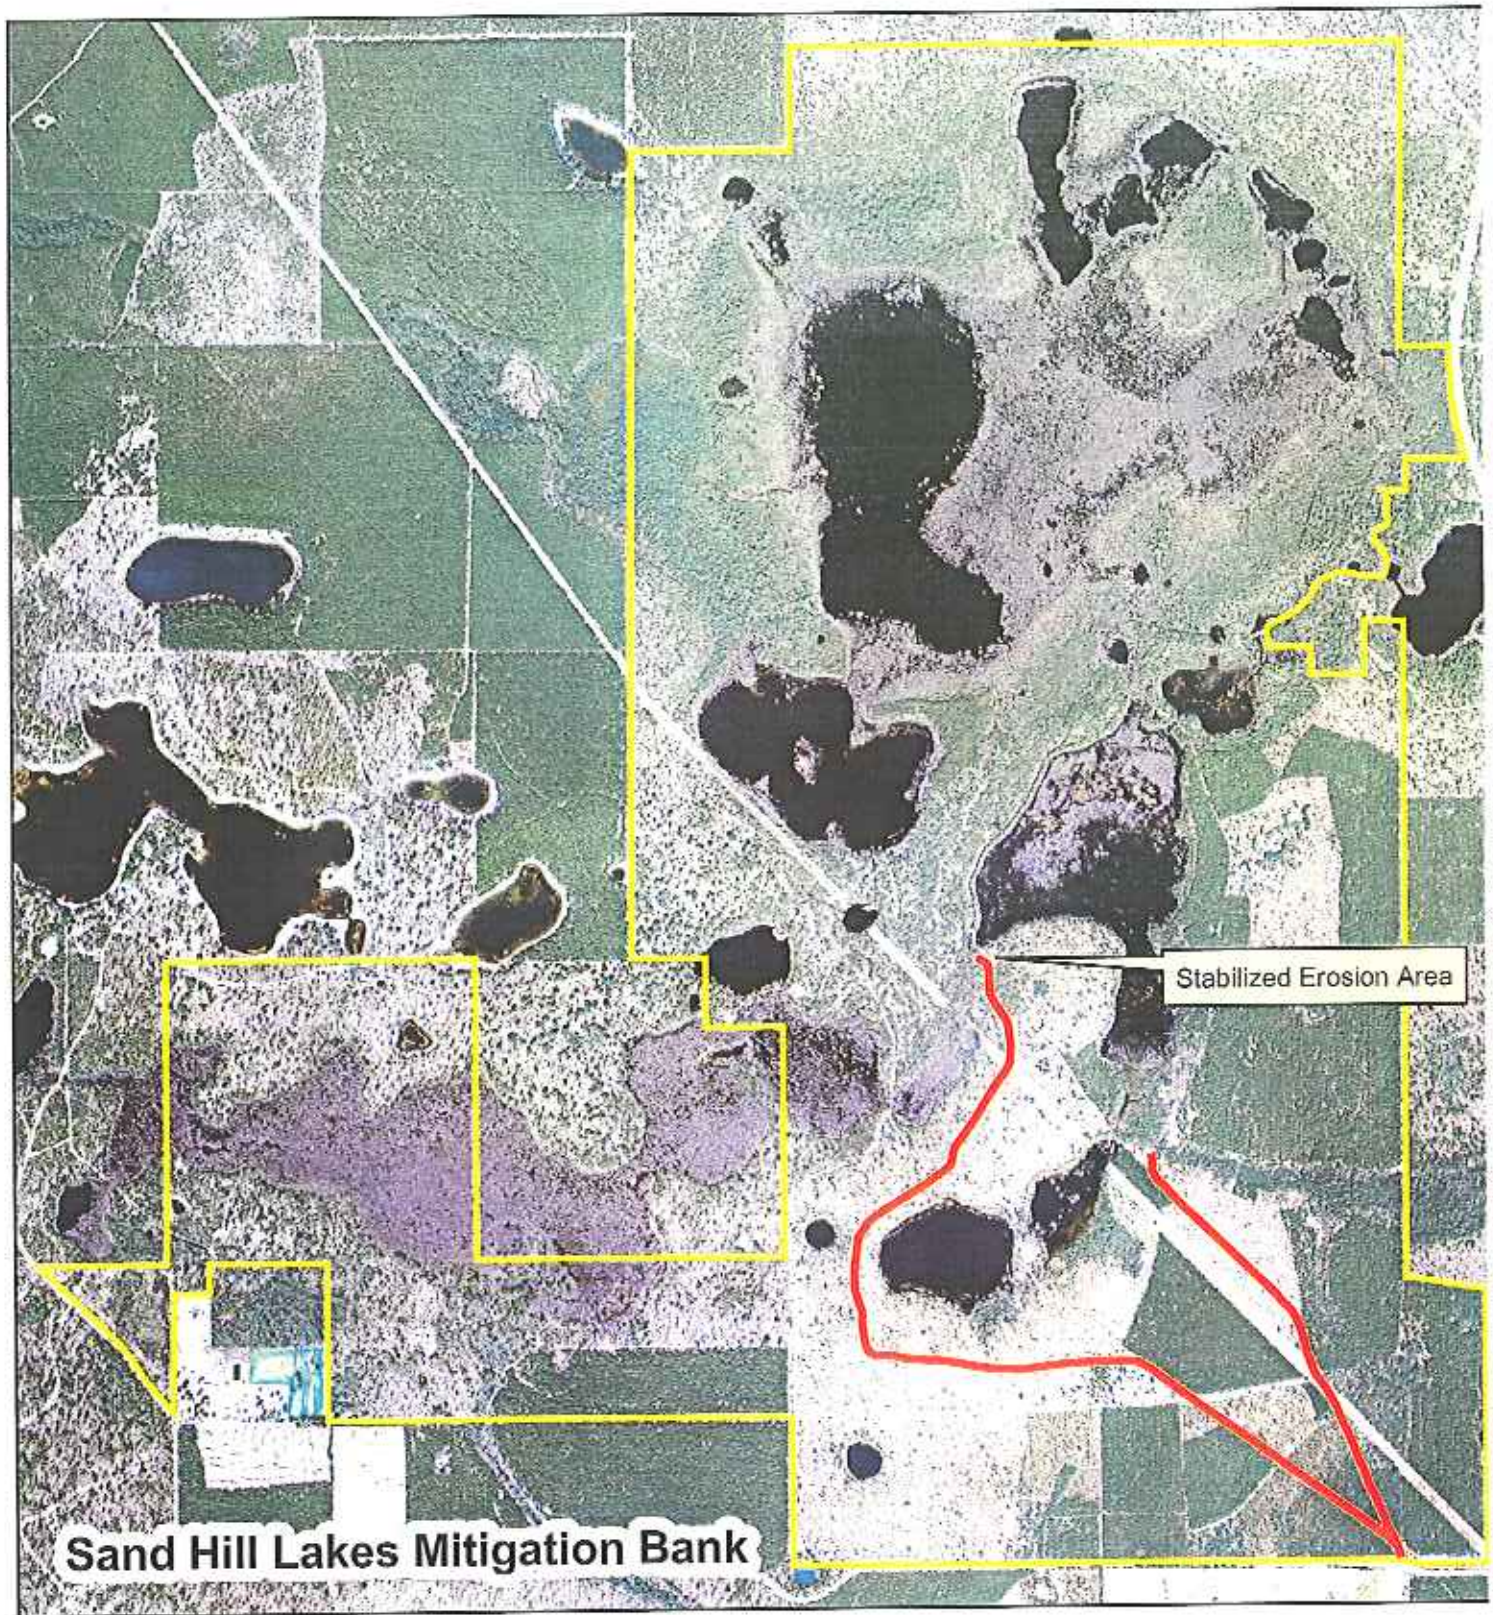
Figure 10a - Road Improvements

1. Road work was completed on the main loop from the entrance to Deep Edge Pond and eastward to Dykes Mill Pond and Greenhead Branch, and from Greenhead Branch back to the entrance road (Figure 10a). Selected portions of the road were capped with limestone. The roadwork was initiated on April 24<sup>th</sup> and was completed in July.
2. In June, a portion of old road adjacent to Dykes Mill pond was abandoned. This road had extensive erosion. The eroded road was restored by the creation of a

series of shallow basins. The area was then planted with annual rye grass. Photos of the restored roadway are included in Appendix 1.

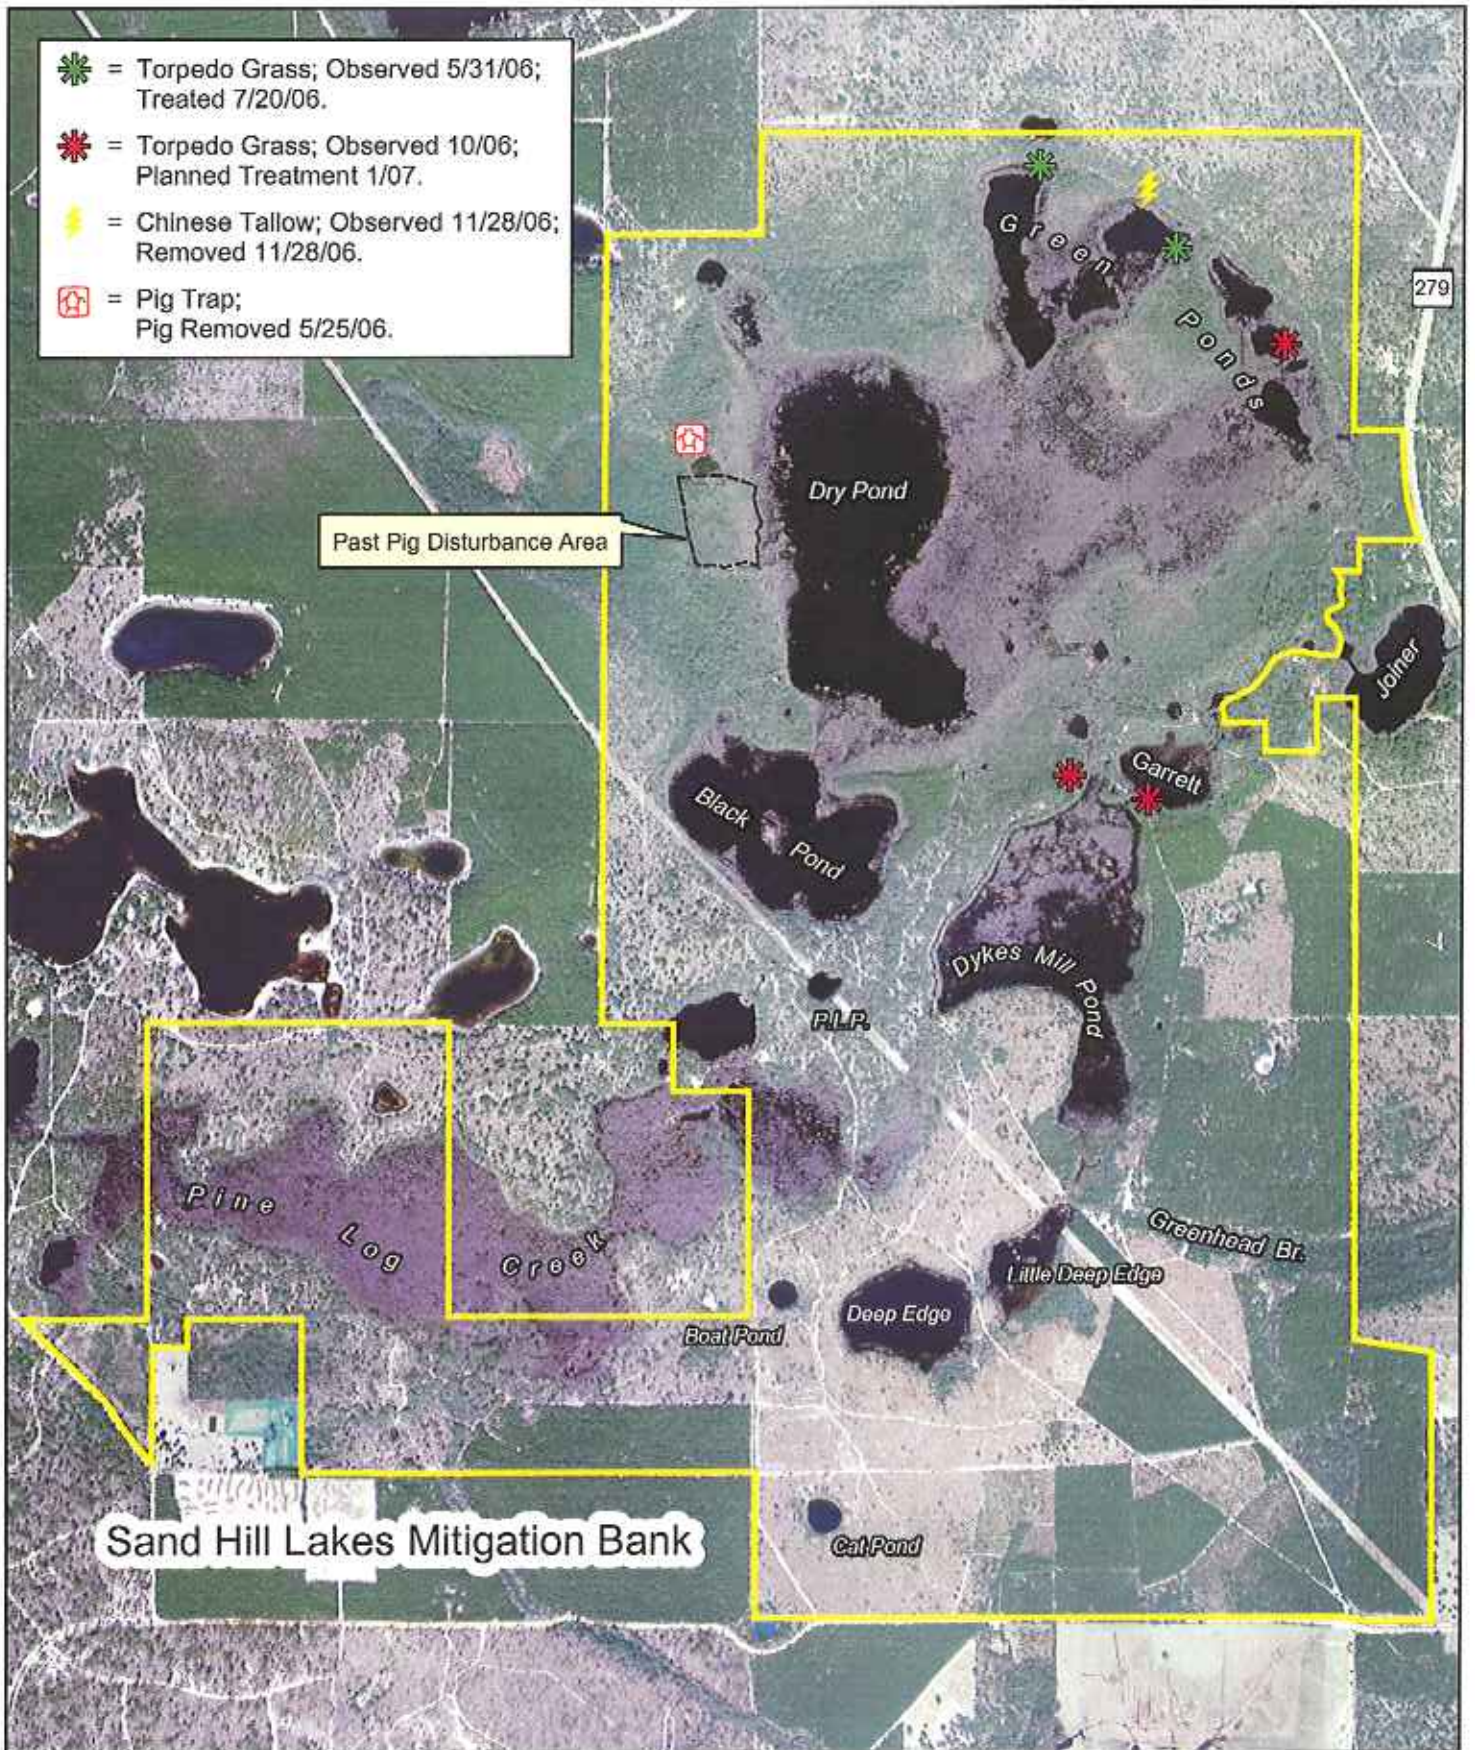
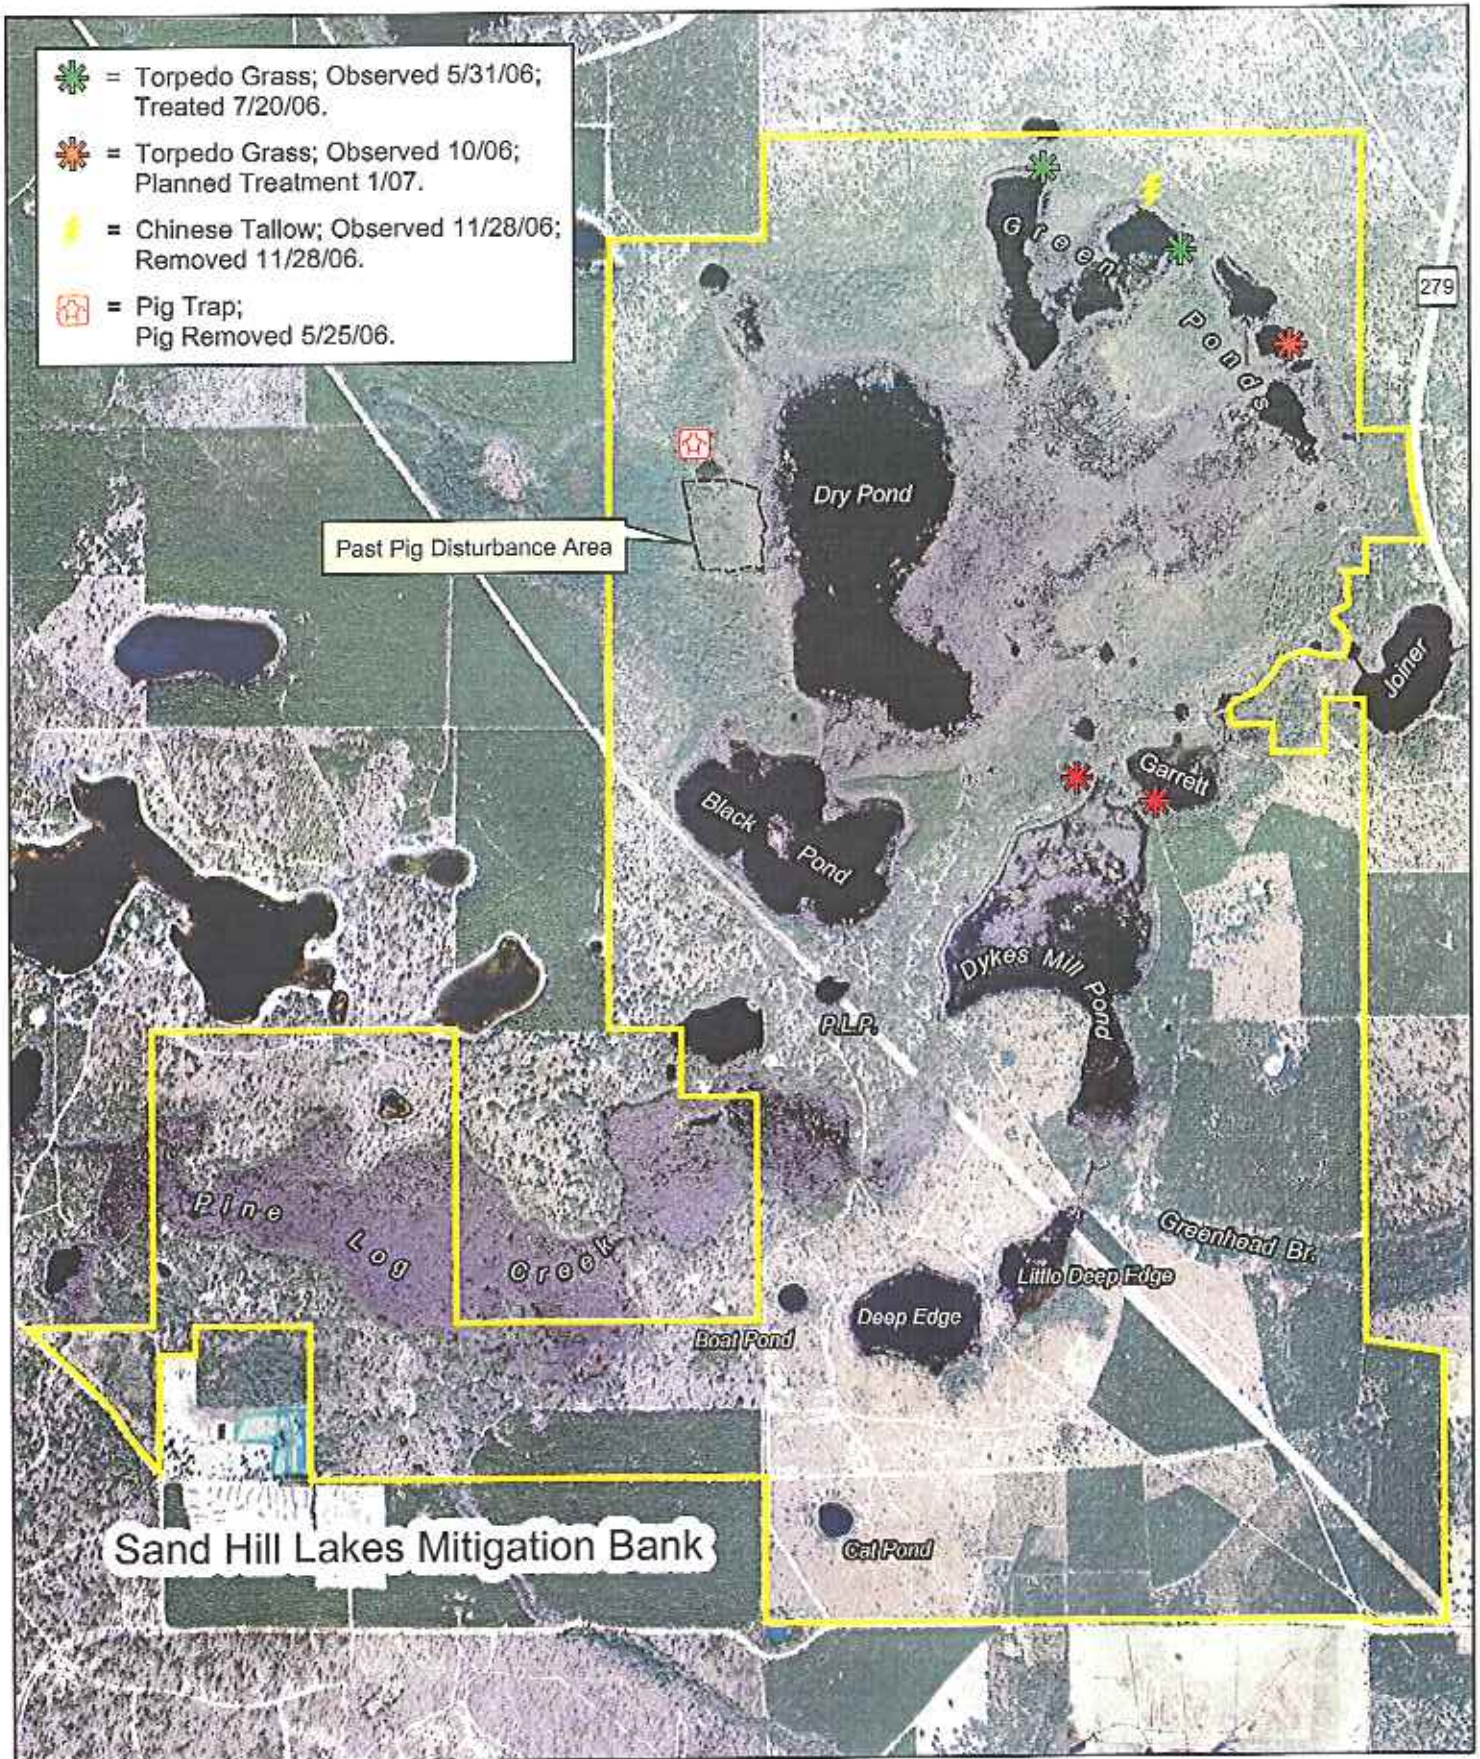
Figure 10b - Nuisance and Exotic Species Tracking

4. Surveys for feral hogs and beavers continued through the summer at the SHLMB. No additional sightings or disturbances have been observed.
5. During the May site inspection, torpedo grass (*Panicum repens*) was observed adjacent to the boat ramps of two of the green ponds (Figure 10b). The torpedo grass was subsequently sprayed by DEP employees from the Bureau of Invasive Plant Management on July 20<sup>th</sup> 2006. Follow up visits indicate an excellent kill with little to no surviving torpedo grass. Future site inspections will continue to monitor these areas. Photos of the treated areas are included in the Appendix 3. Several additional patches of torpedo grass and three sapling Chinese tallow (*Sapium sebiferum*) were observed during the annual inspection for nuisance species in October. Torpedo grass was observed at the boat ramp at Garret pond, along a wet dirt road adjacent to dry pond, and on the banks of one of the Green ponds (Figure 10b). The coverage of the torpedo grass was all minimal, small patches approximately 15' in diameter. The torpedo grass will be treated in February of 2007. In addition, three Chinese tallow seedlings were observed on the roadside adjacent to the green ponds (Figure 10b). The plants were hand pulled when they were observed.

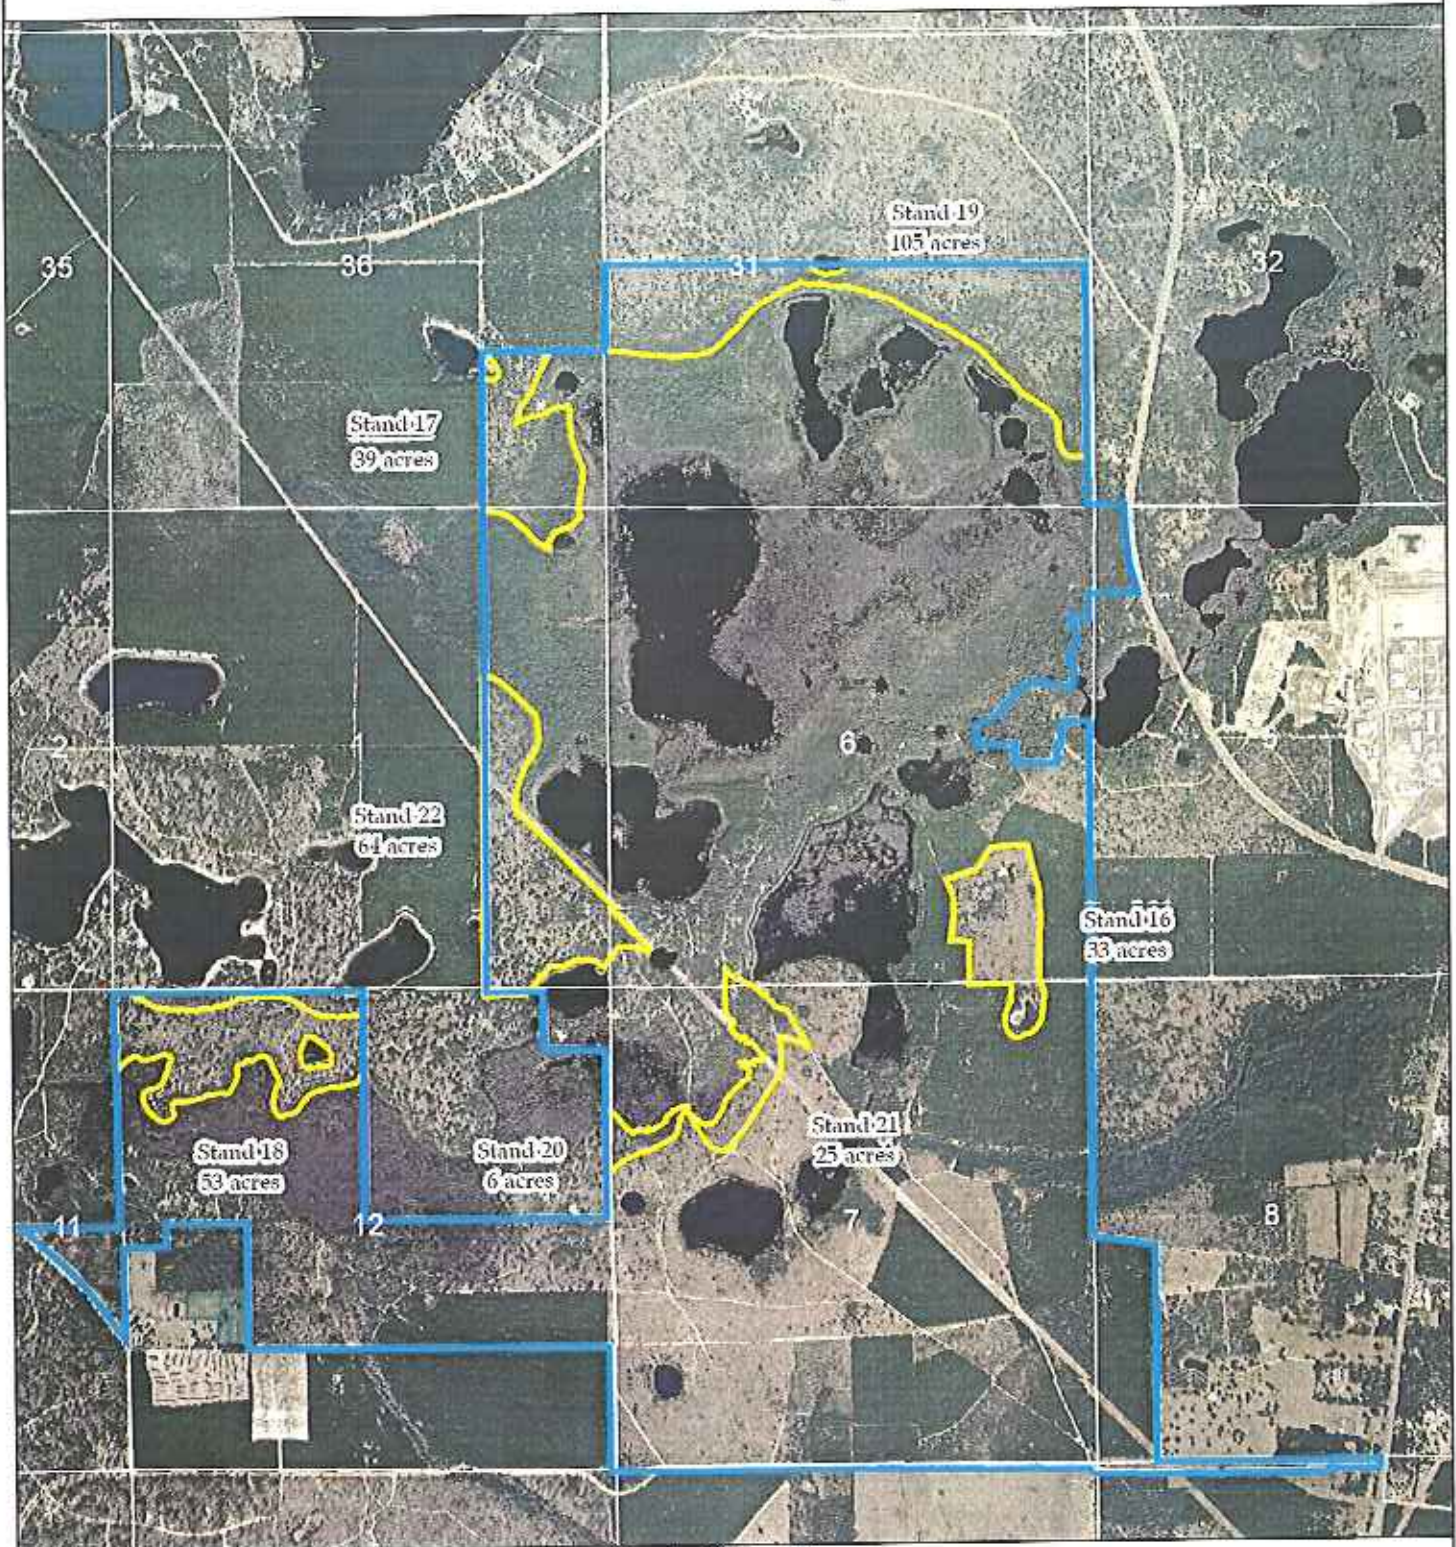
# Exhibit Map 8

7. During September, hardwood and sand pines were cut and the stems treated with herbicide for 325 acres of Management Unit 10 (Exhibit Map 8) (Appendix 4). Wire grass cover within these areas had greatly increased following the initial burns and it was felt that these areas could be restored to a diverse sandhill community if the invading sand pines and hardwoods were removed. These areas will be burned during the winter of 2007/2008.
