## Northwest Florida Water Management District

Re: Progress Report 3

Please accept this submittal as the third progress report for the SHLMB. Since the last progress report, the main roads around Deep Edge and adjacent to the Green Ponds were improved to allow heavy equipment to travel to the work sites. This work continued into July and a limestone cap was placed over selected portions of the roadway. An eroding portion of road adjacent to Dykes Mill Pond was abandoned and restored in late June. Construction of three bridges and two culverts was initiated in July and is ongoing. Prior to the initiation of work, silt screens were installed and have been inspected regularly. No turbidity has been observed. Additional oak and sand pine removal was conducted on 325 acres in Management Unit 10 throughout September. Oblique aerials were taken for the SHLMB on October 23, 2006. The photographs are being processed now and will be included in the annual report. Fall monitoring for the annual report was conducted in October as well as the annual inspection for nuisance and exotic species.

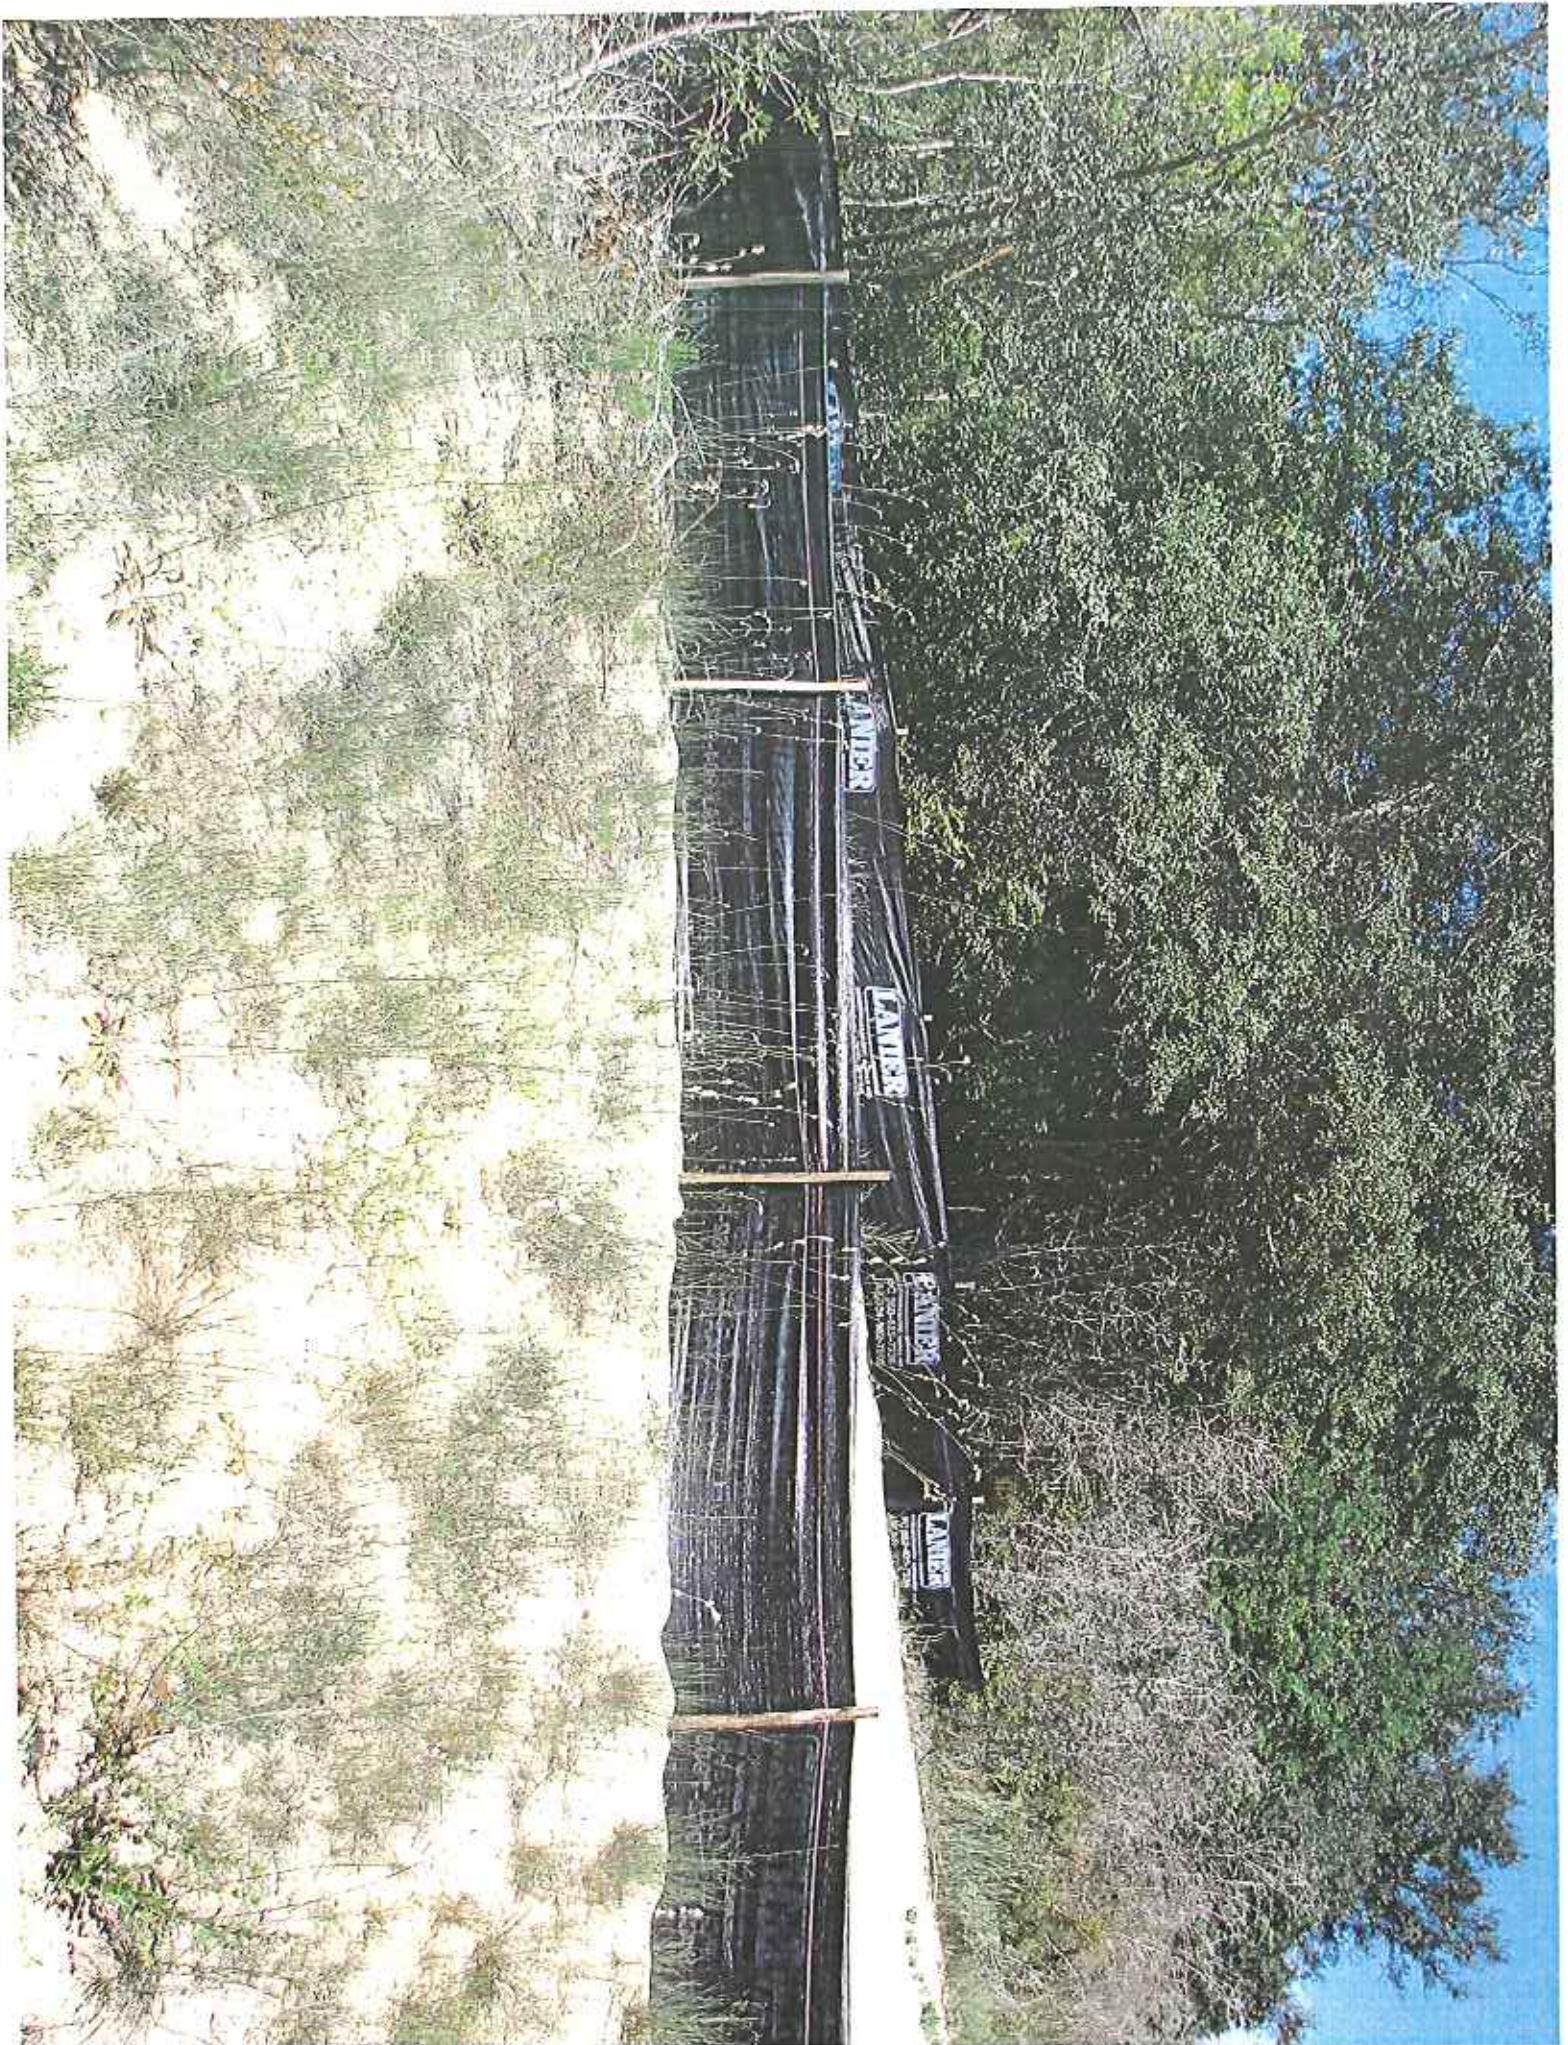
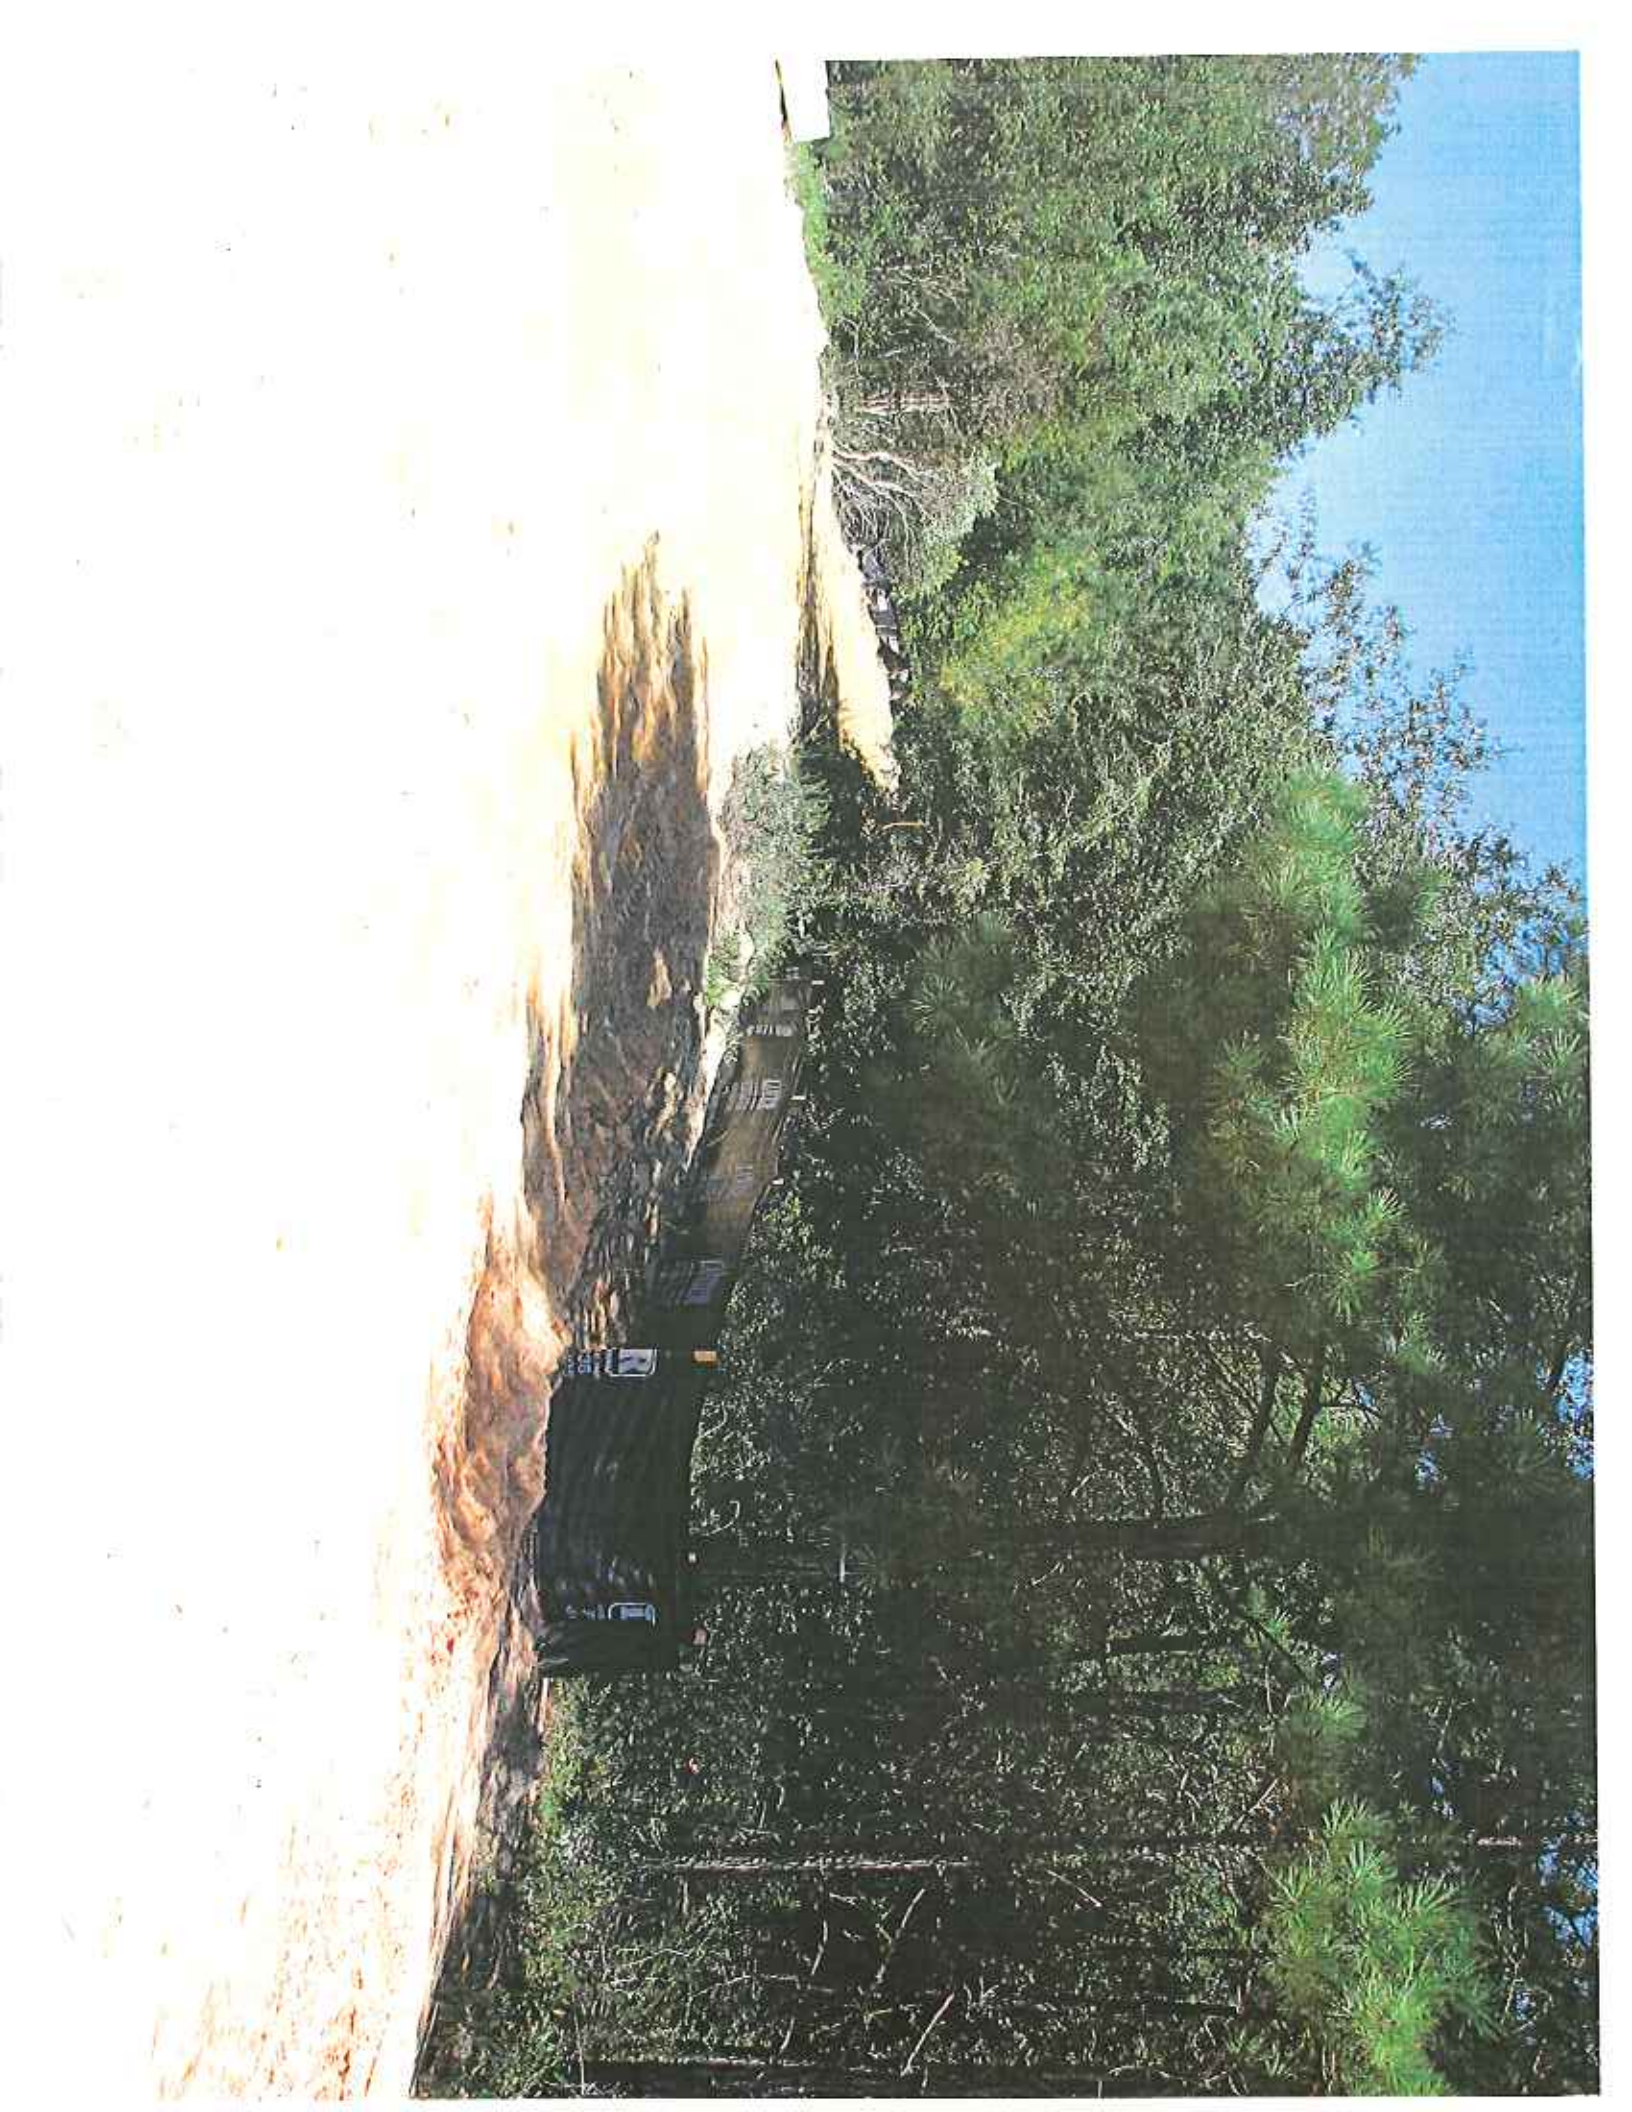
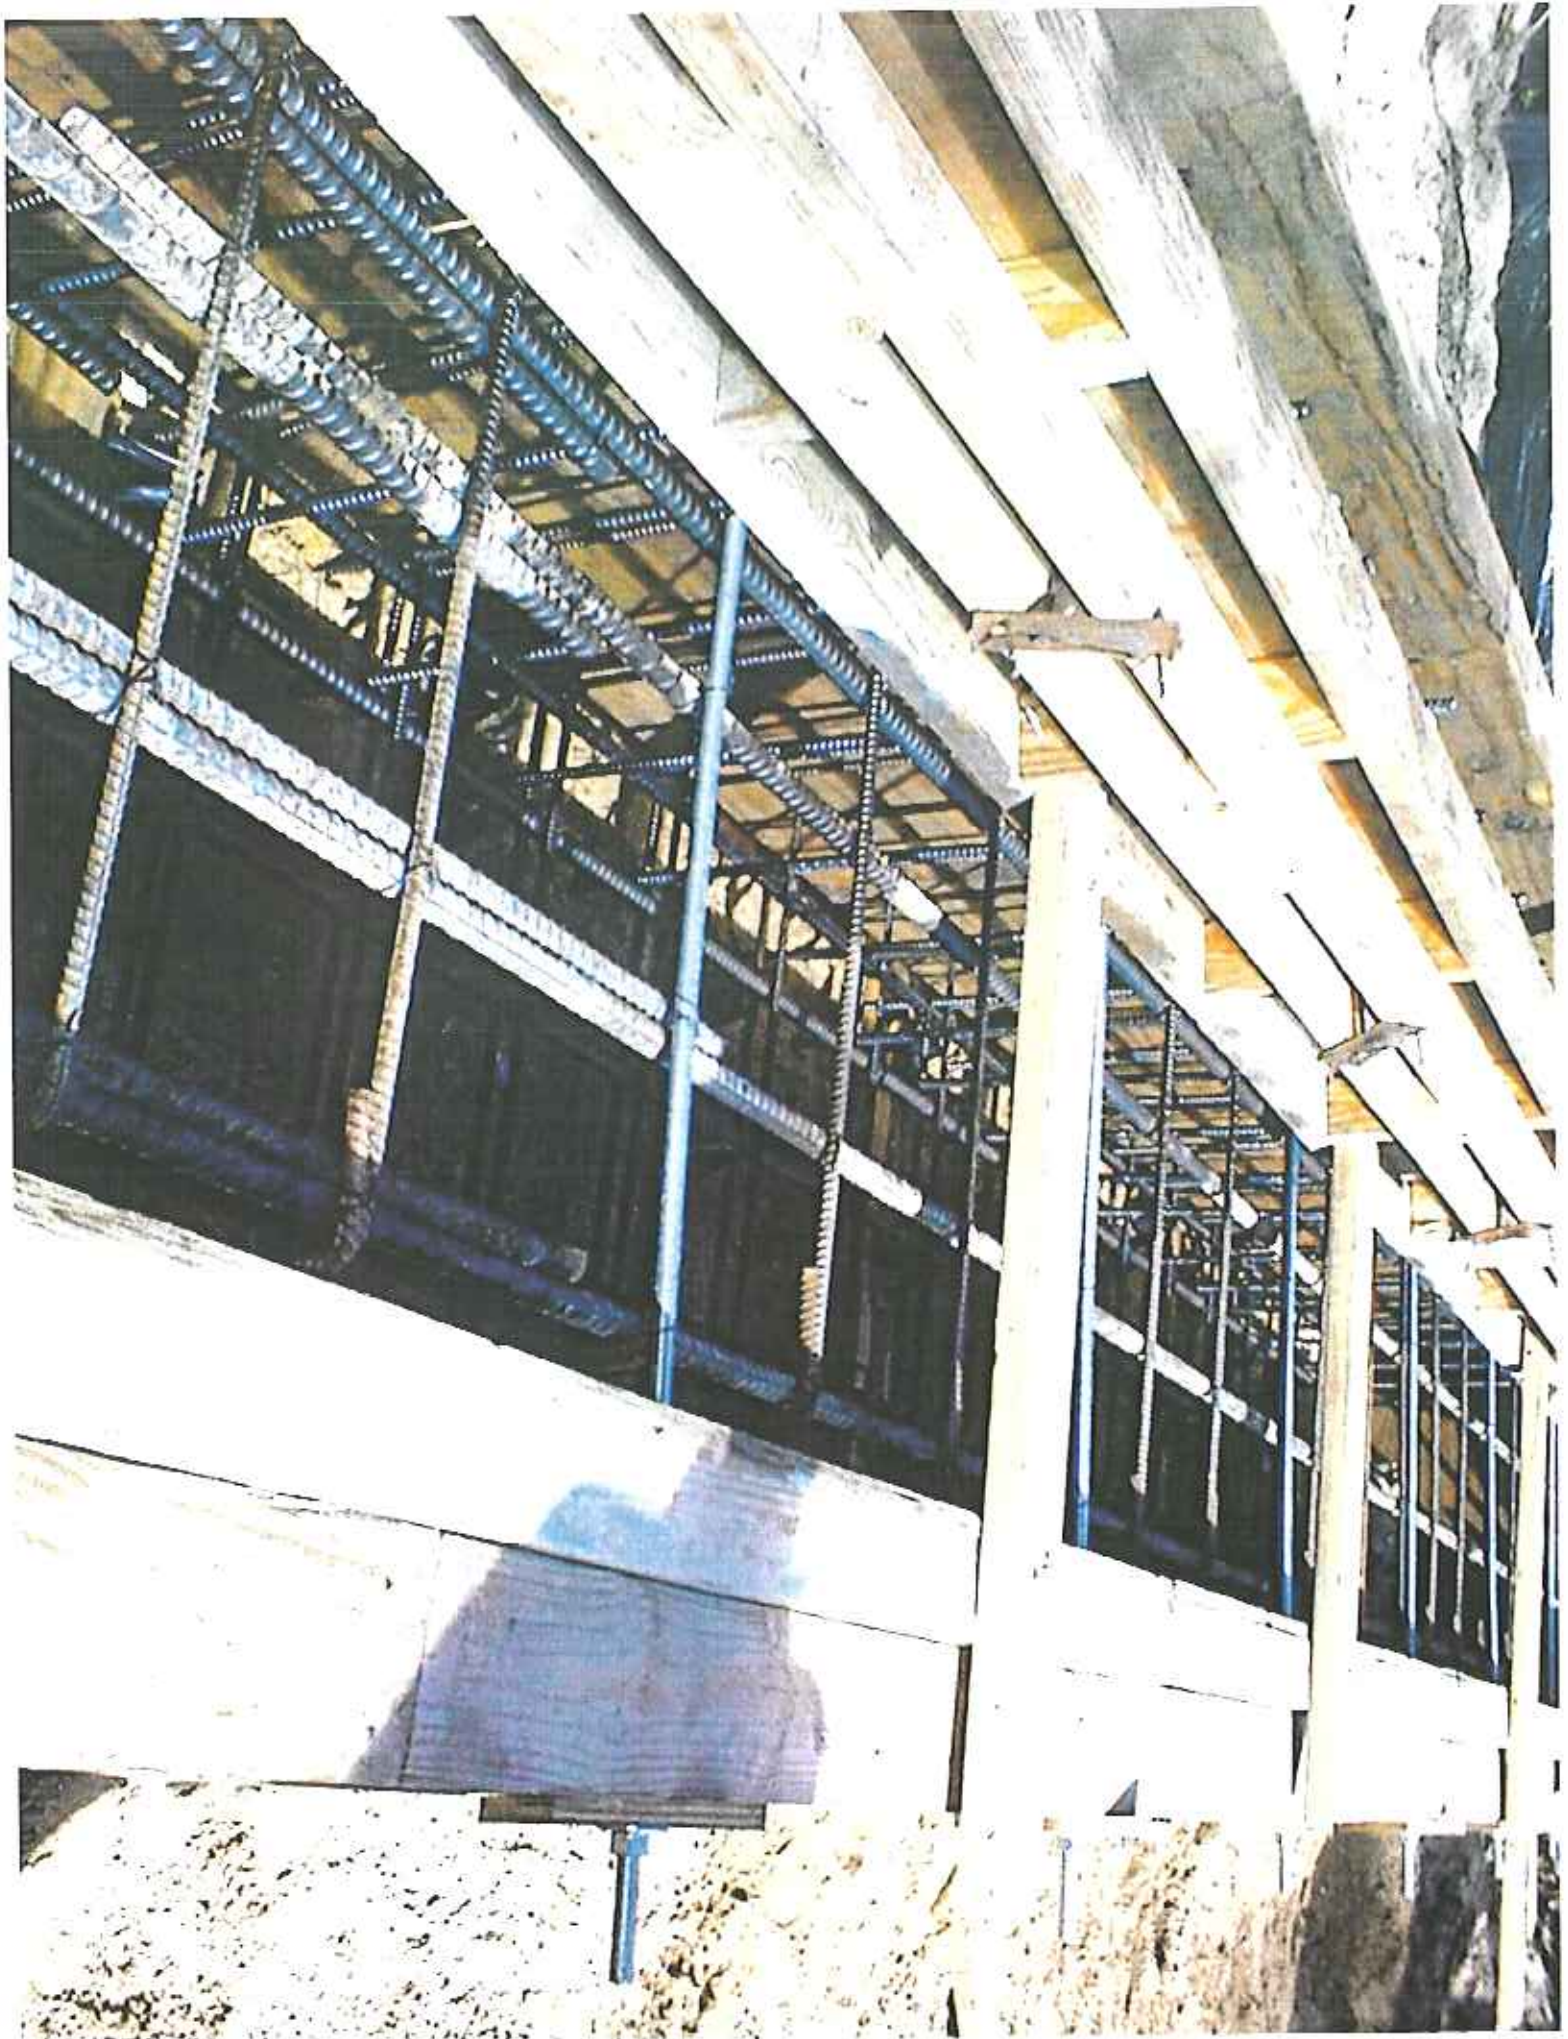
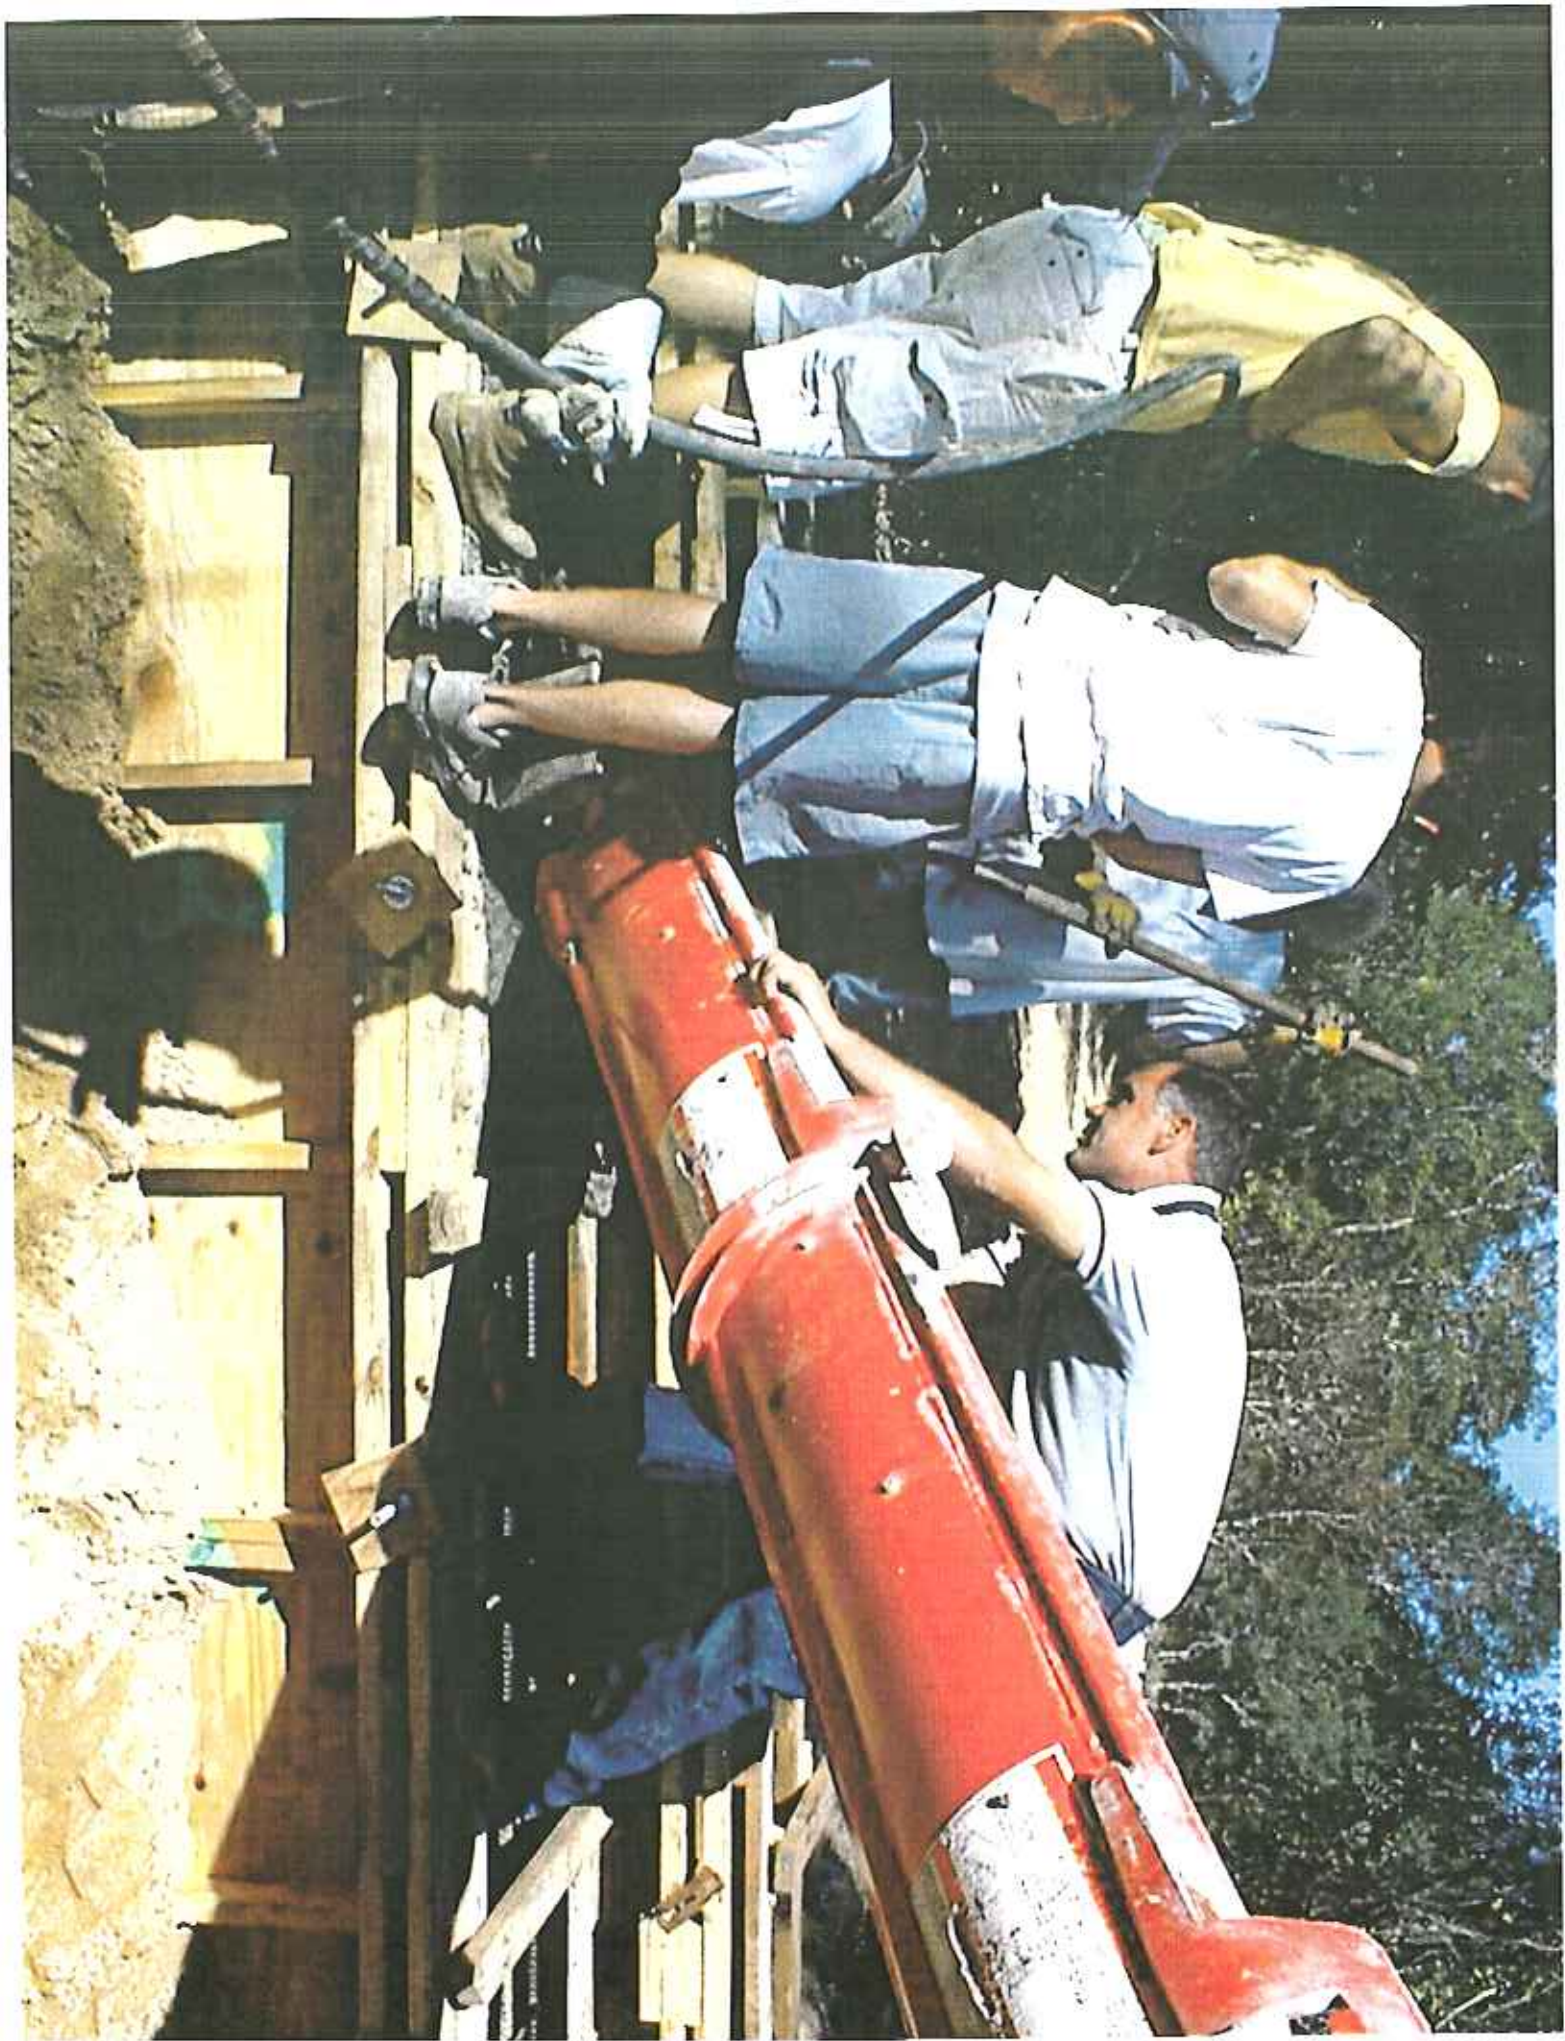
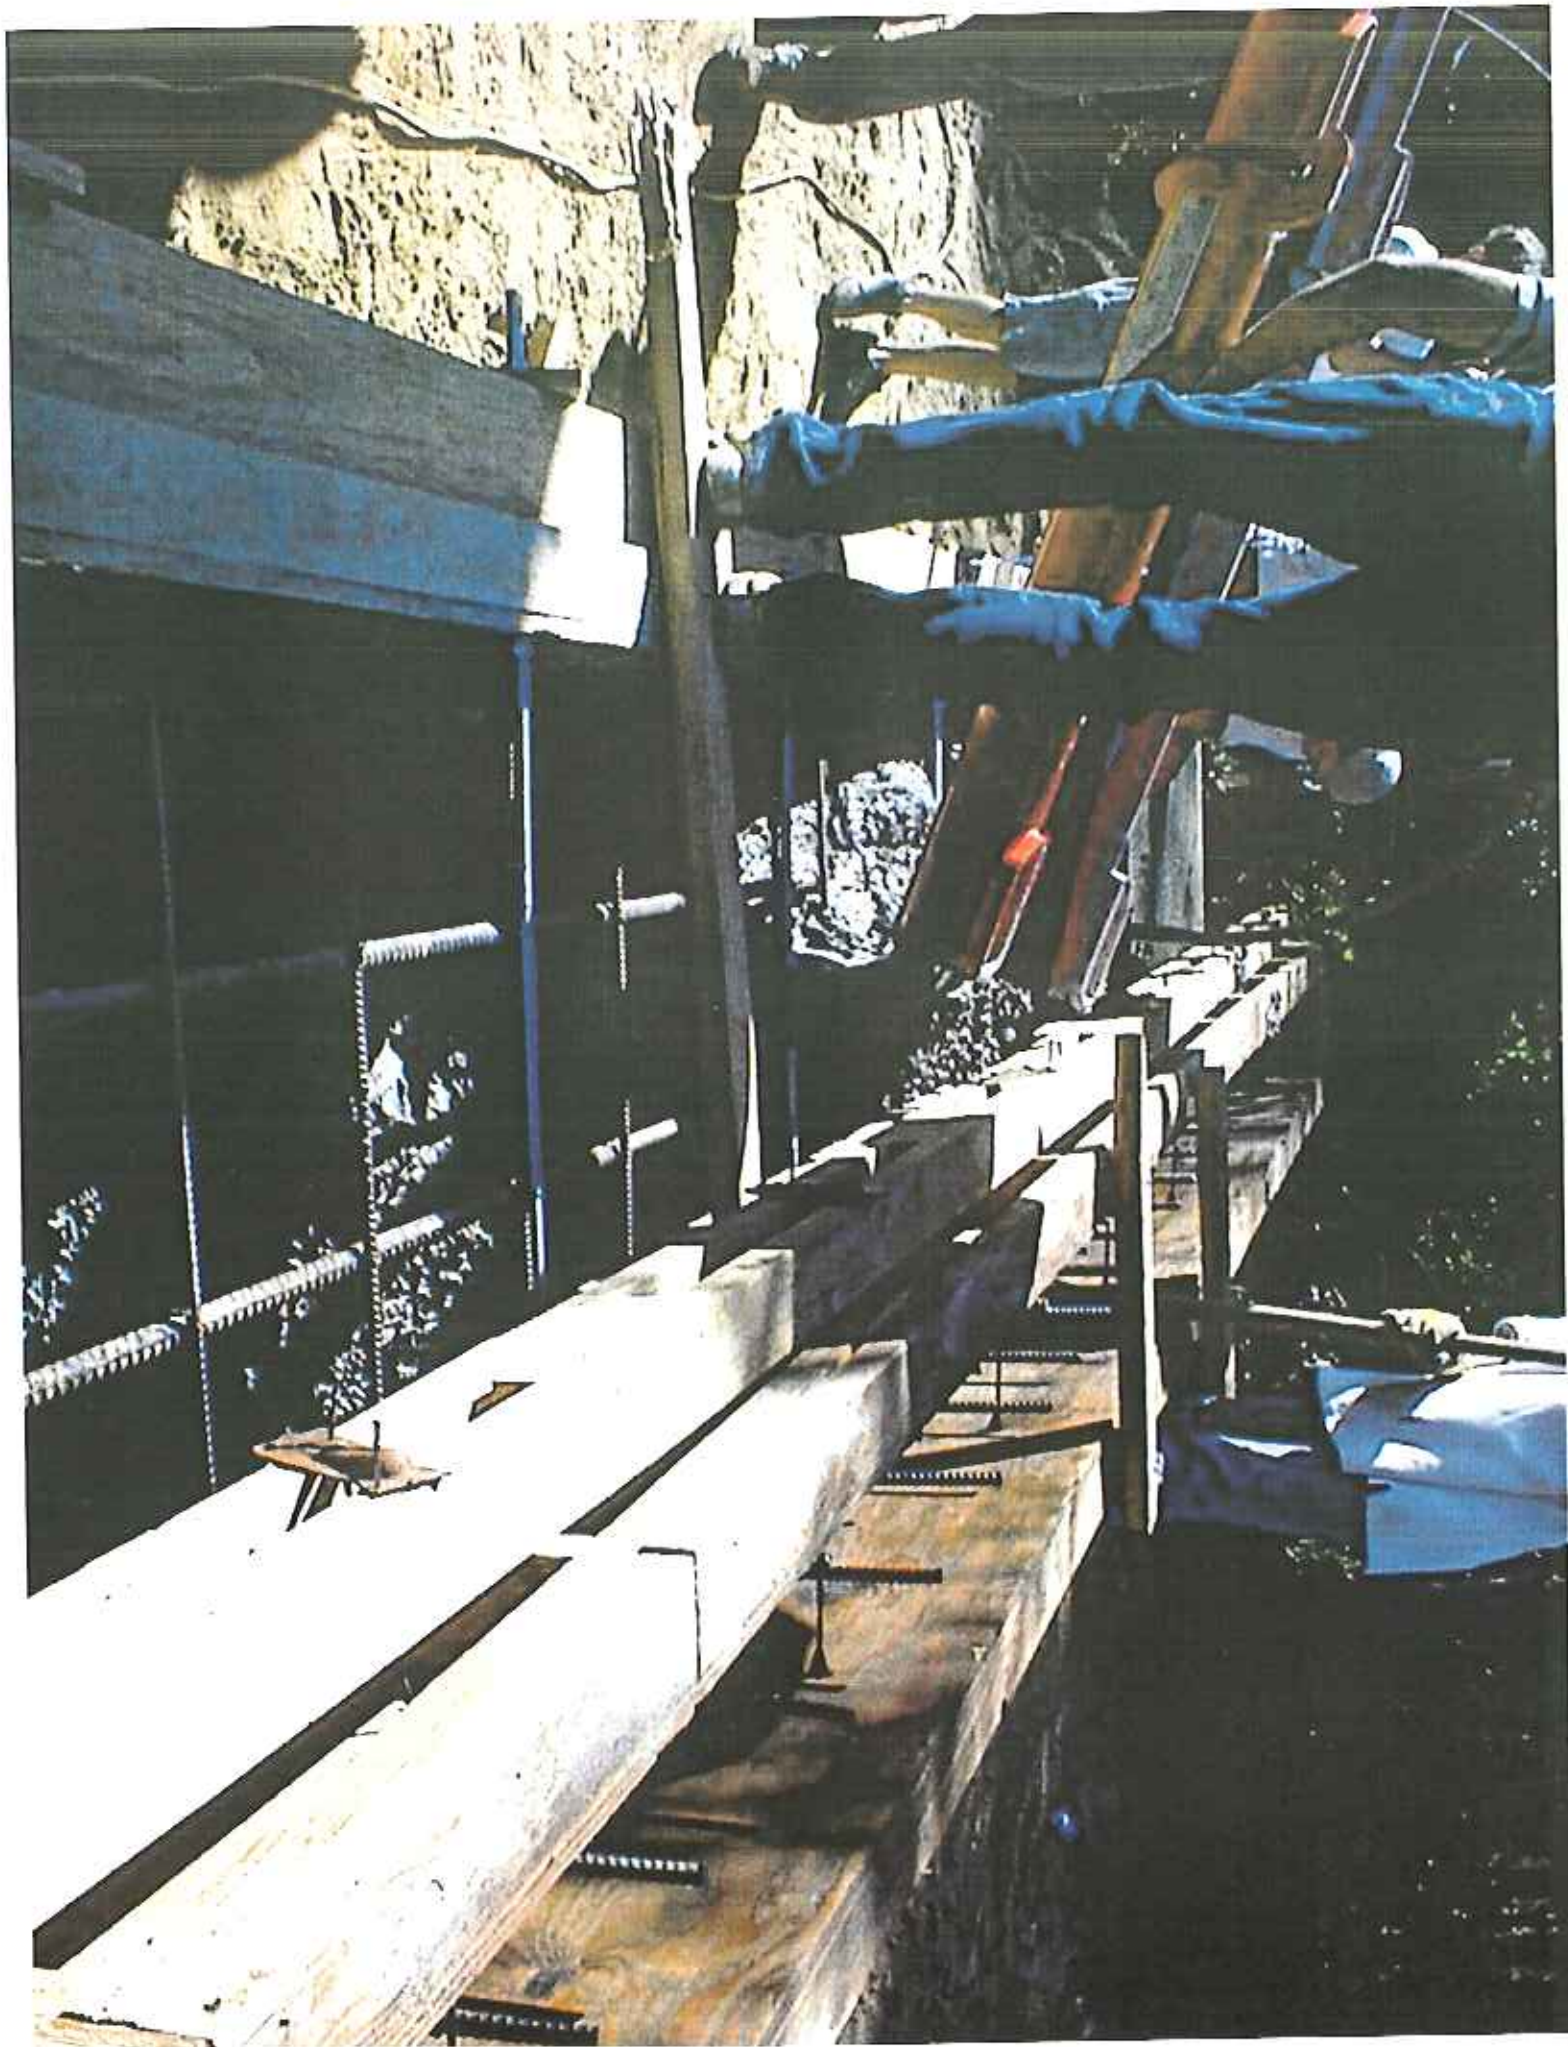
Appendix 2: Photos of bridge construction and Greenhead branch and silt fences located at Greenhead Branch and Pine Log Creek

3. Construction on three bridges and two culverts was initiated in July and is ongoing (Appendix 2). Silt fences and turbidity barriers were installed and have been inspected regularly. Due to the summer drought, water levels at the bridge and culvert sites for all but Greenhead Branch have been well below the construction areas, often 25 to 30' below the work area. Greenhead branch has had minimal flow throughout the summer. No turbid discharge has been observed.
