## Northwest Florida Water Management District

Re: Progress Report 3

Please accept this submittal as the third progress report for the SHLMB. Since the last progress report, the main roads around Deep Edge and adjacent to the Green Ponds were improved to allow heavy equipment to travel to the work sites. This work continued into July and a limestone cap was placed over selected portions of the roadway. An eroding portion of road adjacent to Dykes Mill Pond was abandoned and restored in late June. Construction of three bridges and two culverts was initiated in July and is ongoing. Prior to the initiation of work, silt screens were installed and have been inspected regularly. No turbidity has been observed. Additional oak and sand pine removal was conducted on 325 acres in Management Unit 10 throughout September. Oblique aerials were taken for the SHLMB on October 23, 2006. The photographs are being processed now and will be included in the annual report. Fall monitoring for the annual report was conducted in October as well as the annual inspection for nuisance and exotic species.

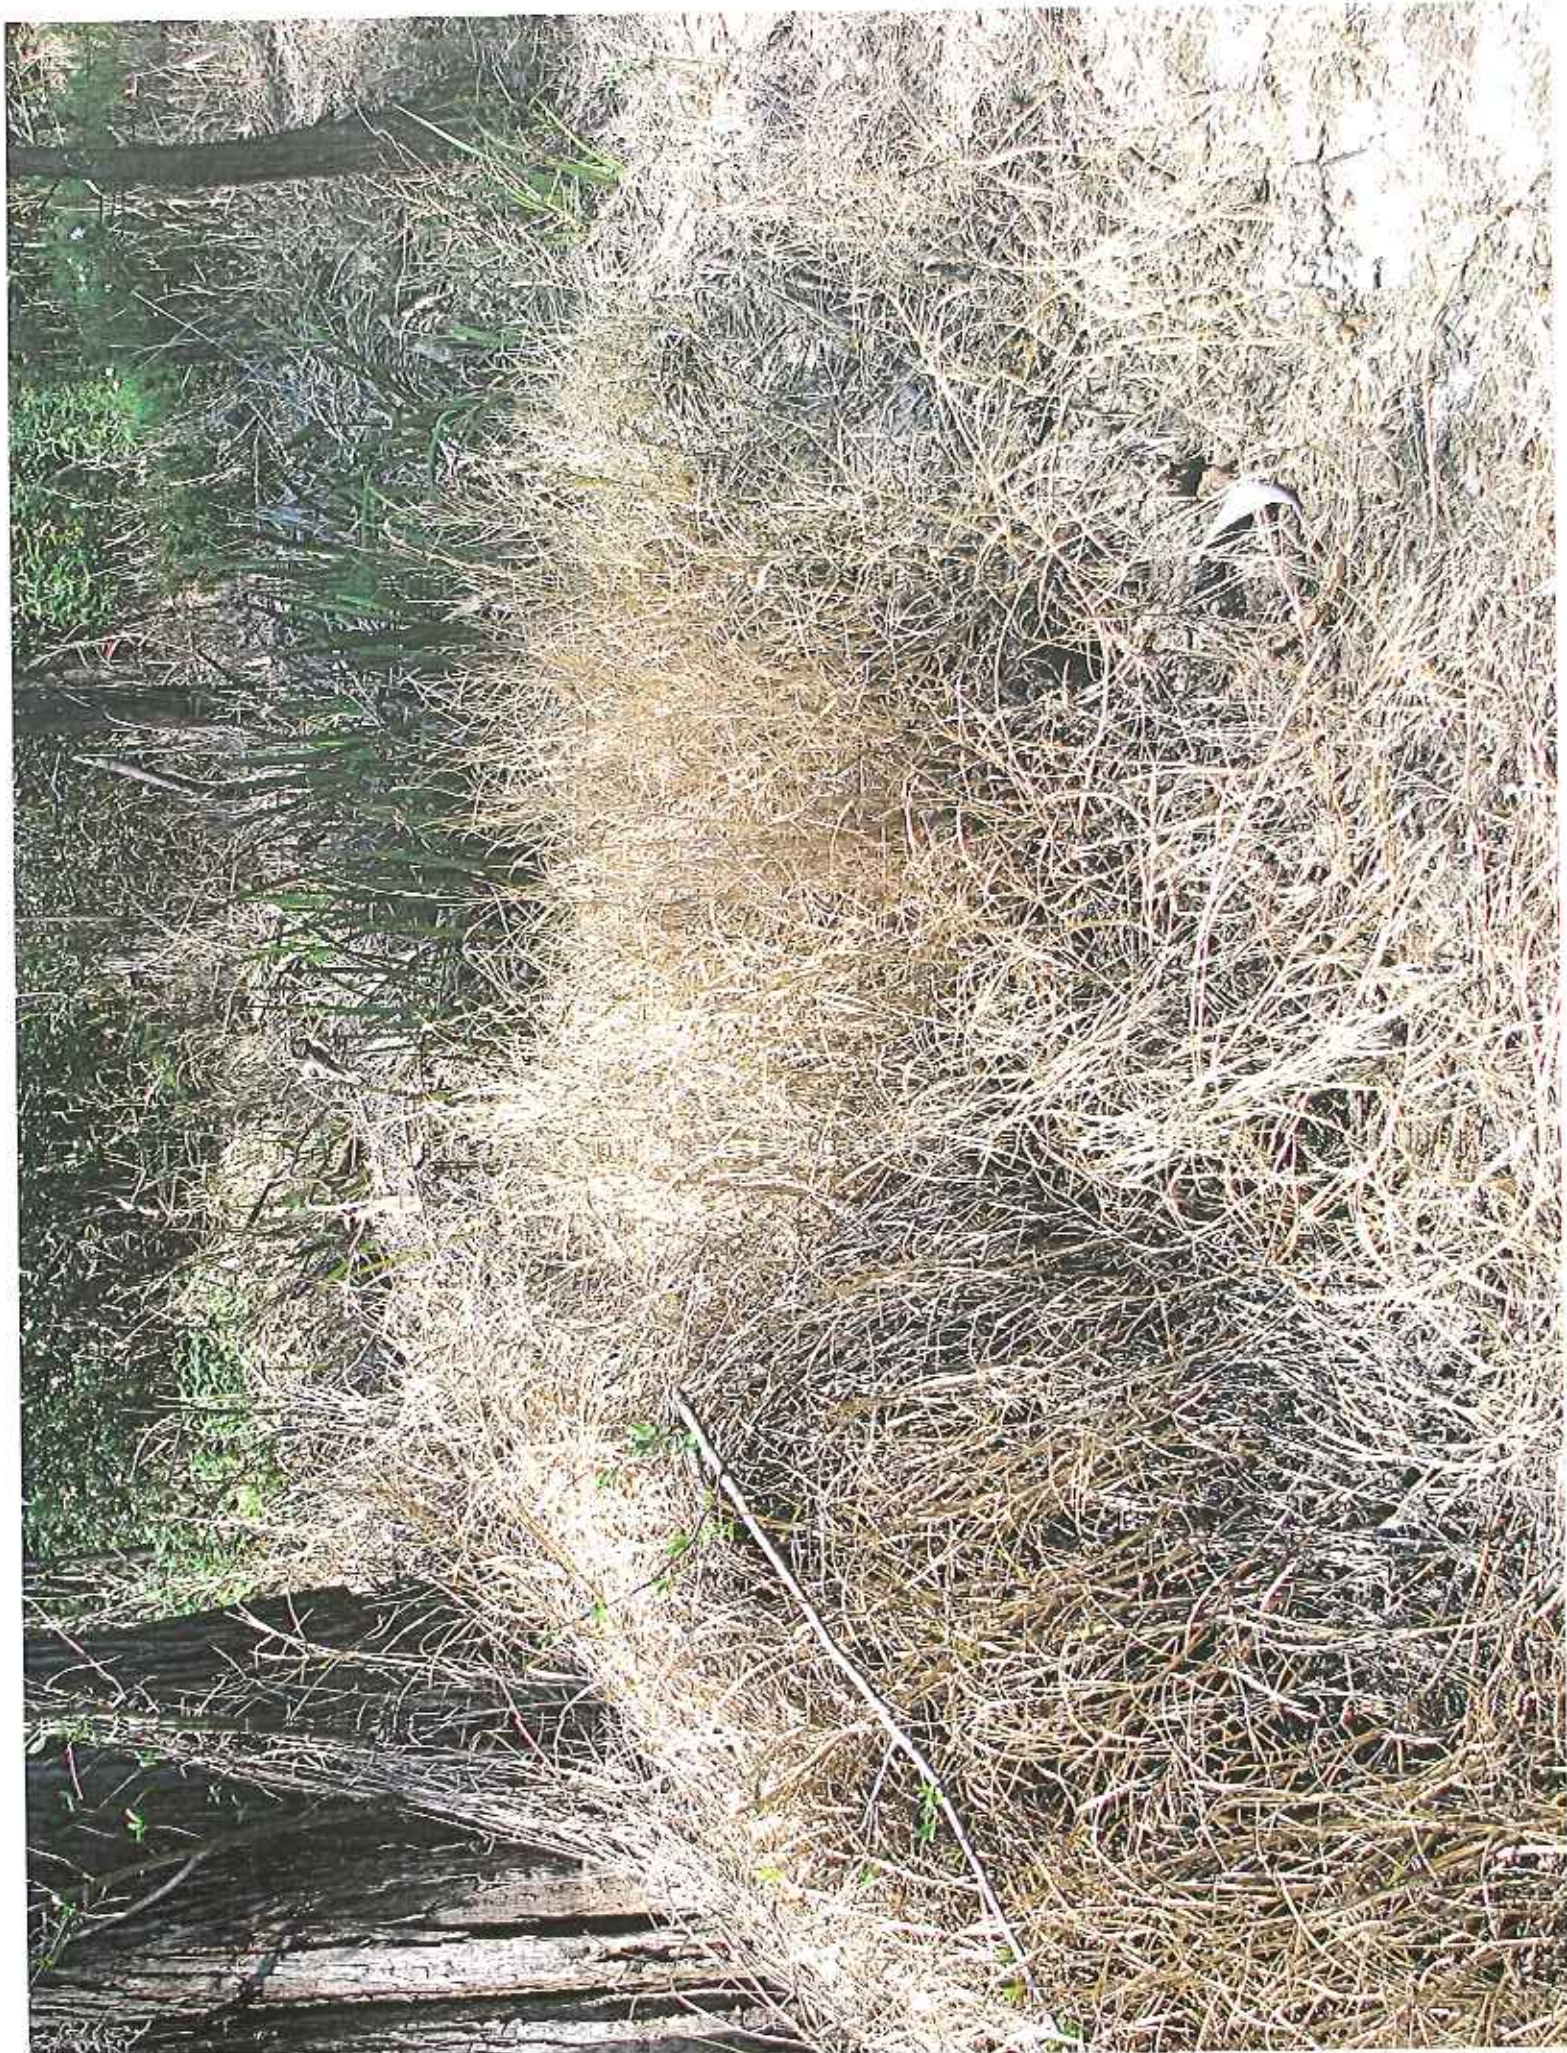
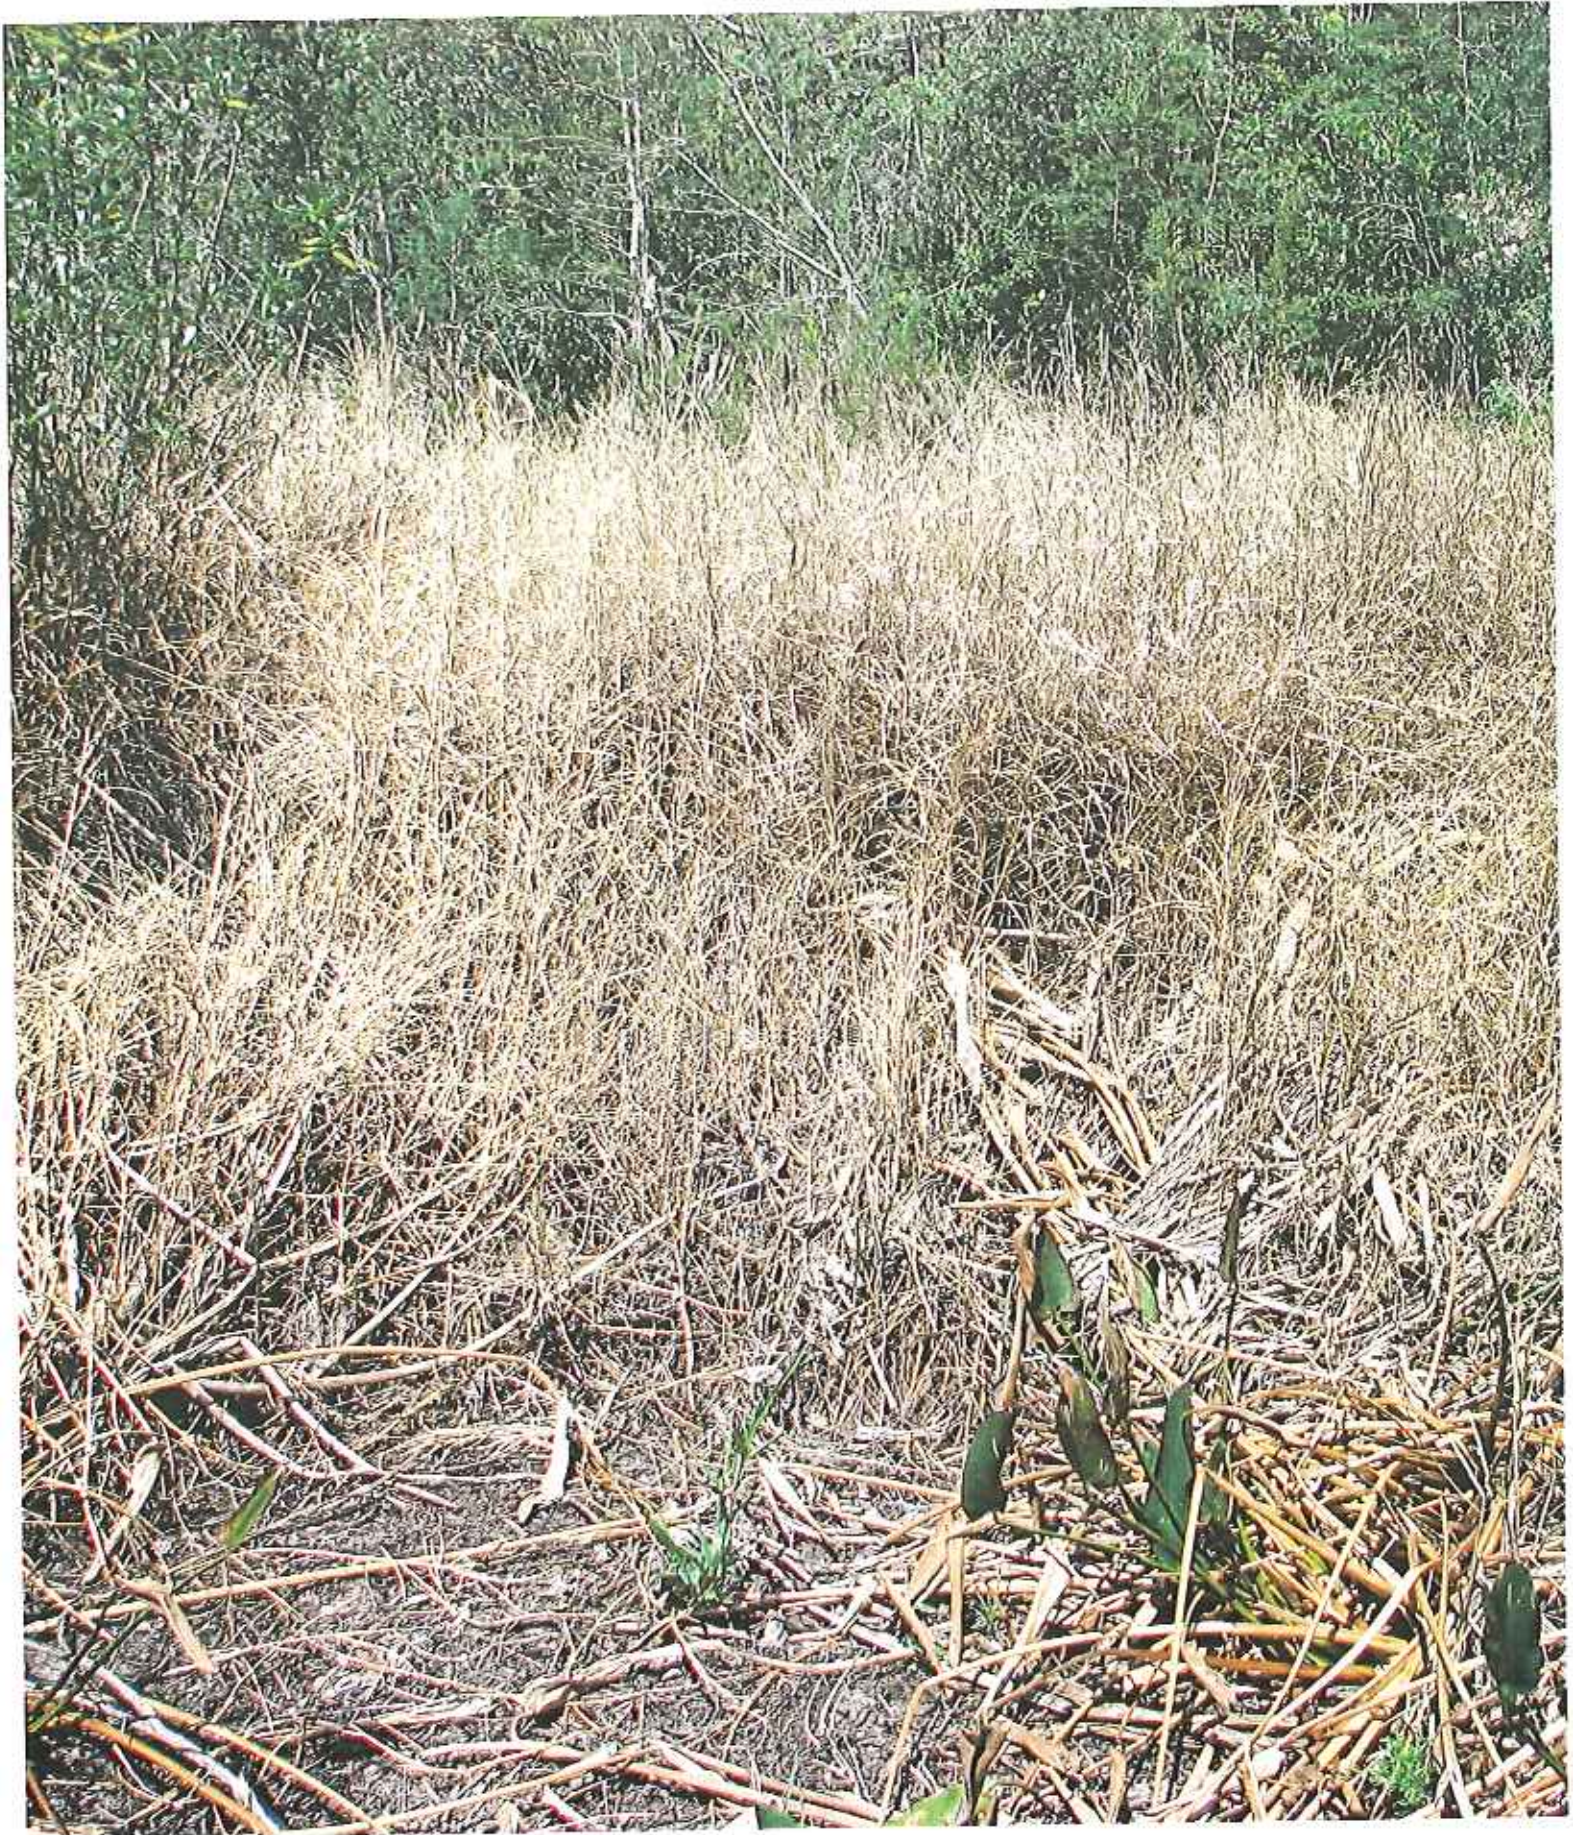
### Appendix 3: Photos of treated torpedo grass at Green Pond

4. Surveys for feral hogs and beavers continued through the summer at the SHLMB. No additional sightings or disturbances have been observed.
5. During the May site inspection, torpedo grass (*Panicum repens*) was observed adjacent to the boat ramps of two of the green ponds (Figure 10b). The torpedo grass was subsequently sprayed by DEP employees from the Bureau of Invasive Plant Management on July 20<sup>th</sup> 2006. Follow up visits indicate an excellent kill with little to no surviving torpedo grass. Future site inspections will continue to monitor these areas. Photos of the treated areas are included in the Appendix 3. Several additional patches of torpedo grass and three sapling Chinese tallow (*Sapium sebiferum*) were observed during the annual inspection for nuisance species in October. Torpedo grass was observed at the boat ramp at Garret pond, along a wet dirt road adjacent to dry pond, and on the banks of one of the Green ponds (Figure 10b). The coverage of the torpedo grass was all minimal, small patches approximately 15' in diameter. The torpedo grass will be treated in February of 2007. In addition, three Chinese tallow seedlings were observed on the roadside adjacent to the green ponds (Figure 10b). The plants were hand pulled when they were observed.

Comments: During the annual monitoring for the SHLMB, the annual nuisance and exotic species monitoring was conducted. The previous patches of torpedo grass observed at the green ponds was treated on 7/20 and destroyed. Three additional infestations of torpedo grass (*Panicum repens*) were observed during the annual exotic species monitoring. A small patch of approximately 10' in diameter was observed on the edge of a green pond, the second patch of approximately 20' in diameter was observed at the old boat ramp to Garret pond and a third patch approximately 25' in size was located along a wet roadway adjacent to dry pond. A map has been generated and will be included in progress report. In addition, three seedling popcorn trees (*Sapium sebiferum*) were observed along the road on adjacent to the green ponds. The seedlings were destroyed.

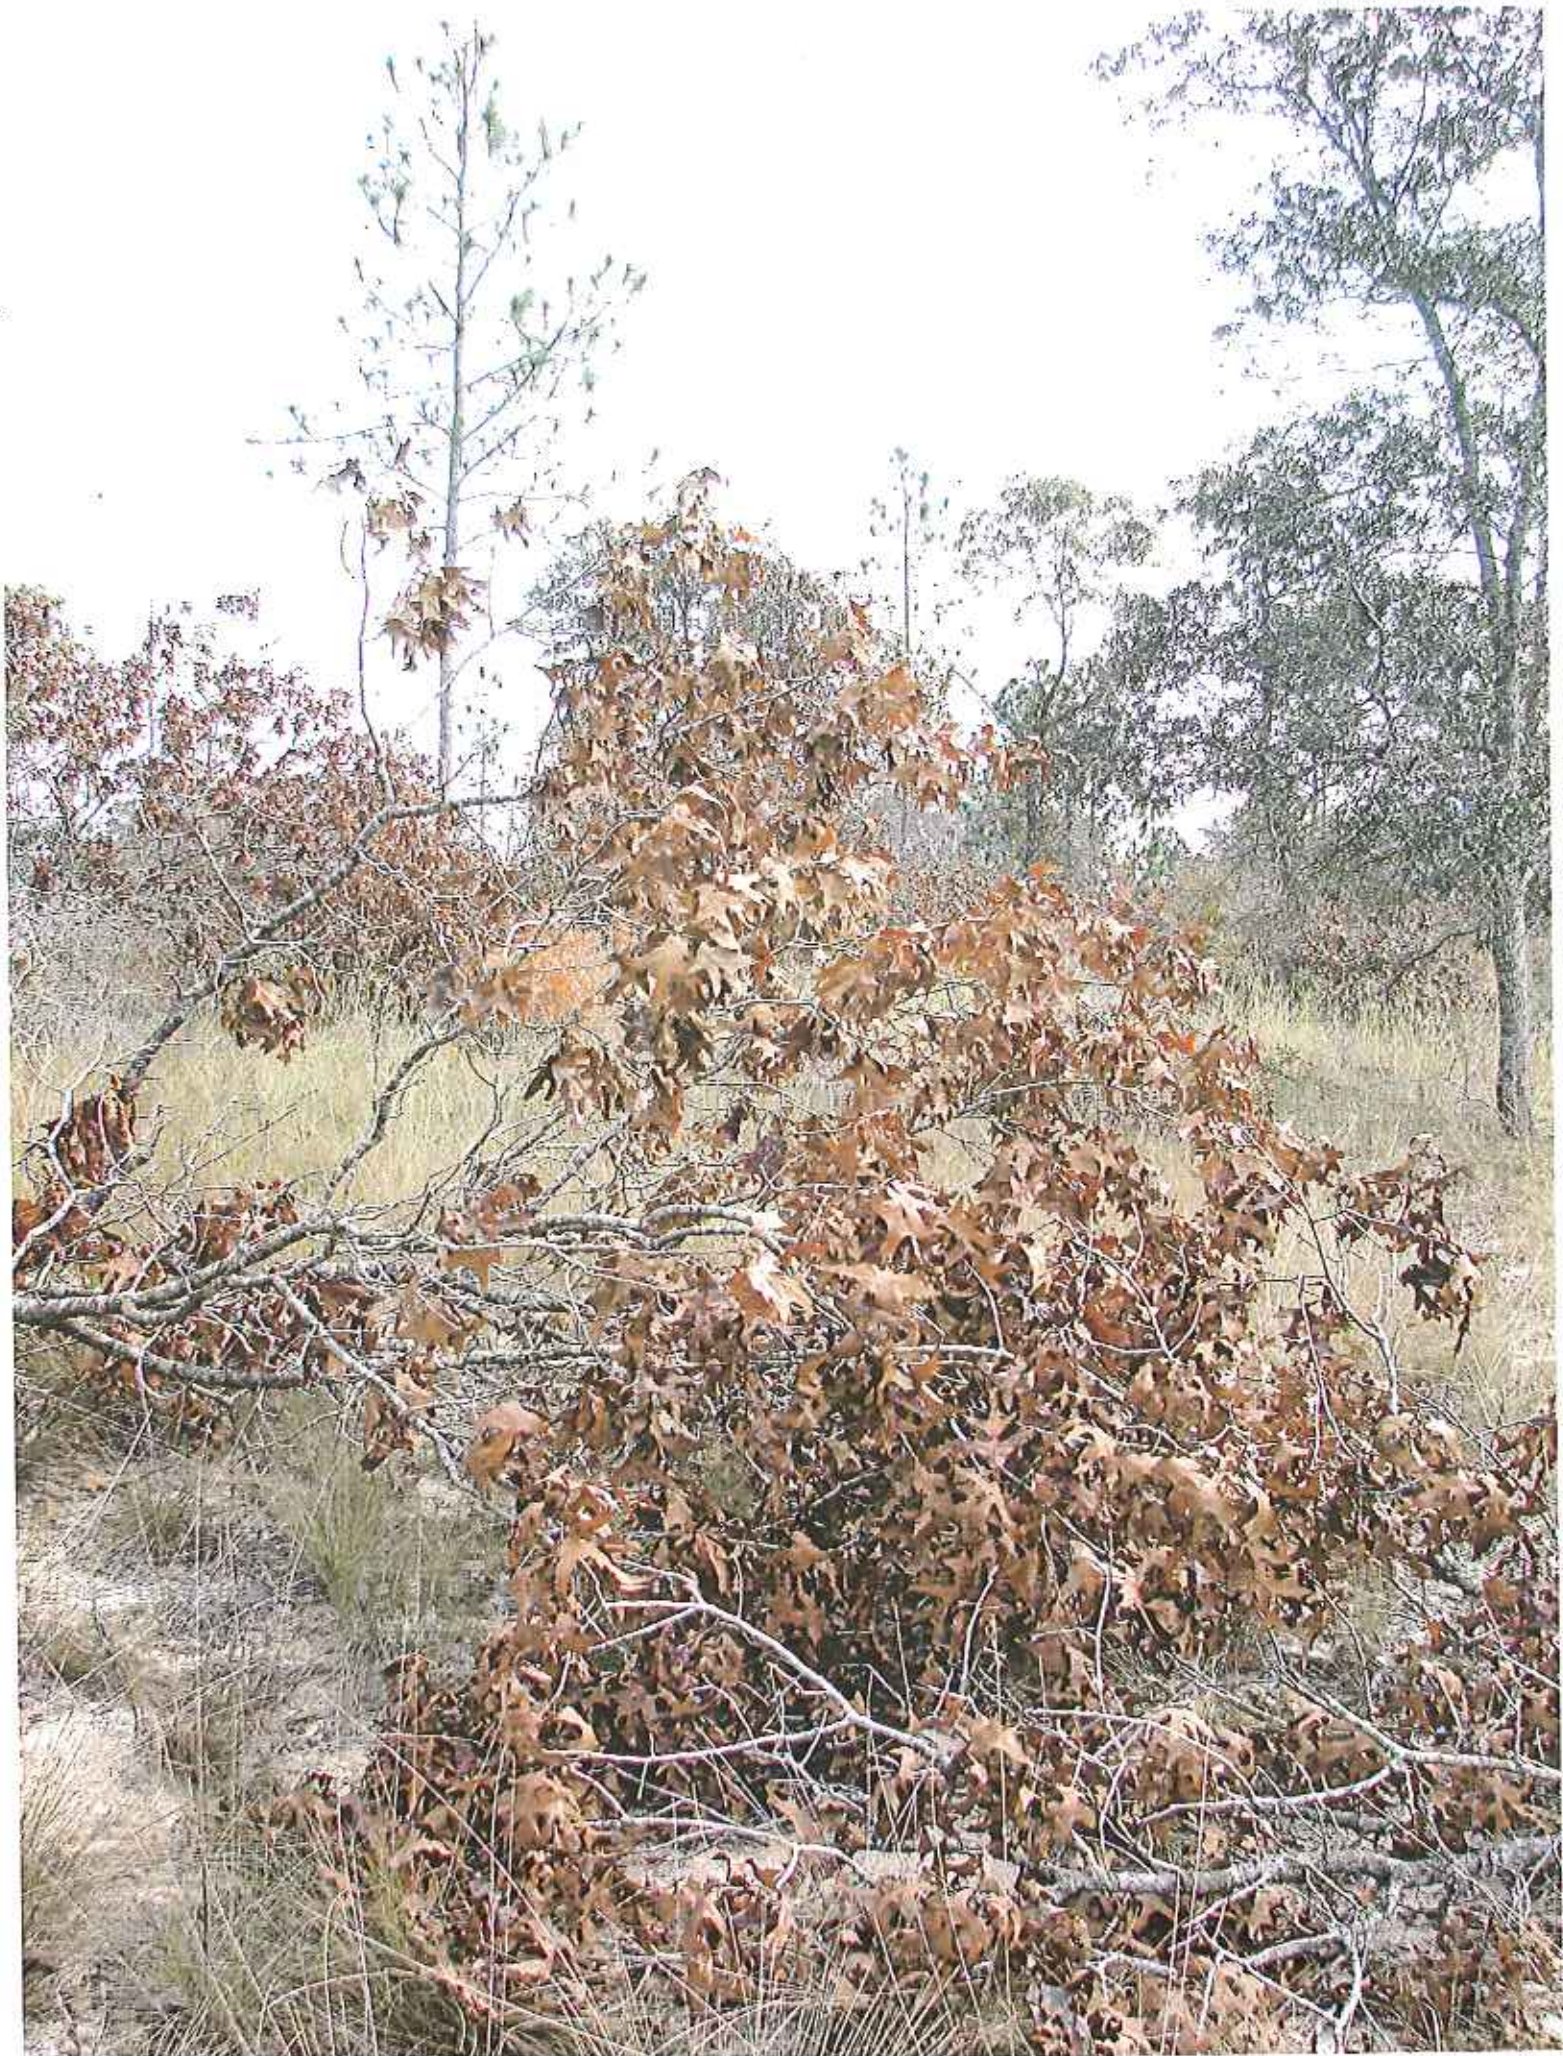
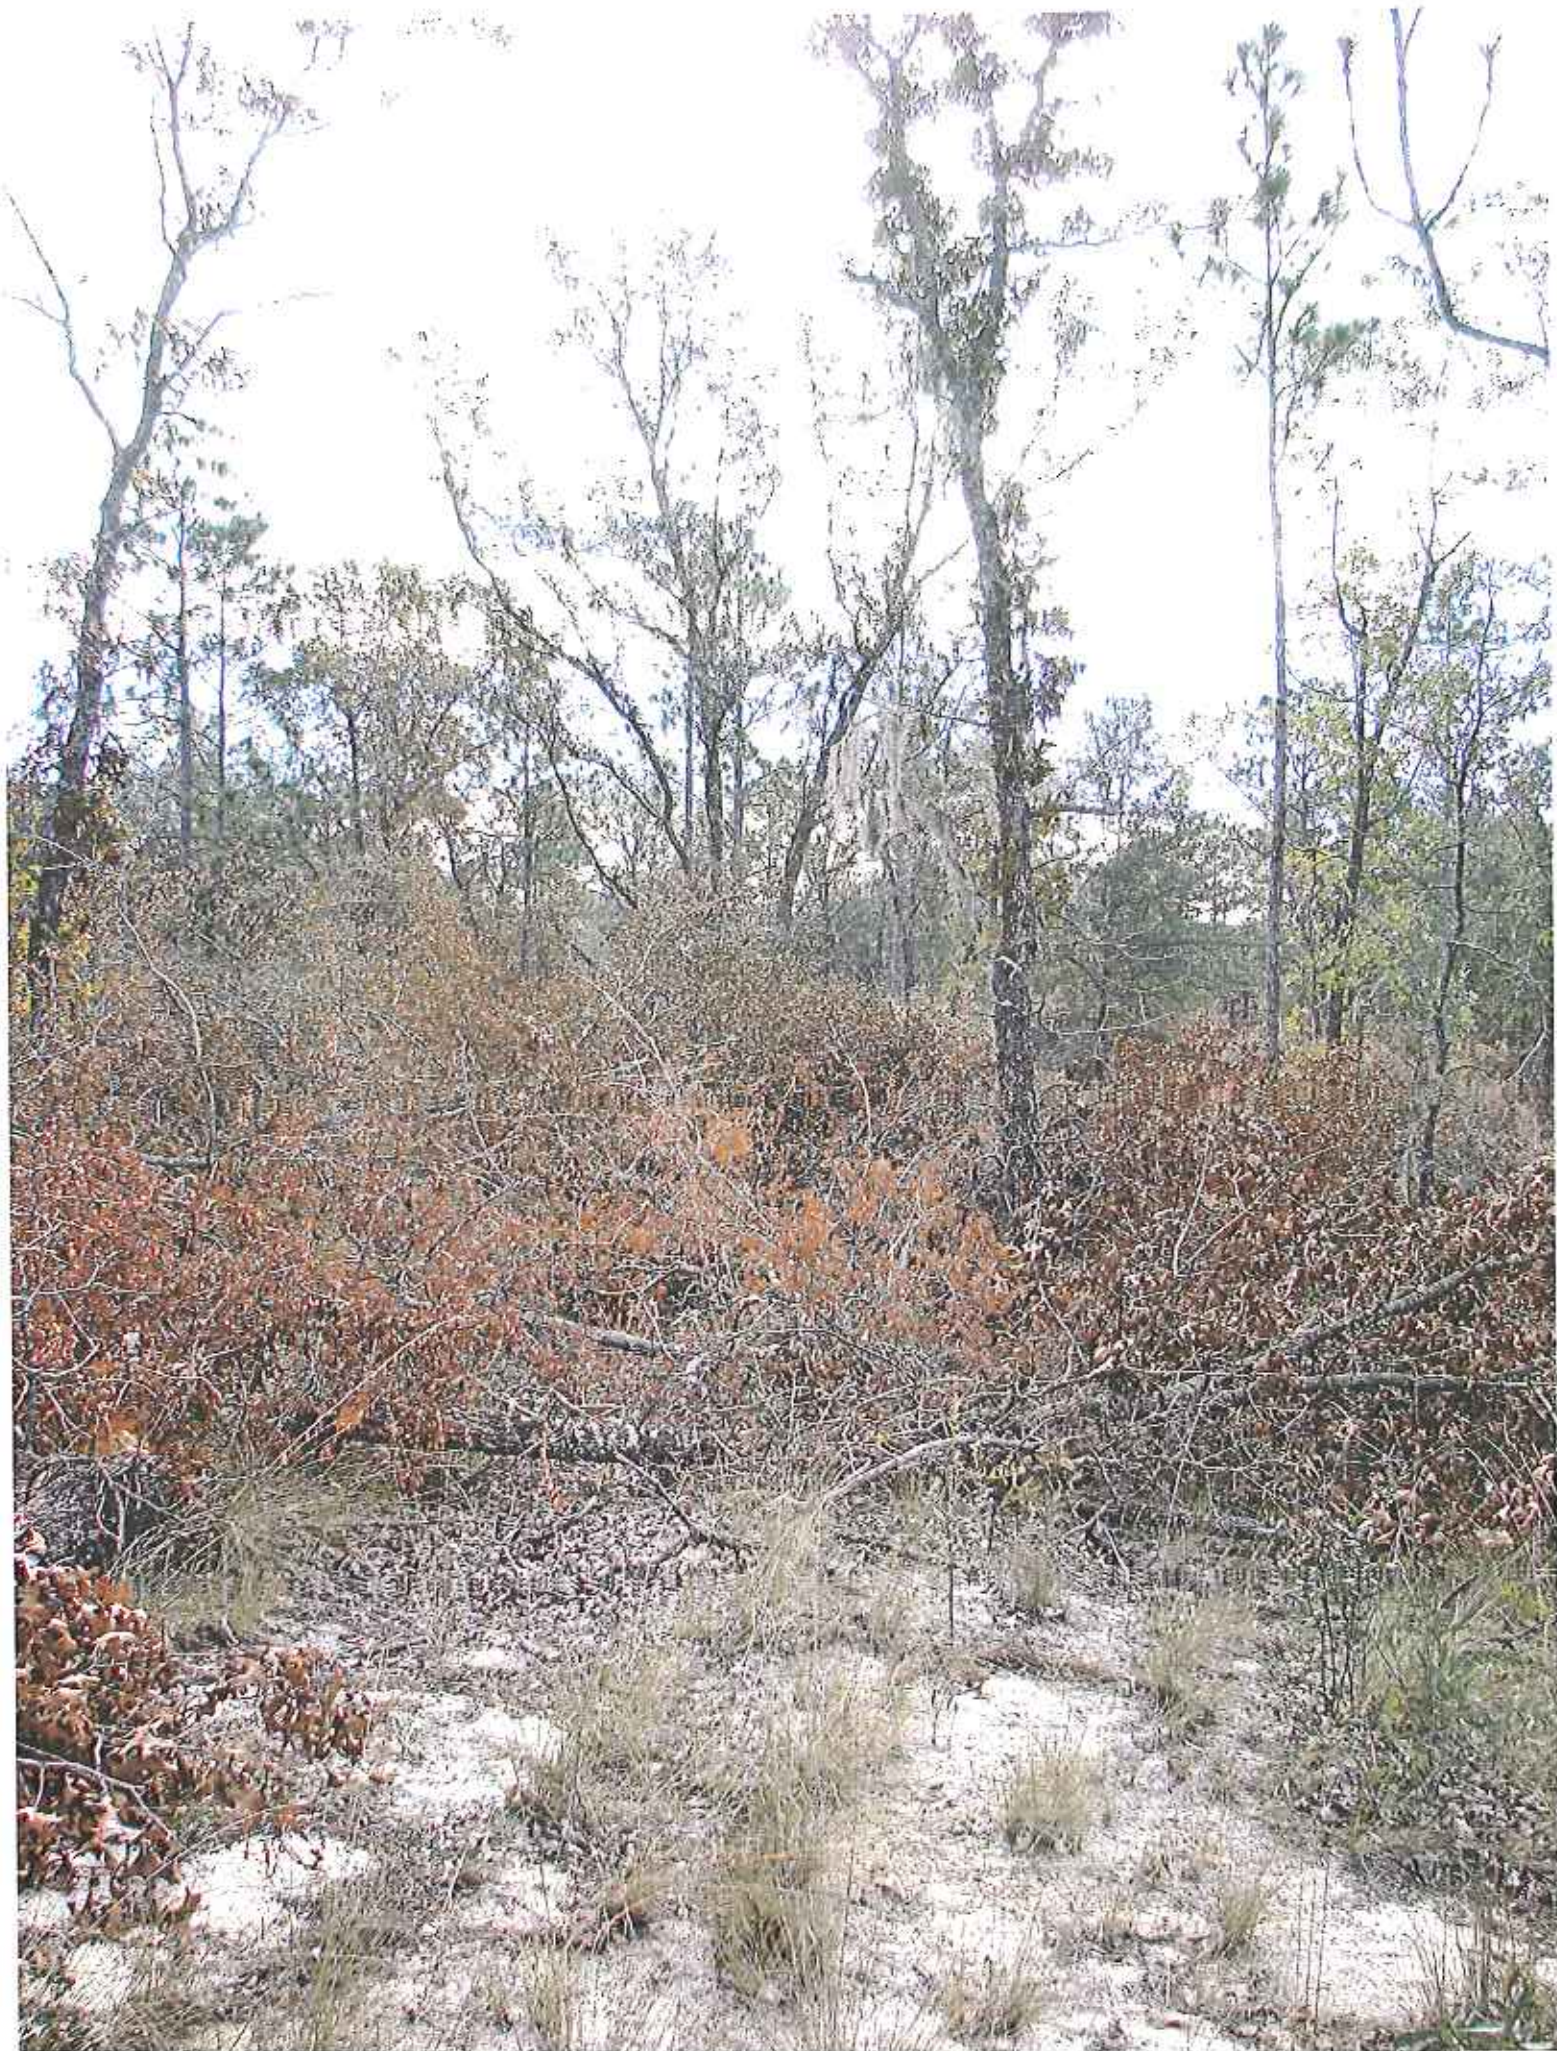
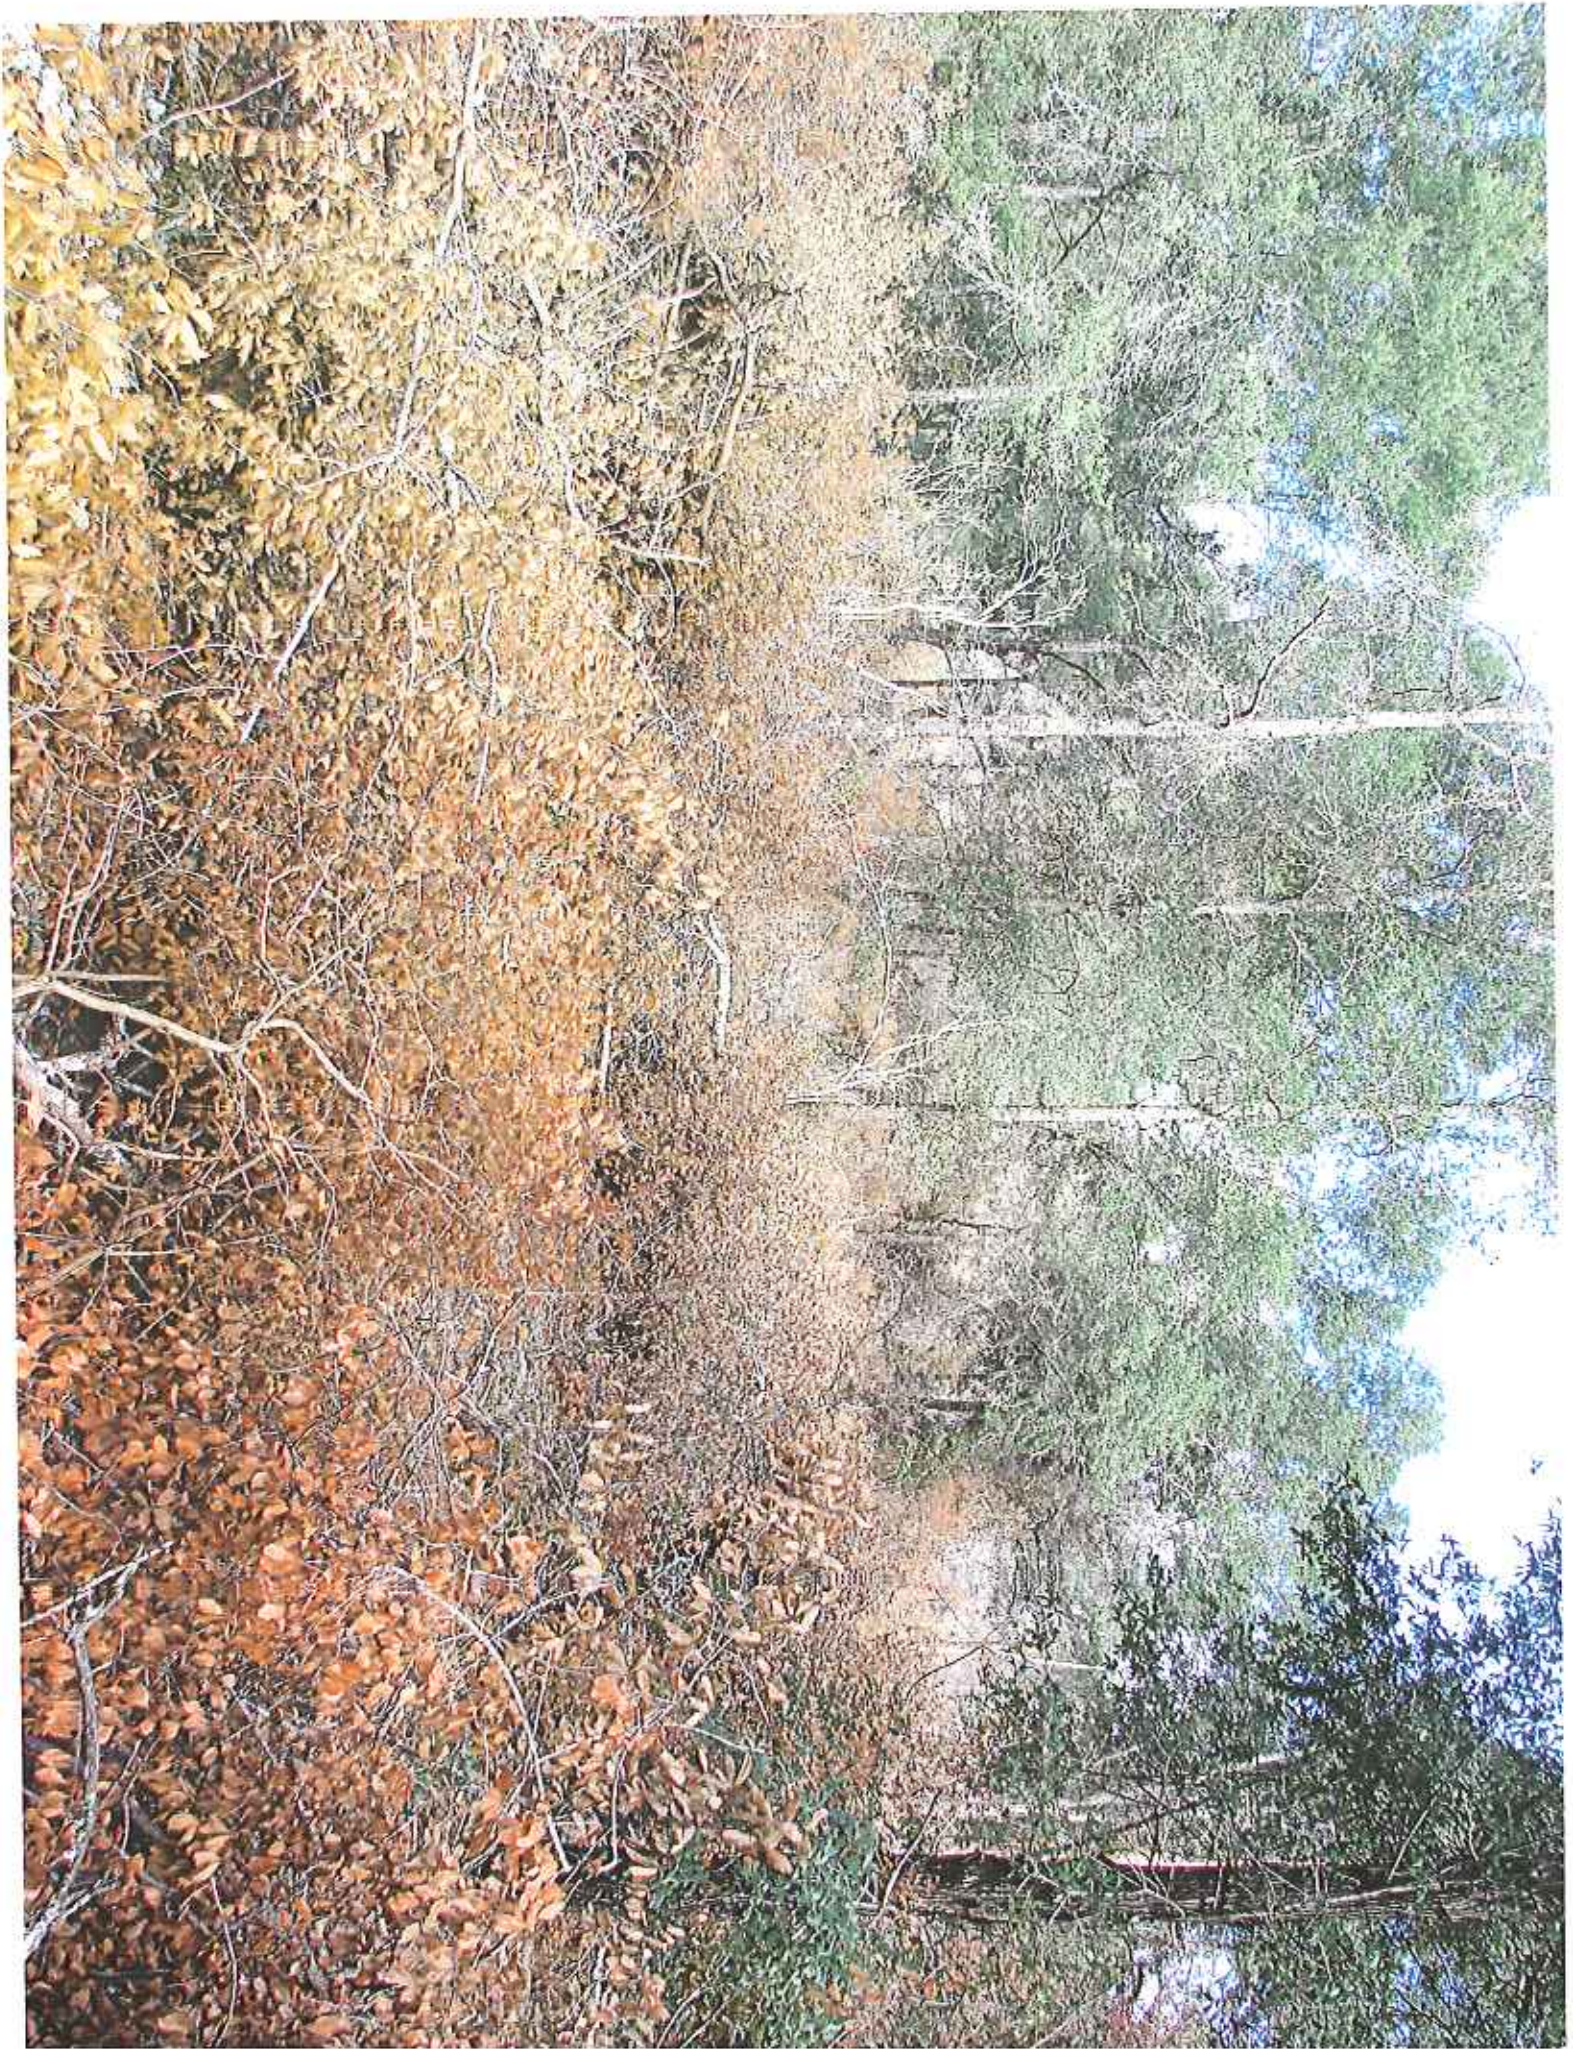
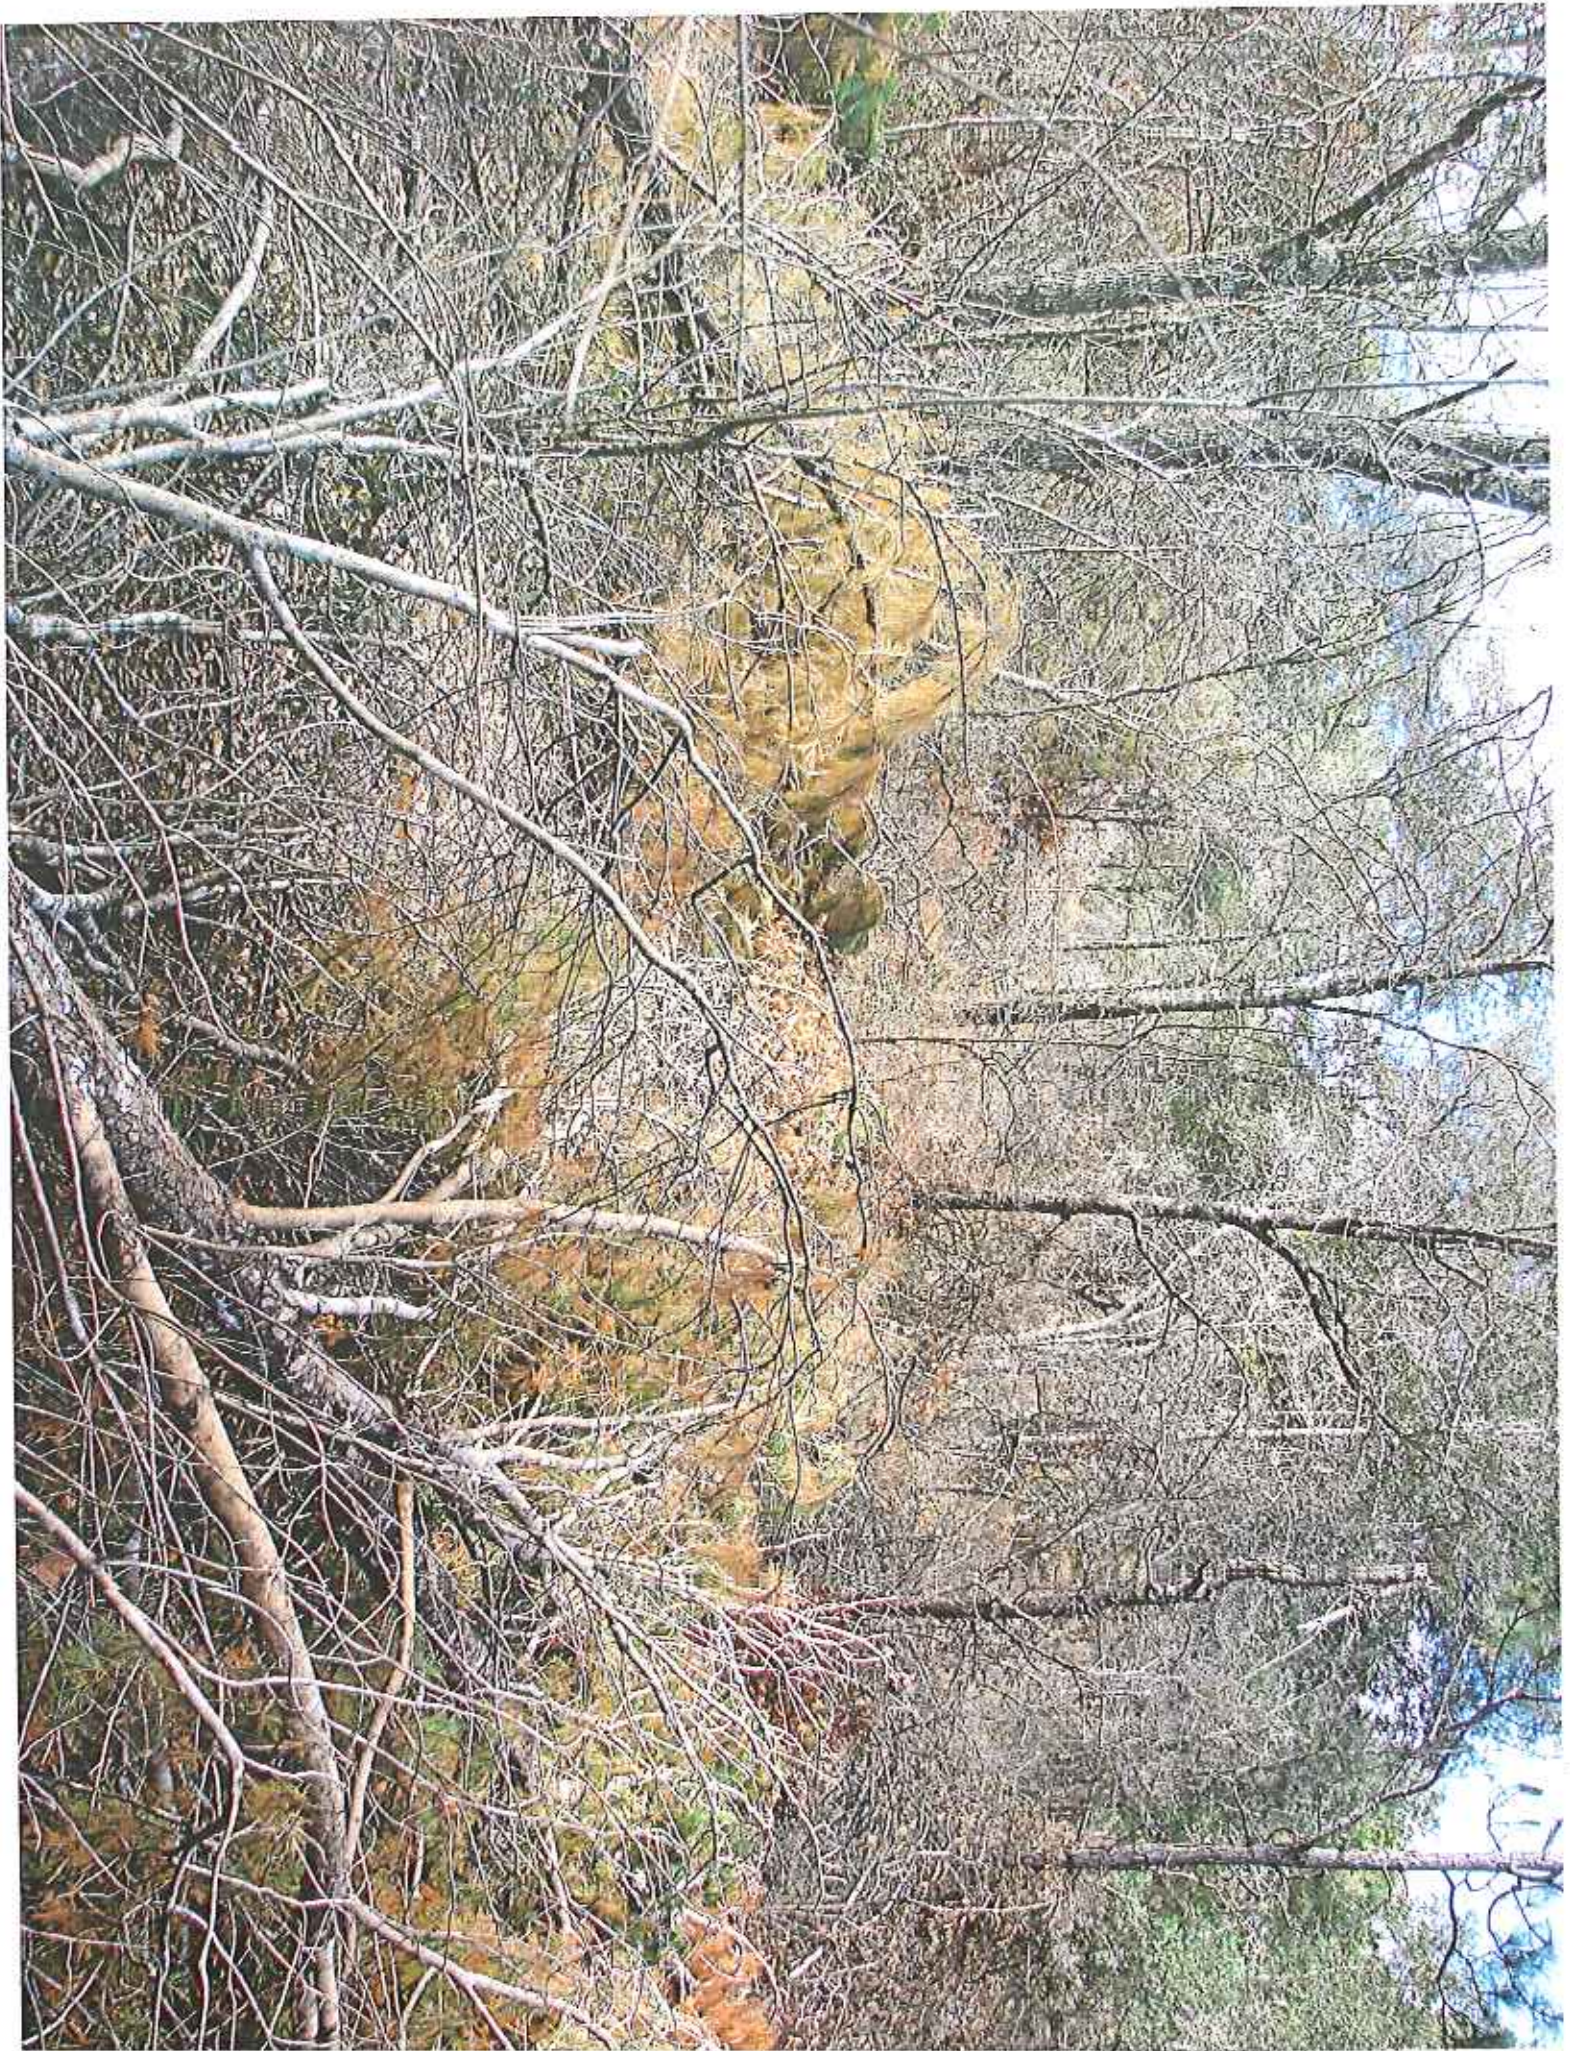
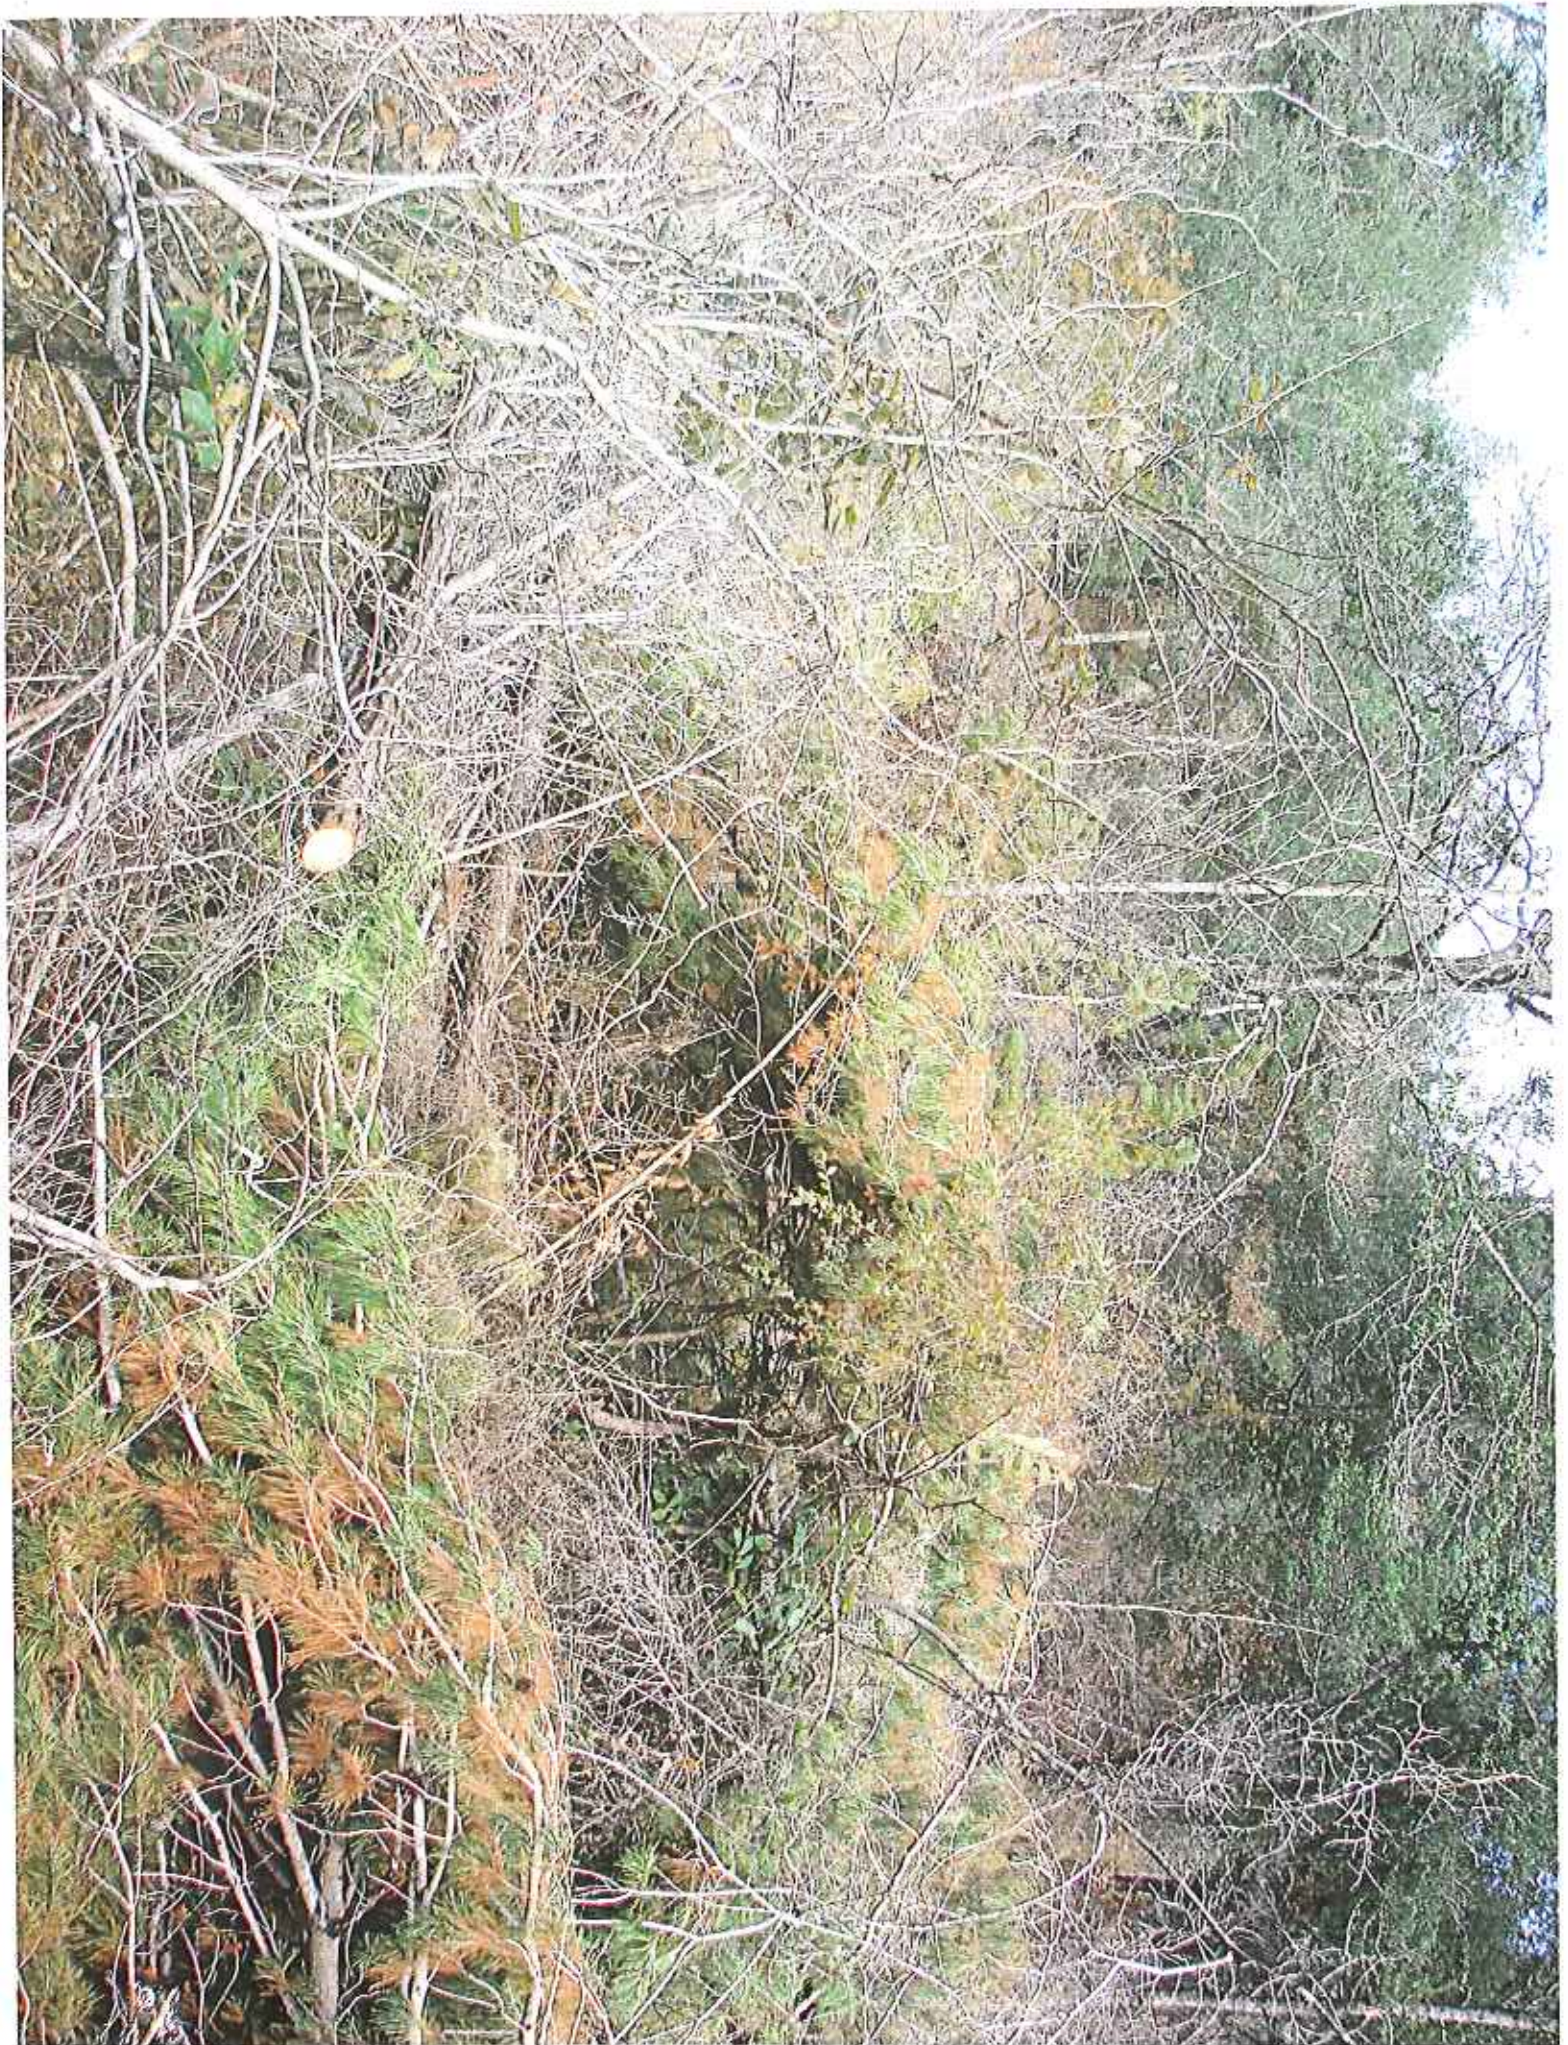
Appendix 4: Photos of thinned sand pine and oak trees in Management  
Unit 10

7. During September, hardwood and sand pines were cut and the stems treated with herbicide for 325 acres of Management Unit 10 (Exhibit Map 8) (Appendix 4). Wire grass cover within these areas had greatly increased following the initial burns and it was felt that these areas could be restored to a diverse sandhill community if the invading sand pines and hardwoods were removed. These areas will be burned during the winter of 2007/2008.
