First Annual Monitoring Report for the Yellow River Ranch (2007)
ACOE Permit No. SAJ-2000-02363 (IP-CP)

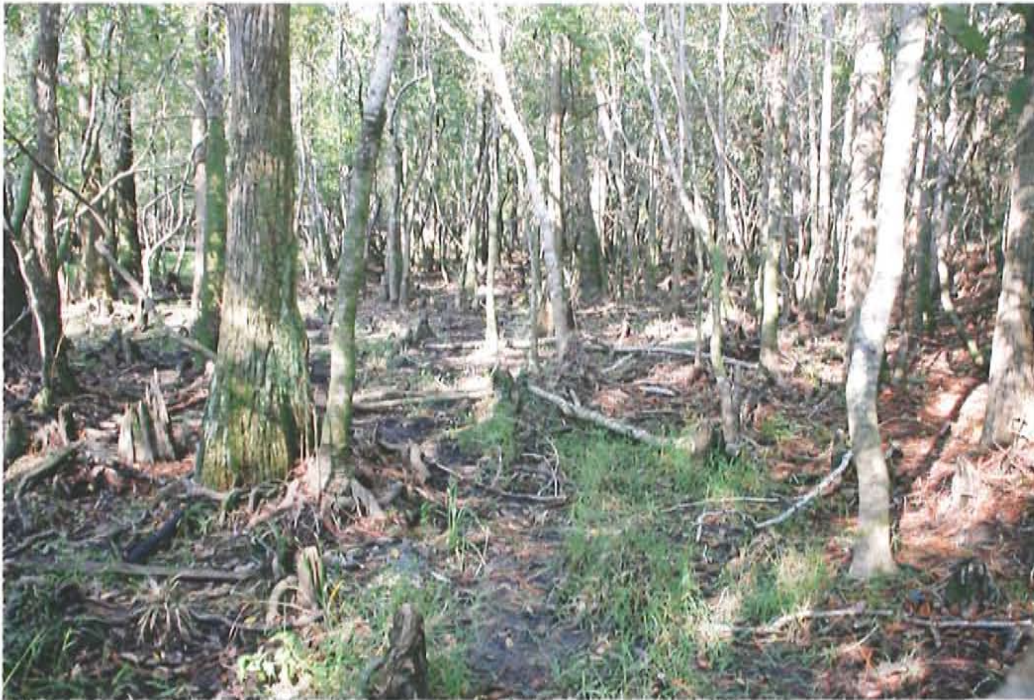
Figure 3. Bottomland hardwood floodplain forest

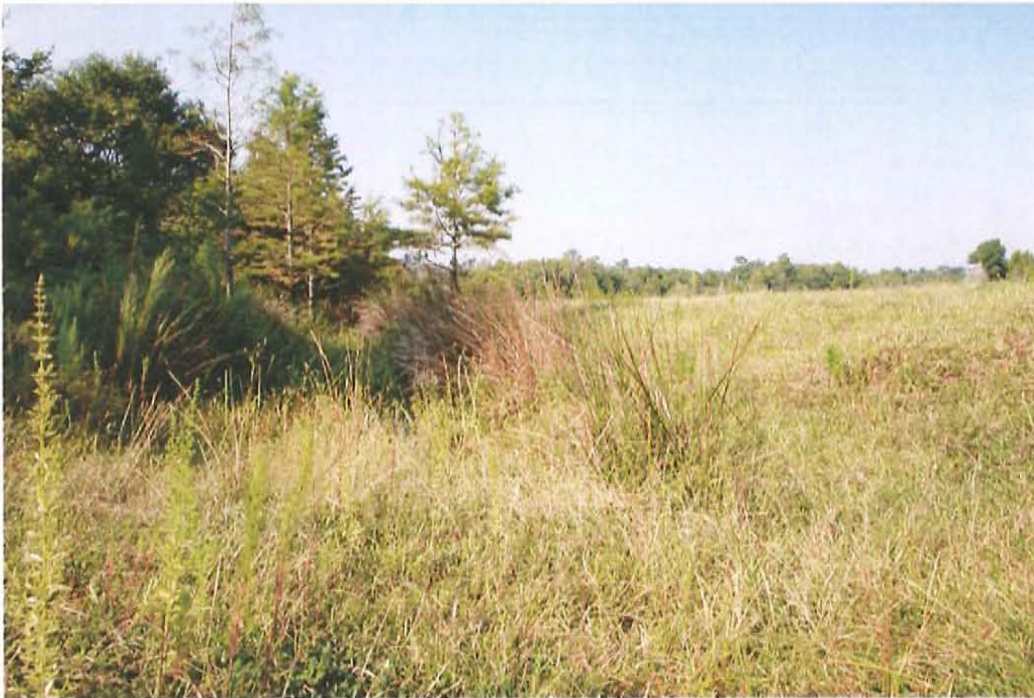
Figure 4. Edge of burn showing pasture grass and cypress

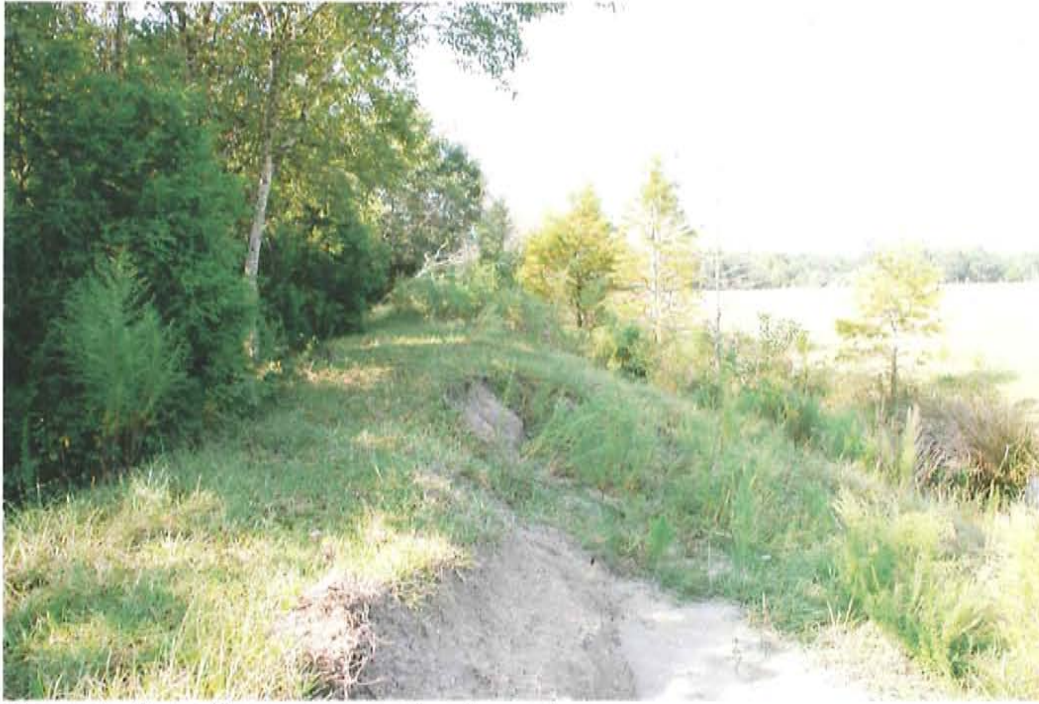
Figure 5. Top of berm surrounding the pasture

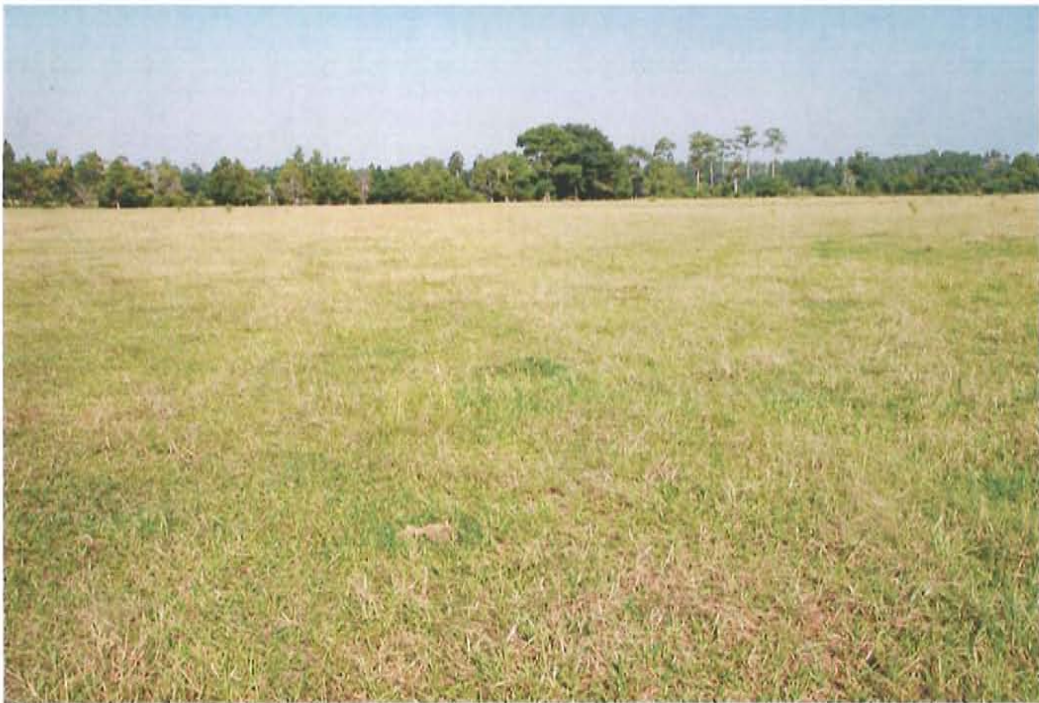
Figure 6. Pasture grasses in the interior of the property

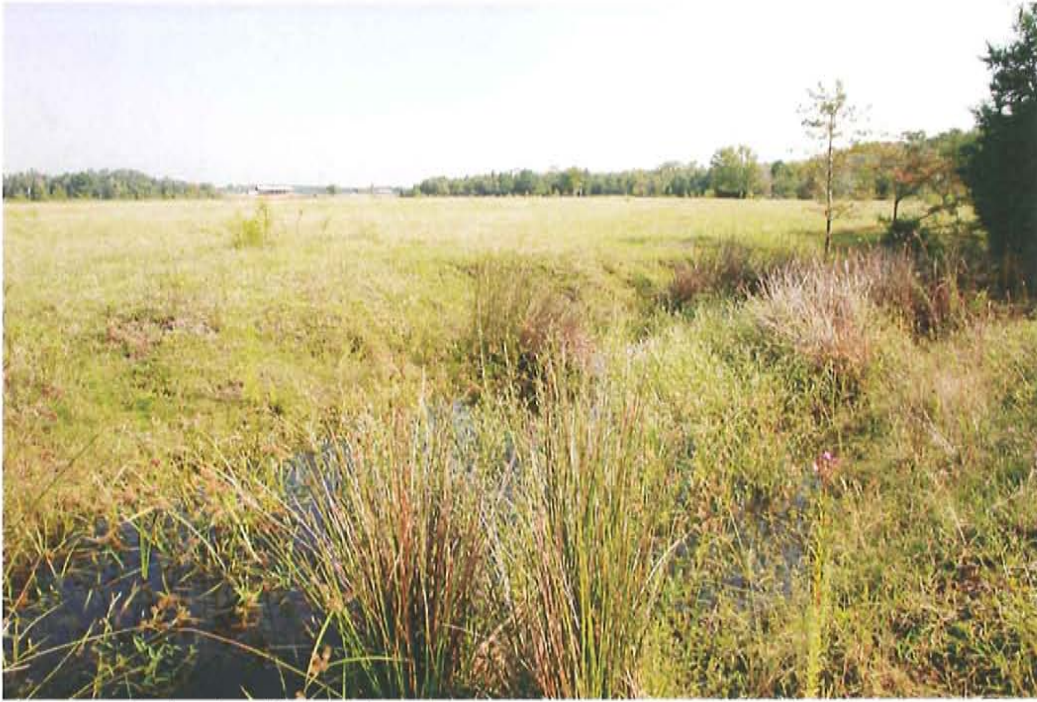
Figure 7. Perimeter ditch and pasture

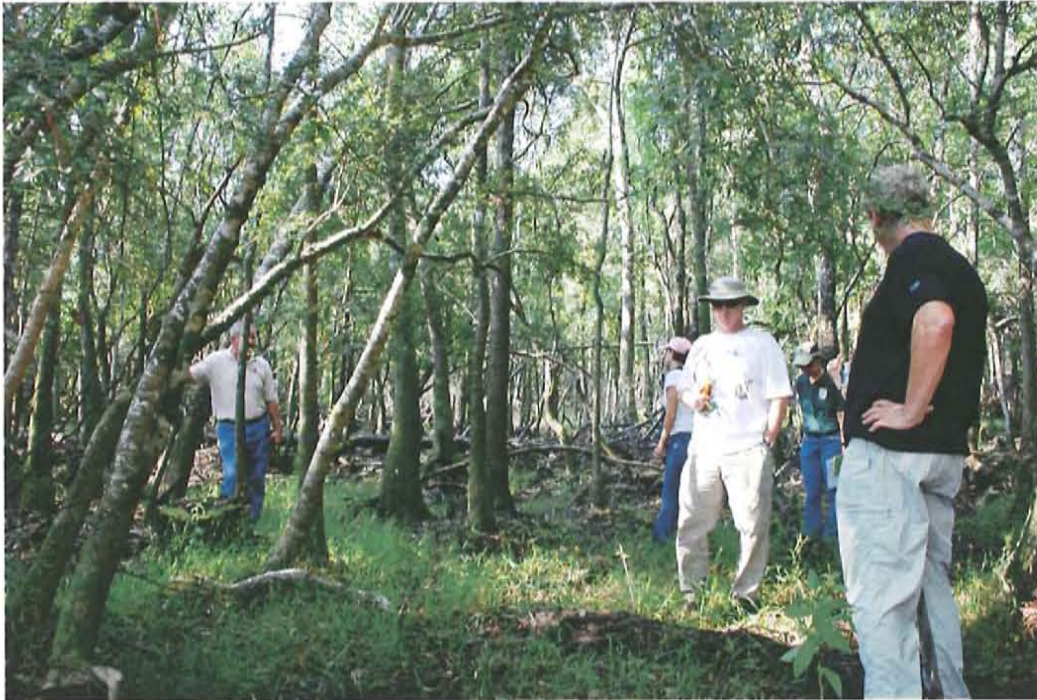
Figure 8. Bottomland floodplain forest under evaluation by MRT
