Doyle Creek – 2007 Monitoring
CORPS Permit No. SAJ-2004-706 (NW-TLZ)
[SR 65 Mitigation]

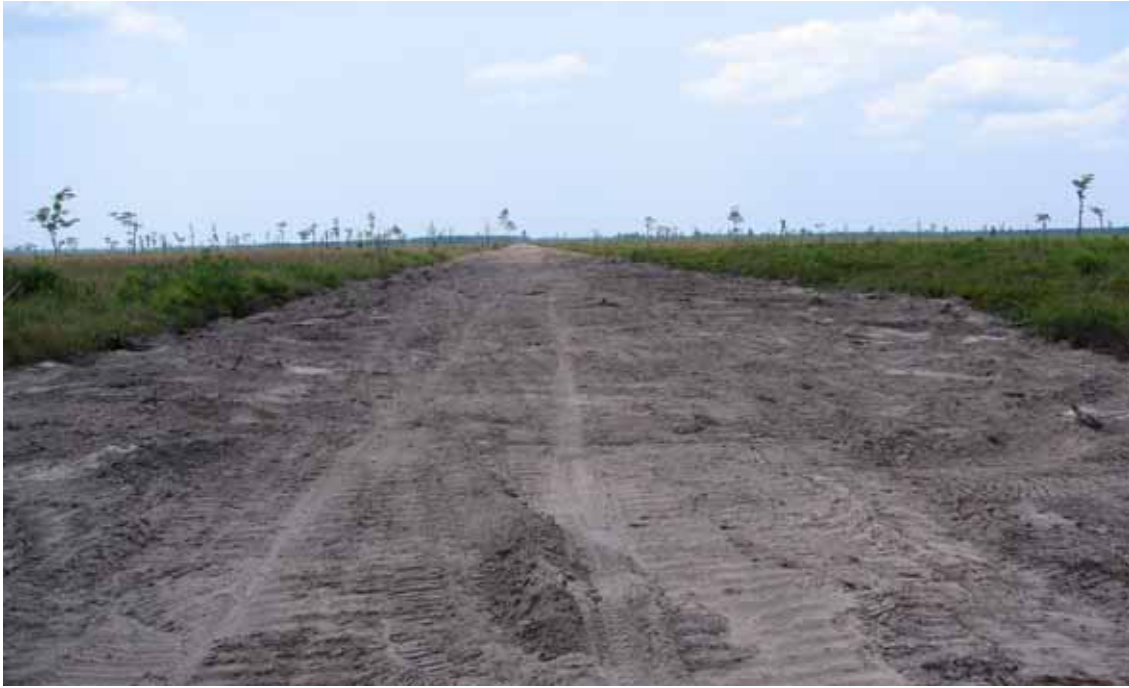
Figure 3. Road removal site #1 (westernmost road) after roadbed material was pushed into adjacent ditches and contoured to existing adjacent natural grade.

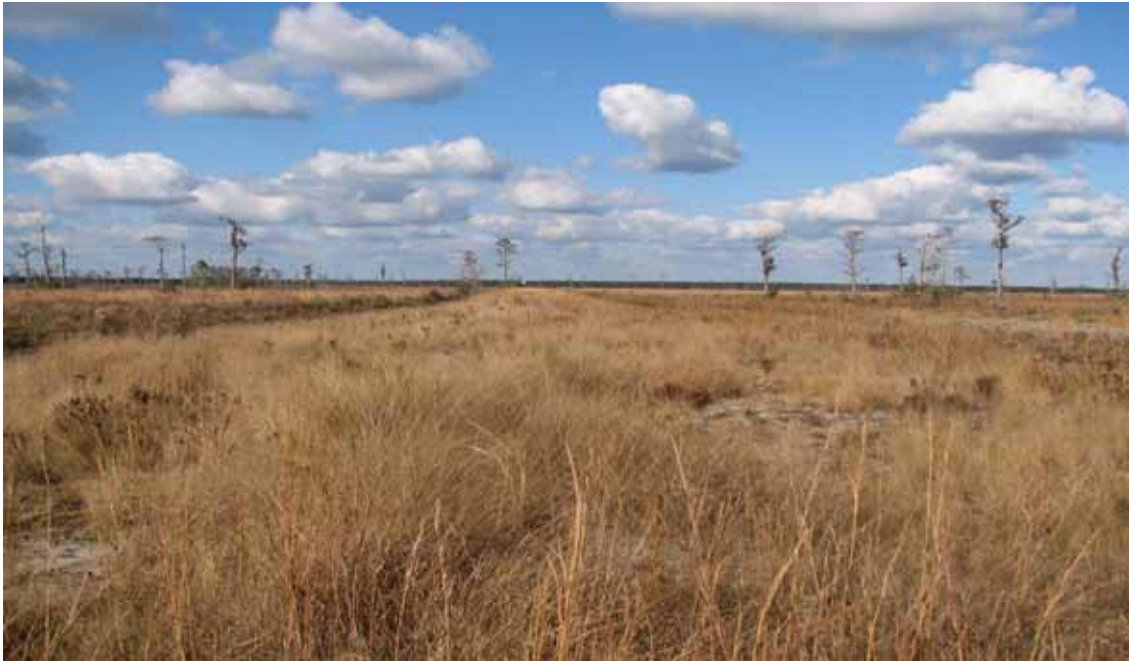
Prior to planting the roadbed sites were surveyed for existing vegetation on December 10, 2007 (see Figures 4 and 6). A 15-minute pedestrian survey was taken at each site; thirty-six plant species were observed at site #1 (Table 1) with 30 species noted at site #2 (Table 2). Native groundcover covered about 30-40% of both sites and no invasive or exotic species were observed. Evidence of wildlife usage (e.g., tracks, scat) at the sites is given at the bottom of each table.

Figure 4. Road removal site #1 (westernmost road) after natural recolonization of vegetation. Photograph was taken about 16 months after completion of construction and can be compared with that in Figure 3.

Wiregrass will be planted on 4-foot centers throughout the roadbed footprint beginning January 2008. Additional cypress seedlings will be planted in appropriate areas of the footprint.

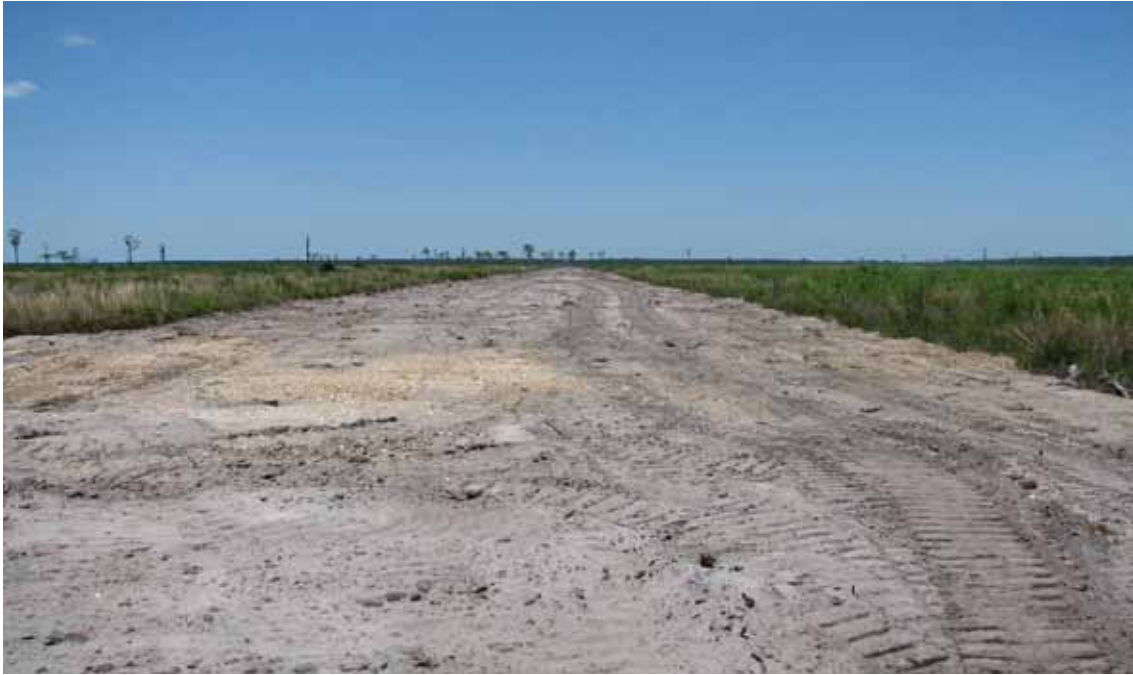
Figure 5. Road removal site #2 (easternmost road) after roadbed was pushed into adjacent ditches and contoured to existing adjacent natural grade.

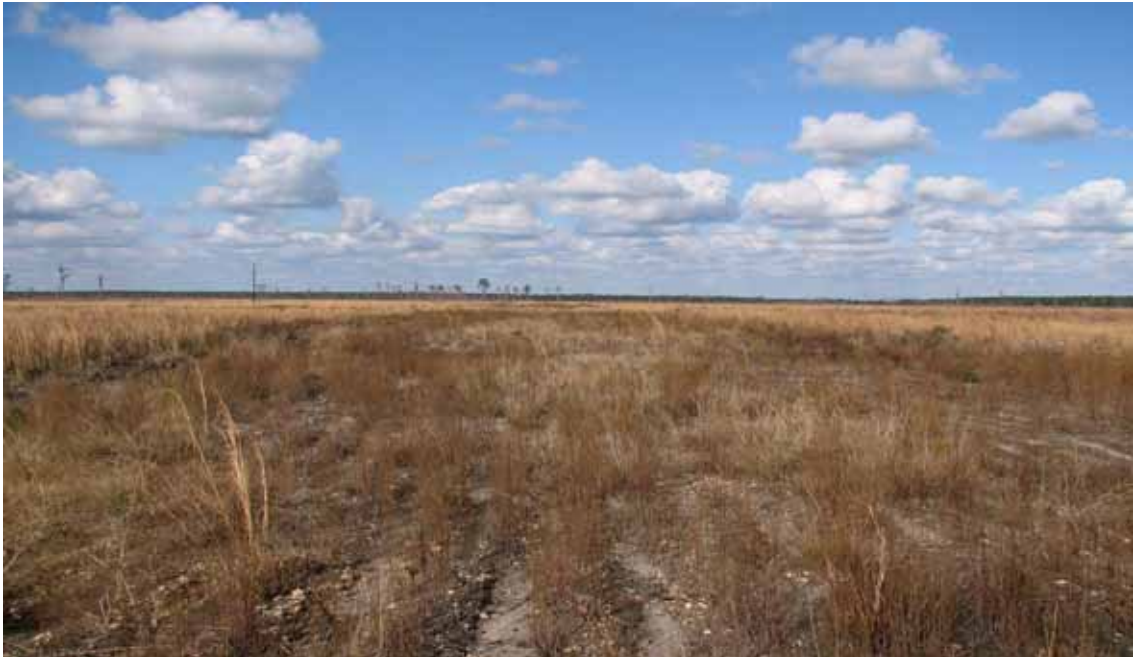
Figure 6. Road removal site #2 (easternmost road) after natural recolonization of vegetation. Photograph was taken about 16 months after completion of construction and can be compared with that in Figure 5.

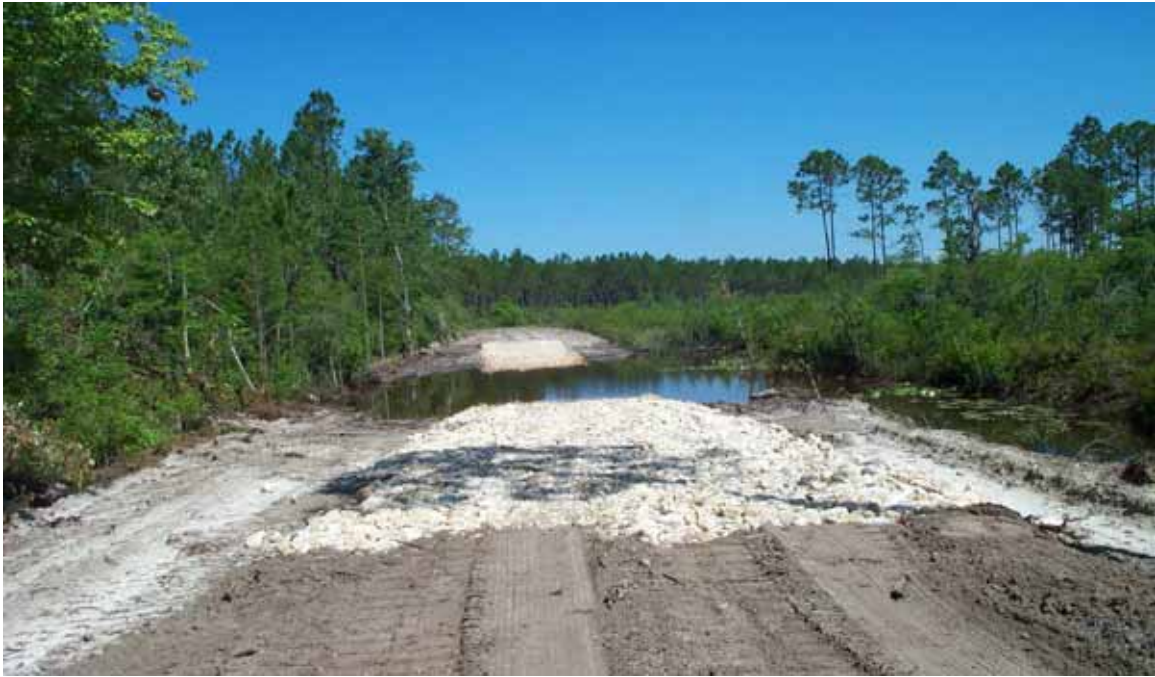
Figure 7. Hardened low-water crossing at site #4 after completion of construction. Water is flowing from right to left across the structure after a recent rain.
