Sand Hill Lakes Mitigation Bank

16th Semi-Annual Report

5/23/12

Permit No. 0227351-001

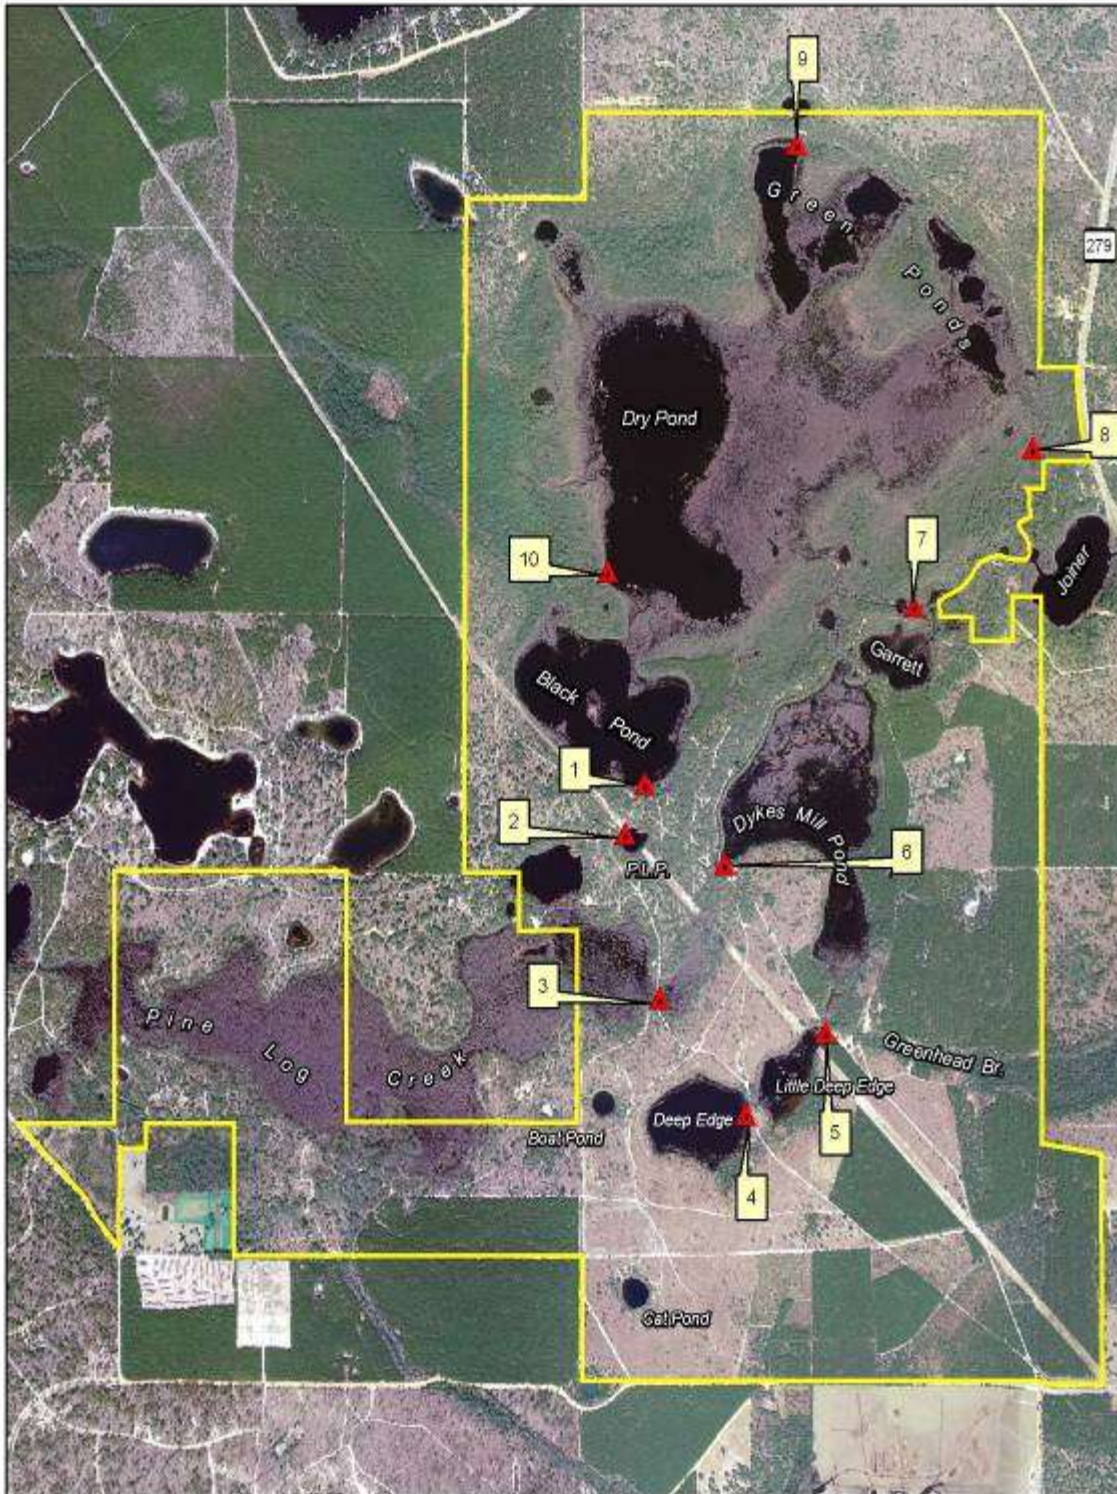
Figure 9 - Water Level Staff Gage Locations

2. Staff gauges were monitored from January to June in accordance with Specific Condition 25, Management and Maintenance, and Attachment H, Monitoring (Figure9).

3. In accordance with Specific Condition 8 (Protection and Preservation) and Attachment A, passive recreation as well as fishing and spring gobbler season continued at the SHLMB without incident. The water levels with the lakes remain low due to the continued drought. Most readings were below the staff gages and several of the Green Ponds, Power Line Pond and Garret pond are at near or total drawdown. Water levels continue to be monitored monthly and will be included in annual report (Figure9).

4. In accordance with Specific Condition 25 and Attachment H, Monitoring, Water Level gauges will continue to be measured for the remainder of 2012 (Figure 9).

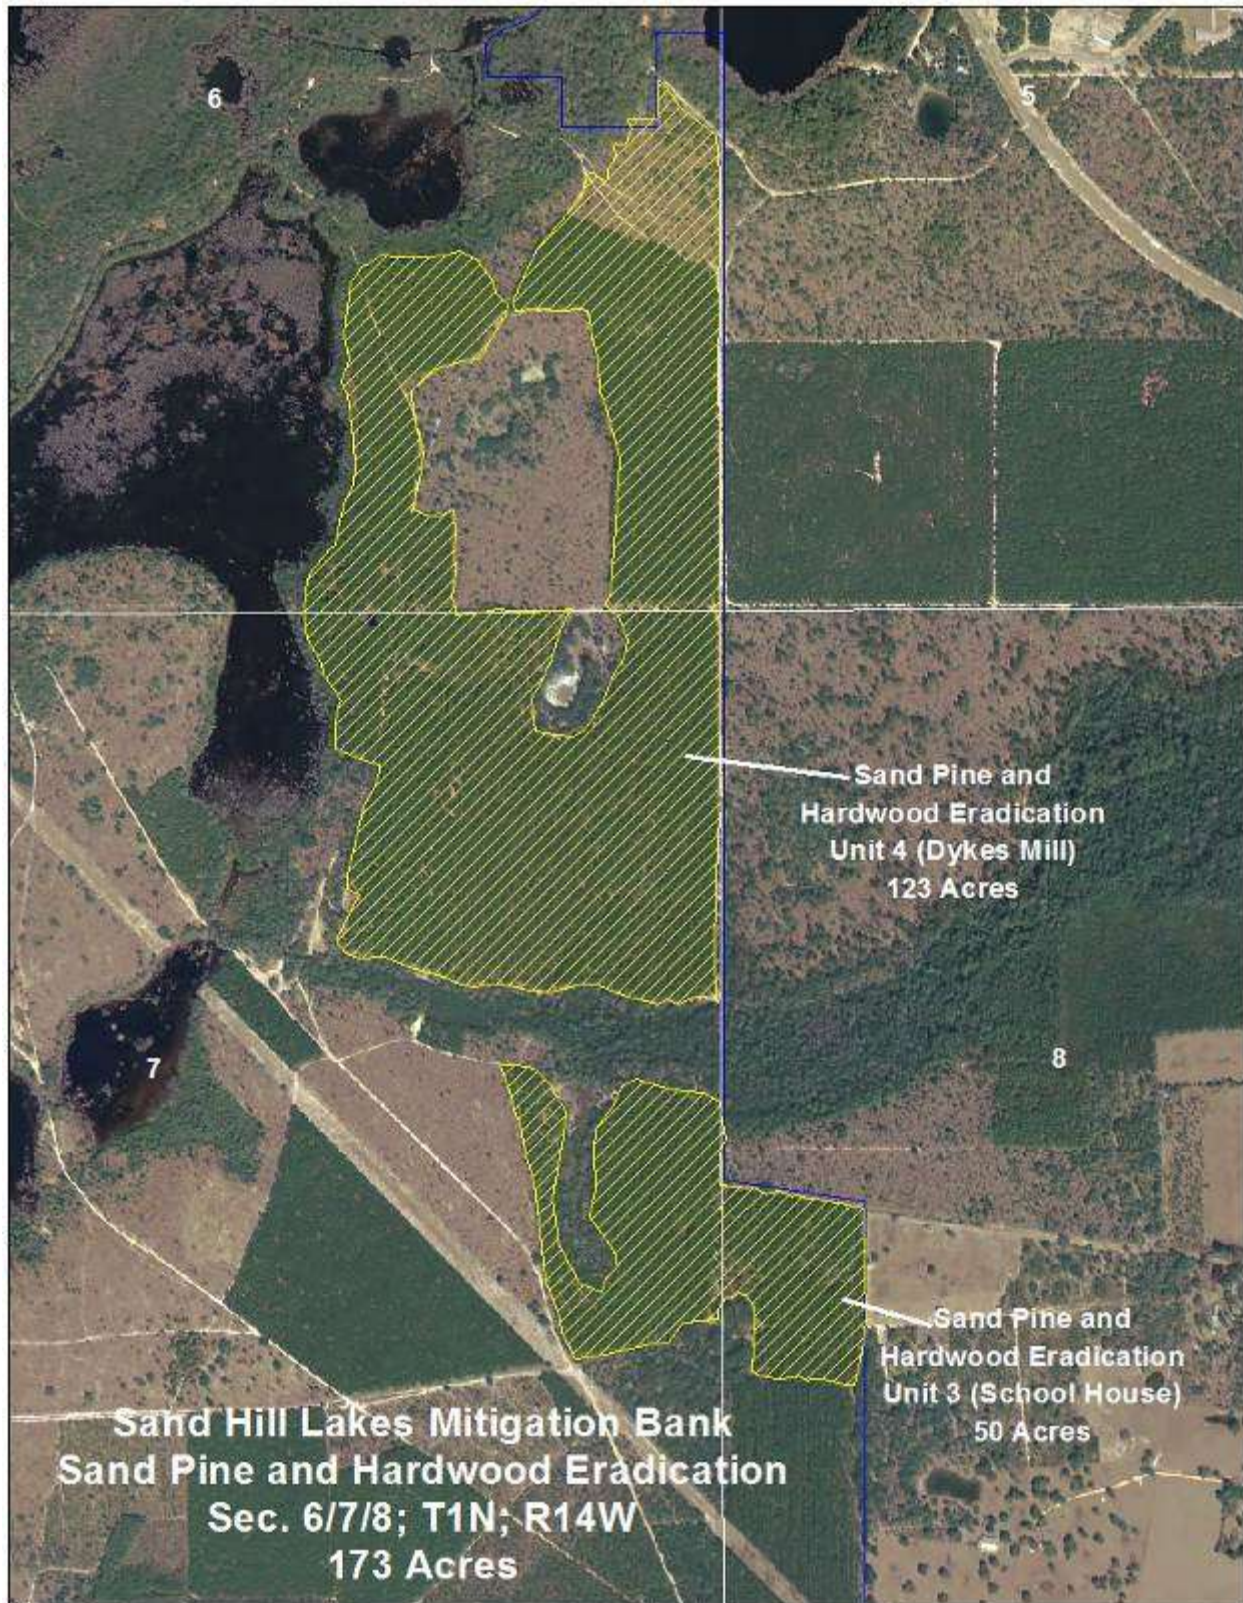
Figure 10. Sand Pine Reduction Areas (173 Acres)

6. In accordance with Specific Condition 10a (Community restoration), sand pine seedlings that emerged post sand pine harvest were eradicated within the 173 acres of former sand pine plantation that is currently being restored to sand hills. Site activities were initiated on April 20, 2012 and completed by April 27, 2012 (Figure 10).

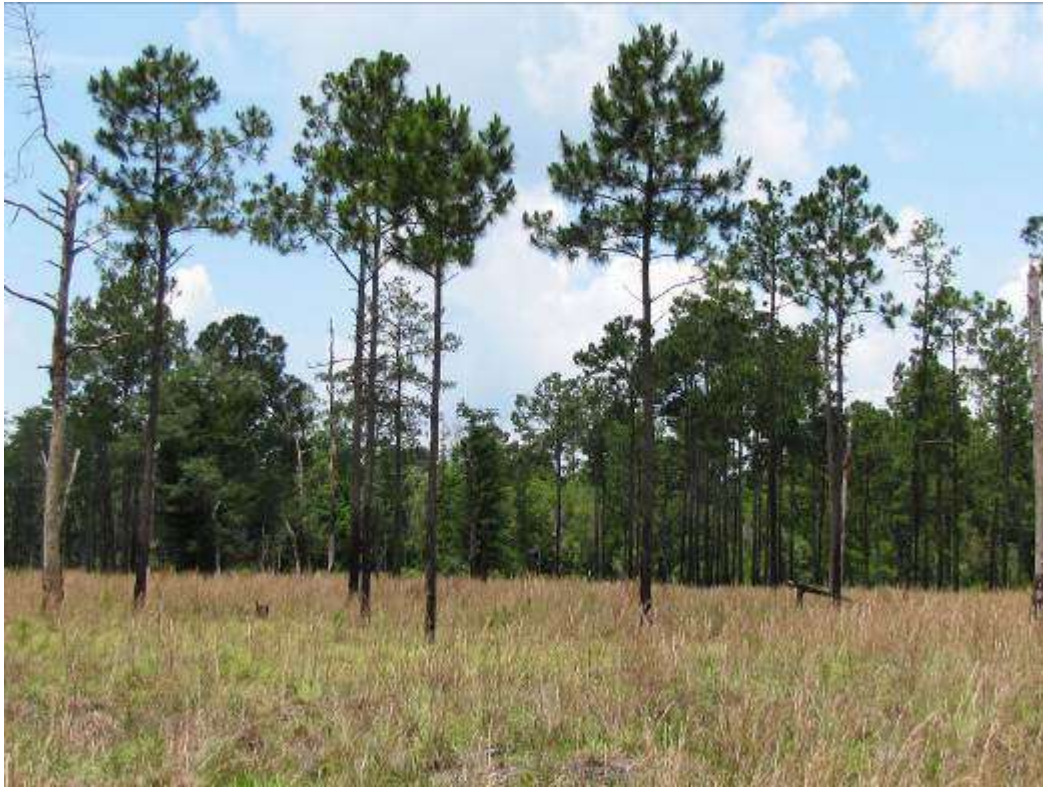
The Whale near Dry Pond: Hydric Pine Flatwoods Restoration (05/23/12)

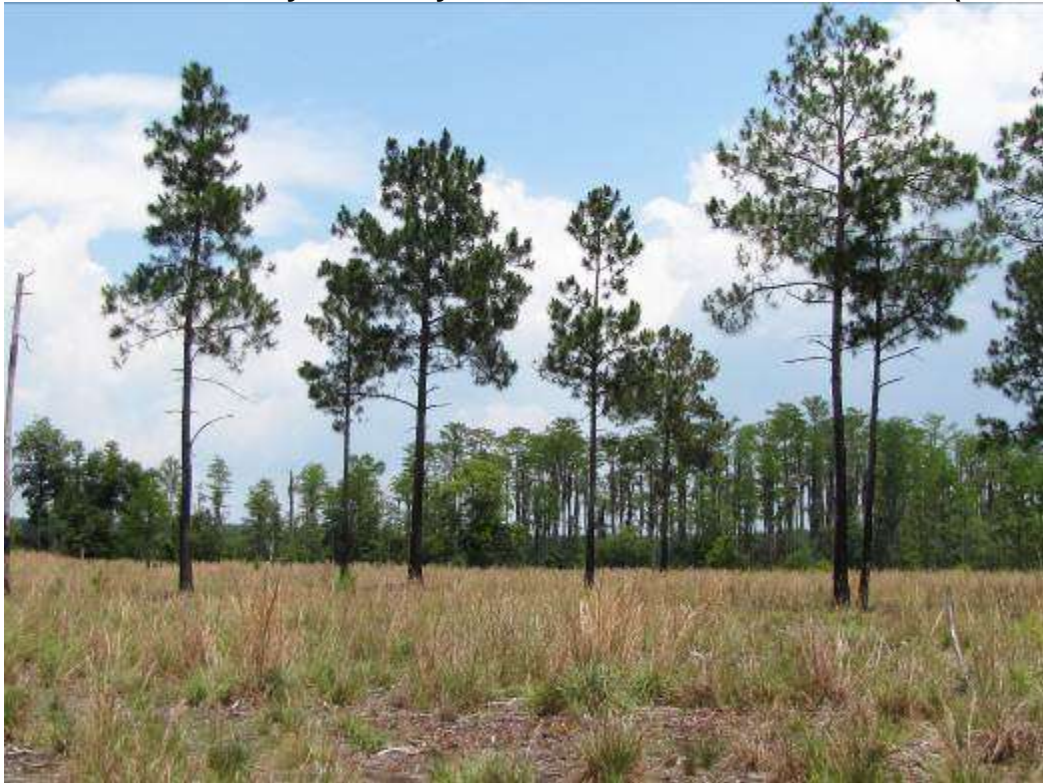
Hydric Pine back side of Dry Pond Flatwoods Restoration (05/23/12)

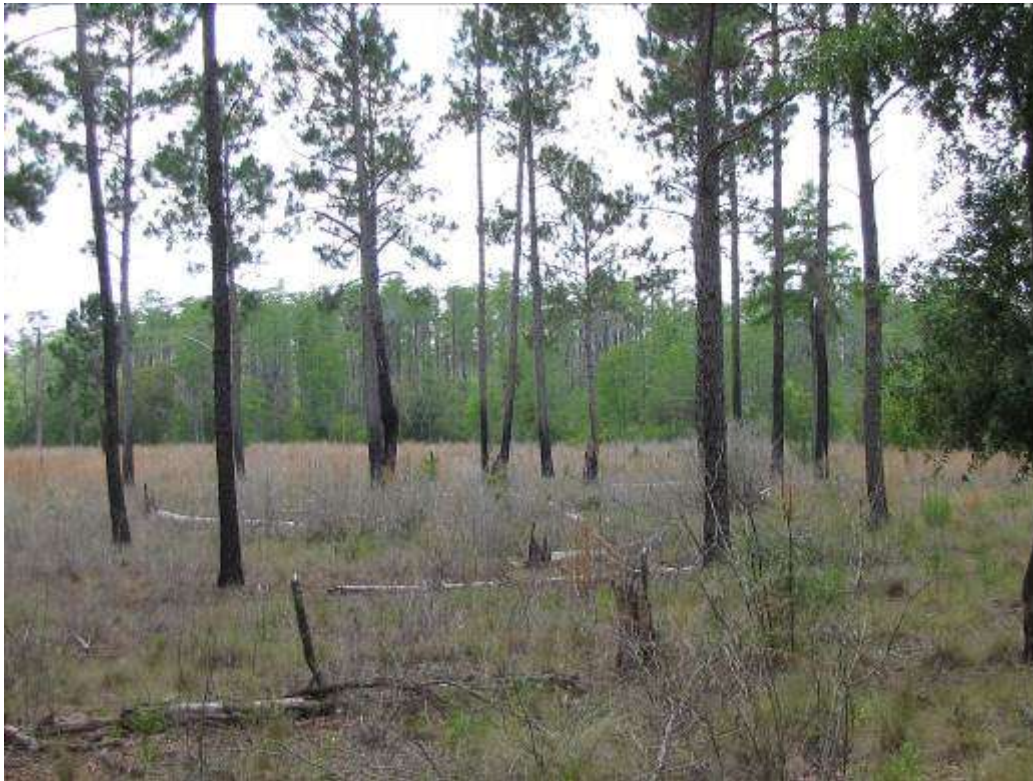
Hydric Pine Flatwoods Restoration, 5 acre, adjacent to Green Ponds: 5/23/12

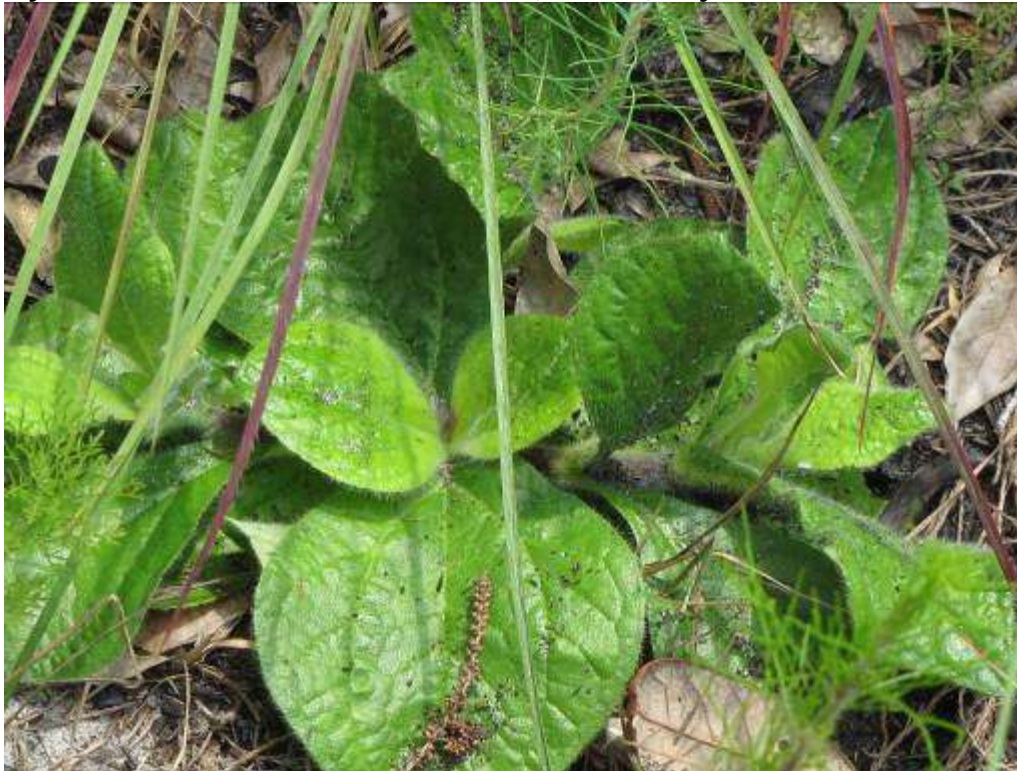
Rayless Sunflower 5 months post planting (*Helianthus radula*) 5/23/12

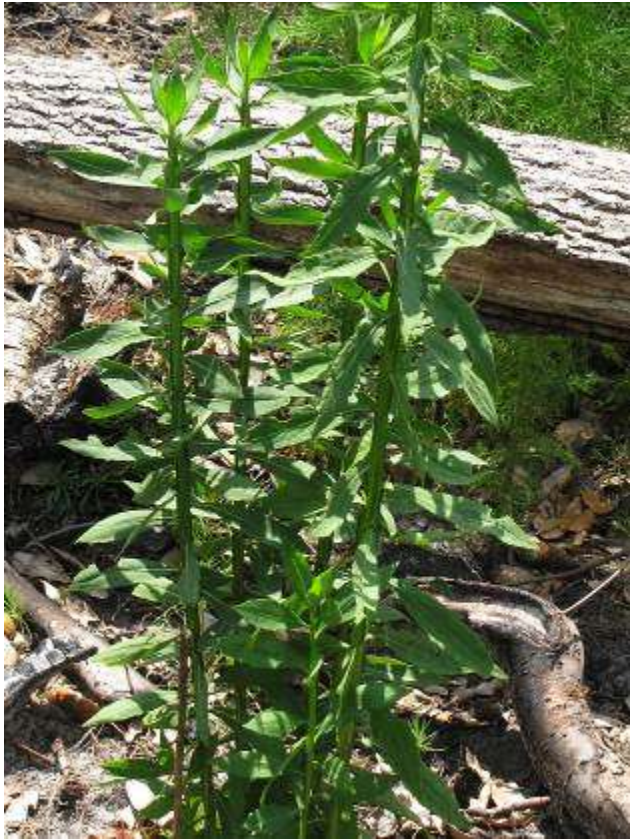
Sneezeweed 5 months post planting, 24" (*Helenium autumnale*) 5/23/12

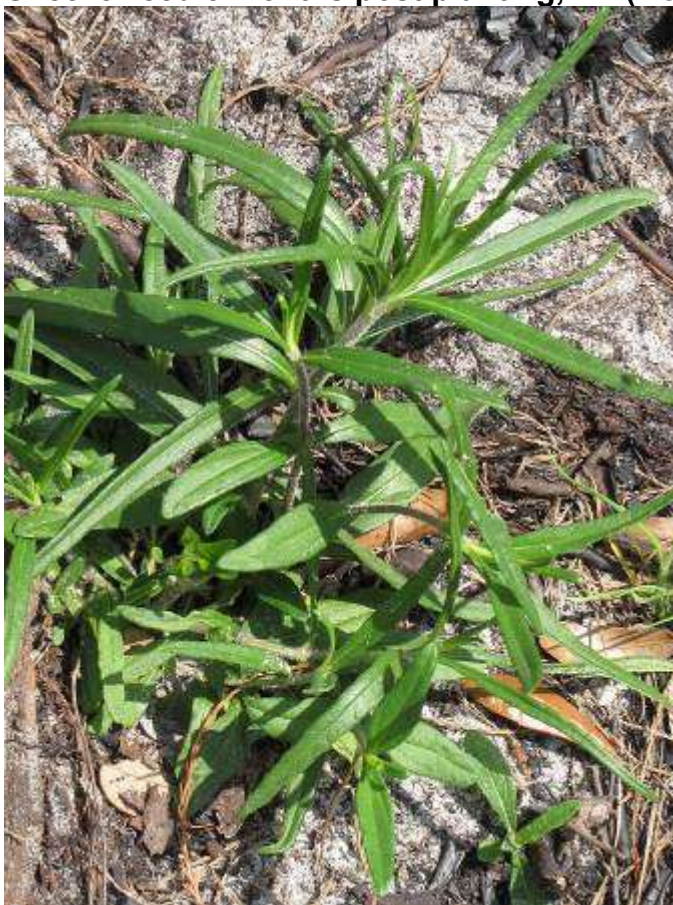
Variable leaved sunflower 5 months post planting, 12" (*Helianthus heterophyllus*) 5/23/12

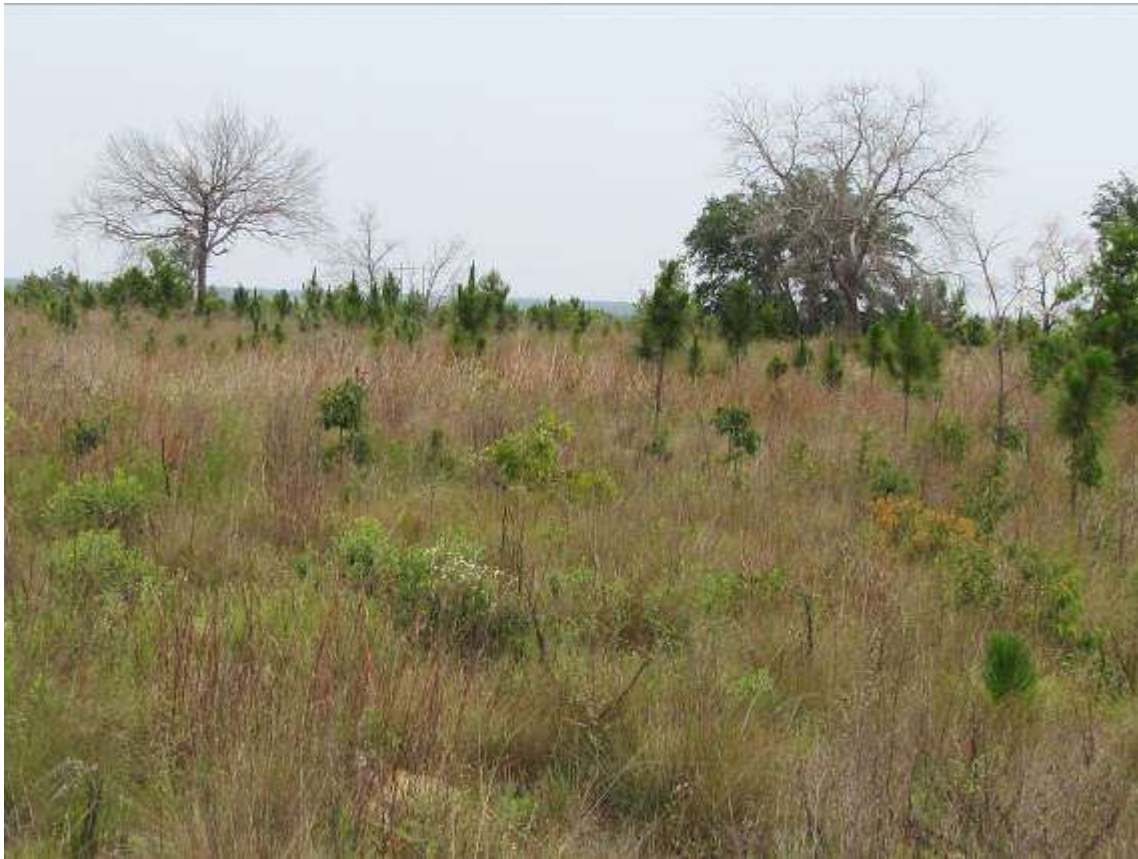
Sandhill restoration: Slash pine plantation to Sandhill

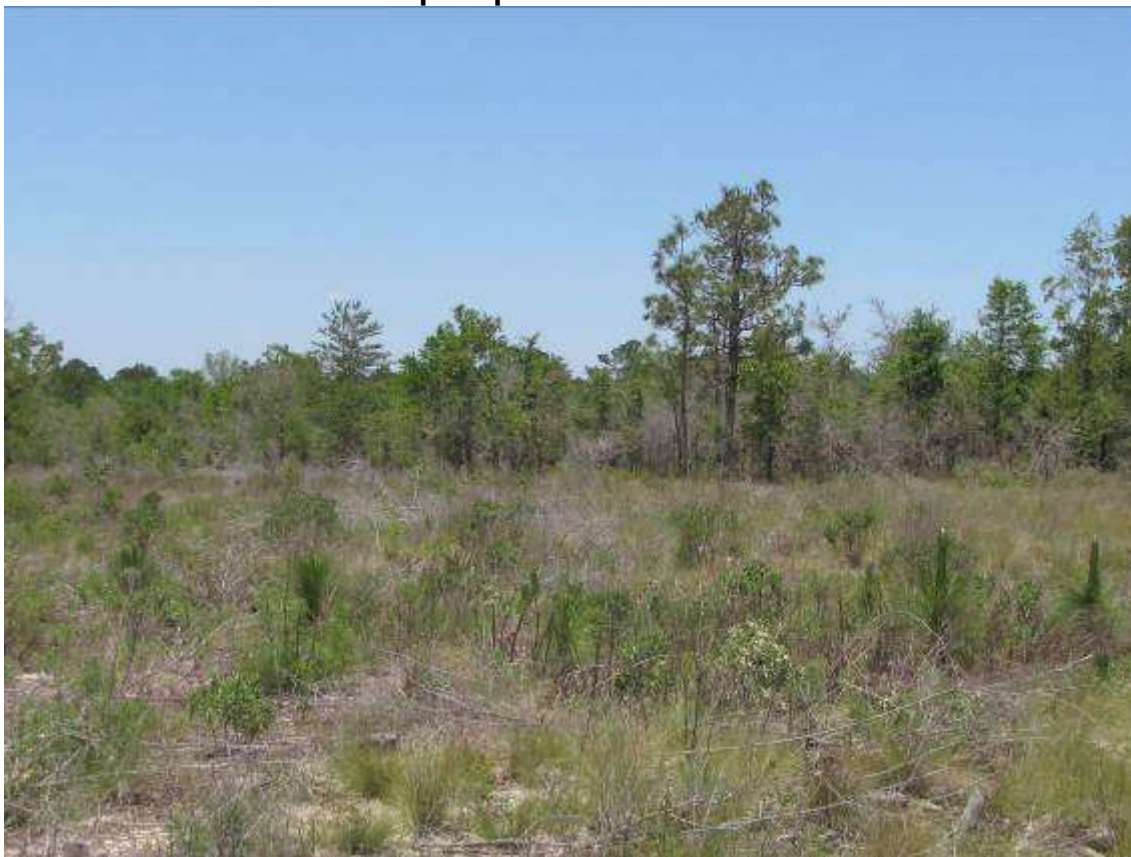
Seedling Sand Pine Removal, Sandhill Restoration 4/2712
