## Northwest Florida Water Management District

Re: Progress Report 19

Please accept this submittal as the 19th semi-annual progress report for the SHLMB. This report was written in accordance with Specific Condition 27.

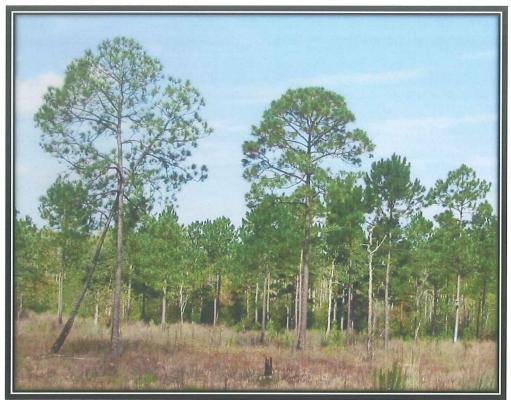
Figure 2. 08-22-13. Facing North. 16 acre hydric pine flatwoods restoration backside of Dry Pond.

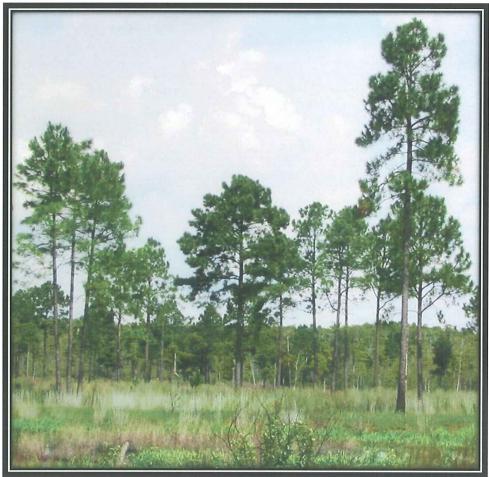
Figure 3. 09-15-13. Facing Northwest. 38 acre hydric pine flatwoods restoration, adjacent to pine log channel

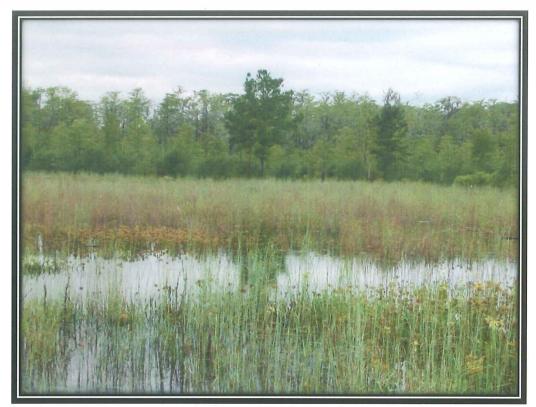
Figure 4. 08-22-13. Facing South. 16 acre hydric pine flatwoods restoration (Peninsula)

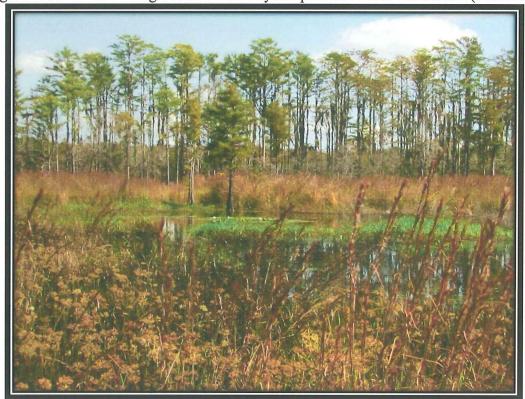
Figure 5. 08-22-13. Facing East. 12 acre hydric pine flatwoods restoration (Whale)

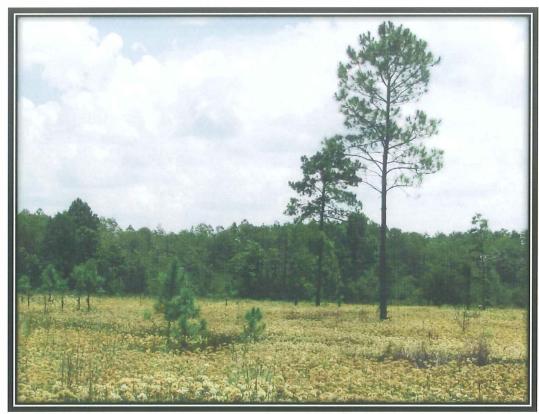
Figure 6. 08-22-13. Facing South. 16 acre hydric pine flatwoods restoration (Peninsula)

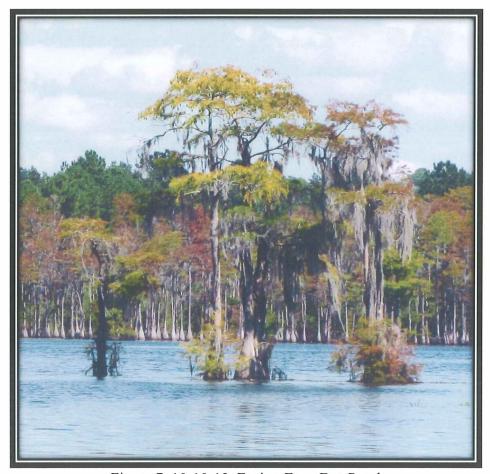
Figure 7. 10-10-13. Facing East. Dry Pond

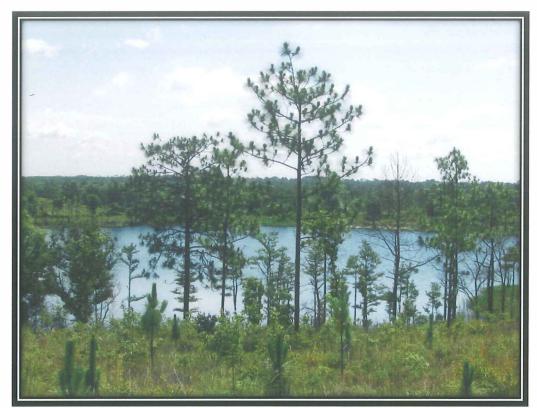
Figure 8. 06-19-13. Facing EastDeep Edge Pond

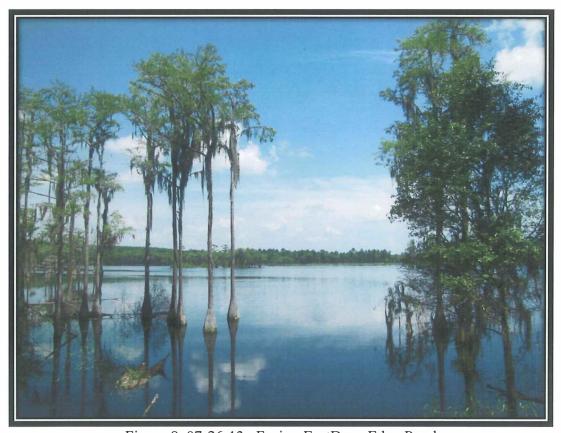
Figure 9. 07-26-13. Facing EastDeep Edge Pond

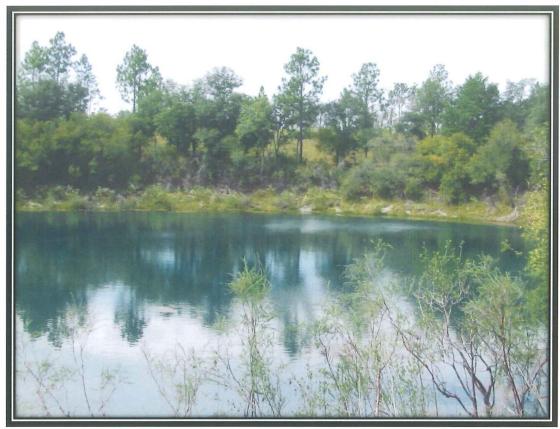
Figure 10. 09-17-13 Facing West. Cat Pond

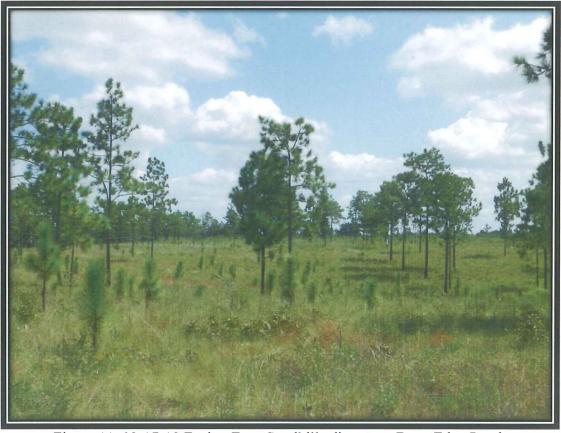
Figure 11. 09-17-13 Facing East. Sandhill adjacent to Deep Edge Pond.
