**NORTHWEST
FLORIDA
WATER
MANAGEMENT
DISTRICT**

EASTPOINT REGIONAL STORMWATER MANAGEMENT SYSTEMS FRANKLIN COUNTY, FLORIDA

FINAL REPORT – TFR 08-01

Florida Department of Environmental Protection Contract Number G0160

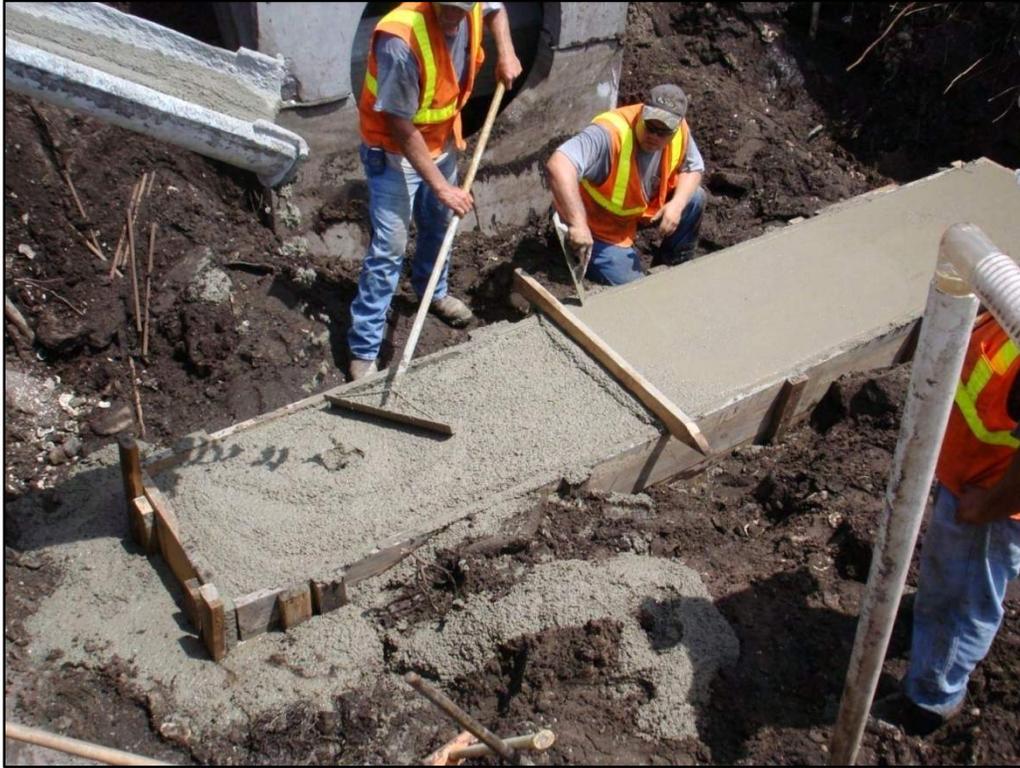
damaged and required replacement. The contractor did not encounter any problems during excavation and placement of the box (Figure 8). When the box was in place, the headwall was formed and poured in place (Figure 9). After the headwall replacement, the site was

Figure 9: Site 1 - Headwall Replacement

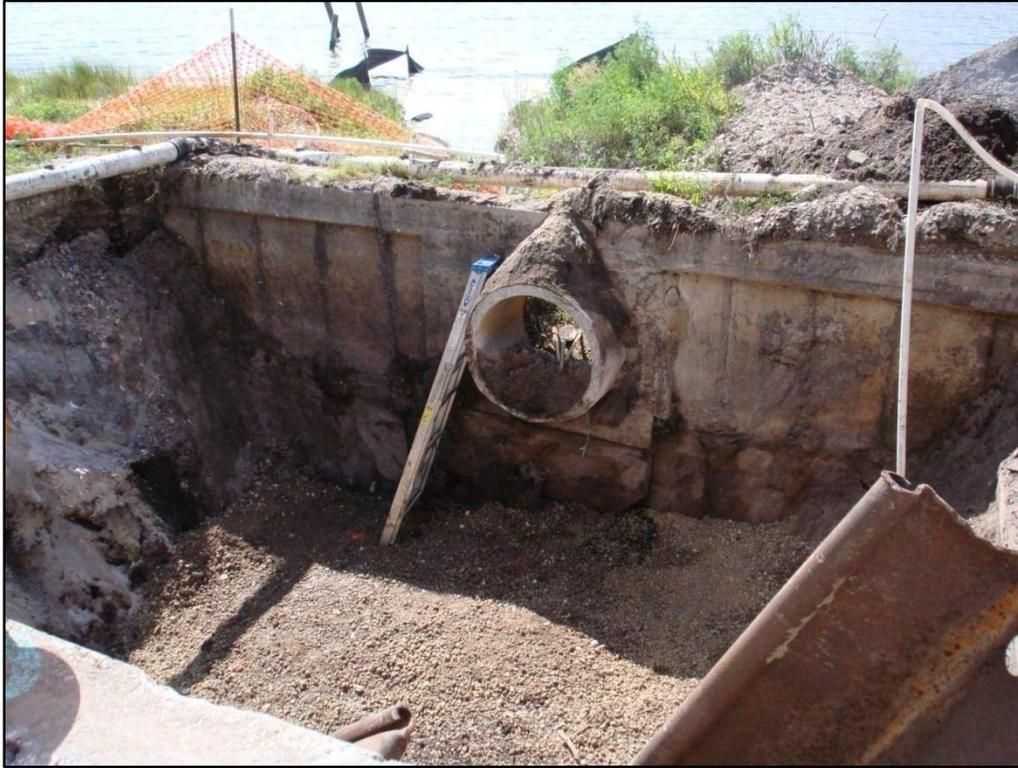
Figure 12: Site 2 – Protective Seawall

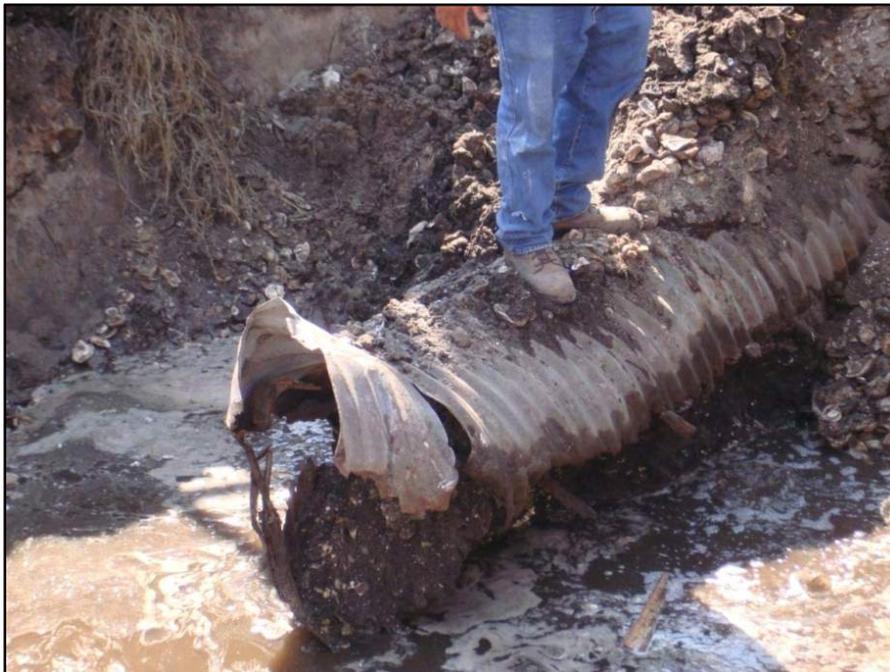
baffle box and the shoreline was a corrugated metal pipe. When the hole was excavated and the drainage pipe uncovered it was found to be rusted away on the bottom due to exposure to salt water and required replacement (Figure 26). Replacement of this 80 feet length of pipe was unexpected and a change order was executed with the contractor for the replacement of the pipe. Franklin County had 80 feet of the proper size ADS plastic pipe (30-inch diameter) that they provided at no charge (Figure 27).

Figure 26: Site 4 – Rusted Existing Culvert

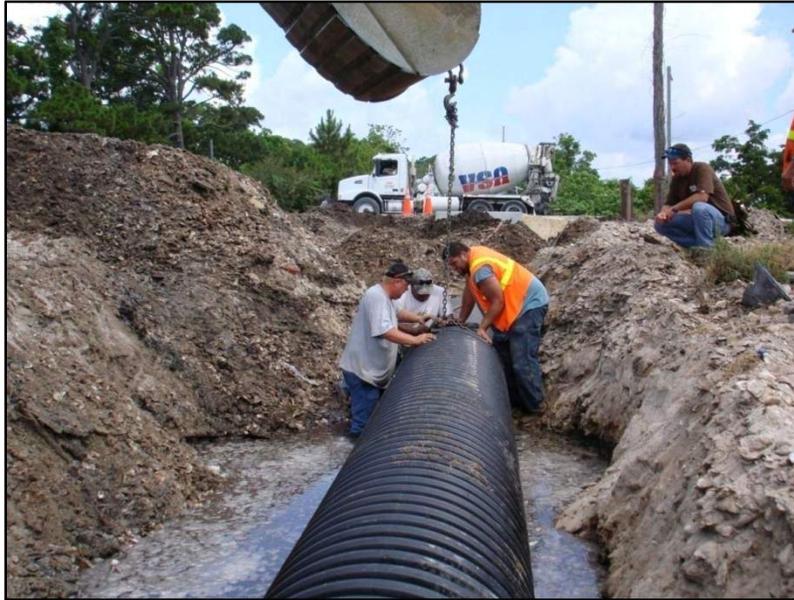
Figure 27: Site 4 – Pipe Replacement

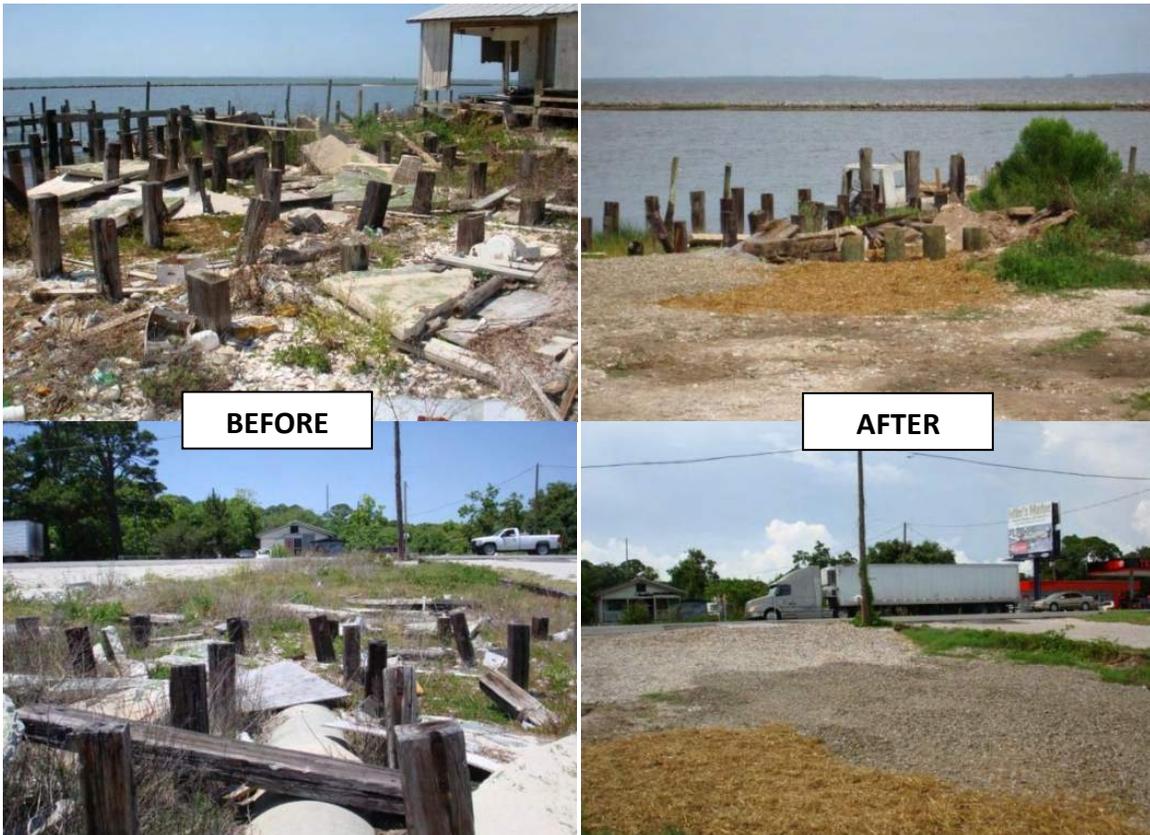
The shoreline area was covered with concrete rubble and debris from Hurricane Dennis storm surge damage prior to construction. After the installation of the baffle box and new drainage pipe, the site was cleaned and graded (Figure 28). Oyster shell was used to dress the site after

Figure 28: Site 4 – Site Cleaning and Stabilization

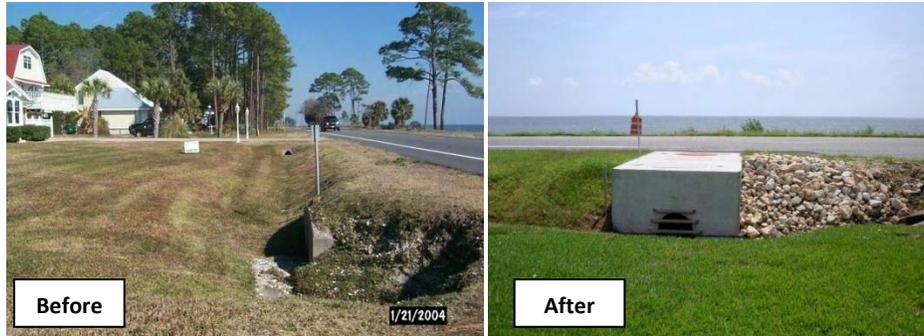
smaller crane to set than the larger boxes. It was placed on 05/08/08 (Figures 44 and 45). Final grading and sod replacement were completed on 05/09/08. The south bank of the swale ditch west of the baffle box had a very steep slope and significant erosion prior to the start of construction. In addition, there is a cross drain pipe flowing into the ditch from the west under 7th Street. Due to these conditions, limestone riprap rock was used to dress the slope on the ditch west of the structure. The riprap will provide long term stability for the bank and allow the cross drain to function properly without scouring the bank or channel bottom. The property owners are pleased with the completed installation and feel it is a significant improvement over the previous condition (Figure 46).

Figure 46: Site 7 – Bank Stabilization
