LIVE OAK POINT LIVING SHORELINES

2022 (Spring) Reference Site Monitoring Report

USACE Permit No.: SAJ-2011-00287

Project Location: Live Oak Point Salt Marsh Reference Site
30.42° North, -86.27° West
Approximately 2 ½ Miles NW of Santa Rosa Beach
Walton County, Florida

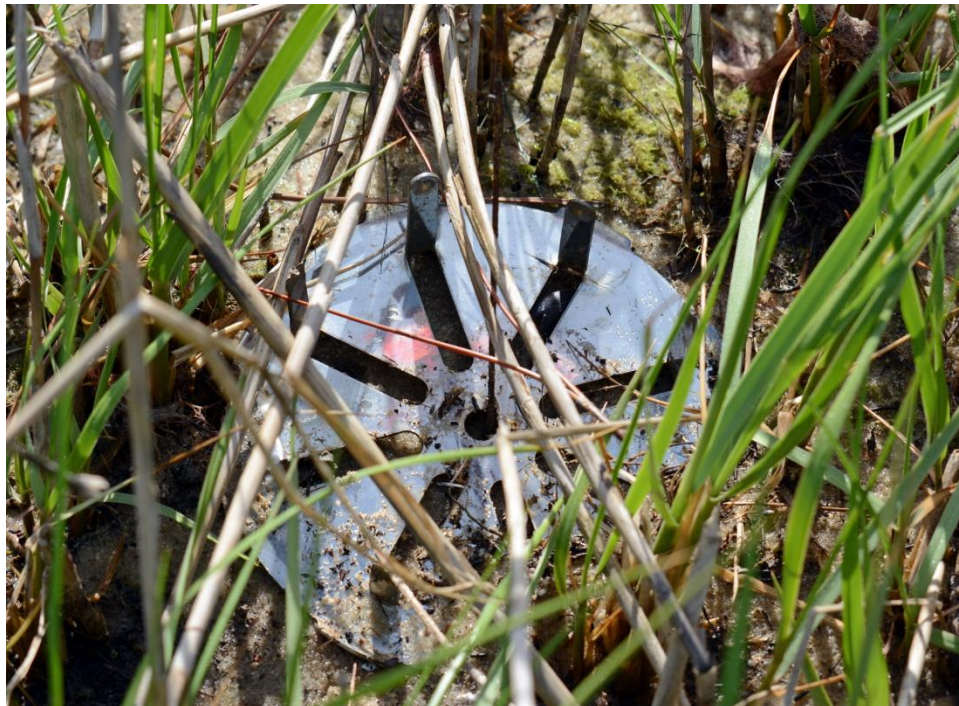
Two sediment accretion monitoring points were established in the mid marsh zone at the reference site on 6/14/2021. Each consisted of a 4-inch diameter circular plate set below the surface. Plate A was set 25.4 mm below the surface, whereas Plate B was set 50.8 mm below the surface. Initial measurements on 10/21/2021 indicated that sediment accretion was exceeding sea level rise (estimated by National Oceanic and Atmospheric Administration for the Panama City area at 2.29 mm per year). However, the 3/21/2022 inspection revealed that the sediment plates were completely exposed from erosion, apparently caused by winter storm activity. These plates will be reinstalled at a greater depth below surface and monitoring will resume.

Figure 20. Reference Site Monitoring (Sediment Plate Exposed from Erosion) – 3/21/2022
