Sand Hill Lakes Mitigation Bank Combined DEP/USACE Sixteenth Annual Report

FDEP Permit # 0227351-001 Issued 9/6/2005, Washington County

**Northwest Florida Water Management District
Submitted by David Clayton
In support of Specific Conditions 26 and 28**

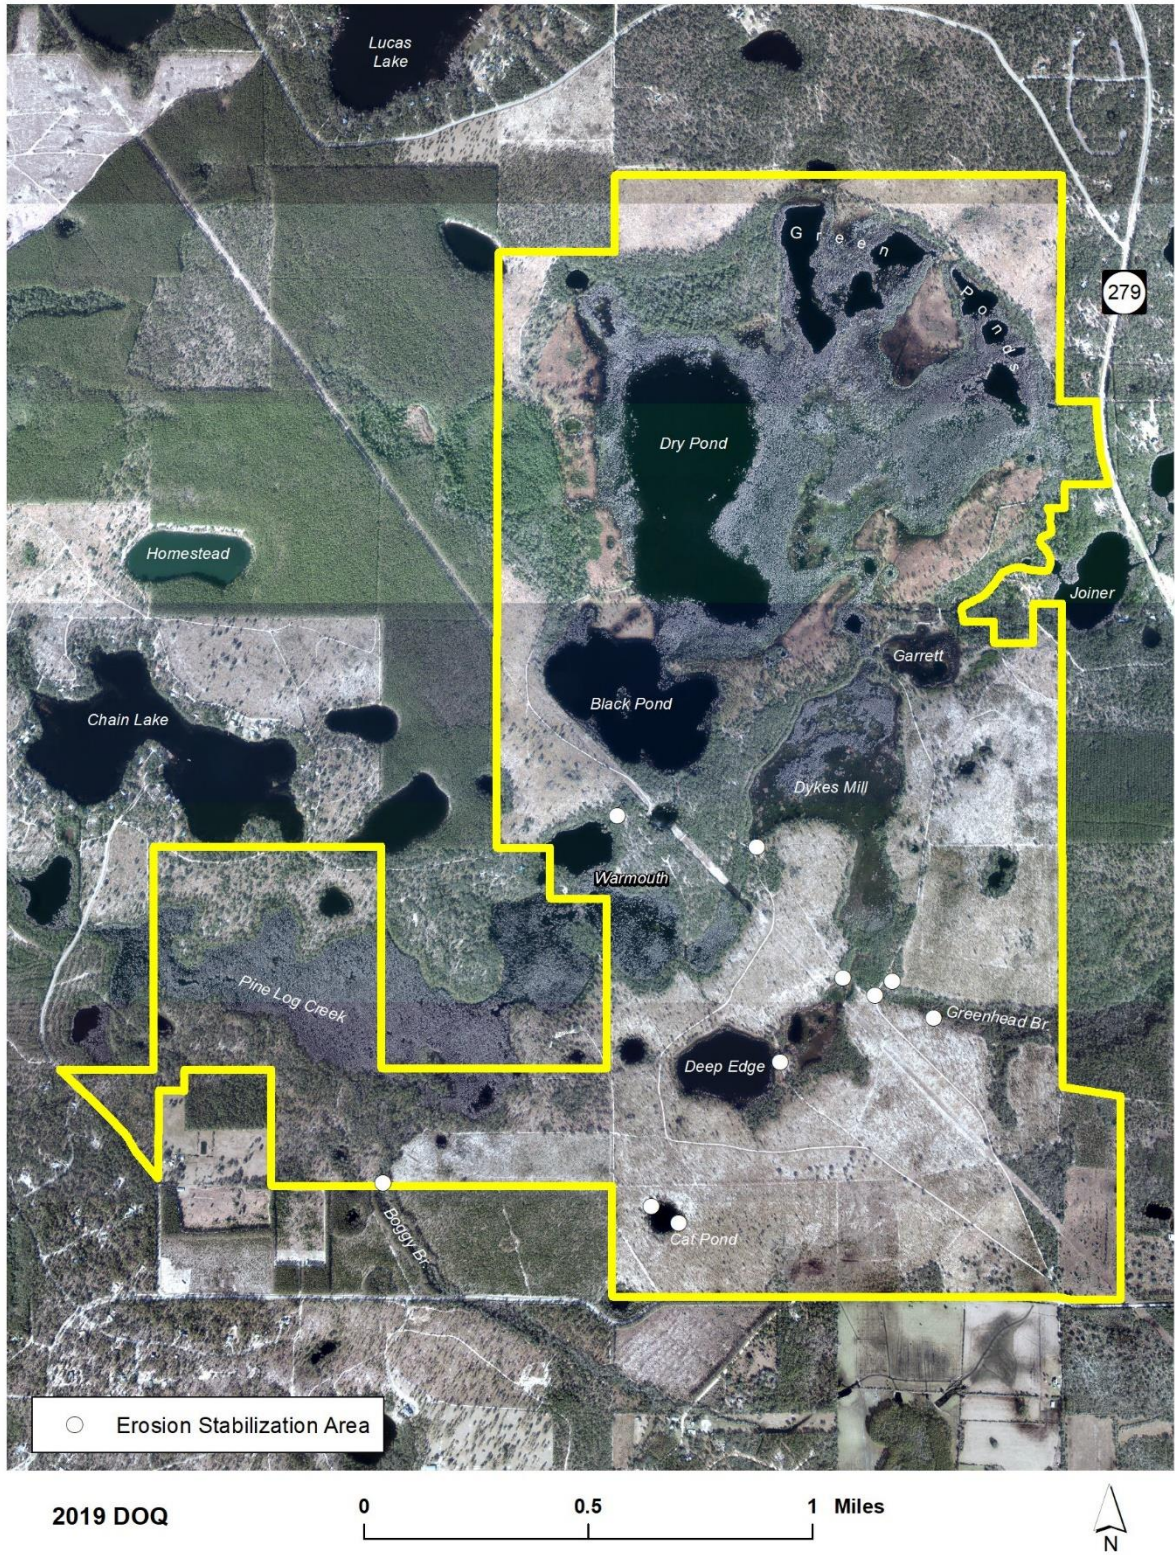
Figure 4. Erosion Stabilization Areas Restored at the SHLMB

remediation of ten erosion areas, and the stabilization of a boat launch (Figures 3 and 4). All water control structures, culverts and road removals and erosion stabilization areas continue to function as designed.

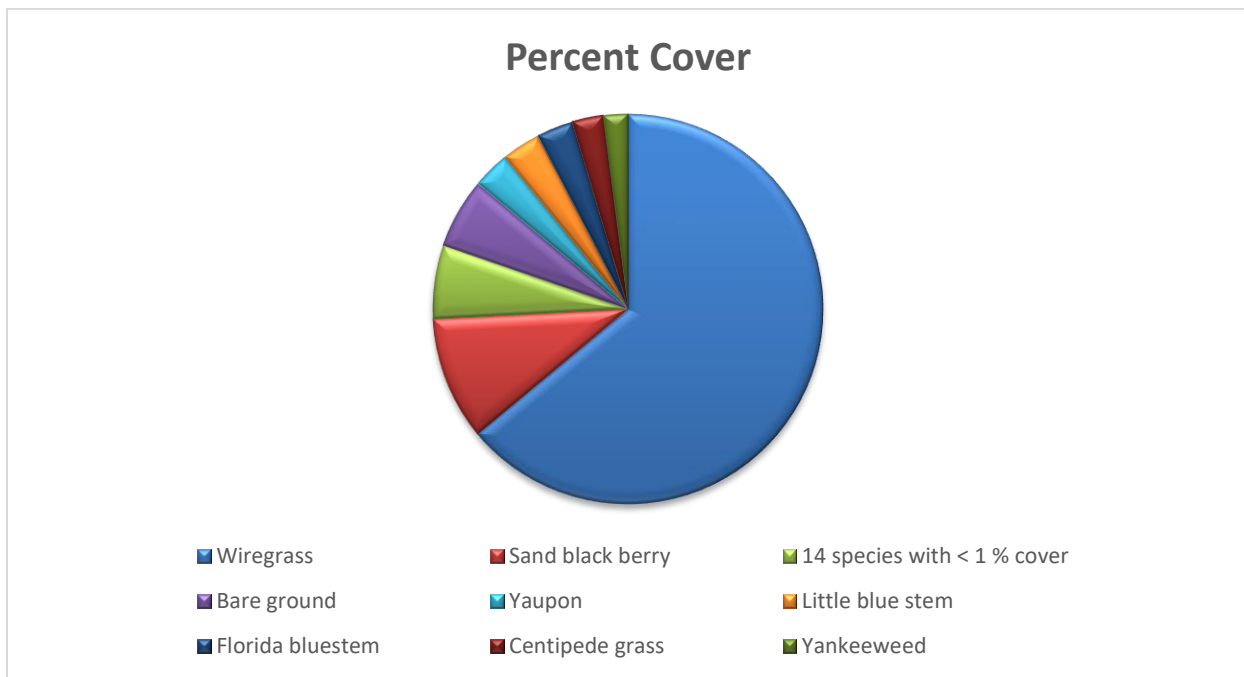
Figure 10. Transect 1: Sand pine plantation restored to sandhill

During the 2021 monitoring, 21 species were observed in Transect 1, 31 in Transect 2 and 38 within Transect 4. (Tables 3-5; Figures 10-12). Wiregrass had the greatest vegetative cover for each transect ranging from 64 percent in Transect 1 to percent 30.6 percent in Transect 2. Bare ground ranged from 5.8 percent in Transect 1 to 28.3 percent in Transect 4. The site continues to develop in species richness.

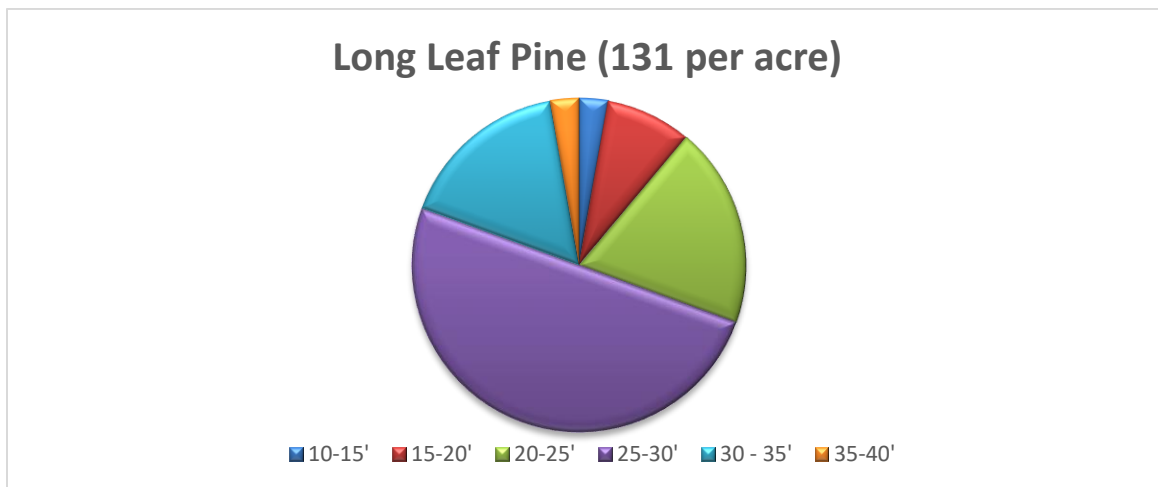
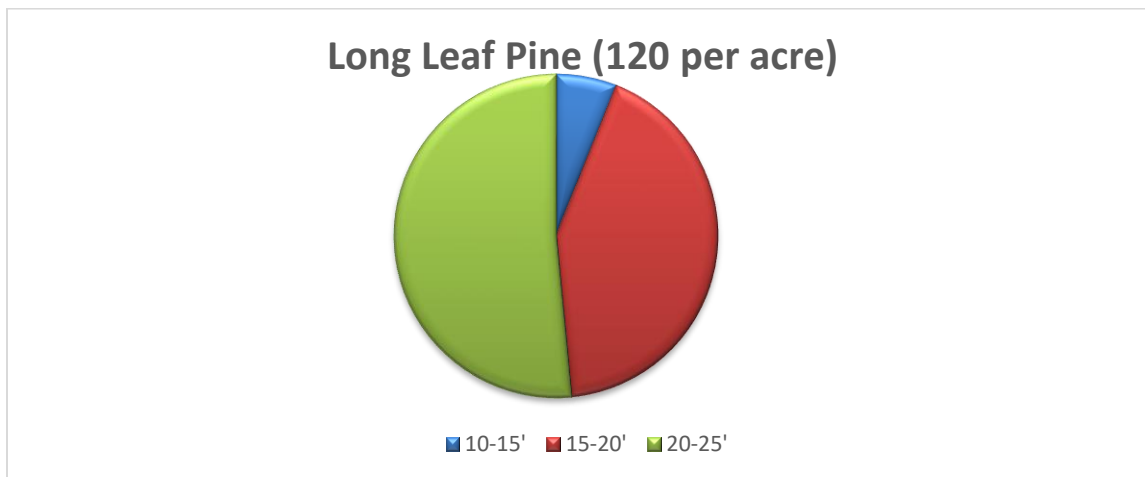
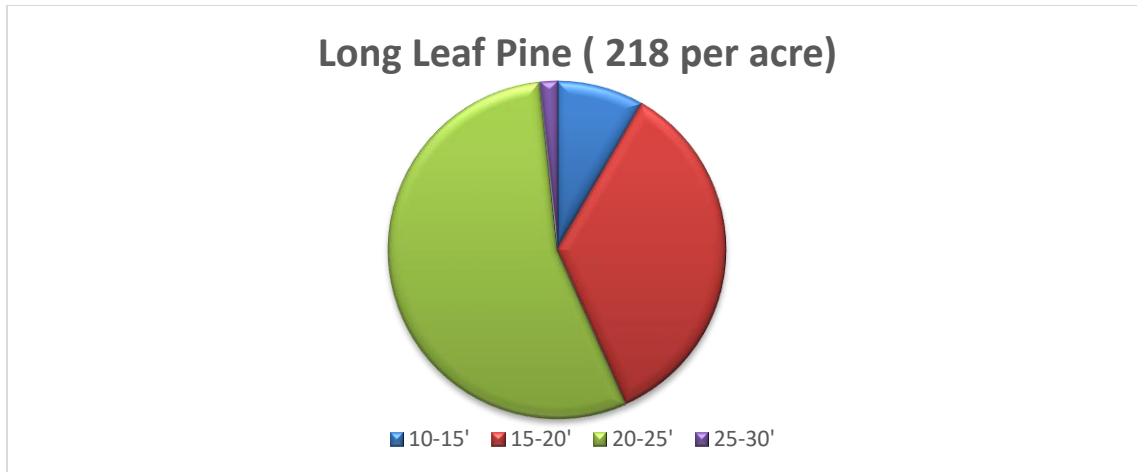
Longleaf pine seedlings were planted in the sandhills at a rate of 436 trees per acre. Permit conditions require a maximum average of 200 longleaf pine trees per acre. Planted tree densities are determined by counting all the seedlings in a 30' X 600' plot co-located with each transect and converting to trees per acre. All tree seedlings counted and measured by size class and notes on tree condition are included. The survival of longleaf pine seedlings along each transect was observed to be trees between 120 and 218 trees per acre. Overall health of the planted seedlings was excellent. Most trees were 20 -25 feet in height and the average diameter and breast height (DBH) is ten inches (Figures 13-15).

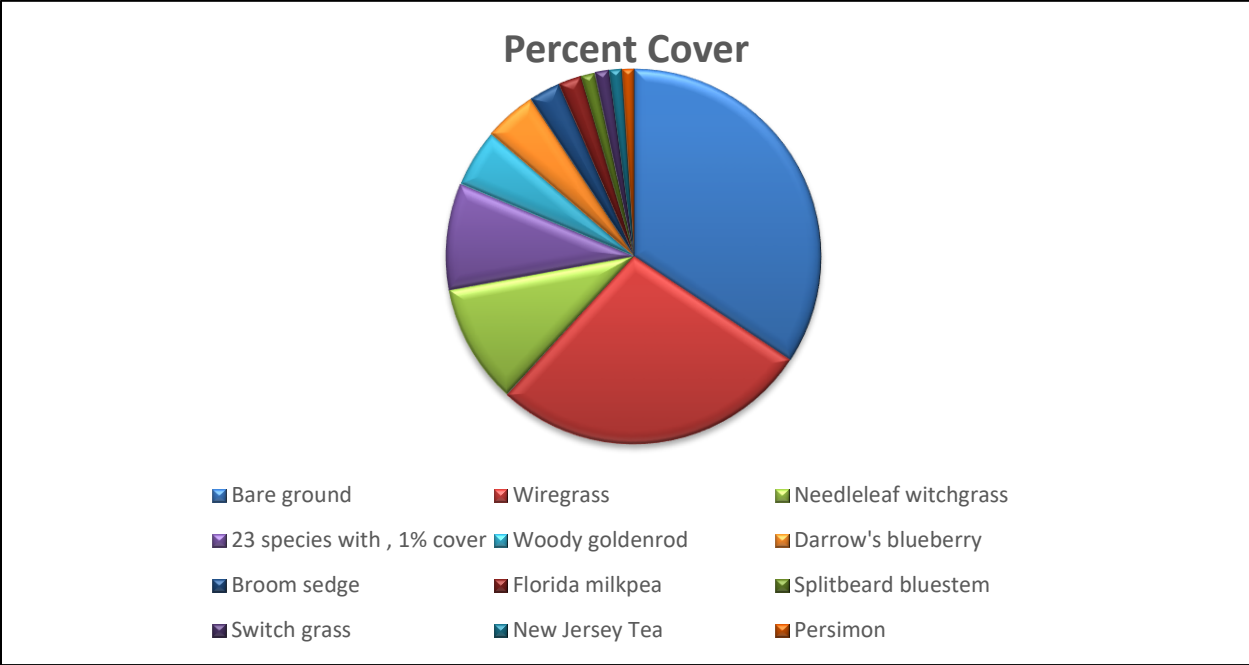
Figure 16. Transect 3: Species cover and occurrence (Sandhill Enhancement)

During the 2021 monitoring, 33 species were observed within Transect 3. A total of 33 species were also observed within Transect. Wiregrass cover was the greatest cover class observed with 27.5 percent cover in Transect 3 and 26 percent within Transect 5. Bare ground cover was 34.3 percent within Transect 3 and 32 percent within Transect 5 (Table 6, 7, Figures 16 and 17).

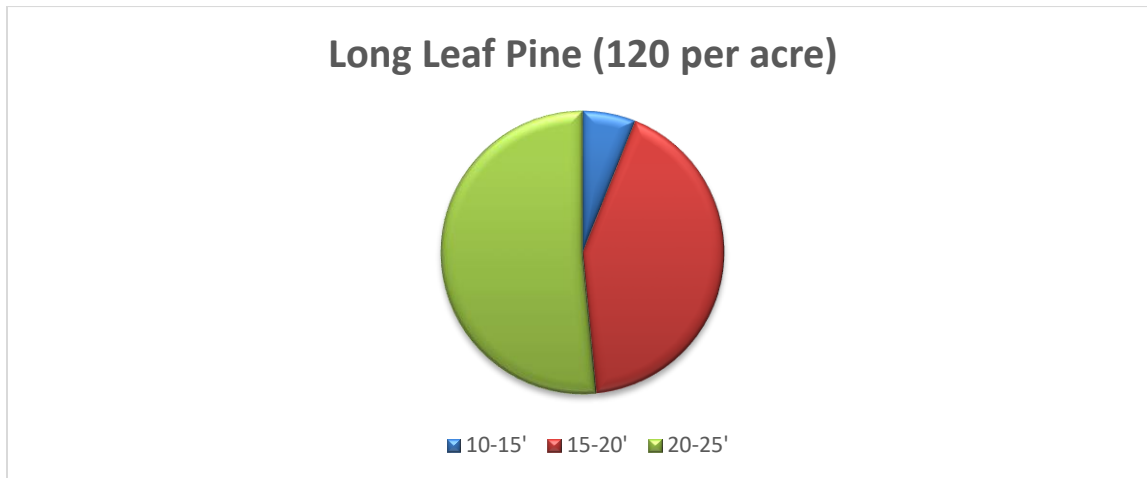
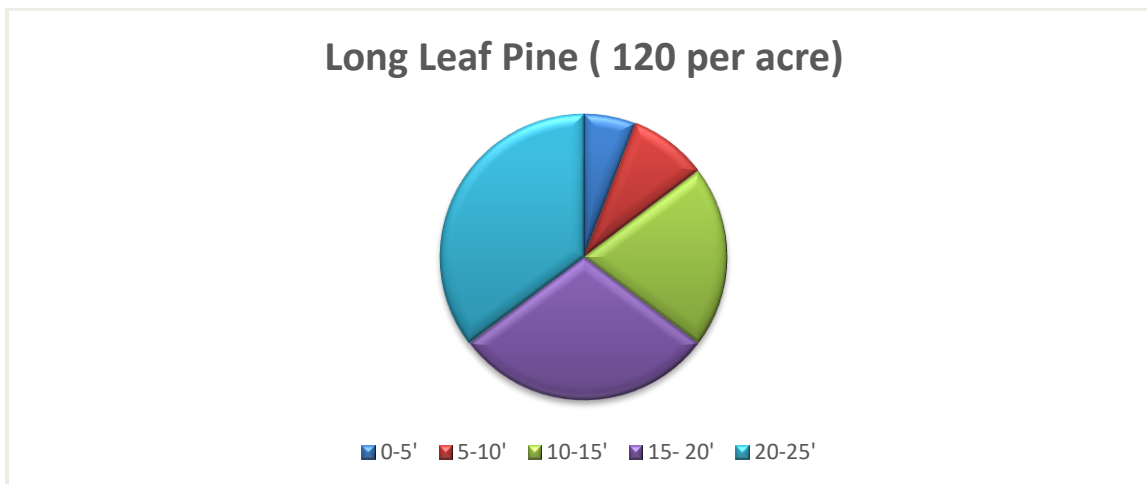
In 2021, the survival of longleaf pine seedlings was 120 per acre in Transect 3 and 120 per acre in Transect 5. Tree height was variable but with the most trees in the 15-20' and the 20-25' class. Trees appear healthy and vigorous (Figures 18 and 19).

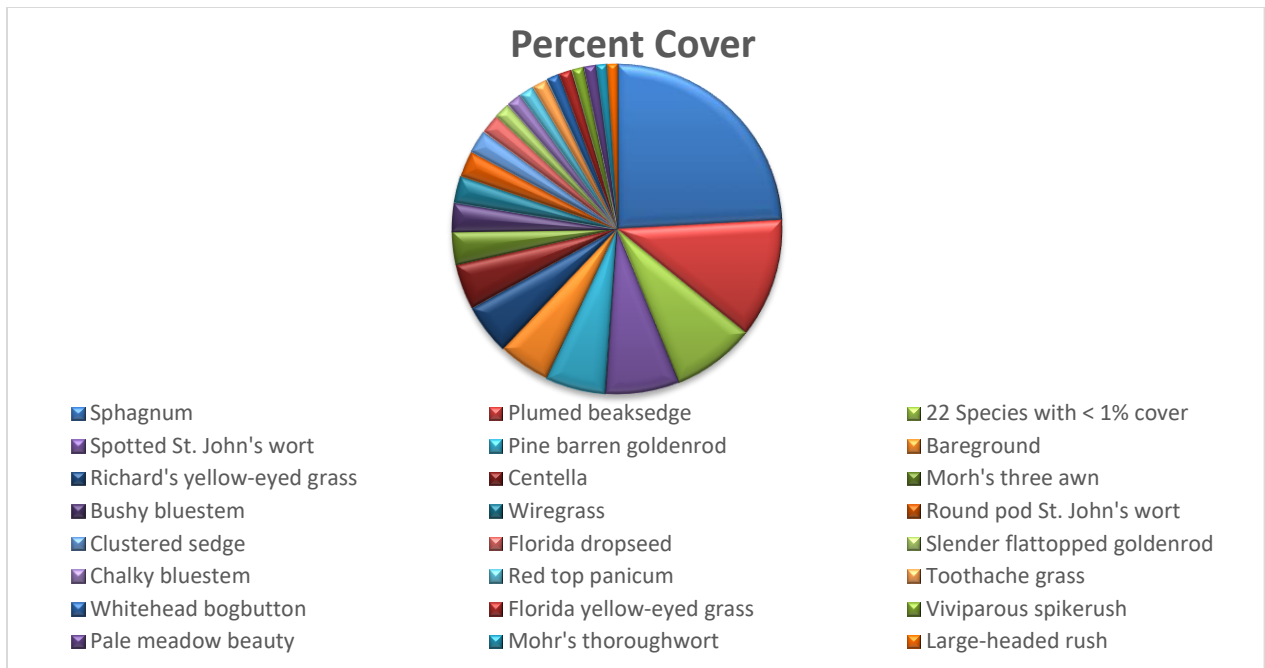
Figure 20. Transect 8: Species cover and occurrence

During the 2021 monitoring 44 species were observed. The site diversity continues to improve as the site develops. Bare ground was low at 5.2 percent. Nuisance shrub species cover was 0.3 percent and herbaceous species cover was 94.5 percent cover. (Table 8, Figure 20).

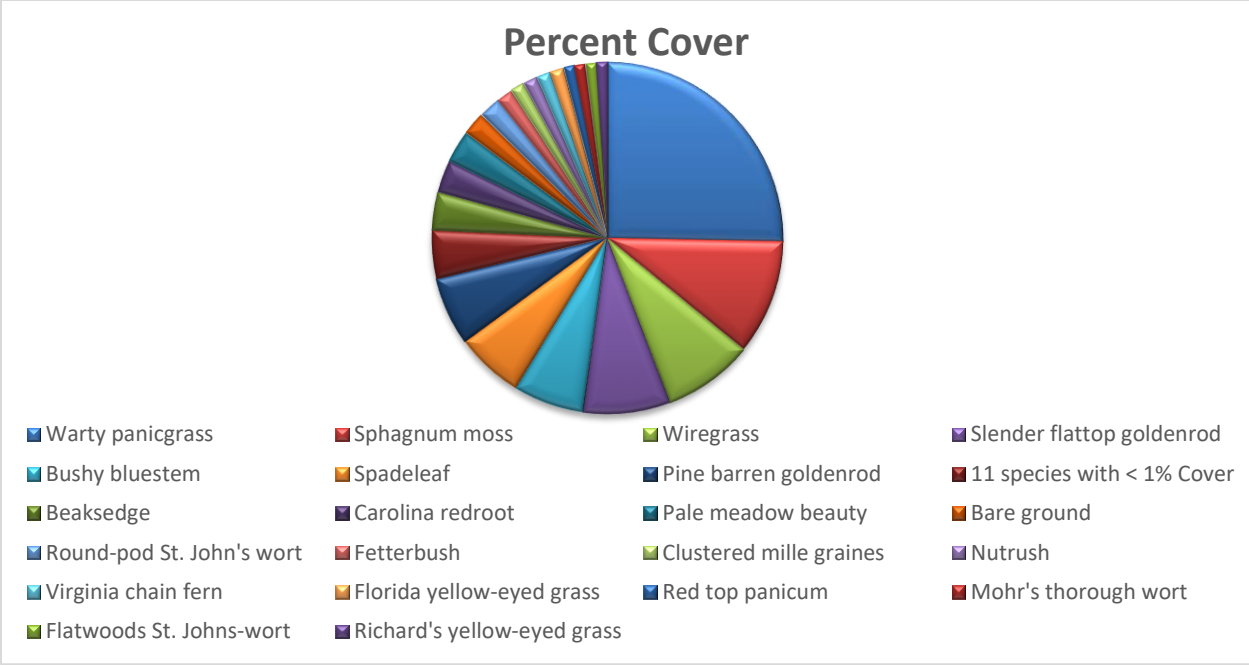
Figure 21. Transect 6. Species cover and occurrence (Hydric Pine Flatwoods Restoration)

During the 2021 monitoring, 31 and 24 species were observed within Transect 6 and 7. Hydric pine flatwood species dominated both transects. Shrub cover was 1.5 percent for Transect 6 and 1.8 percent for Transect 7, a reduction from the previous year. Vegetative cover was 96.4 percent for transect 6 and 92.9 for Transect 7 (Table 9, 10, Figure 21 and 22).

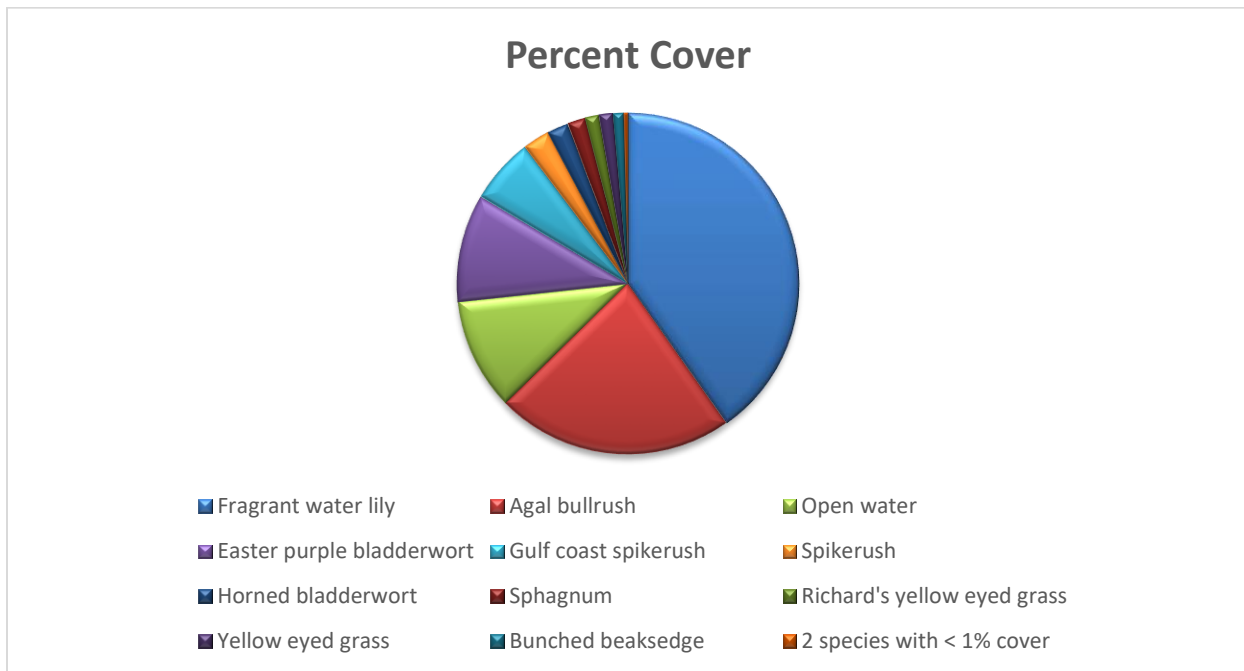
Figure 23. Transect 9. Species cover and occurrence (Dykes Mill Pond)

In 2021, a total of 12 species were observed along Transect 9. The aquatic vegetation is thriving providing important habitat for wildlife. Fragrant water lily represented the dominant cover class with 40.2 percent
