LIVE OAK POINT LIVING SHORELINES

2022 (Fall) Reference Site Monitoring Report

USACE Permit No.: SAJ-2011-00287

Project Location: Live Oak Point Salt Marsh Reference Site
30.42° North, -86.27° West
Approximately 2 ½ Miles NW of Santa Rosa Beach
Walton County, Florida

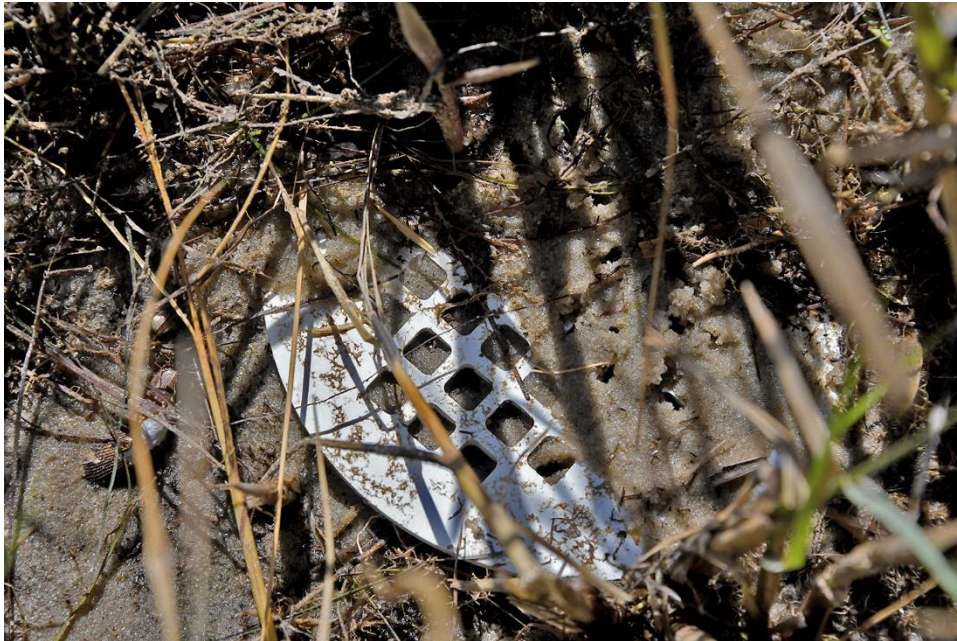
Date	Average Depth Below Surface (cm)				
	Point SB1	Point SB2	Point SB3	Point A	Point B
6/14/2021	-	-	-	2.5	5.1
10/21/2021	-	-	-	2.9	7.0
3/21/2022	-	-	-	0.0	0.0
10/20/2022	-	-	-	0.0	Missing
10/24/2022	21.9	16.9	21.3	1.1	Missing

⁶ Point "A" is a circular (4" DIA) stainless steel drain plate installed 6/14/2021 at 2.5 cm below the surface. Point "B" was (missing and presumed washed away) a circular (4" DIA) PVC drain plate installed 6/14/2021 at 5.1 cm below the surface. Points SB1 – SB3 are 4" x 7" concrete paving stones installed 10/24/2022 at depths of 21.9 cm, 16.9 cm, and 21.3 cm, respectively, beneath the surface (identified on Figure 2 map as Points 1 – 3).

Figure 26. Initial Sediment Monitoring Plate (Plate A) Exposed by Erosion – 10/20/2022

To increase accuracy of sediment accretion monitoring, three additional points were installed in the mid marsh zone of the reference site on 10/24/2022. Each new point, assigned a unique ID of SB1 through SB3, consists of a 4" x 7" concrete paving stone placed approximately 20 cm below the vegetated ground surface. By placing these markers at greater depths and beneath vegetated surfaces, they will be at much less risk of washout than the initial monitoring points (Point A and Point B) installed on 6/14/2021. As of 10/24/2022, Point A was partially exposed at the surface and Point B is missing (apparently washed away). Sea level rise for the Panama City area is estimated by National Oceanic and Atmospheric Administration for the Panama City area at 2.91 mm per year.⁵ Moving forward, data will be periodically collected at SB1 through SB3 to establish sediment accretion trends for comparison with estimated sea level rise.

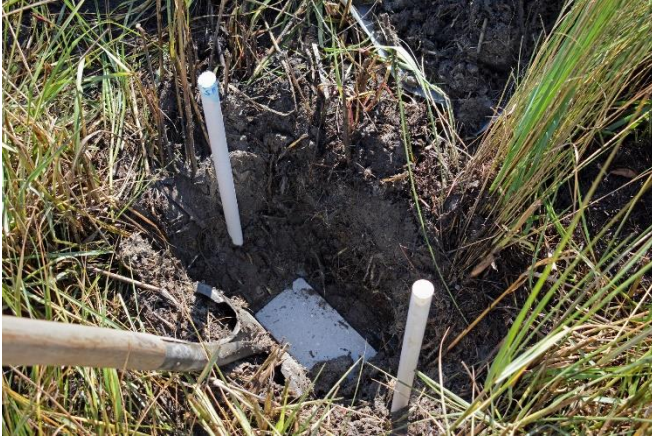
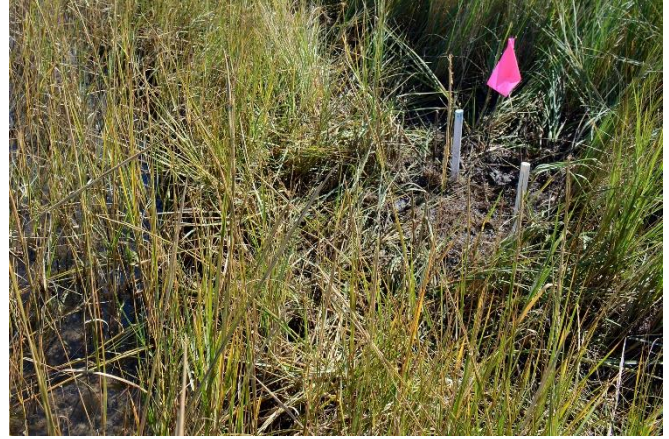
Figure 27. Installation of Additional Sediment Monitoring Points – 10/24/2022
