# LIVE OAK POINT LIVING SHORELINES

## 2023 (Fall) Project and Reference Site Monitoring Report

USACE Permit No.: SAJ-2011-00287

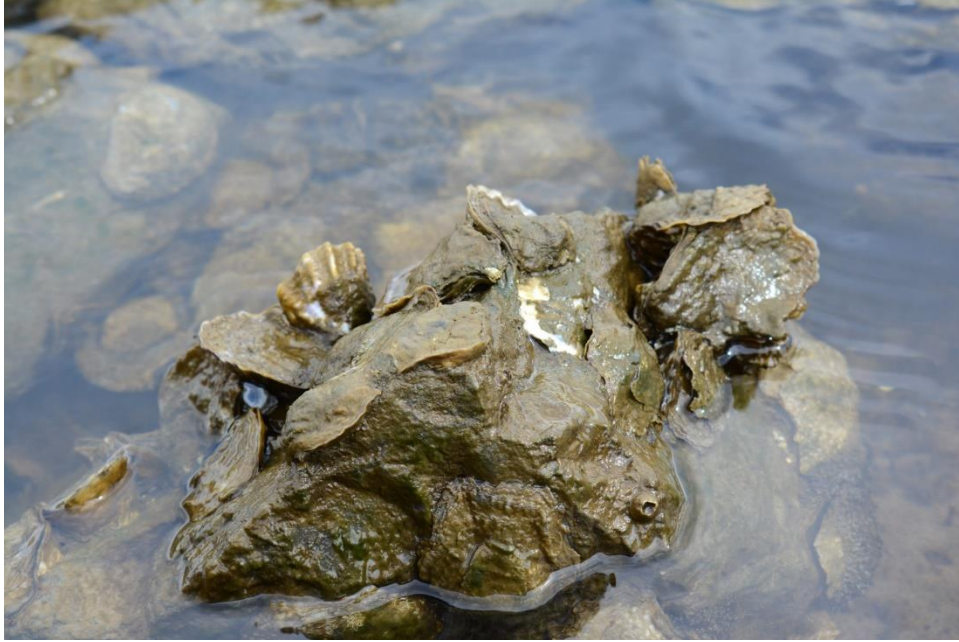
Figure 31. Oyster Colonization on Breakwater

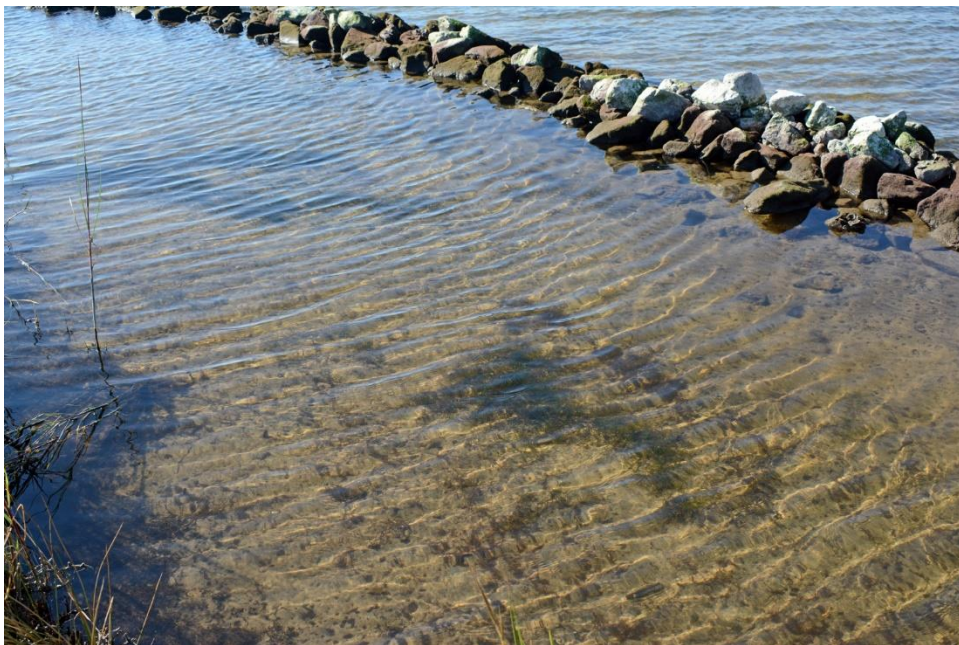
Figure 32. Sediment Accumulation and SAV Behind Constructed Breakwaters

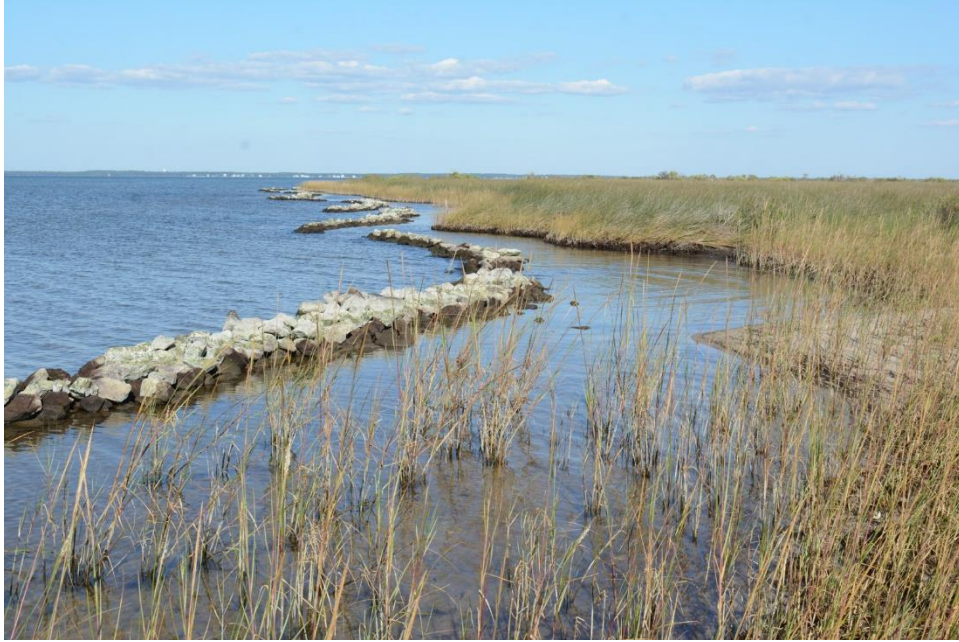
Figure 33. Expansion of *Spartina alterniflora*

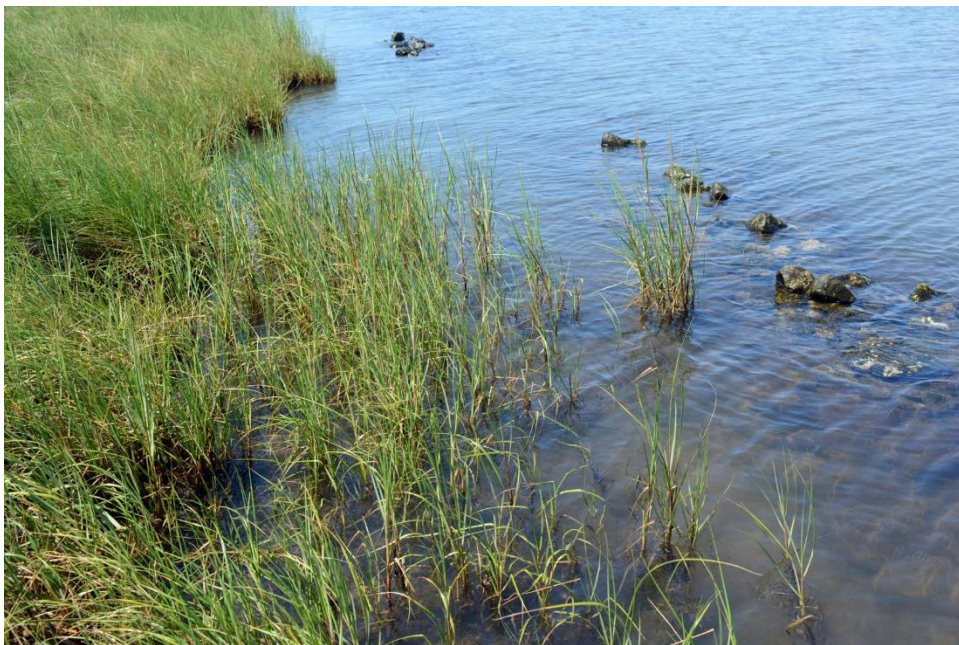
Figure 34. Expansion of *Spartina alterniflora*

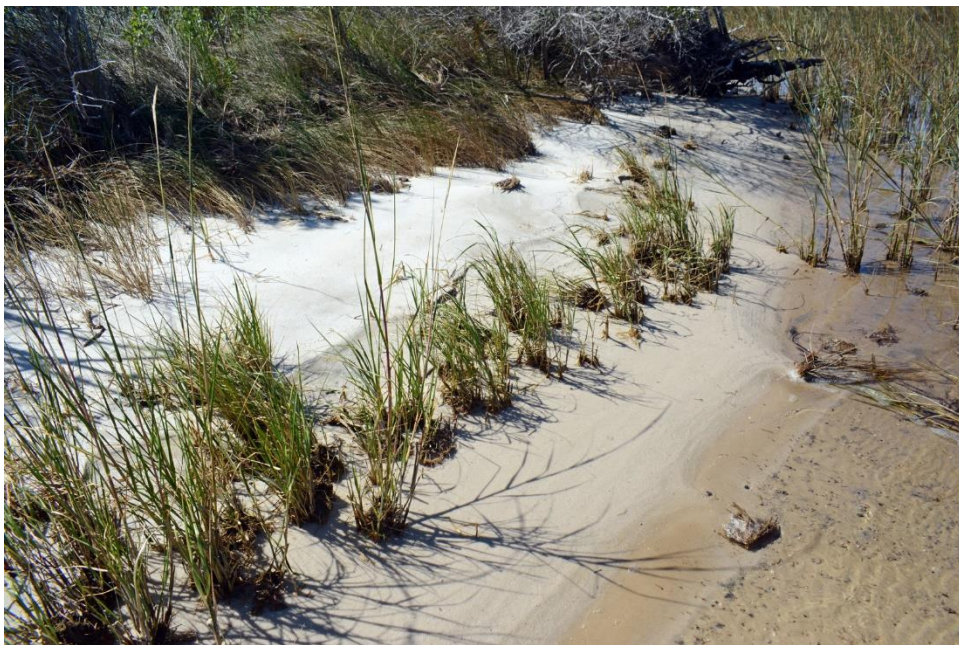
Figure 36. Established Marsh Plantings
