LIVE OAK POINT LIVING SHORELINES

2024 (Spring) Project and Reference Site Monitoring Report

USACE Permit No.: SAJ-2011-00287

Project Location: Live Oak Point Salt Marsh

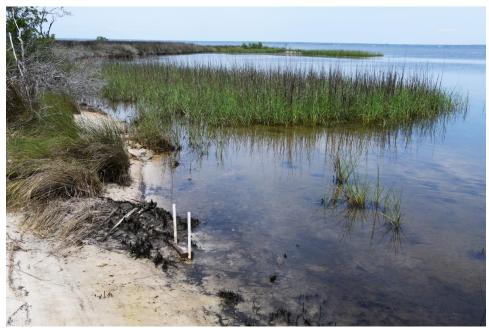
Use of buried markers (in this case, buried paving stones) is commonly used to monitor sediment accretion in salt marsh habitat. Our experience at the Live Oak Point Living Shorelines project indicates that useful data will be generated in the centimeter resolution range. However, the coarseness of data obtained from this technique may preclude obtaining definitive trends at millimeter resolutions. At face value, measurements from May 2023 to May 2024 indicate an annual accretion rate of 1.22 mm per year in the existing marsh at the reference site, whereas data from the project site indicate an annual loss of 9.79 mm per year in the existing marsh. Visual observations, however, strongly suggest that vertical erosion is not occurring in the existing marsh at either the project site or the reference site. The unevenness of the marsh surface at the monitoring points, the potential for continued settling of soil after burial of the paving stone, and possible imprecise leveling of the buried paving stone, makes millimeter to submillimeter resolution of sediment accretion trends problematic at best. Additional methods of measuring sediment accretion may become necessary, and sediment monitoring may be expanded into the restoration areas between the breakwaters and the existing marsh where sediment accretion is definitively occurring. Sea level rise for the Panama City area has been estimated by National Oceanic and Atmospheric Administration (2023) area at 3.10 mm per year. Data collected at SB1 through SB15, and possibly other data collected in the future using more precise measurement techniques and/or data collected within the areas between the breakwaters and shoreline, will be used to establish sediment accretion trends for comparison with estimated sea level rise. One sediment accretion monitoring point (SB13; Figure 29), not protected by breakwaters and located in the marsh/water interface, is anomalous in that it has become fully exposed from shoreline erosion. The other fourteen monitoring points appear unlikely to become exposed from shoreline erosion.

Figure 29. Sediment Accretion Monitoring Point SB13 Exposed from Erosion (5/3/2024)

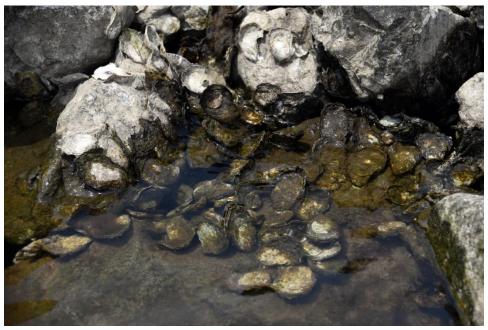
Results of the Spring 2024 vegetation monitoring indicate strong similarity between the project site and the reference site. The Sorensen's Similarity Index comparing the project site with the reference was 0.77. Vegetation diversity was limited (Simpson's Diversity Index [Project Site] = 0.67; Simpson's Diversity Index [Reference Site] = 0.72). At both the project and reference sites, the low marsh is dominated by *Spartina alterniflora*, the mid marsh is dominated by *Spartina patens*, and the high marsh is dominated by *Juncus roemerianus*). At the project site, sediment is generally accumulating behind the newly constructed breakwaters (e.g., see Figure 32), with *Spartina alterniflora* expanding in places (e.g., see Figure 33). Oyster colonies are rapidly becoming established on the breakwaters and submerged aquatic vegetation (SAV), primarily *Halodule wrightii*, has moved in behind breakwaters in multiple locations (e.g., see Figure 31).

Figure 31. Oyster Colonization on Breakwater (5/3/2024)

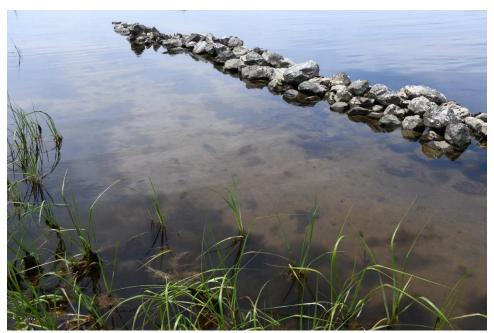
Figure 32. Sediment Accumulation Behind Constructed Breakwaters (5/3/2024)

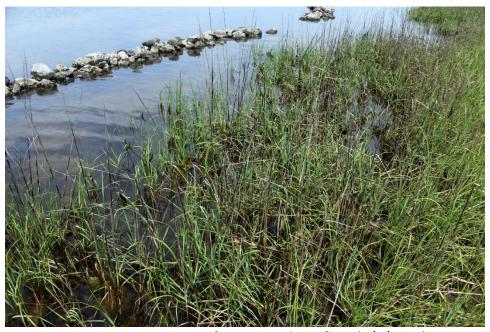
Figure 33. Expansion of Spartina alterniflora (5/3/2024)

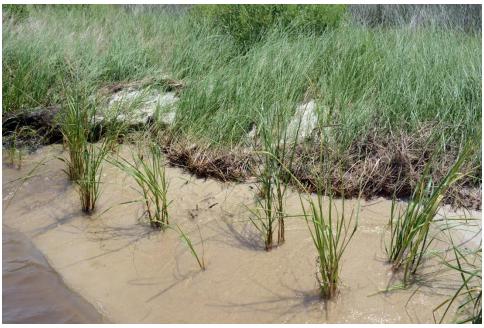
Planted vegetation has generally done well in locations protected by limerock breakwaters (e.g., see Figure 35). Where breakwaters are absent (i.e., where breakwaters were not constructed due to SAV-avoidance concerns), planted vegetation has generally washed out (e.g., see Figure 36). Expectations that multiple rows of sandbag plantings (i.e., sandbags with three vegetation plugs per bag) would be sufficient to stop erosion where breakwaters were not constructed were not realized. Corrective measures will entail use of reef balls or concrete "volcanoes" along approximately 1,250± FT of shoreline where limerock breakwaters were not constructed.²

Figure 35. Successful Supplemental Plantings Protected by Breakwaters

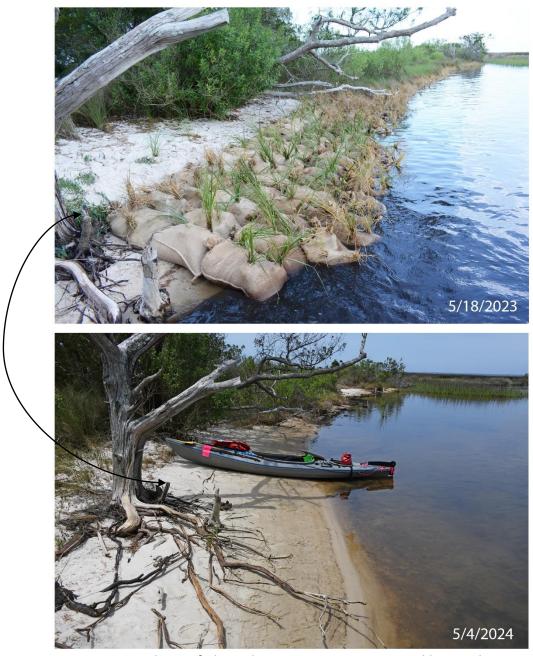
Figure 36. Washout of Planted Vegetation Not Protected by Breakwaters
