Sand Hill Lakes Mitigation Bank Combined DEP/USACE Eleventh Annual Report

FDEP Permit # 0227351-001 Issued 9/6/2005, Washington County

**Northwest Florida Water Management District
Submitted by David Clayton
In support of Specific Conditions 26 and 28**

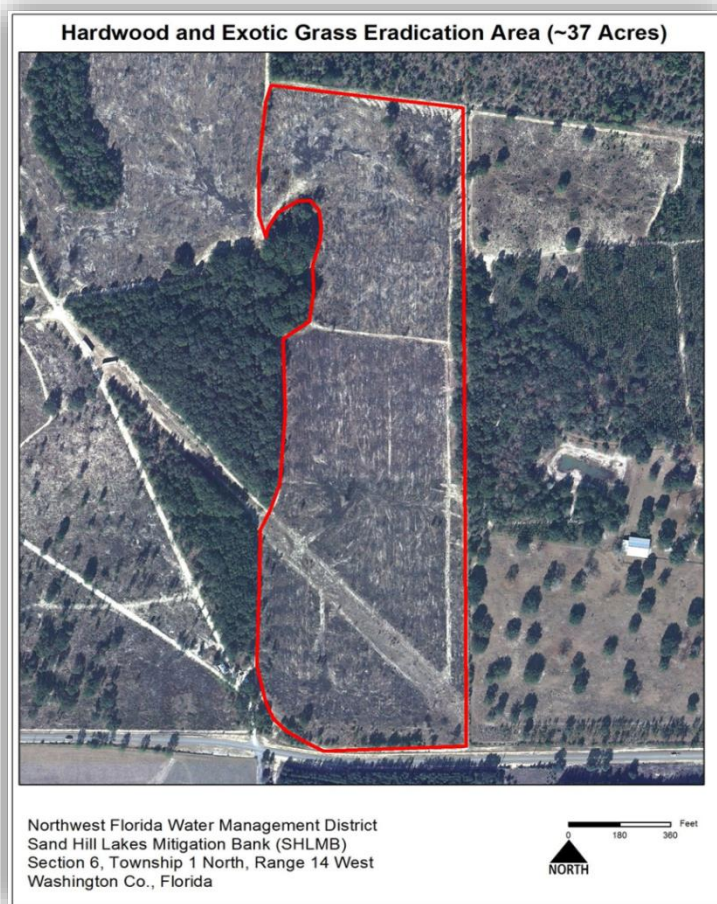
Figure 7. Bahia grass eradication on 37 Acres of sandhill restoration

In 2016, Bahia grass (*Paspalum notatum*) coverage exceeded five percent in a 37 acre sandhill restoration area to the east of the check station (UMAM polygon II) (Figure 7). Following the warm season burn in 2014, the Bahia grass seed bank emerged and Bahia grass cover increased significantly. The University of Florida Bahia grass specialist Dr. Anne Blount helped develop a strategy to eradicate the Bahia grass. The Bahia grass was treated in August of 2015 and 2016. The cover of Bahia grass has been reduced to incidental.

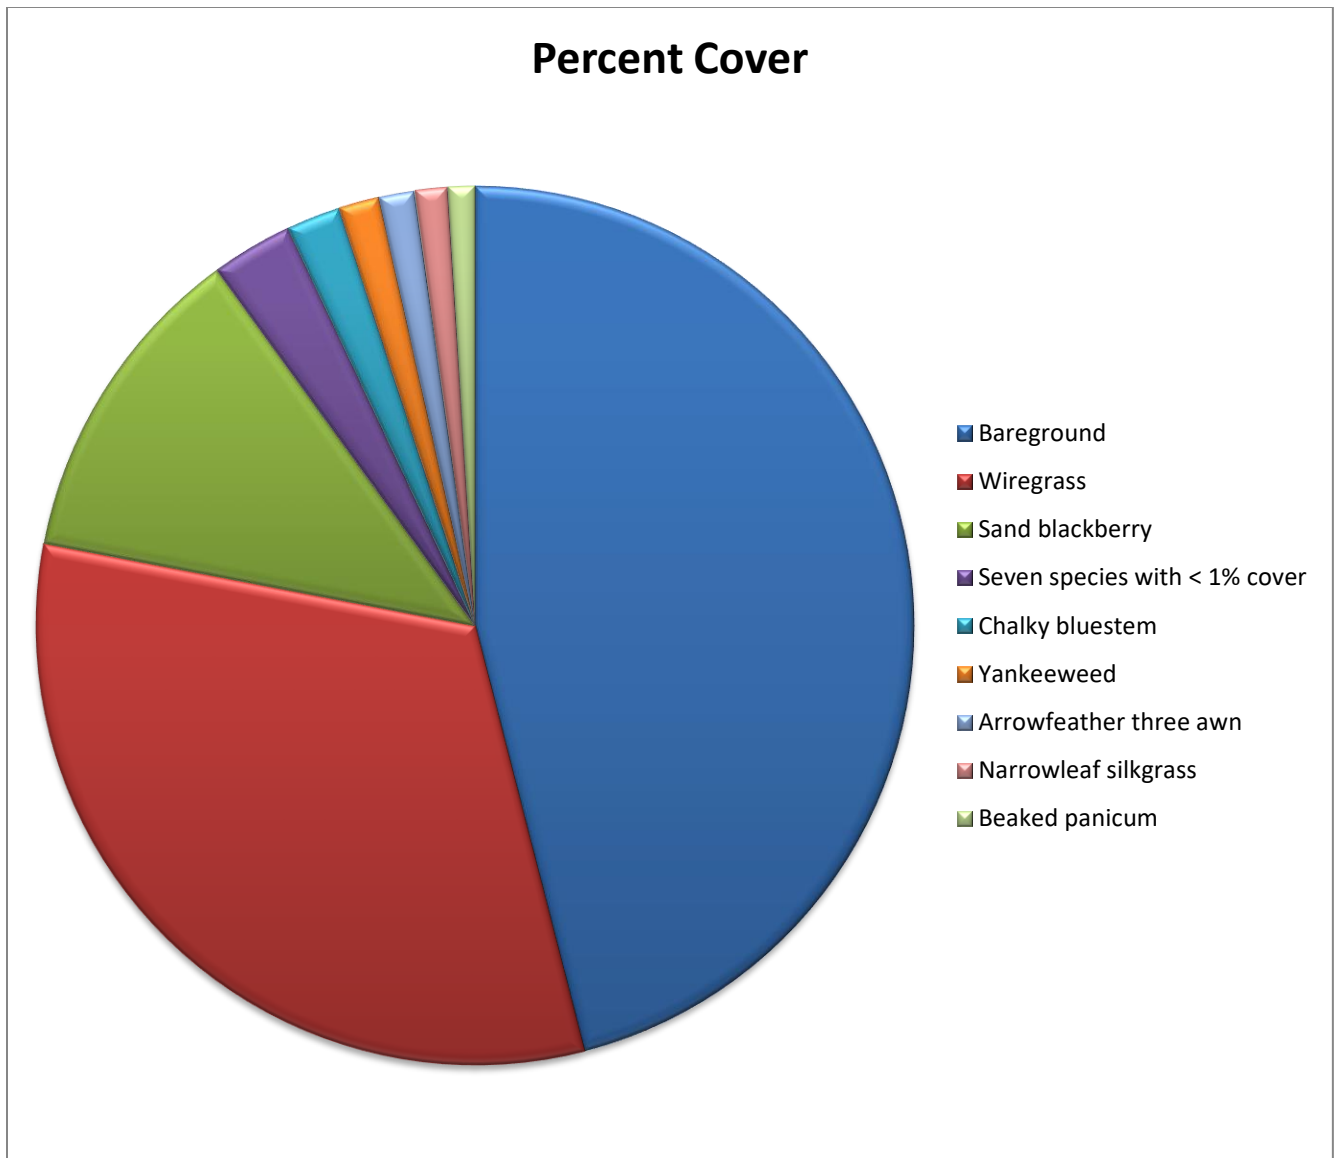
Figure 12. Transect 1: Sand pine plantation restored to sandhill

During the 2016 monitoring, 14 species were observed in Transect 1, 20 in Transect 2, and 18 in Transect 4. (Tables 4-6; Figures 12-14). Wiregrass had the greatest vegetative cover for each transect ranging from 31% in transect 1 to 17% in Transect 2 and 25.6% in transect 4. Bare ground cover ranged from 46% in Transect 1 to 57% in Transect 2. The areas that contained the sandhill restoration transects were burned in late July. Warm season burns tend to remove annual species. The reduced species cover and occurrence maybe due to the mid-summer burns. In addition, the area surrounding transect 1 had been treated over the summer with herbicide to reduce centipede grass cover. The increase in bare ground is attributed at least in part to the herbicide treatment.

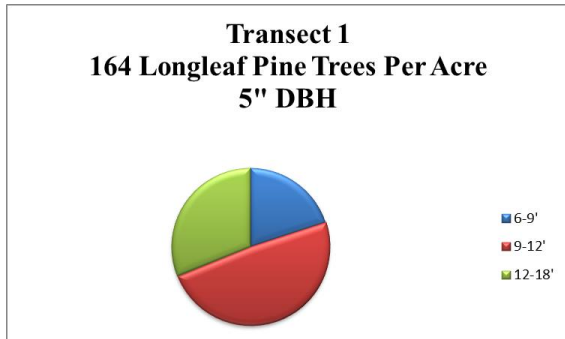
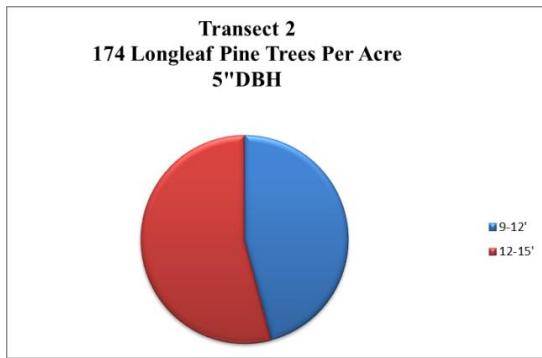
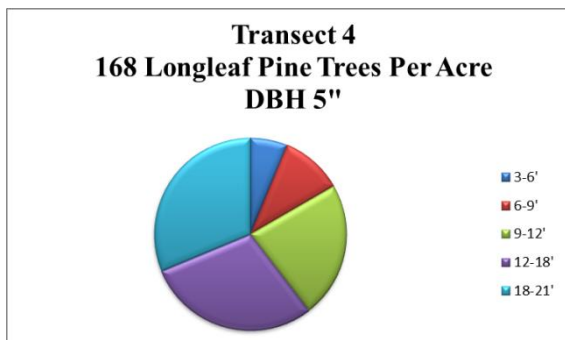
Longleaf pine seedlings were planted in the sandhills at a rate of 436 trees per acre. Permit conditions require a maximum average of 200 longleaf pine trees per acre. Planted tree densities are determined by counting all the seedlings in a 30' X 600' plot co-located with each transect and converting to trees per acre. All tree seedlings counted and measured by size class and notes on tree condition are included. The survival of longleaf pine seedlings along each transect was observed to be trees between 164 and 174 trees per acre. Overall health of the planted seedlings was excellent. Most trees are 9-12 feet or 12-15 feet in height and the average diameter and breast height (DBH) is 5 inches (Figures 15-17).

Figure 15. Planted longleaf pine seedlings (Transect 1)

Figure 16. Planted longleaf pine seedlings (Transect 2)

Figure 17. Planted longleaf pine seedlings (Transect 4)

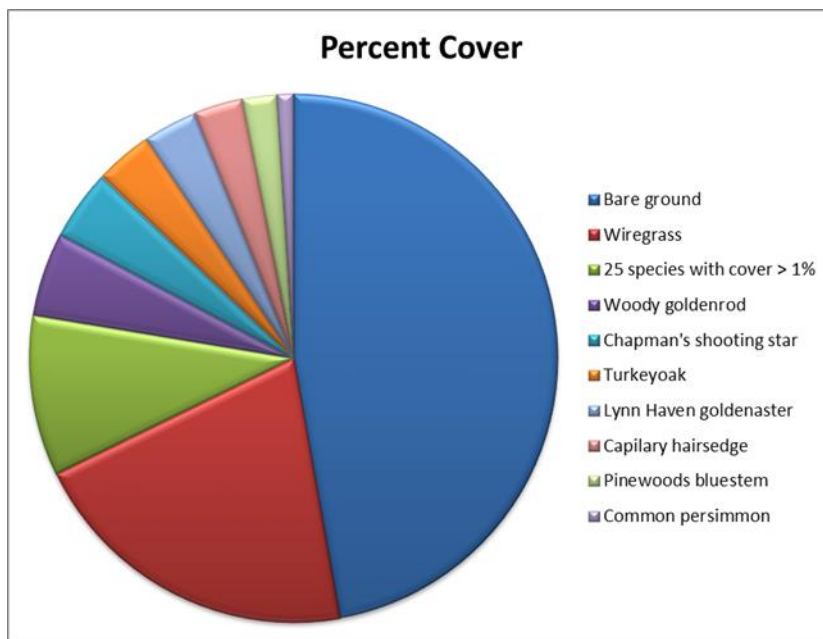
Figure 18. Transect 3: Species cover and occurrence (Sandhill Enhancement)

During the 2016 monitoring, 34 species were again observed within Transect 3. Nineteen species were observed within Transect 5, a decrease of 22 species from 2016 (Tables 7 and 8; Figures 18 and 19). Wiregrass cover was the greatest cover class observed for both transects with 21% cover observed within Transect 3, and 40 % cover observed in Transect 5. Bare ground cover was 47% within Transect 3 and 36.1% within Transect 5. Later warm season burns appeared to have reduced percent cover and diversity of annuals within the sandhill enhancement areas.

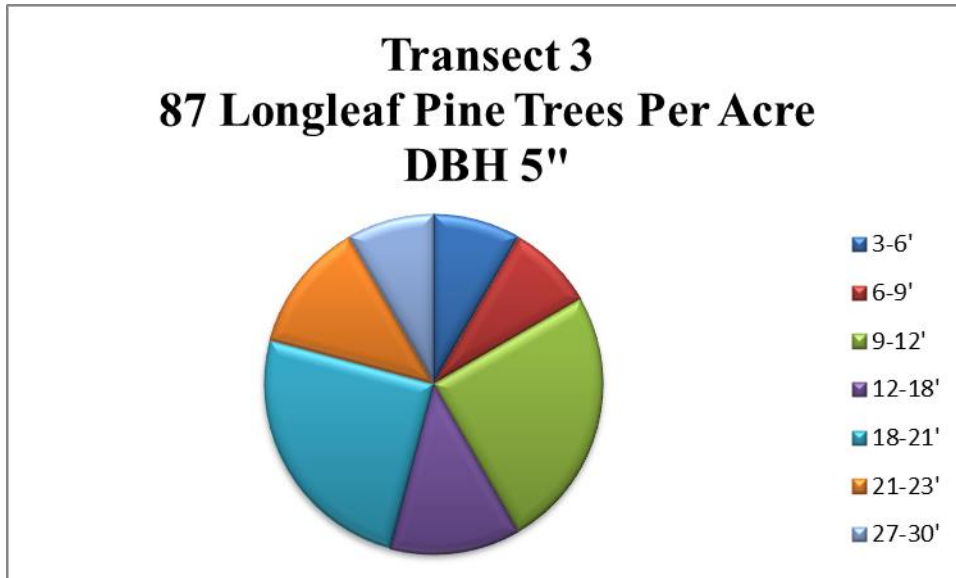
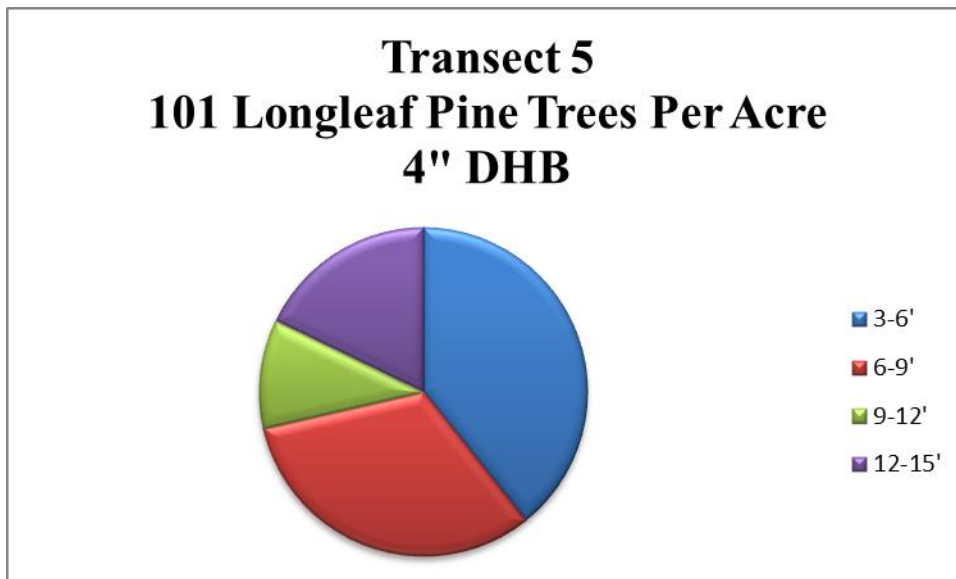
In 2016, the survival of longleaf pine seedlings was 87 per acre in Transect 3 and 101 in Transect 5. There was a significant increase in tree density along Transect 5, due to recovery and growth of planted seedlings during the previous year. Remaining trees appear healthy (Figure 20 and 21).

Figure 20. Planted longleaf pine seedlings (Transect 3)

Figure 21. Planted longleaf pine seedlings (Transect 5)

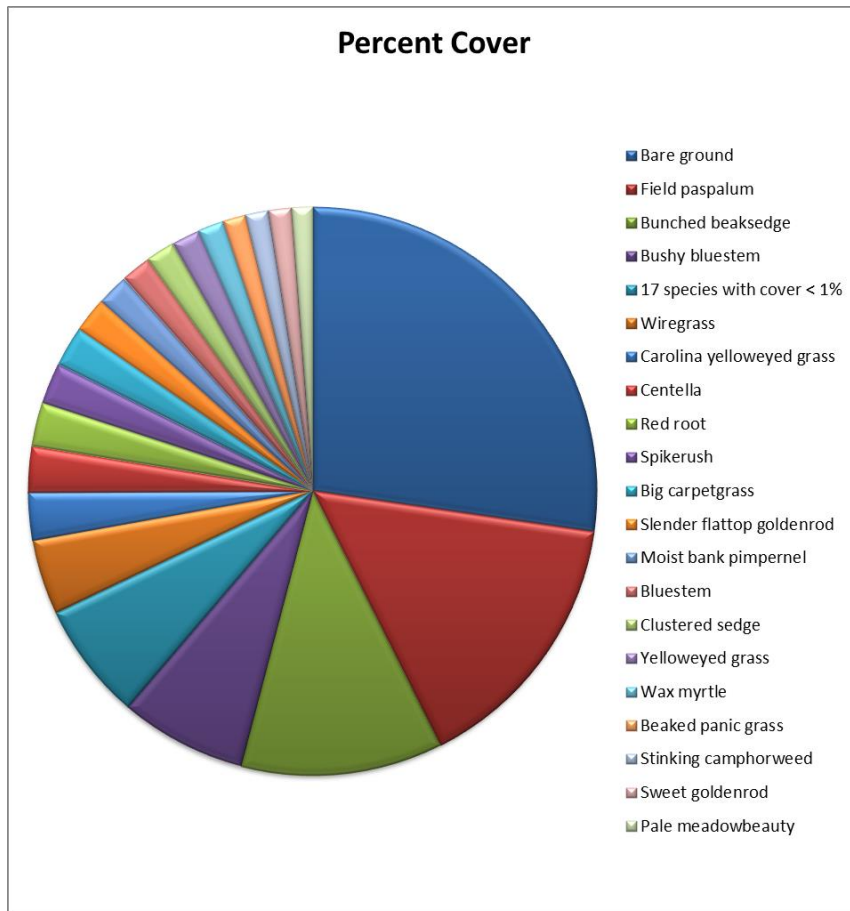
Figure 22. Transect 8: Species cover and occurrence

During the 2016 monitoring, 35 species were observed. The diversity of the site continues to improve as the site develops. Bare ground cover increased slightly to 27.33% in the last year. Hydric pine flatwood species dominate the site with over 72% cover (Table 9; Figure 22).

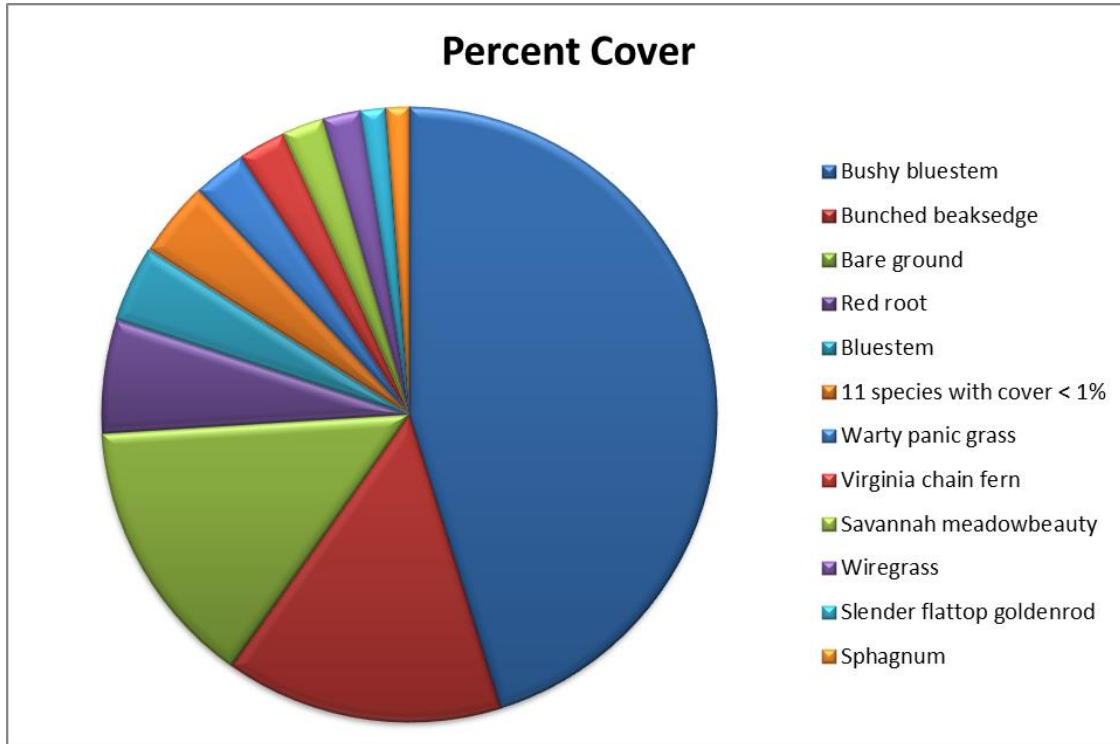
Figure 23. Transect 6. Species cover and occurrence (Hydric Pine Flatwoods Restoration)

During the 2016 monitoring, 21 species were observed in transects 6 and 17 for Transect 7 (Table 10 and 11; Figure 23 and 24). Hydric pine flatwood species dominated both transects. Shrub cover was less than two percent for each transect. Vegetative cover exceeds 80% for both transects. Transect 6 and 7 are dominated by grasses and sedges.
