**GROUND WATER FLOW PATTERNS  
IN THE ECONFINA CREEK SPRINGSHED  
WASHINGTON AND BAY COUNTIES, FLORIDA**

PREPARED BY:  
NORTHWEST FLORIDA  
WATER MANAGEMENT DISTRICT  
JULY 2004

Water Resources Special Report 04-03

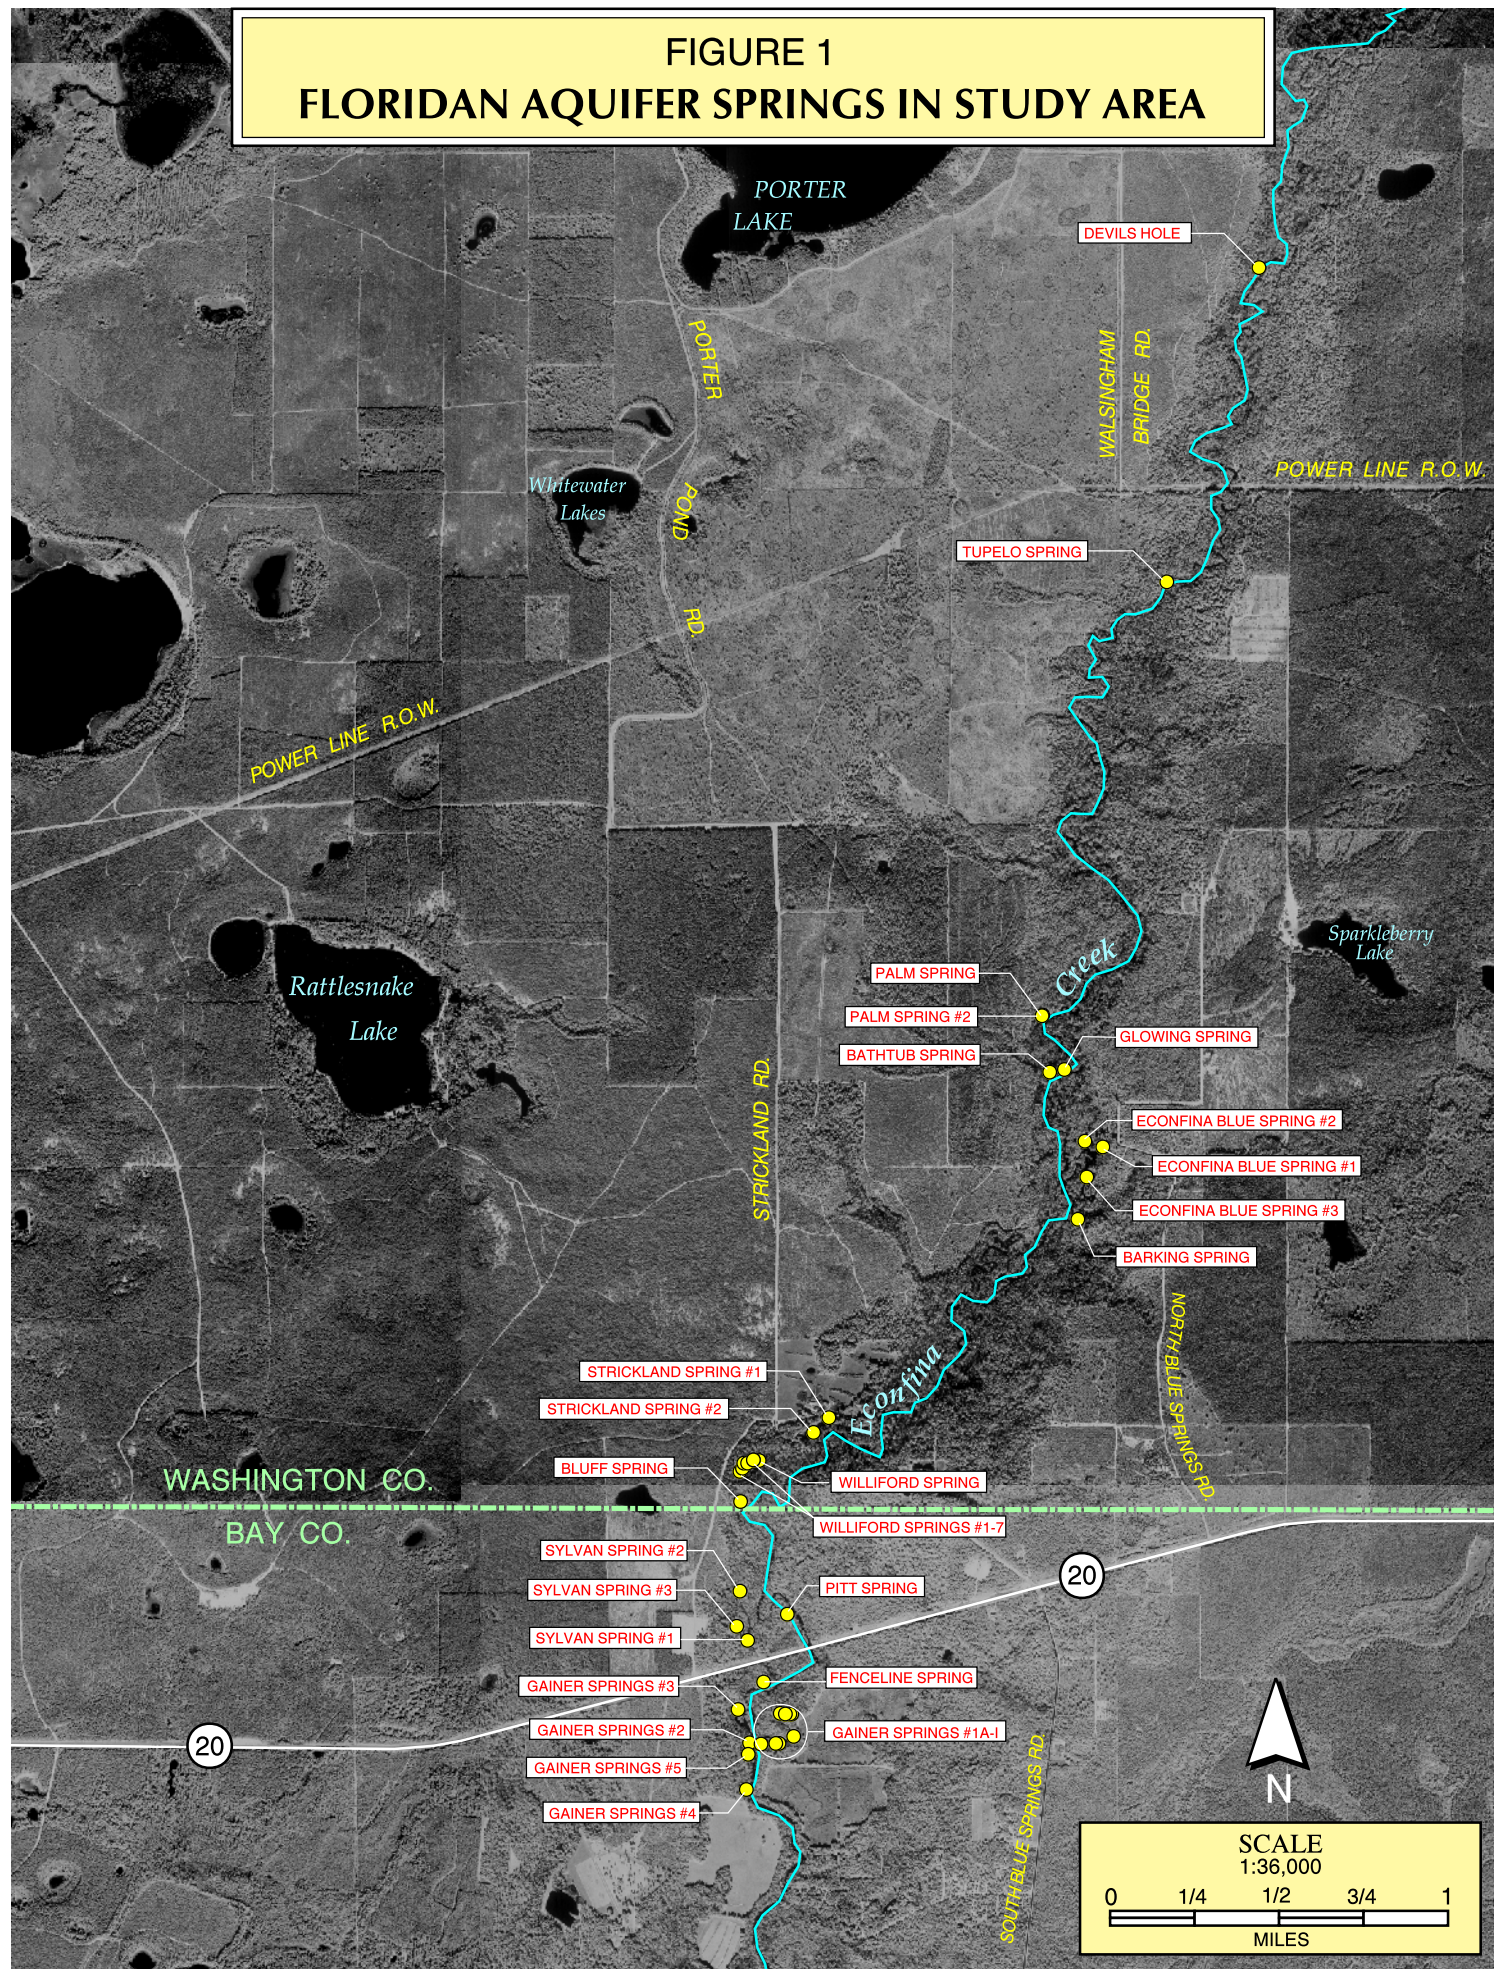
FIGURE 1  
FLORIDAN AQUIFER SPRINGS IN STUDY AREA

The known Floridan Aquifer springs located along Econfina Creek (Figure 1) are found in Washington and Bay counties. This portion of Econfina Creek lies within the Bennett, Fla USGS 7.5 minute topographic quadrangle, both north and south of State Highway 20. The study area is at the southern extent of the Dougherty Karst Plain within the Sand Hill Lakes physiographic subregion. The karst aquifer underlying the area is developed in a sequence of southward dipping Miocene aged and older carbonates.

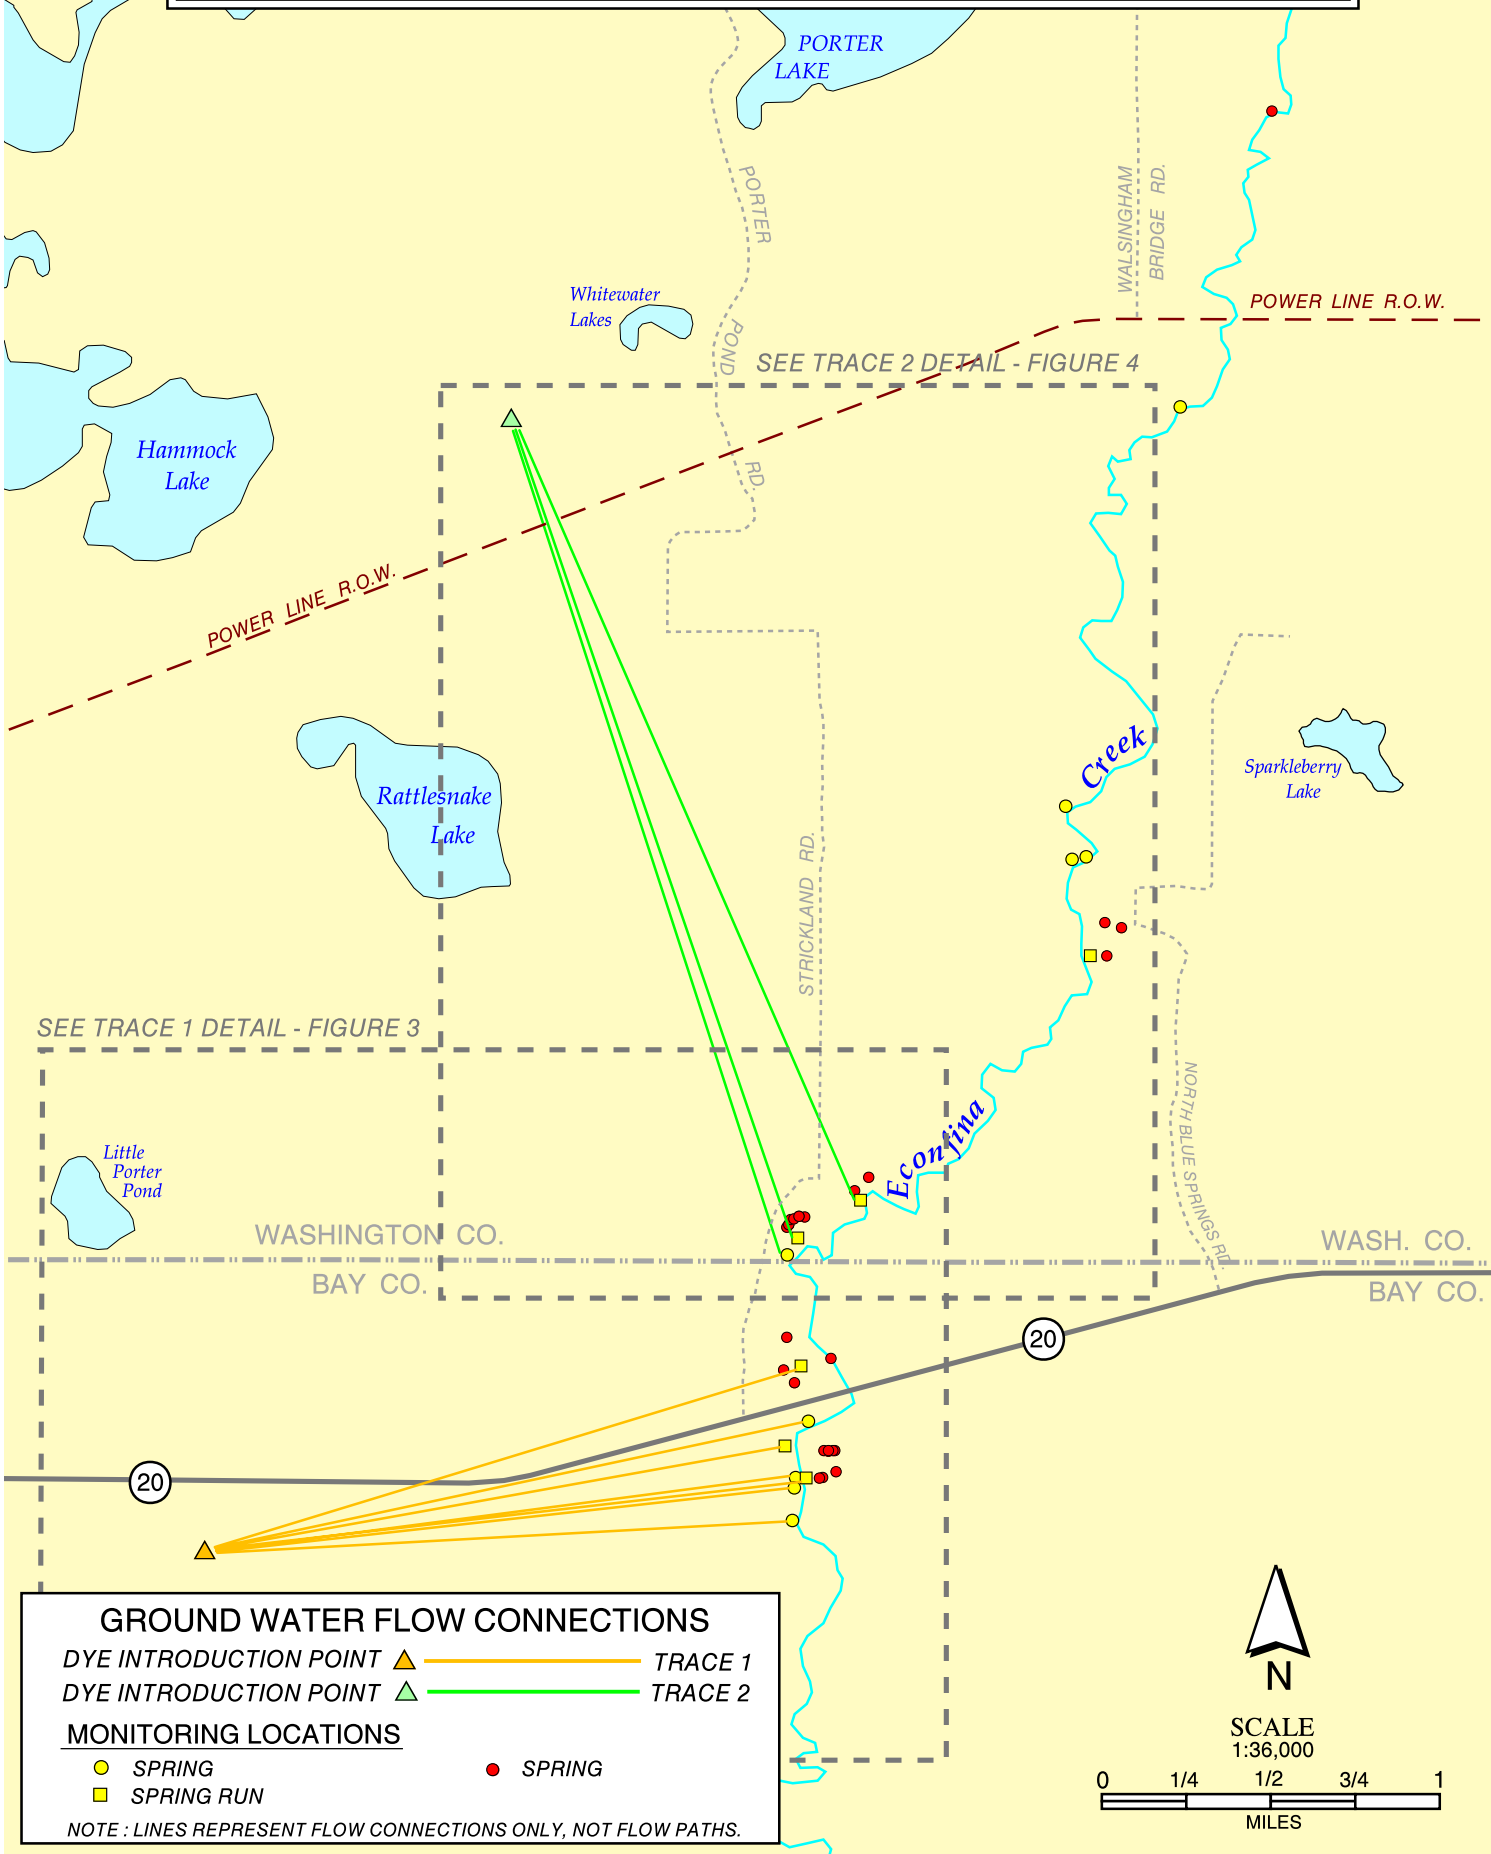
# FIGURE 2 GROUND WATER FLOW CONNECTIONS IN STUDY AREA

The ground water flow connections established by the two dye traces (Figure 2) provide an initial understanding of the ground water flow pattern in the area. The results reveal that in this portion of the basin, a dispersive ground water flow pattern exists between areas of aquifer recharge and springs located along Econfinia Creek. This pattern is demonstrated in the first trace by the recovery of dye at seven different monitoring sites (Figure 3) representing approximately 20 springs located along one mile of Econfinia Creek. Dye introduced during the second trace was recovered at three different monitoring sites (Figure 4) representing 11 known springs located along one half mile of Econfinia Creek.

NOTE : LINES REPRESENT FLOW CONNECTIONS ONLY, NOT FLOW PATHS.

The results of the traces do not allow definitive basin boundaries to be drawn. They do however demonstrate that groups of springs share a common springshed within the larger more general Floridan Aquifer zone of contribution delineated in the 1997 District study. To more closely define these individual springsheds, it will be necessary to introduce dye at points located between the introduction points in this and future studies. A more general recommendation is to focus dye introduction in areas that would test the 1997 delineation. Testing this boundary could reveal areas that lie outside of the currently delineated ground water basin. These areas could then be purchased as public lands for further protection of the resource.

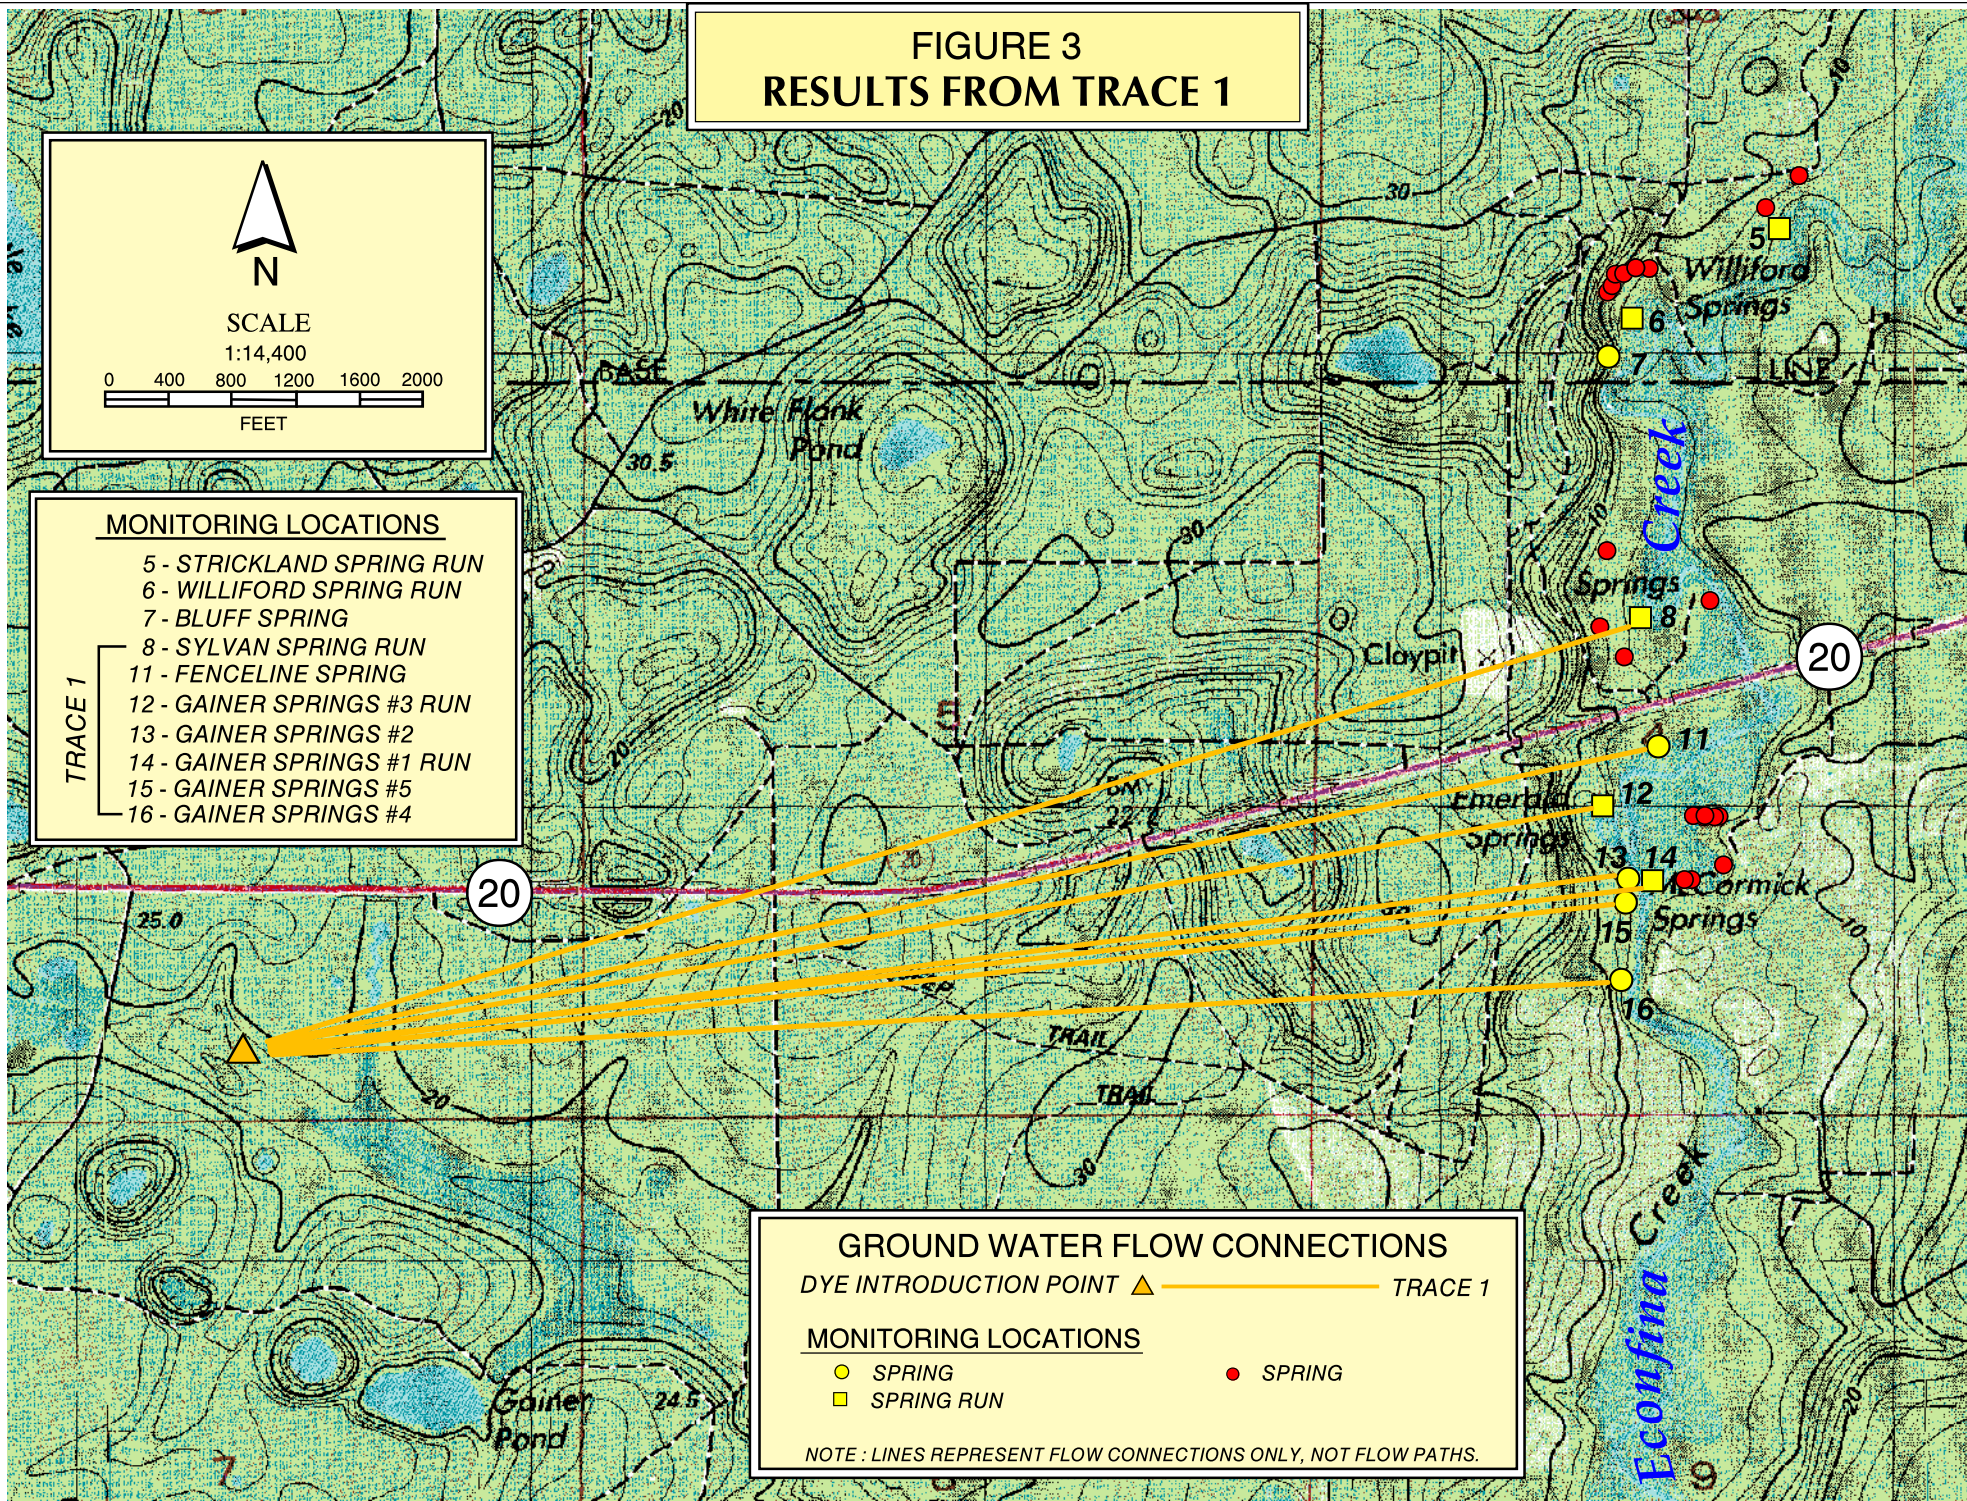
FIGURE 3  
RESULTS FROM TRACE 1

- 5 - STRICKLAND SPRING RUN
- 6 - WILLIFORD SPRING RUN
- 7 - BLUFF SPRING
- 8 - SYLVAN SPRING RUN
- 11 - FENCELINE SPRING
- 12 - GAINER SPRINGS #3 RUN
- 13 - GAINER SPRINGS #2
- 14 - GAINER SPRINGS #1 RUN
- 15 - GAINER SPRINGS #5
- 16 - GAINER SPRINGS #4

NOTE : LINES REPRESENT FLOW CONNECTIONS ONLY, NOT FLOW PATHS.

On March 22, 2004, three-and-one-half pounds of a 25 percent solution of eosine (diluted to two gallons) were introduced through a swallet southeast of Bay Gall (Appendix D). The dye was released with a peristaltic pump over a fifteen minute period to a small stream discharging into the swallet.

Analysis of the first post-introduction exchange dated March 25 reported eosine recoveries in charcoal and water samples at Sylvan Spring run, Fenceline Spring, and Gainer Springs 1, 3, and 5. Although the charcoal samples were lost, eosine was recovered in the water samples from Gainer Springs 2 and 4.

The second post-introduction exchange dated April 1 showed eosine recoveries at Sylvan Spring run, Fenceline Spring, and Gainer Springs 1-5. No conclusive recoveries were reported for the water samples collected on this date.

The third post-introduction exchange dated April 8 showed recoveries of eosine in charcoal samples at Sylvan Spring run, Fenceline Spring, and Gainer Springs 1, 2, 4, and 5. The detector for Gainer Springs 3 was lost. Due to the lack of recoveries in the water samples from April 1, they were no longer collected for trace 1.

The exchanges dated April 15, 22, 29, and May 5 show eosine recoveries from charcoal were restricted to the five Gainer Springs. Reports and intensities of recoveries at the individual

springs decreased as weeks progressed. The limited recovery from the May 5 exchange demonstrated that all but a minimal quantity of eosine had exited the system prior to the second dye introduction.
