## COTTON CREEK MITIGATION SITE

Monitoring Report No. 2 (2016)

4 November 2016

Date of Inspection: 10/28/2016

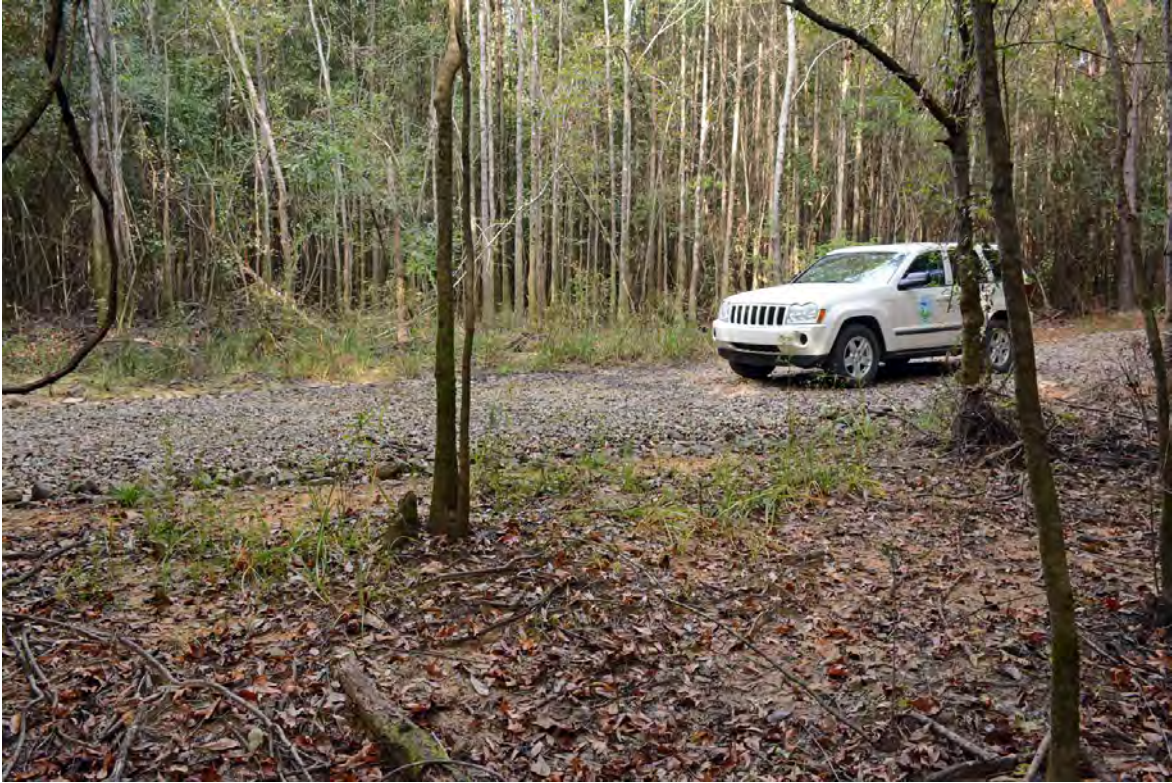
Cotton Creek Road LWC (10/28/2016)

Raised above natural grade, Cotton Creek Road bisected a palustrine forested slough and disrupted natural hydrologic flows and moisture regimes. The low-water-crossing designed to enhance the hydrology of adjacent wetlands was installed in July 2015. An inspection by NFWFMD staff on October 28, 2016 concluded that the low-water-crossing was functioning as designed, and that natural hydrologic flows had been reestablished. The forested slough appears ecologically healthy; no exotic or nuisance vegetation was noted. Annual monitoring inspections will continue through 2020 or as directed by the USACE. In the event of failure of the low-water-crossing, remedial action will be taken.
