**2017 Monitoring Report**

**YELLOW RIVER RANCH  
Santa Rosa County, Florida**

ERC #: 17-196C

October 2017

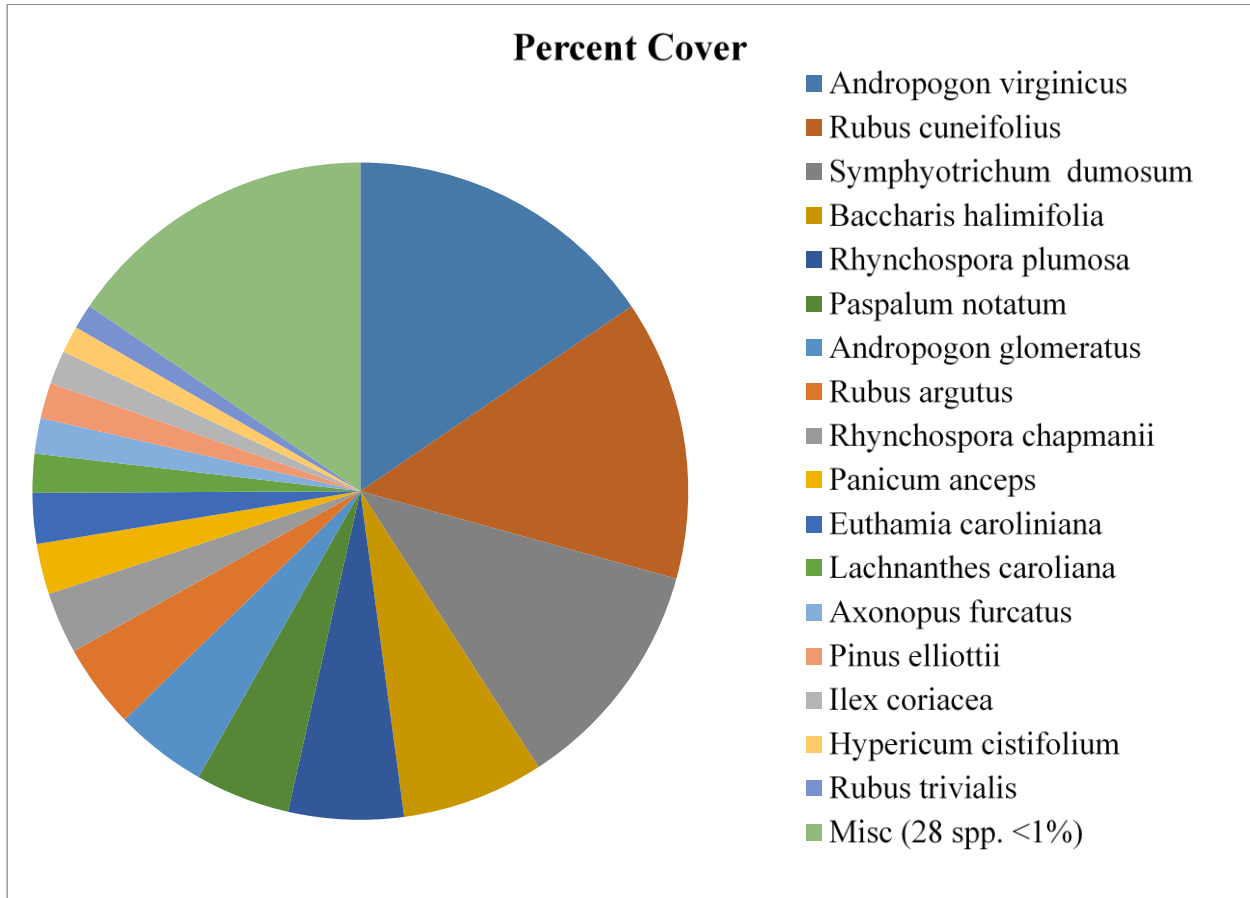
2017-YRR-T1-625

### Graphical Depiction of Percent Cover for Transect YRRT1-625 Hydric Pine Flatwoods

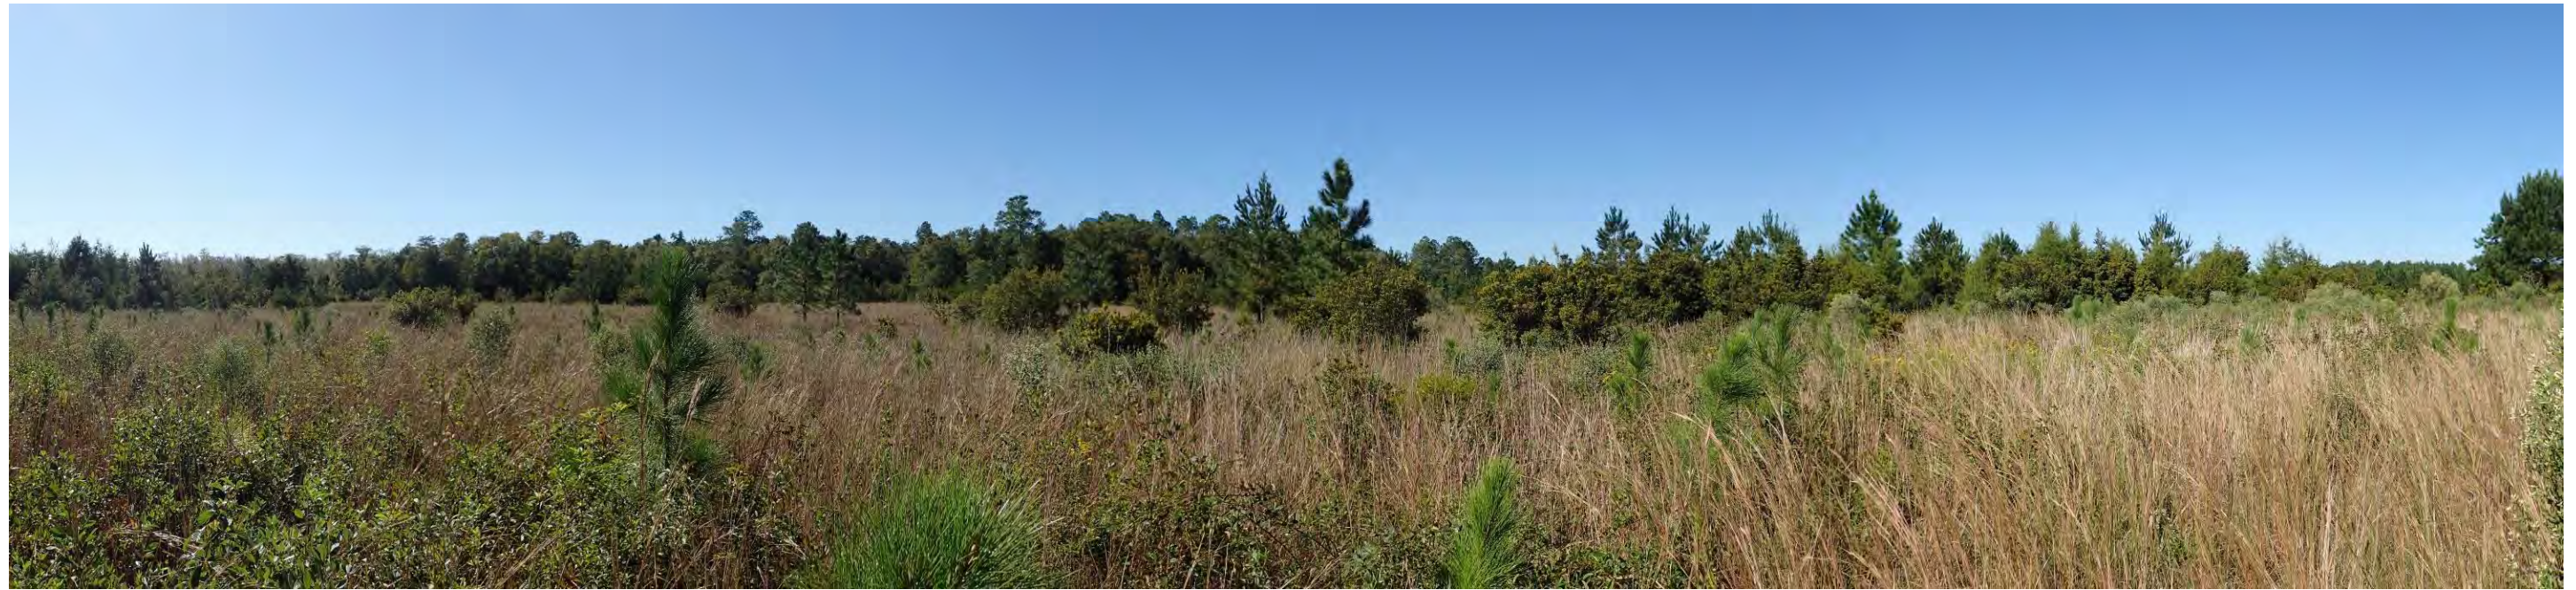
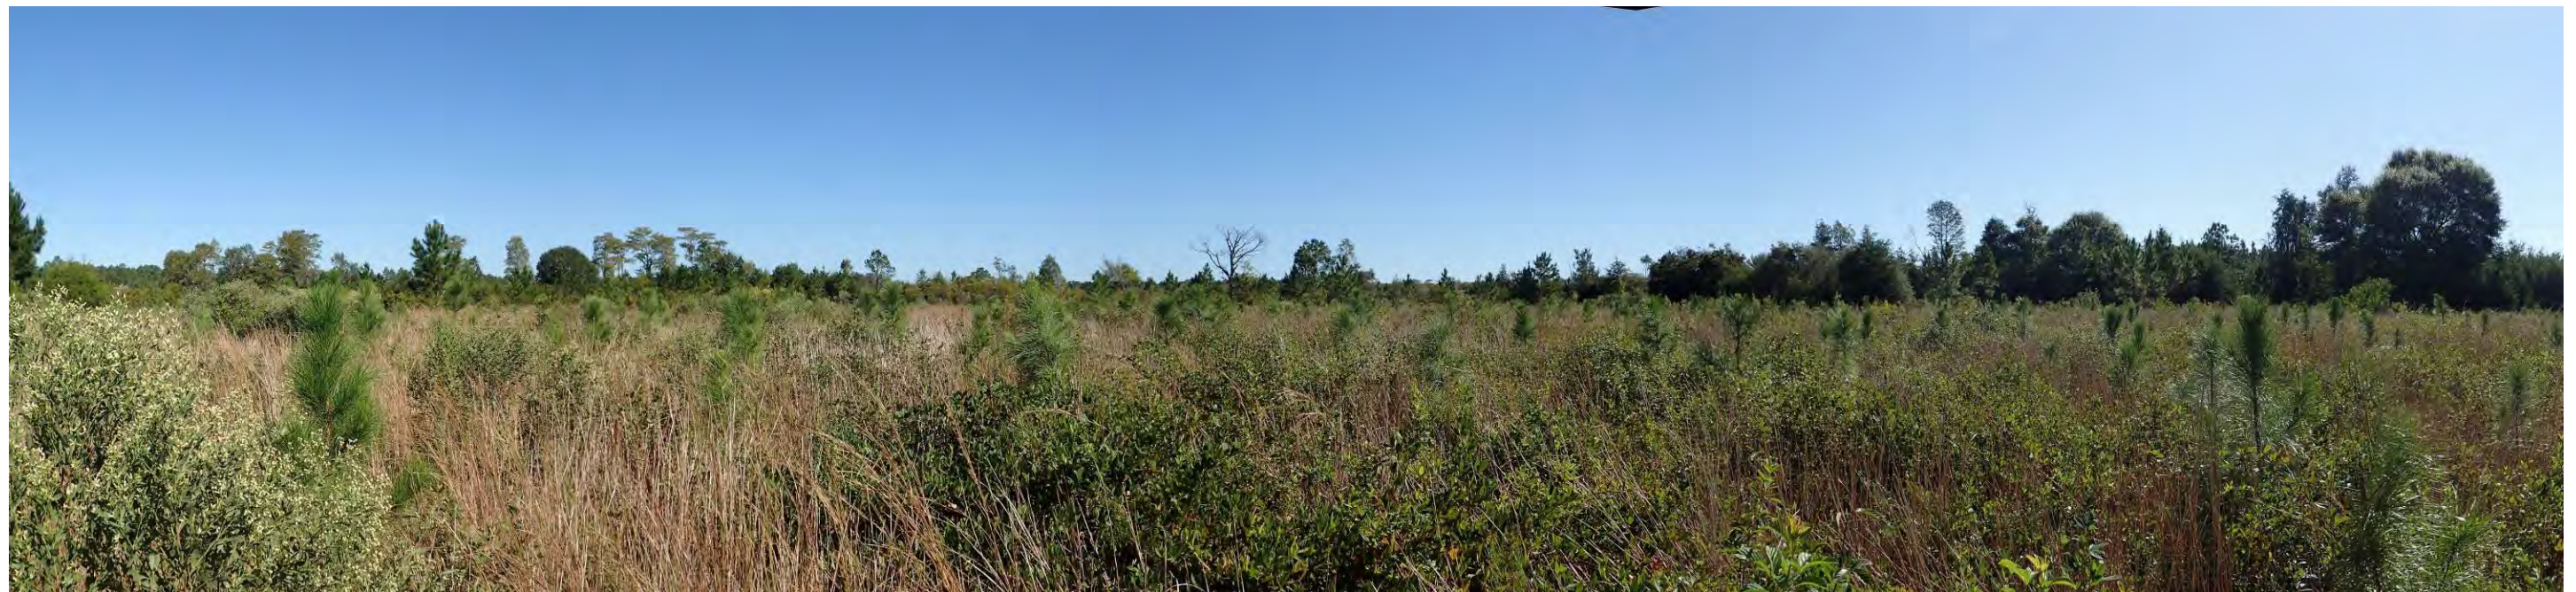
**Yellow River Ranch Quantitative Transect YRR-T1-625: Panoramic Photograph depicted in two 180 degree sections.**

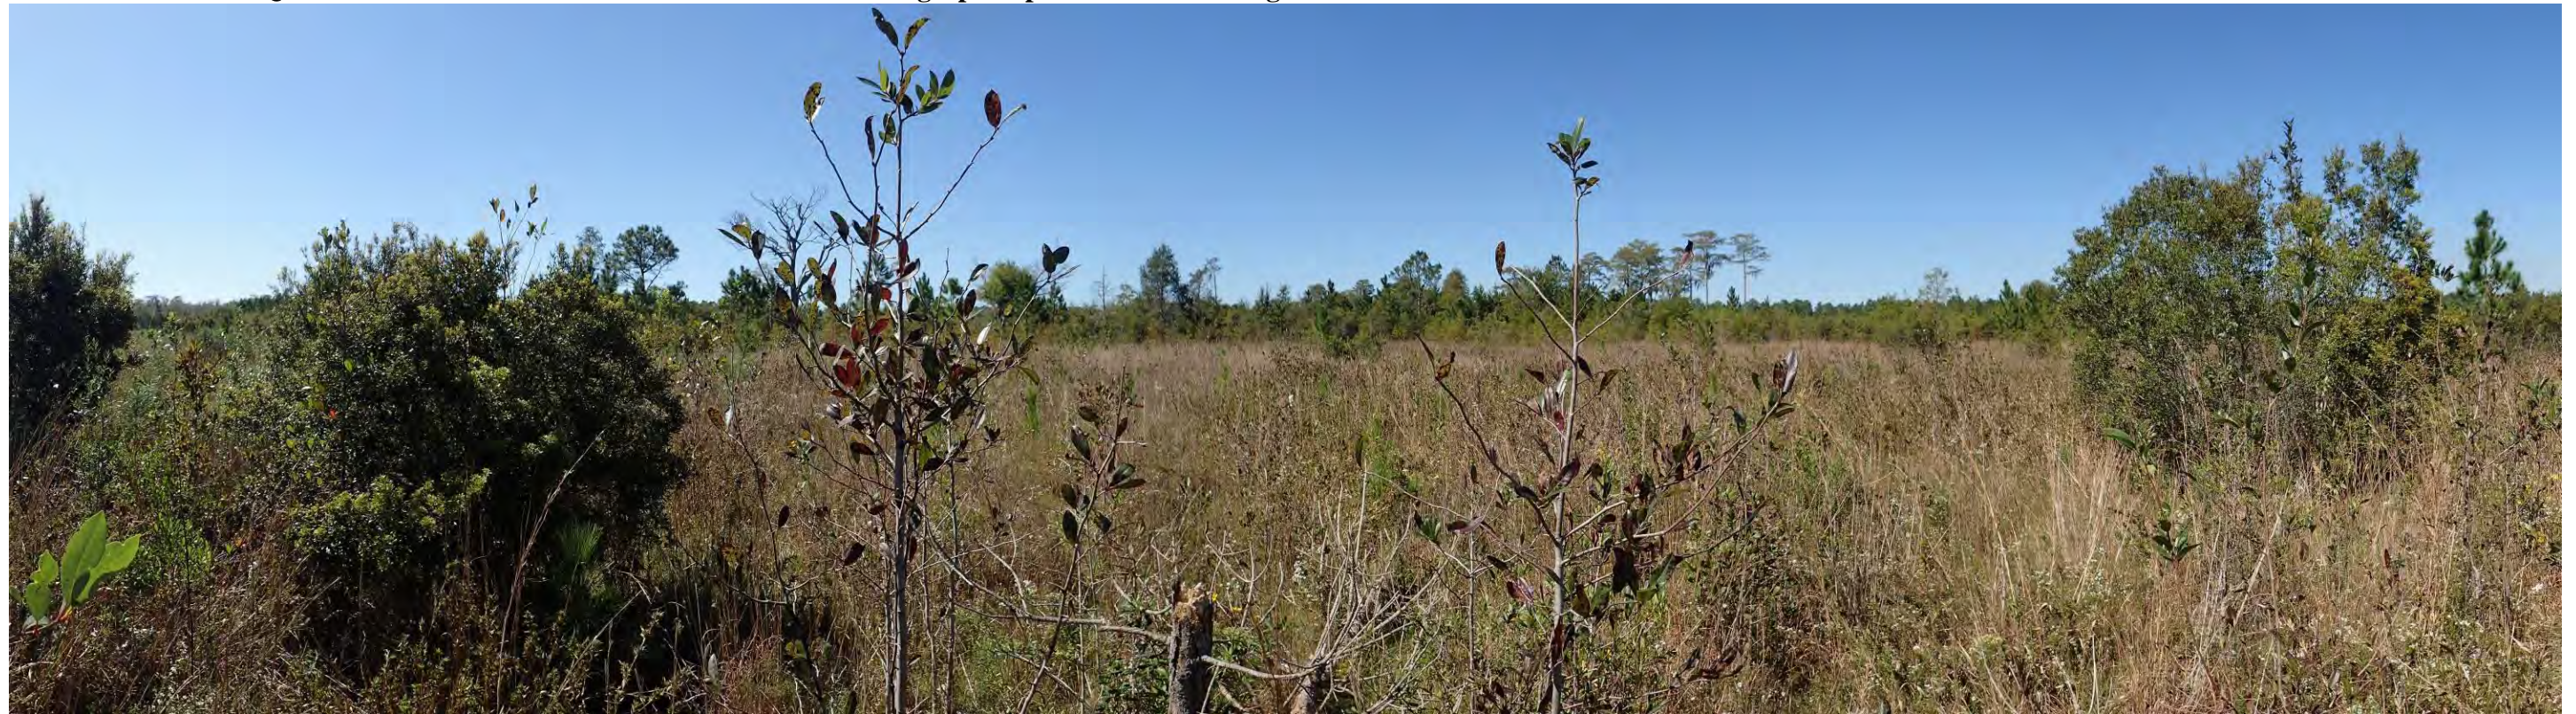
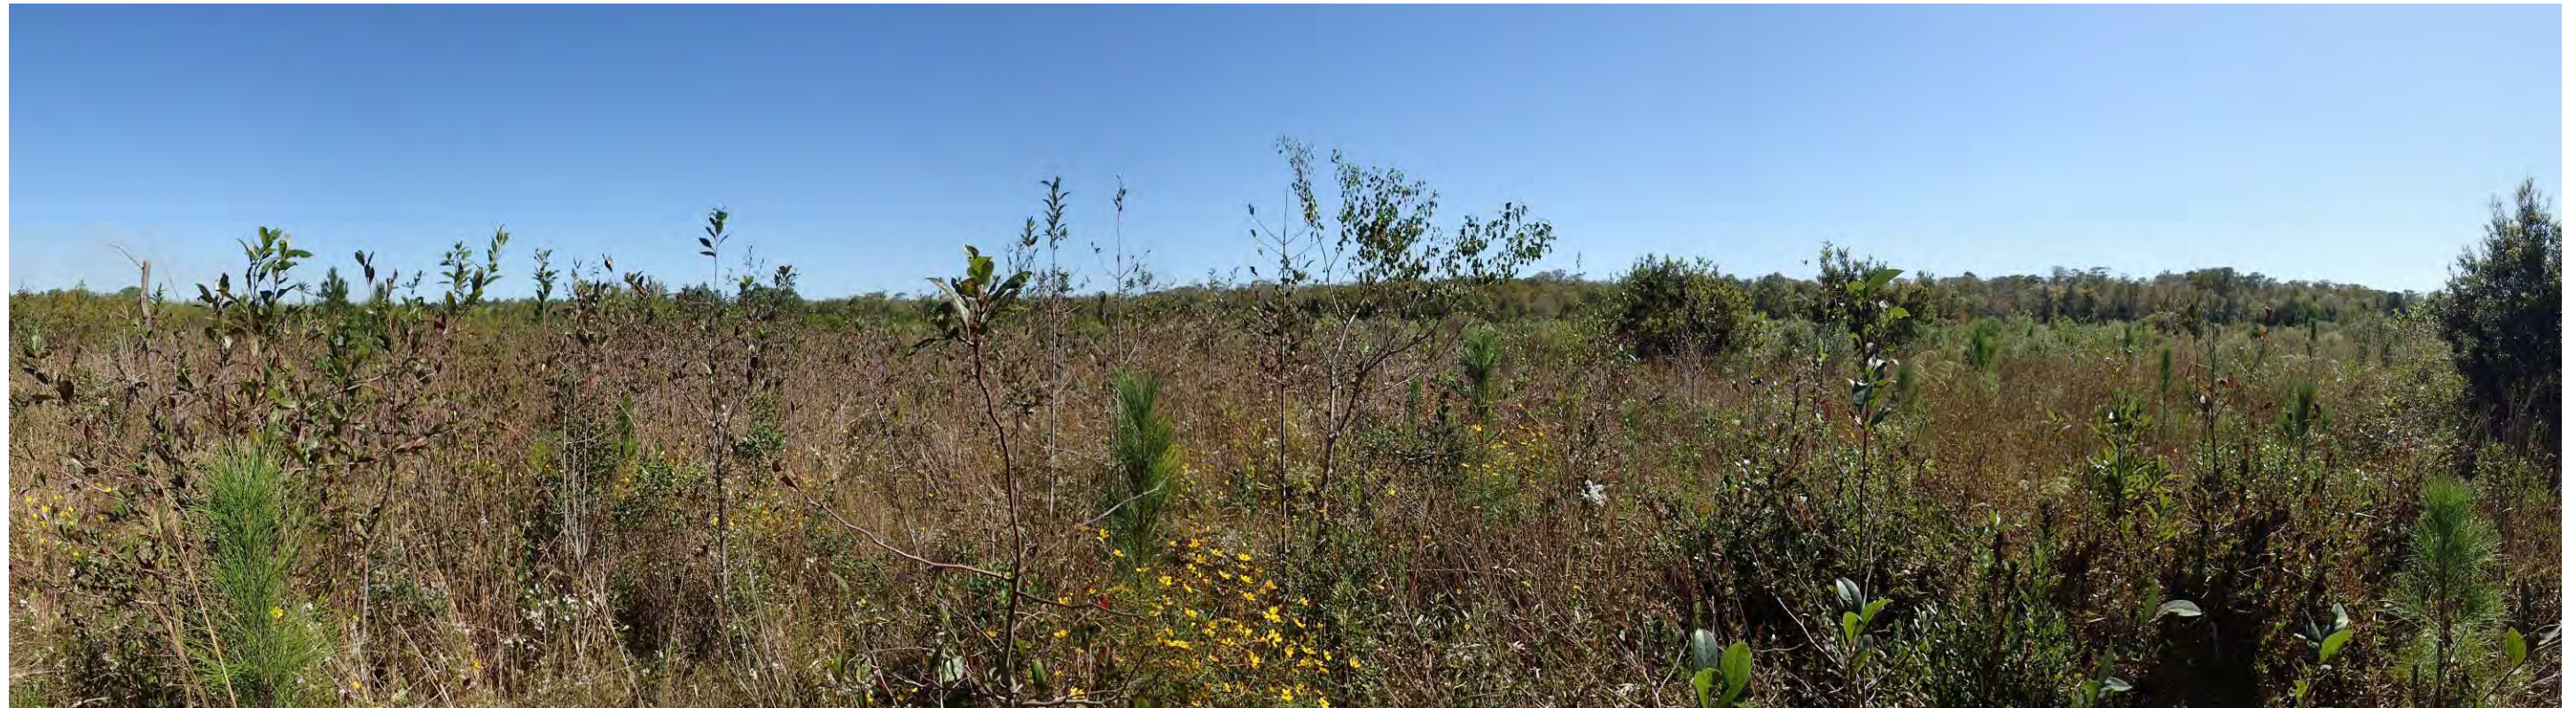
Yellow River Ranch Quantitative Transect YRR-T2-625: Panoramic Photograph depicted in two 180 degree sections.

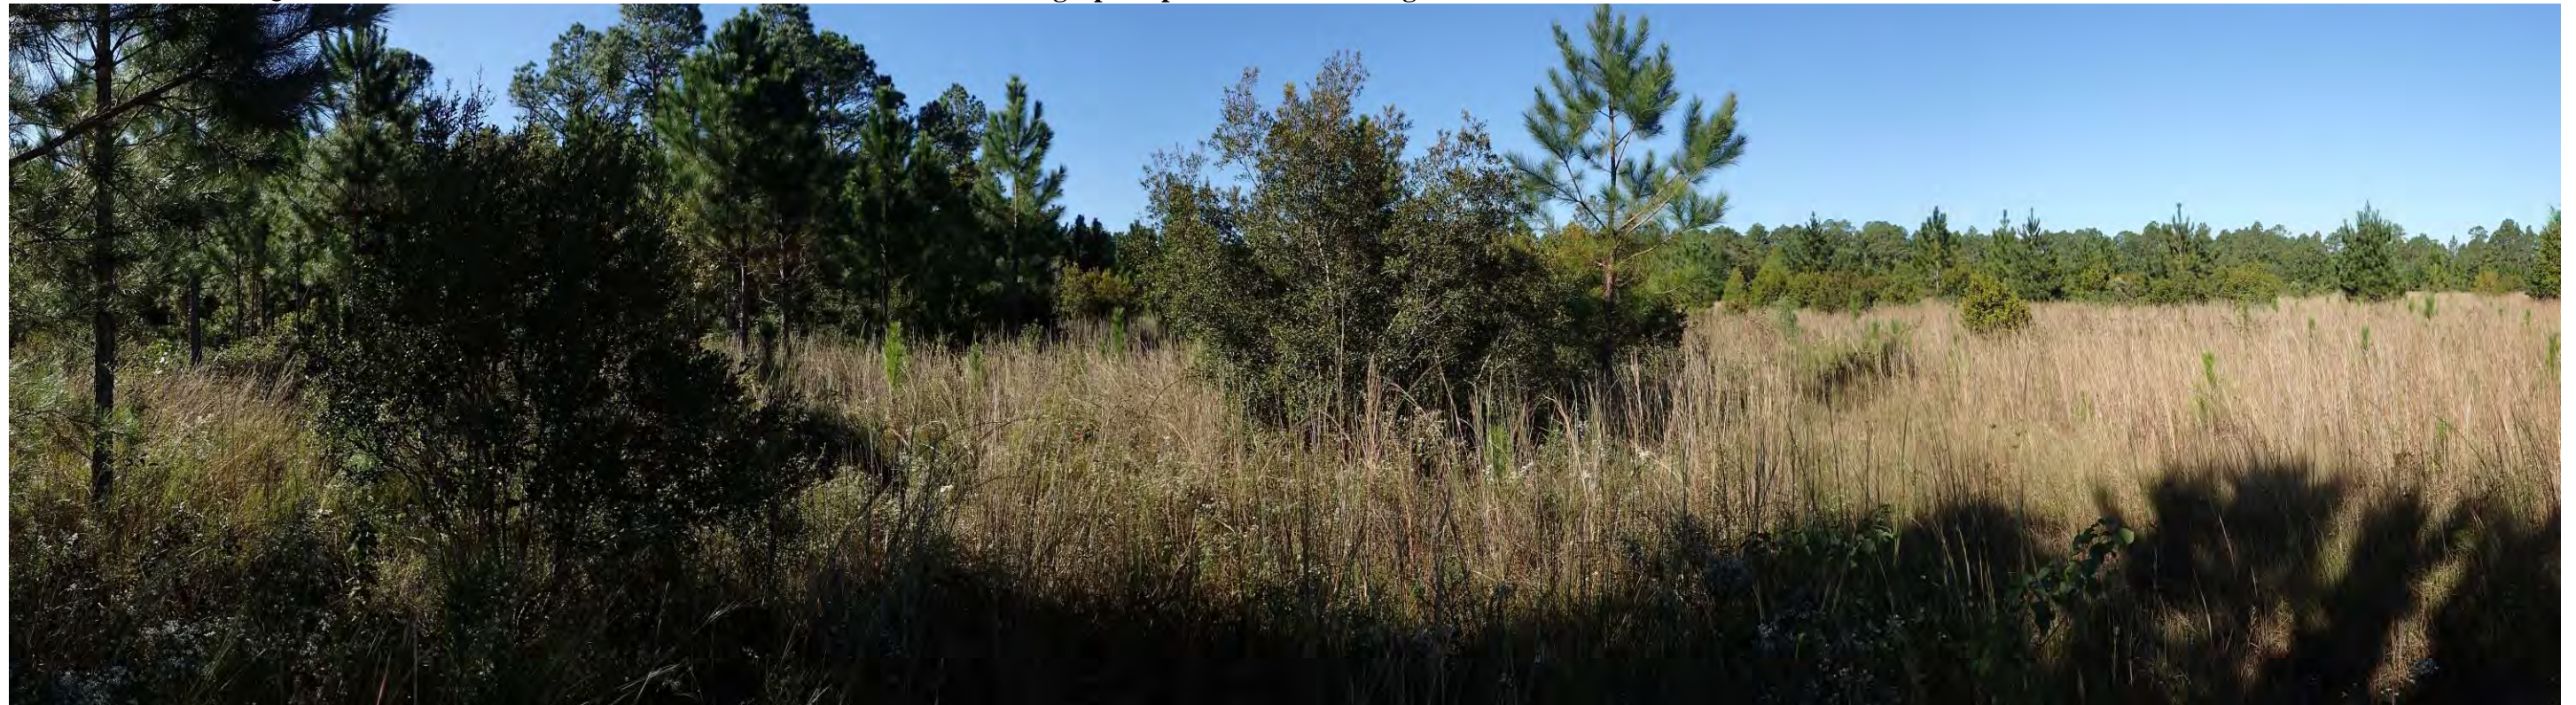
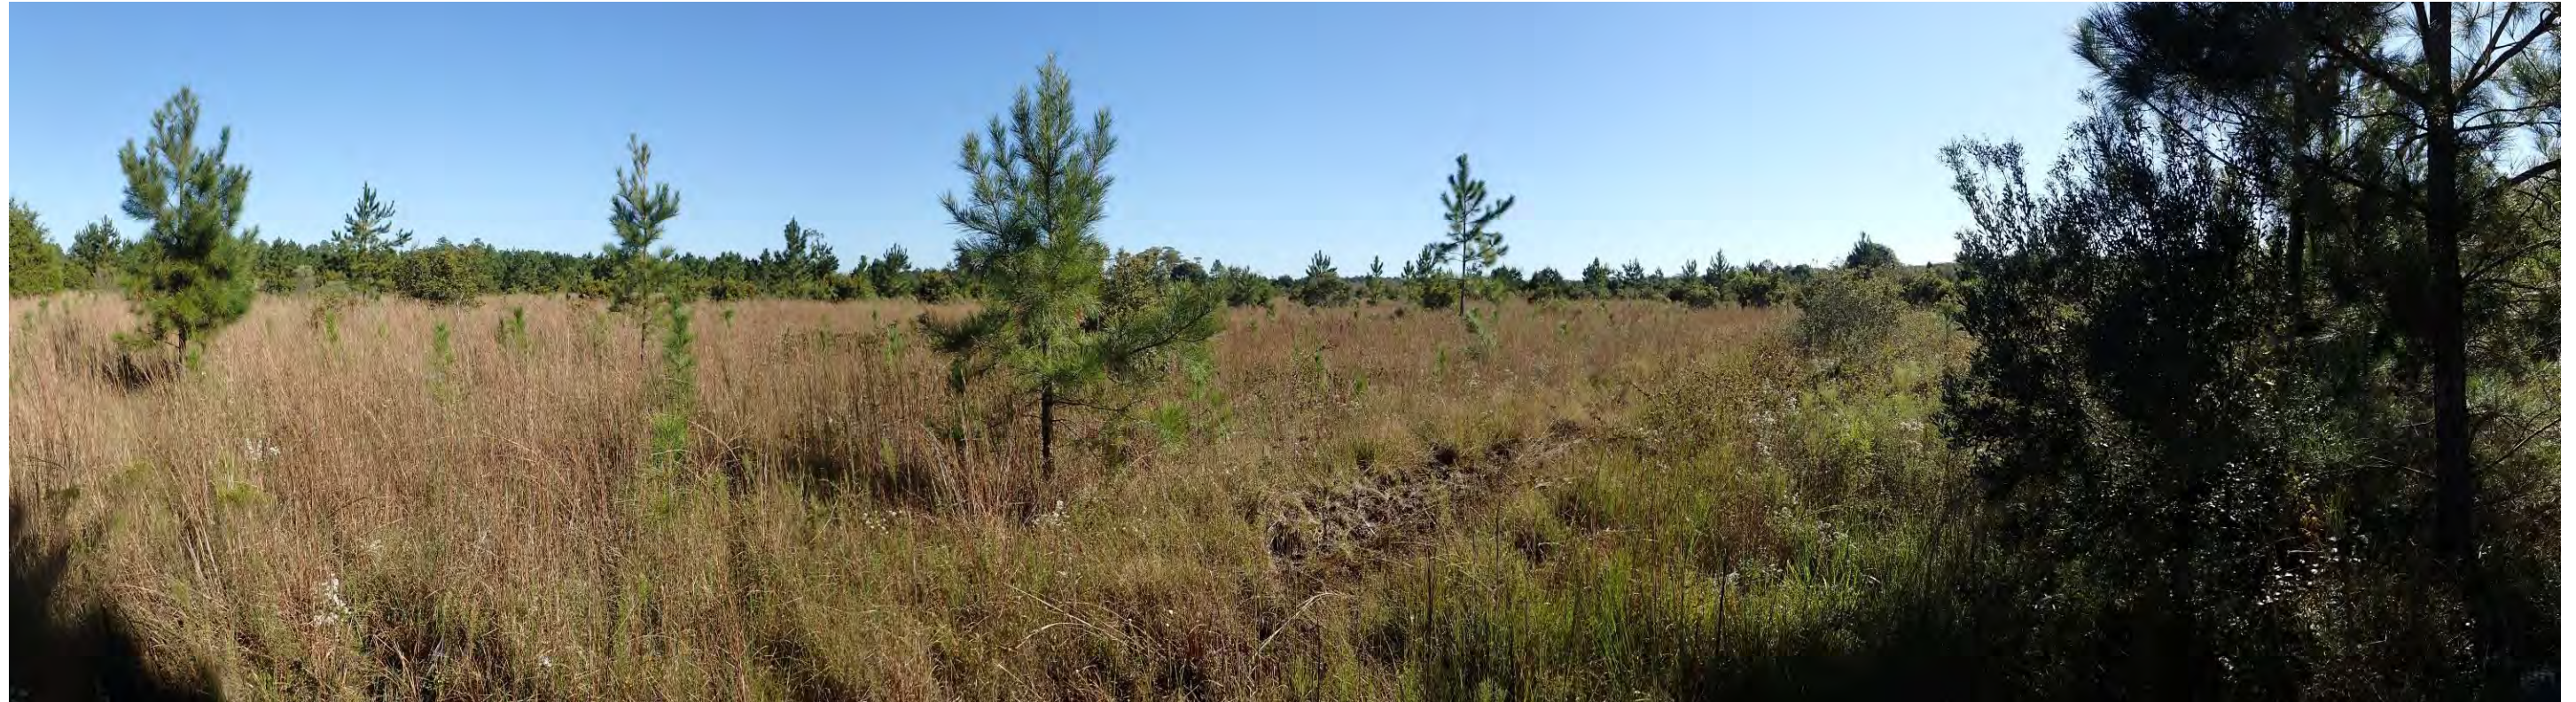
**Yellow River Ranch Qualitative Pedestrian Transect YRR-PT1-625: Panoramic Photograph depicted in two 180 degree sections.**

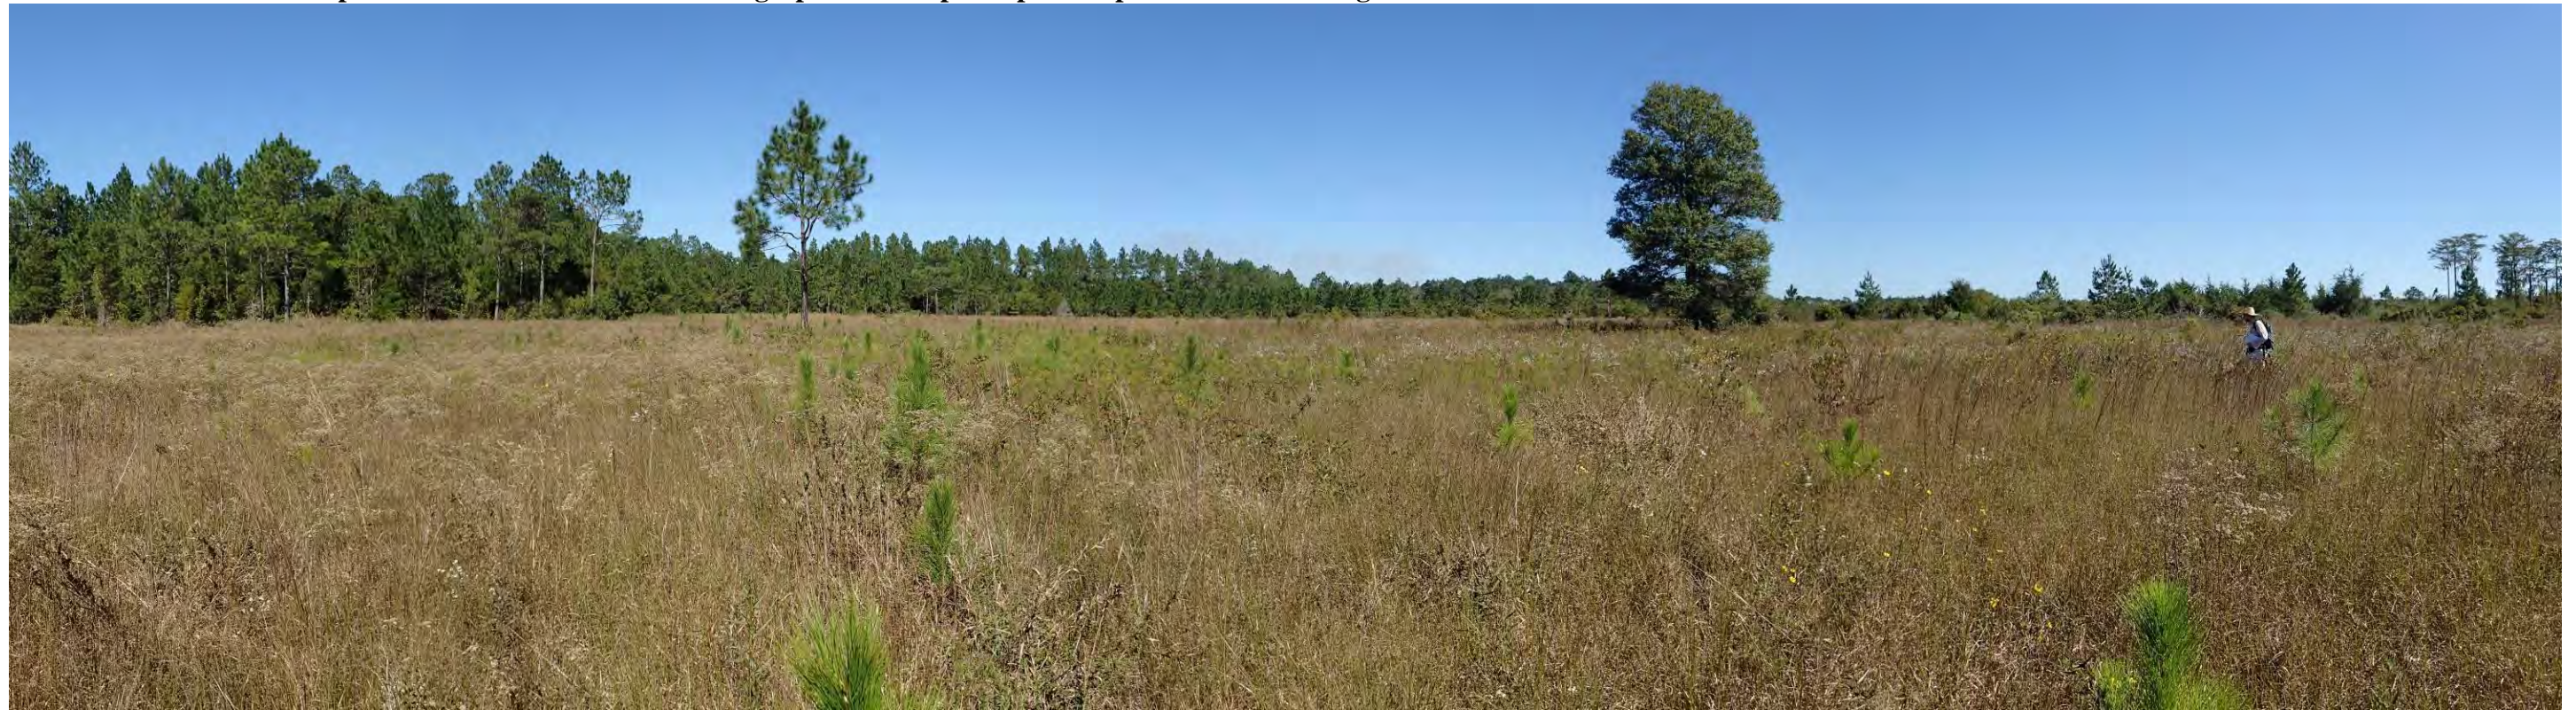
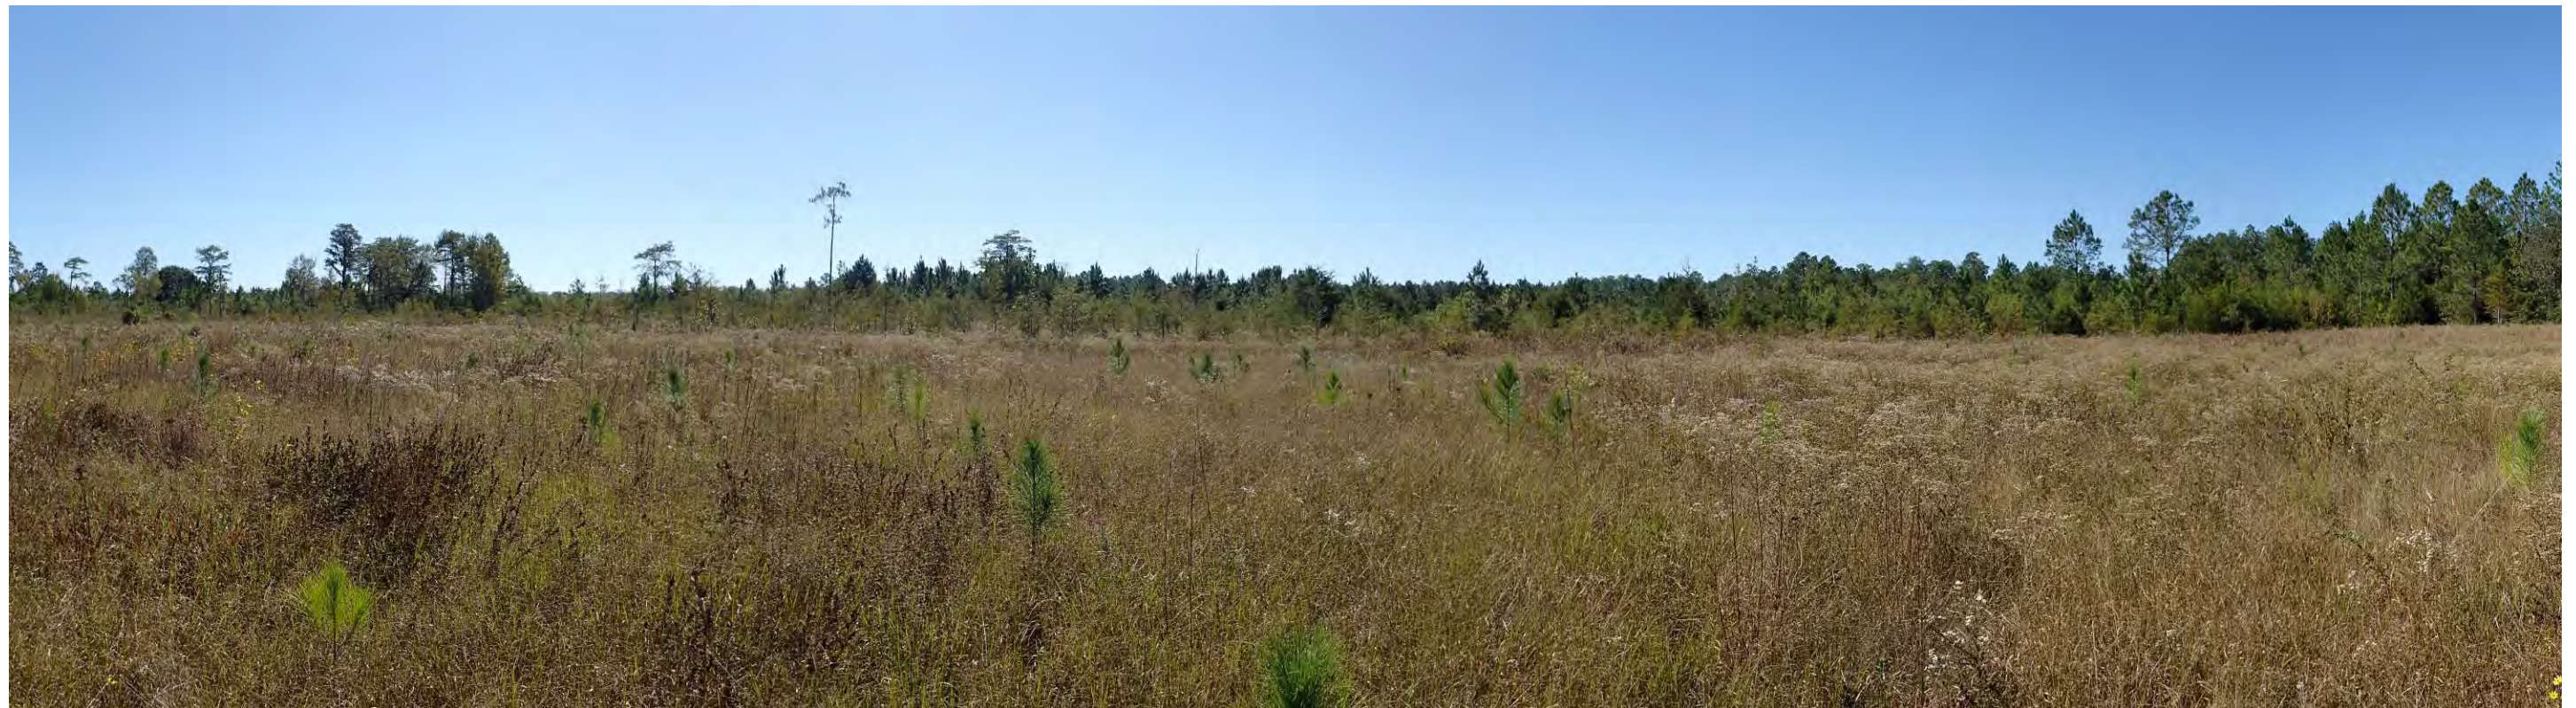
**Yellow River Ranch Photo point YRR-PP1: Panoramic Photograph taken at photo point depicted in two 180 degree sections.**

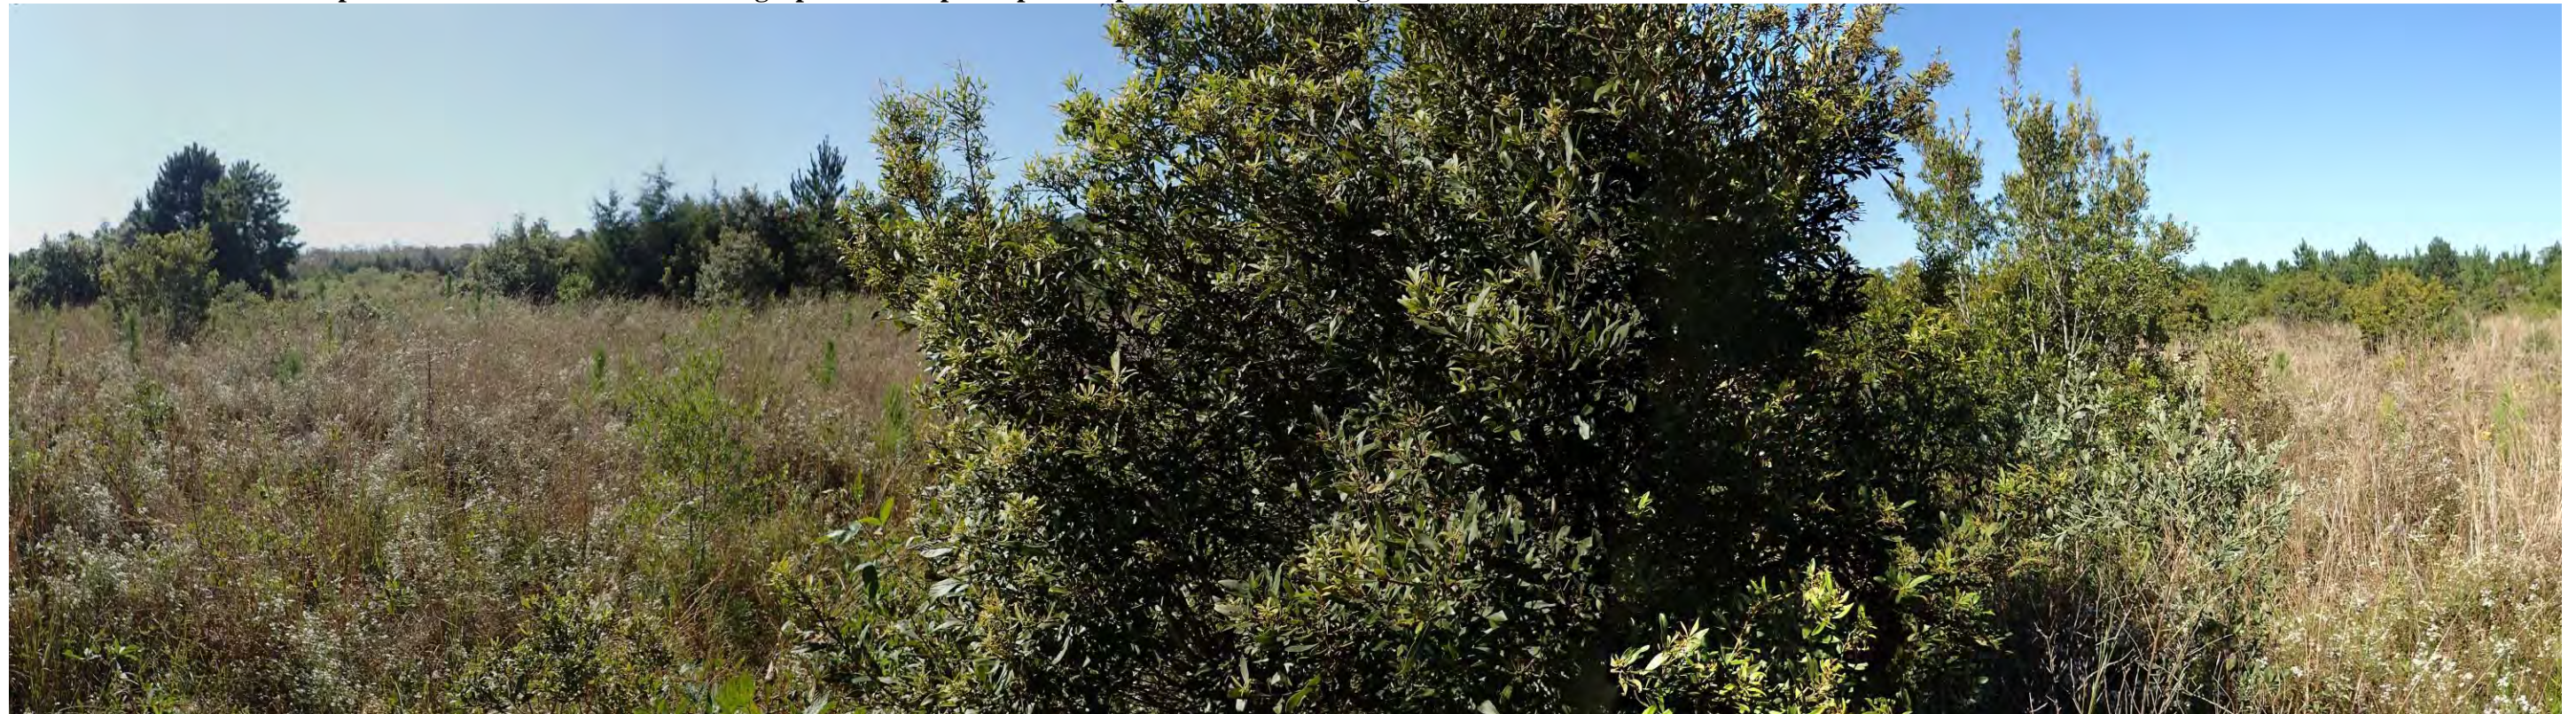
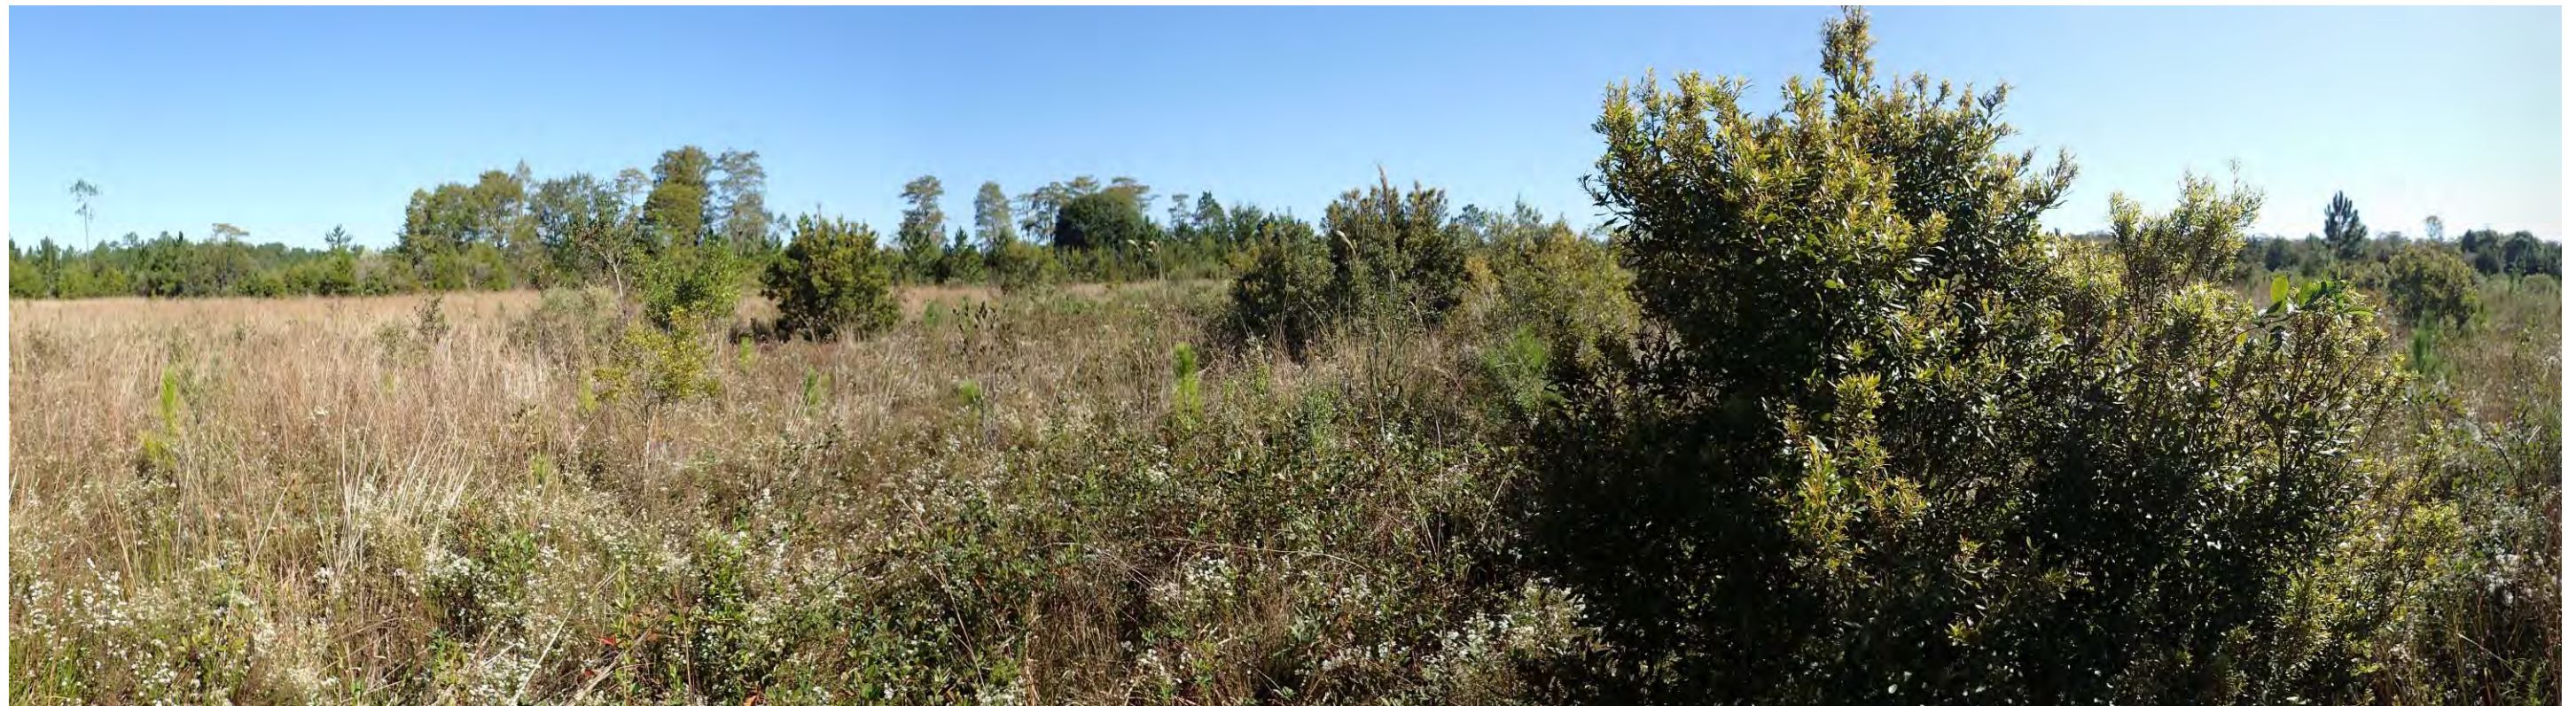
**Yellow River Ranch Photo point YRR-PP2: Panoramic Photograph taken at photo point depicted in two 180 degree sections.**

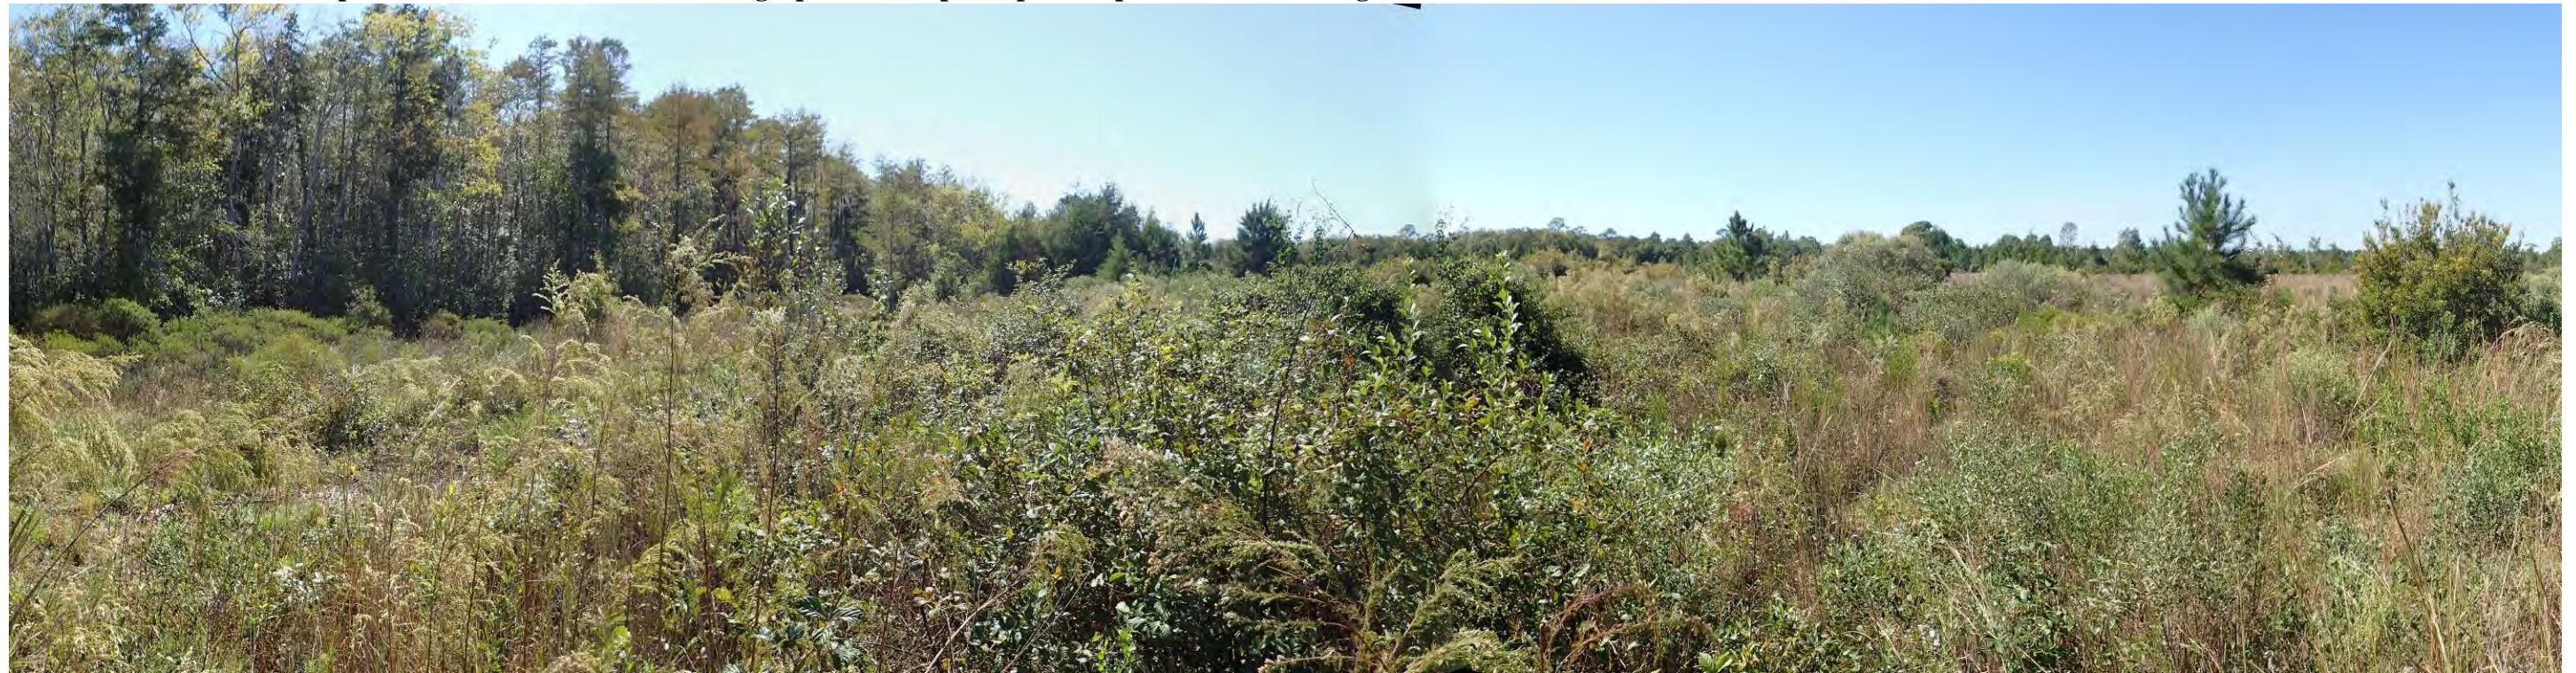
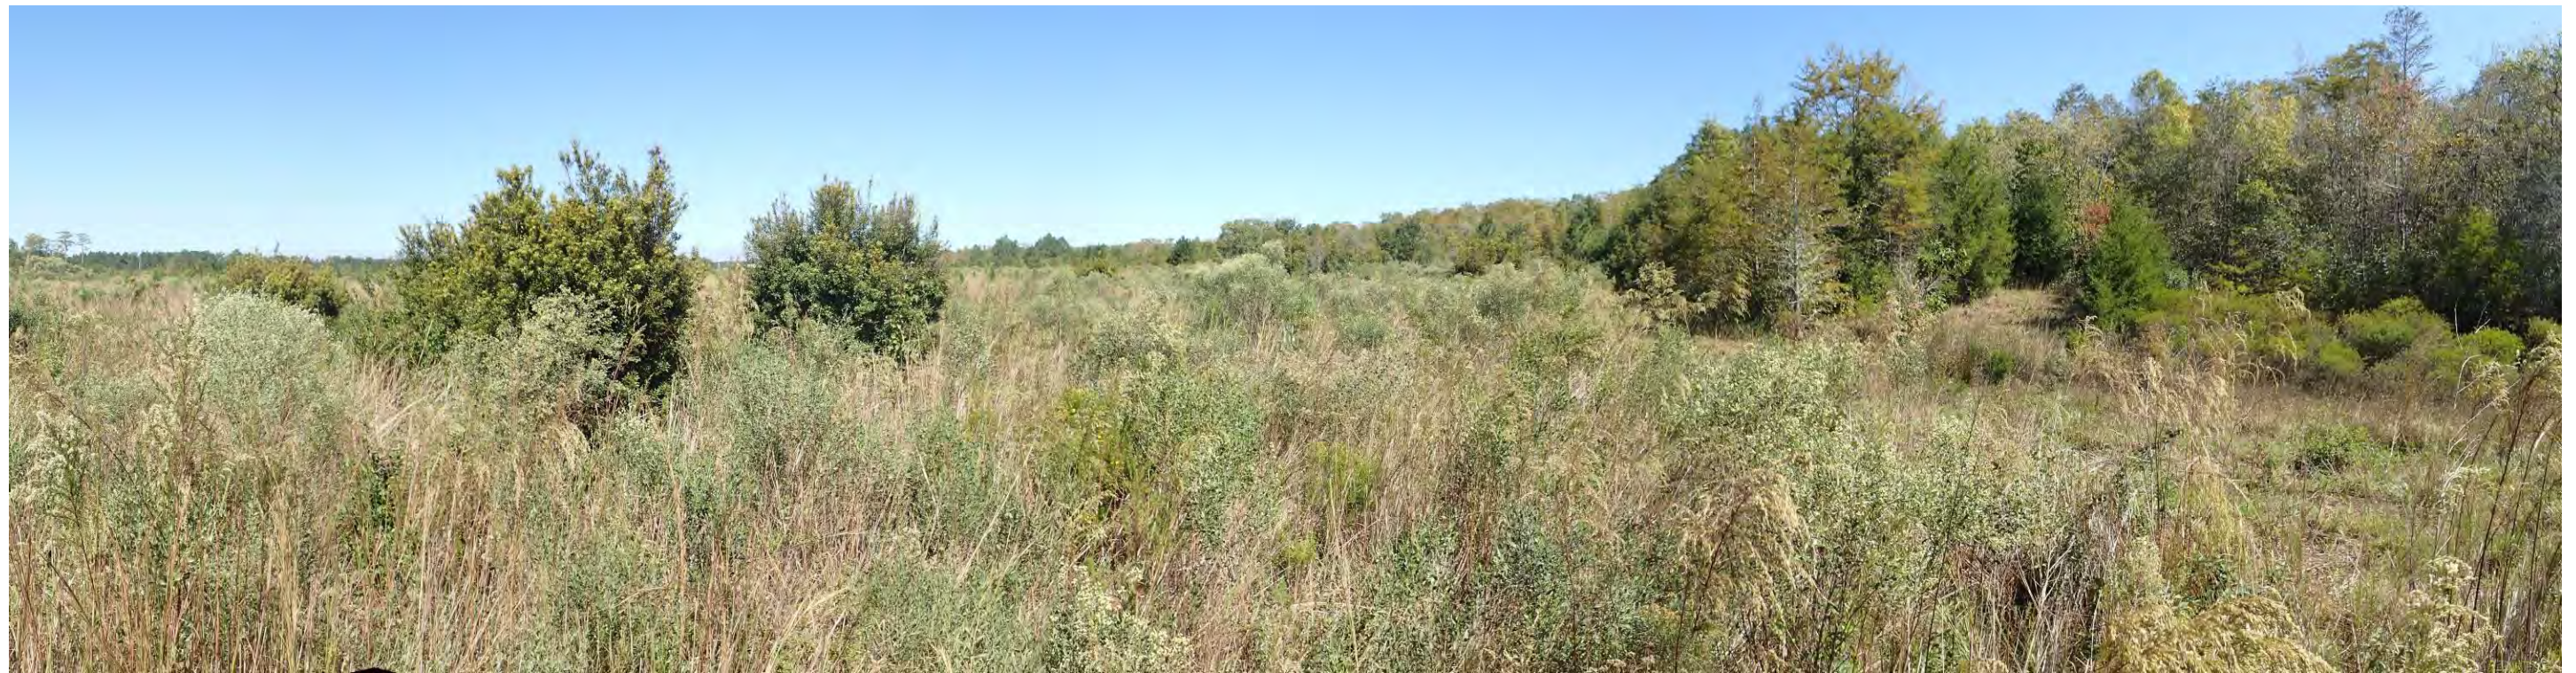
**Yellow River Ranch Photo point YRR-PP3: Panoramic Photograph taken at photo point depicted in two 180 degree sections.**
