Sand Hill Lakes Mitigation Bank Combined DEP/USACE Twelfth Annual Report

FDEP Permit # 0227351-001 Issued 9/6/2005, Washington County

**Northwest Florida Water Management District
Submitted by David Clayton
In support of Specific Conditions 26 and 28**

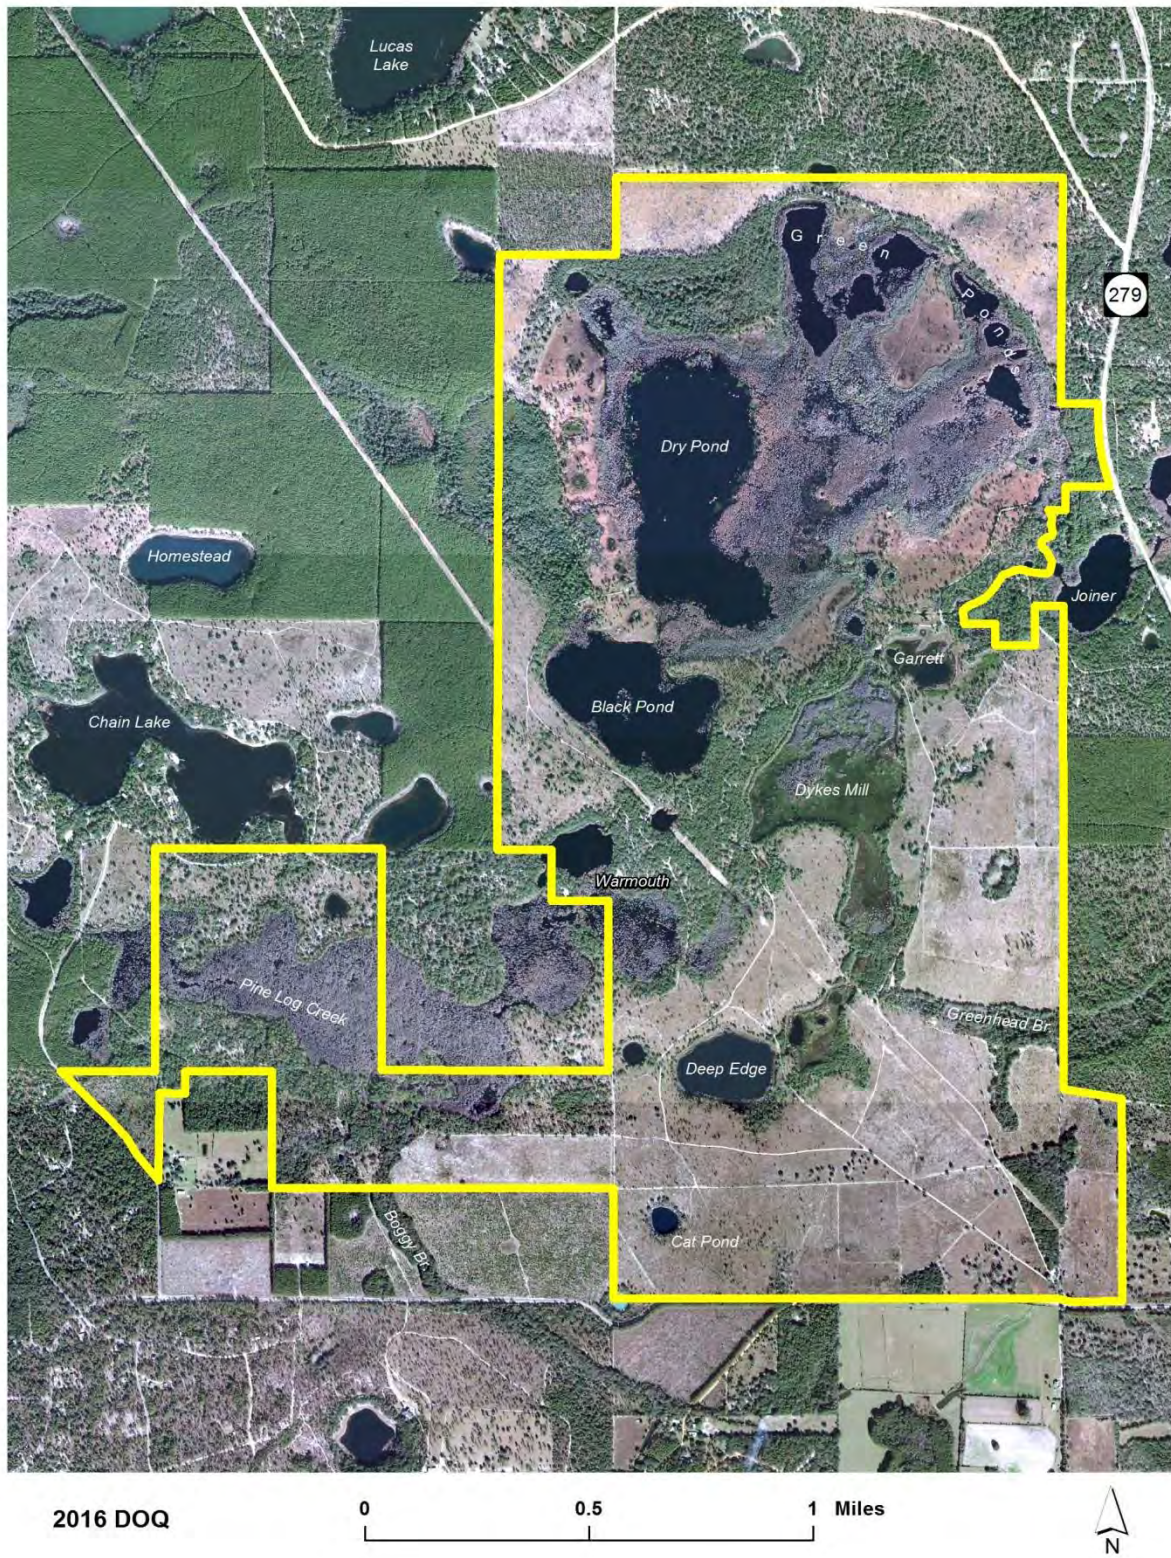
Figure 2. SHLMB boundary map

The Sand Hill Lakes Mitigation Bank (SHLMB) consists of 2,155 acres in southern Washington County in the Sand Hill Lakes region of the Florida Panhandle (Figure 1). It is located just west of the intersection of SR77 and SR 279, and is within Township 1 North, Range 14 & 15 West. The property contains 850 acres of wetlands including high quality cypress sloughs and strands, hydric pine flatwoods restoration, bayheads, seepage slopes, and approximately 155 acres of natural solution ponds and shallow, gently-sloped lakes connected by streams and ditches. The uplands consist of 1,150 acres of hardwood oak communities and sandhill enhancement and sandhill restoration (Figure 2).

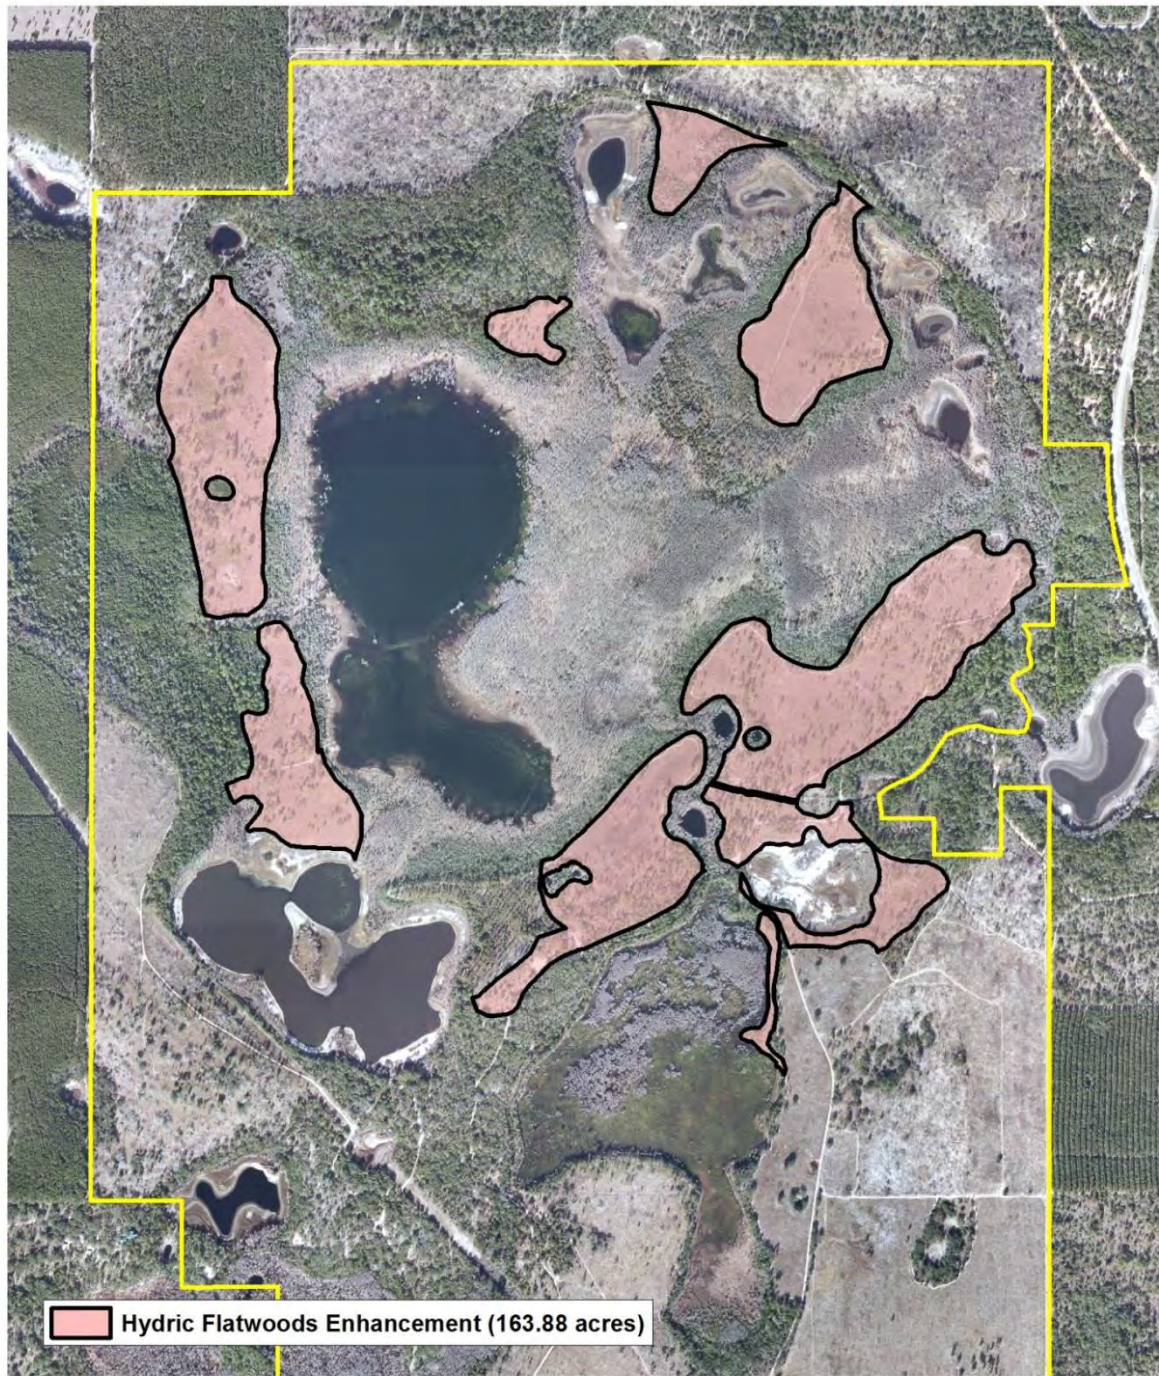
Figure 7. Hydric pine flatwoods restoration areas

According to the permit requirements, 147 acres of wet flatwood restoration was scheduled to occur at the SHLMB, UMAM Polygon V. However, District staff identified an additional 16.88 acres that were historic wet flatwoods and added this acreage to UMAM Polygon V for a total acreage of 163.88 acres of wet flatwoods restoration (Figure 10). Standing biomass of shrubs (primarily titi, gallberry and fetterbush) was reduced to ground level with the use of a Gyro-Trac followed by winter burns. The Gyro-Trac work was initiated on March 13, 2007, and was completed by August 20, 2008. The Gyro-Trac areas were burned following the shrub reduction. Annual herbicide treatments for three years reduced shrub cover to less than 2%. These areas have maintained less than 2% cover of nuisance shrubs with the use warm season burns on a two year interval. The hydric pine flatwoods were planted with 1.18 million wiregrass plants, 182,700 cut over muhly grass, 122,600 toothache grass and 72,600 mixed

hydric pine flatwoods wildflowers. All plantings were conducted in accordance with Specific Condition 10 and Appendix D. The hydric pine flatwood community continues to develop and increase in cover and diversity.

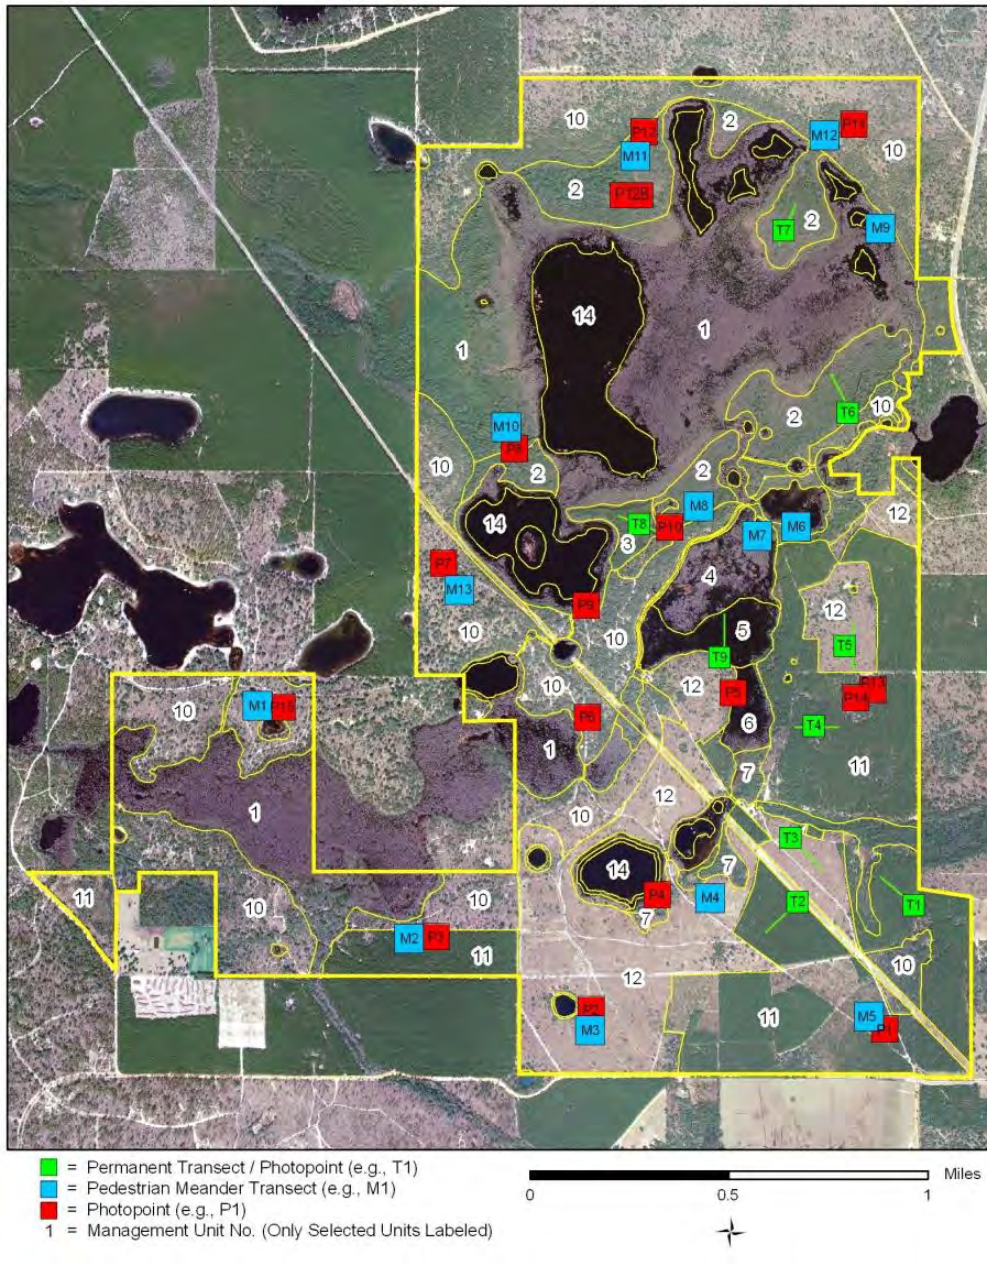
Figure 8. Monitoring locations

Tree density was monitored using the “line strip” (belt transect) technique. Transects were co-located with each vegetation transect. The belt transects will be 600± feet in length and 30± feet in width. Within each belt transect the height and condition of each planted tree was recorded.

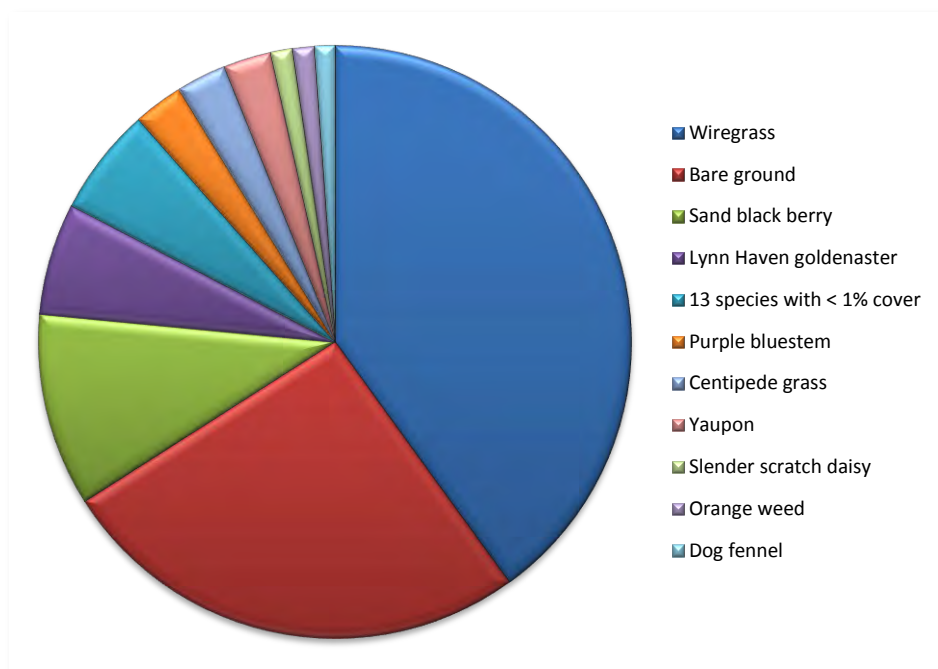
Figure 9. Transect 1: Species Cover and Occurrence (Pine plantation restored to sandhill)

During the 2017 monitoring, 22 species were observed in Transect 1, 27 in Transect 2, and 26 in Transect 4 (Tables 4-6; Figures 12-14). Wiregrass had the greatest vegetative cover for each transect ranging from 46.2% in transect 1 to 20% in Transect 2 and 26% in Transect 4. Bare ground ranged from 17% in Transect 1 to 36% in Transect 2. Species diversity greatly increased from the previous year probably due to a recovery from the late season fire. Wiregrass cover also increased for each site as well as a reduction in bare ground.

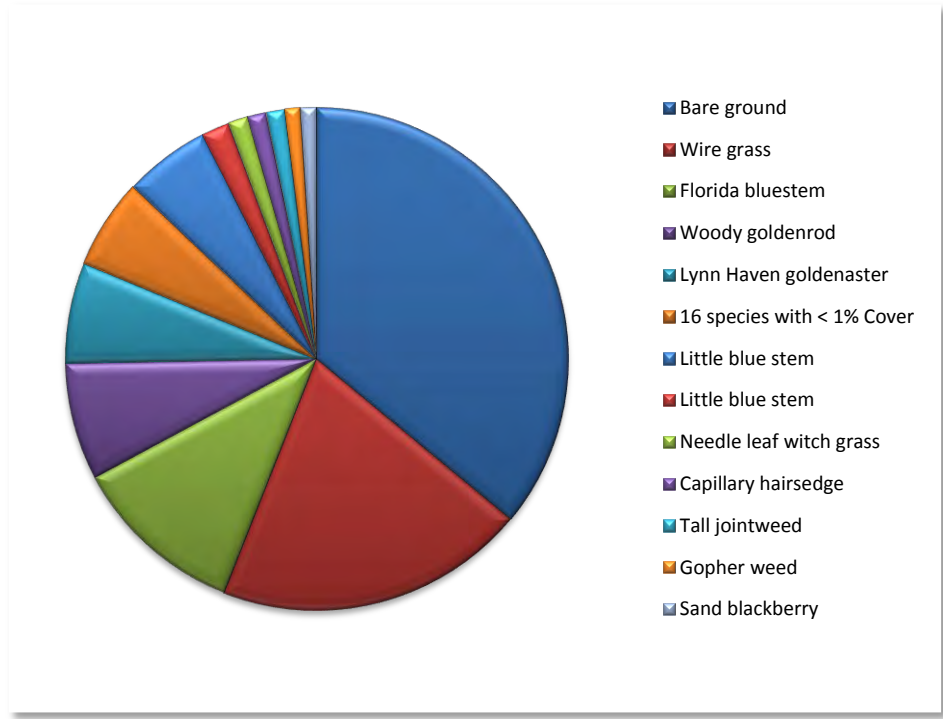
Figure 10. Transect 2 Species cover and occurrence (Sandhill Restoration)

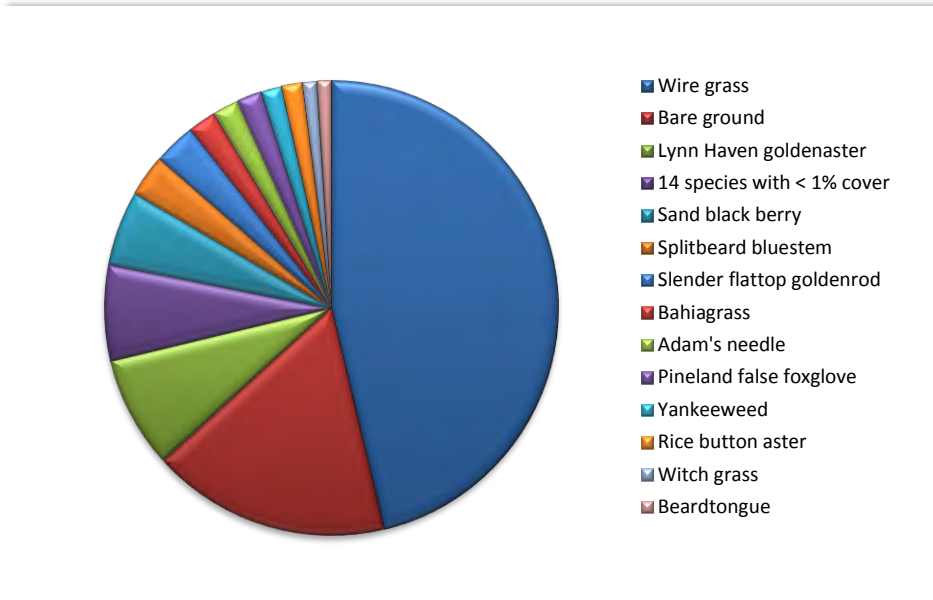
Figure 11. Transect 4 Species Cover and Occurrence (Sand Pine Plantation Restored to Sandhill)

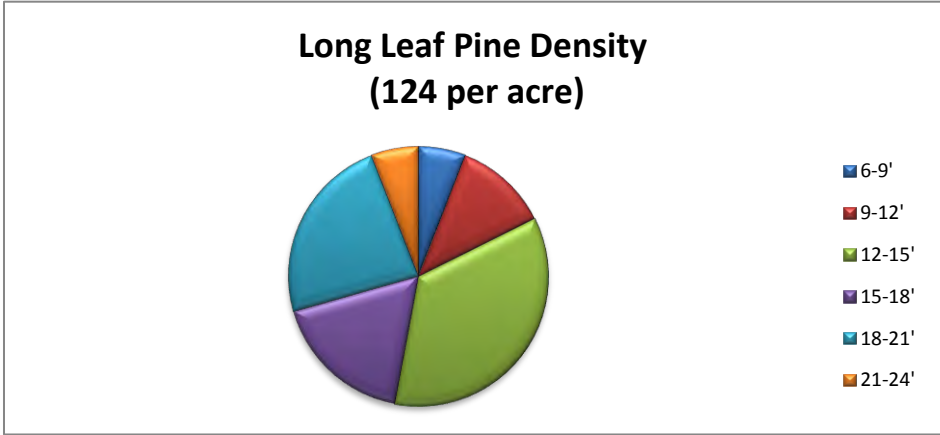
Figure 12. Planted longleaf pine seedlings (Transect 1)

Longleaf pine seedlings were planted in the sandhills at a rate of 436 trees per acre. Permit conditions require a maximum average of 200 longleaf pine trees per acre. Planted tree densities are determined by counting all the seedlings in a 30' X 600' plot co-located with each transect and converting to trees per acre. All tree seedlings counted and measured by size class and notes on tree condition are included. The survival of longleaf pine seedlings along each transect was observed to be trees between 91 and 167 trees per acre. Overall health of the planted seedlings was excellent. Most trees were 12-15 feet in height and the average diameter and breast height (DBH) is six inches (Figures 15-17).

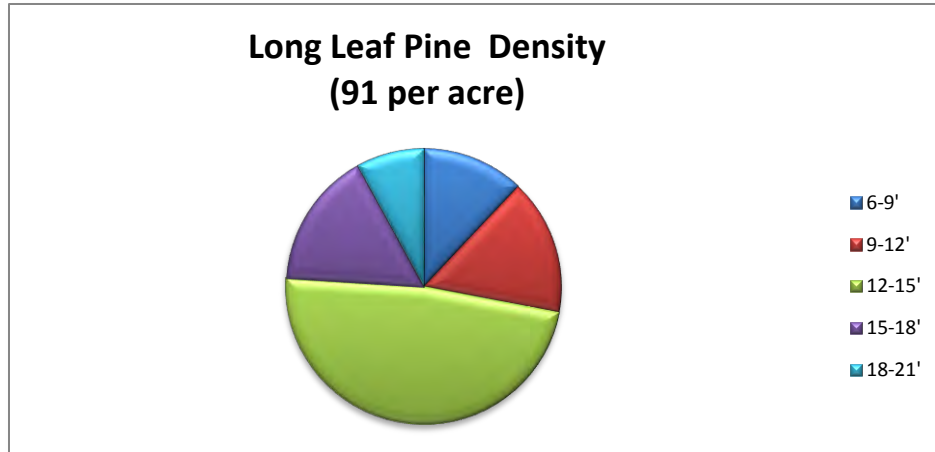
Figure 13. Planted longleaf pine seedlings (Transect 2)

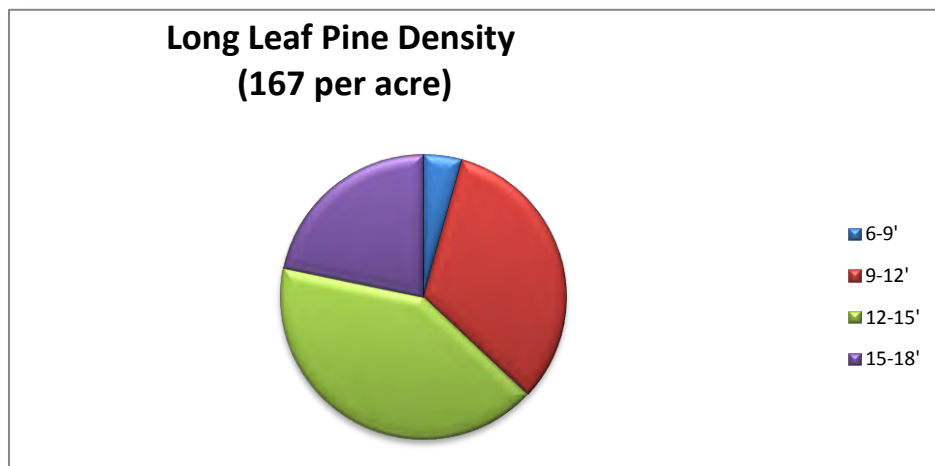
Figure 14. Planted longleaf pine seedlings (Transect 4)
UMAM Polygon I, Management Unit 12- Sandhill Restoration

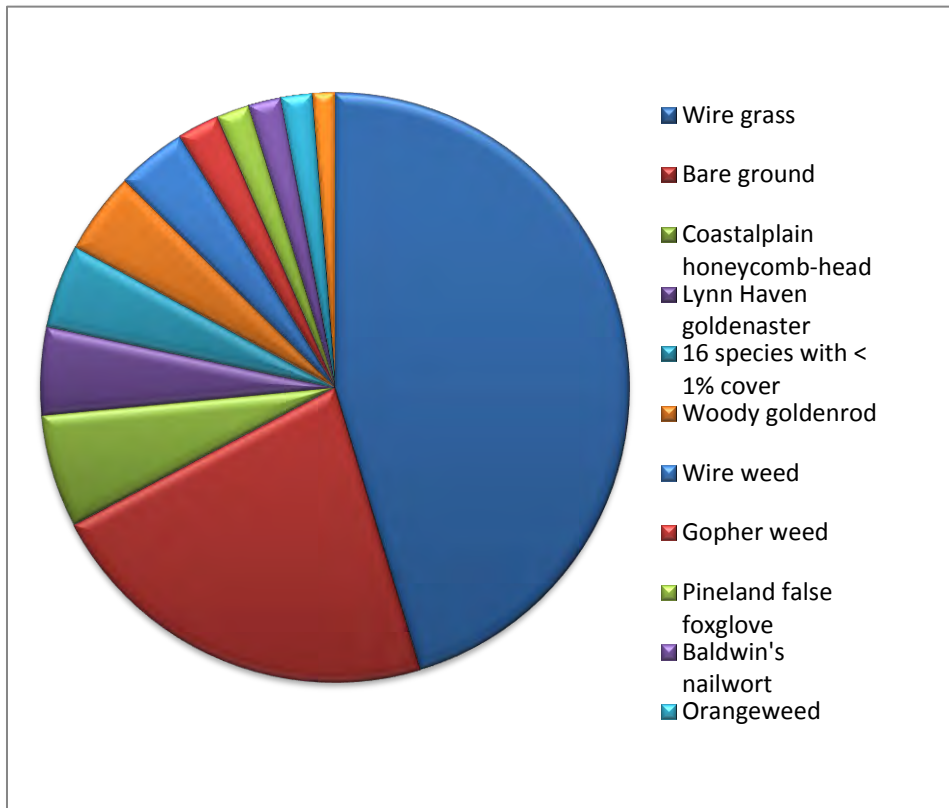
Figure 15. Transect 3: Species cover and occurrence (Sandhill Enhancement)

During the 2017 monitoring, 26 species were observed within Transect 3 a reduction of 8 species. Twenty eight species were observed within Transect 5 (Tables 7 and 8; Figures 18 and 19). Wiregrass cover was the greatest cover class observed for both transects with 45.3% cover observed within Transect 3, and 50.5 % cover observed in Transect 5. Bare ground cover was 22% within Transect 3 and 18.6% within Transect 5. The site has recovered in wiregrass cover and reduced bare ground was observed for both transects.

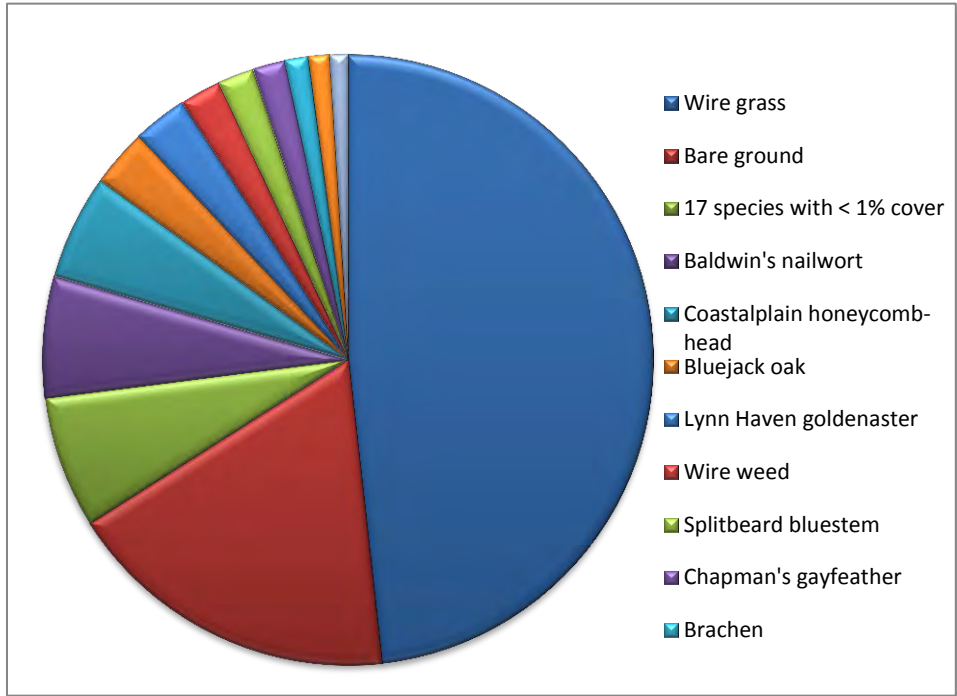
Figure 16. Transect 5: Species cover and occurrence (Sandhill Enhancement)

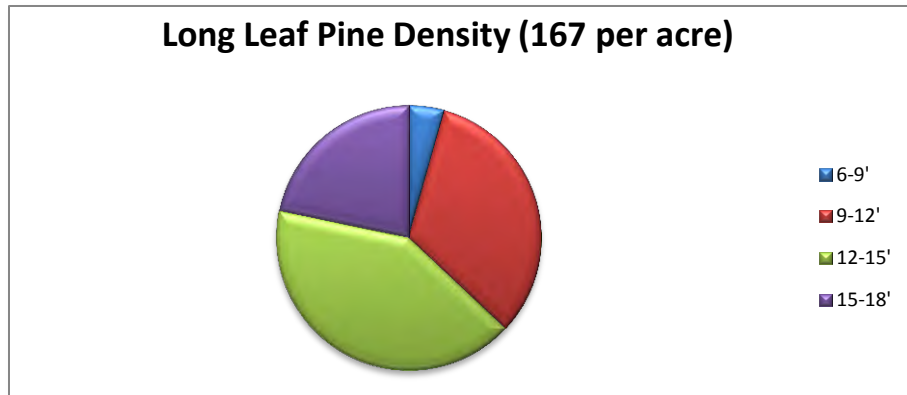
Figure 17. Planted longleaf pine seedlings (Transect 3)

In 2017, the survival of longleaf pine seedlings was 87 per acre in Transect 3 and 101 in Transect 5. Tree height was variable. Trees appear healthy and vigorous (Figure 20 and 21).

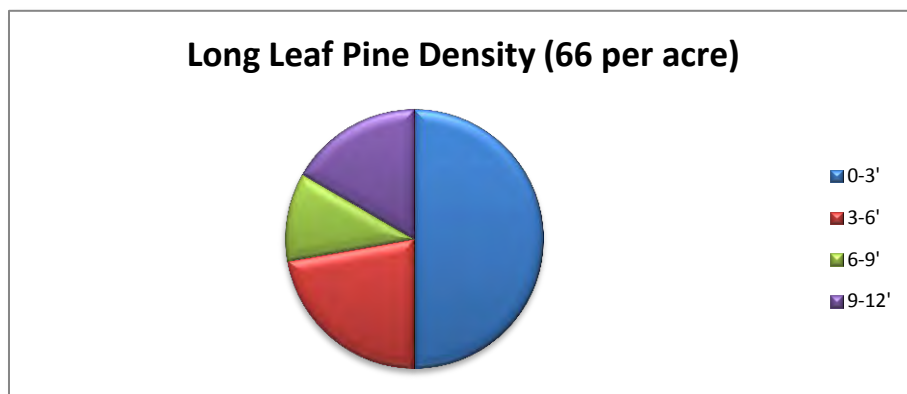
Figure 18. Planted longleaf pine seedlings (Transect 5)

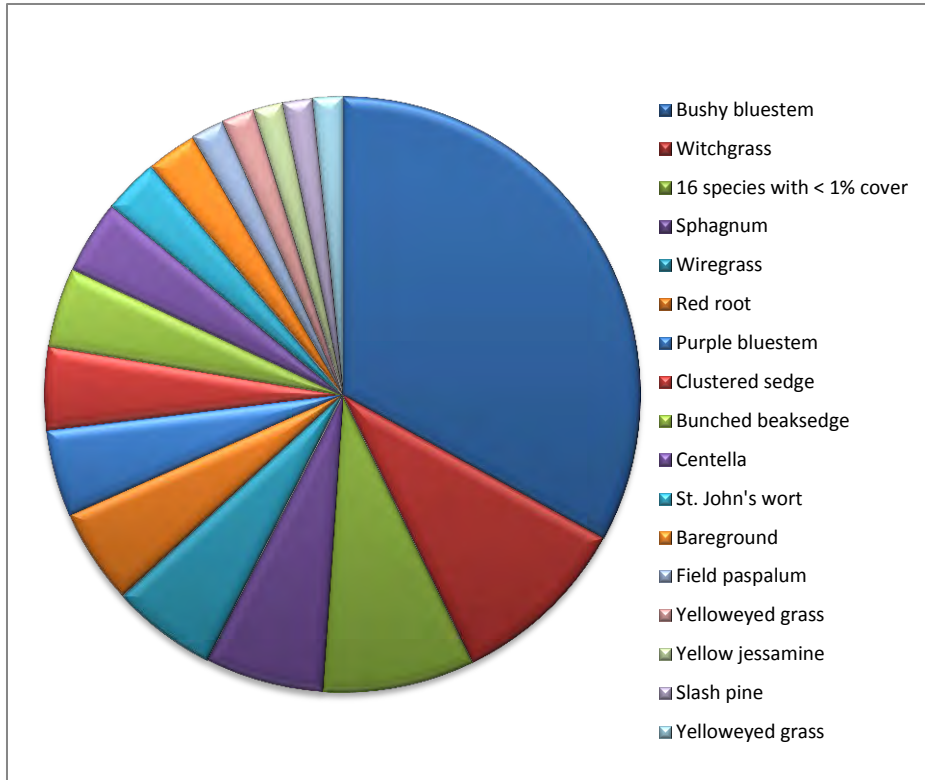
Figure 19. Transect 8: Species cover and occurrence (Hydric Pine Flatwoods Restoration)

During the 2017 monitoring, 31 species were observed a slight increase from the previous year. The diversity of the site continues to improve as the site develops. Bare ground significantly decreased to 2.7 % cover. Grasses and sedges dominated the vegetative cover (66.5%cover) (Table 9; Figure 22).

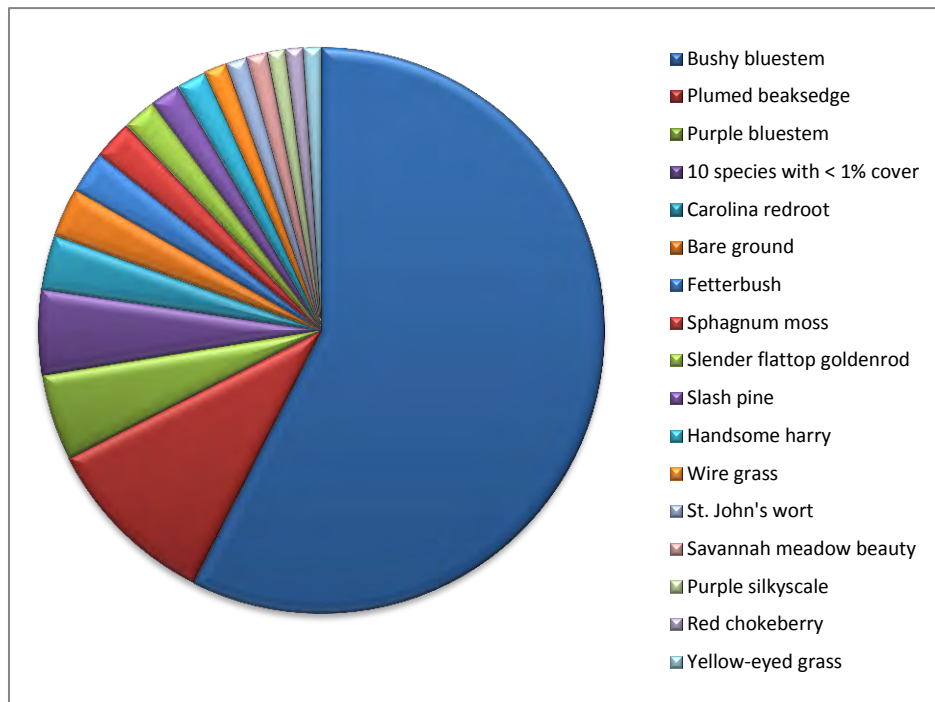
Figure 20. Transect 6. Species cover and occurrence (Hydric Pine Flatwoods Restoration)

During the 2017 monitoring, 25 and 19 species were observed within Transect 6 and 7, respectively, a slight increase from 2016 (Table 10 and 11; Figure 23 and 24). Hydric pine flatwood species dominated both transects. Shrub cover was 2.4% for Transect 6 and 1.8 for Transect 7. Vegetative cover exceeds 95% for both transects and bare ground is minimal.

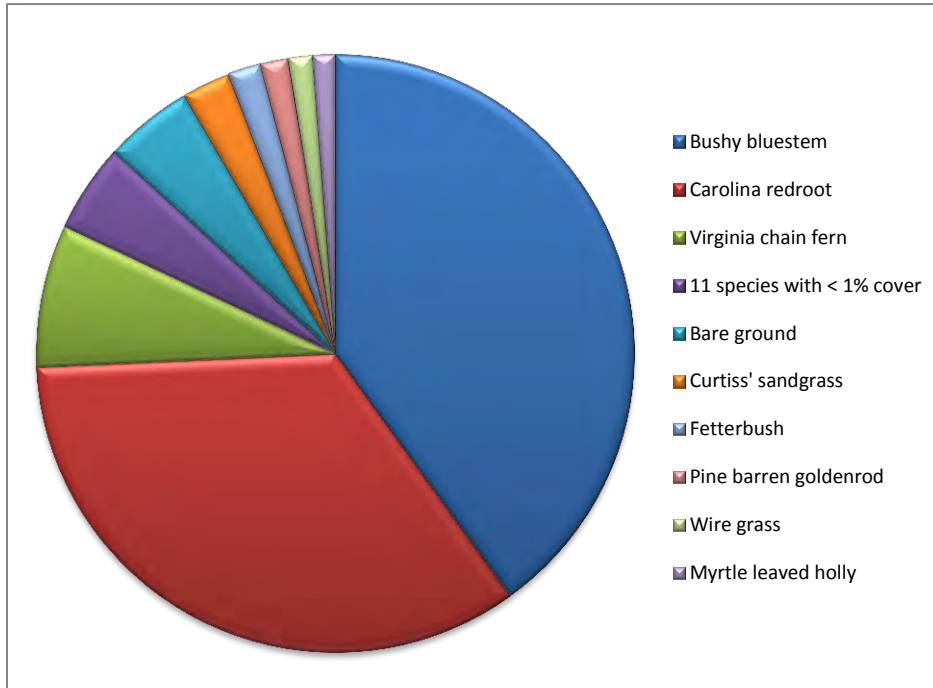
Figure 21. Transect 7. Species cover and occurrence (Hydric Pine Flatwoods)

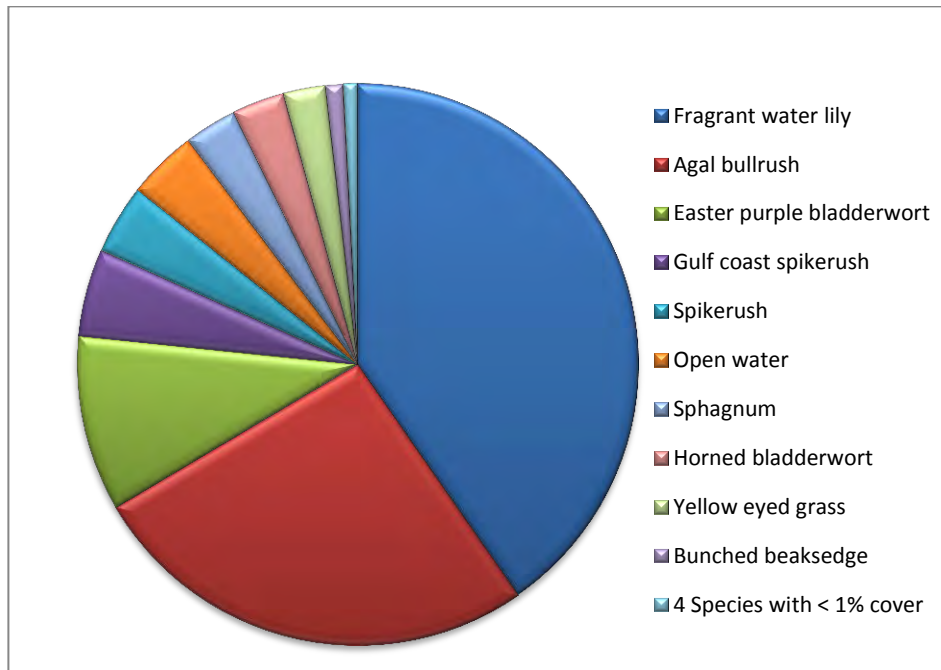
Figure 22. Transect 9. Species cover and occurrence (Dykes Mill Pond)

In 2017, a total of 10 species were observed along Transect 9 (Table 12, Figure 25). The aquatic vegetation is thriving providing important habitat for wildlife. Fragrant water lily represented the dominant cover class with 40% cover followed by agal bullrush with 26 % cover. Open water has steadily decreased from 38% from baseline sampling to 4% in 2017. Water depth averaged 0.8 meter.
