**SACRED HEART MITIGATION
QUALITATIVE AND QUANTITATIVE MONITORING
SECOND MONITORING REPORT, SPRING 2018**

Monitoring conducted in accordance with the approved monitoring plan, April 27, 2018, by David Clayton, Environmental Scientist IV, Northwest Florida Water Management District.

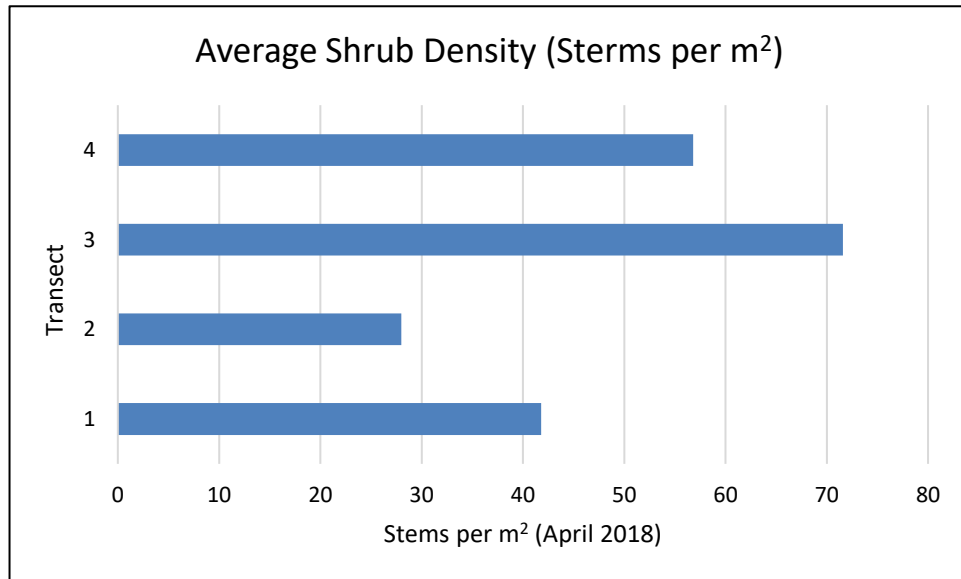
Figure 3. Shrub Density (Stems per Meter Square)

Shrub density within the hydric pine flatwoods, across four transects, for April 2018, averaged 50 stems per m² (Transect 1—42 stems per m²; Transect 2—28 stems per m²; Transect 3—72 stems per m²; Transect 4—57 stems per m²). The dominant shrub species were gallberry, and black titi (Figure 3). Not unexpectedly, the average stems per m² increased from 43 stems per m² (November 2017) to 50 stems per m² (April 2018) following the initial reintroduction of prescribed fire.

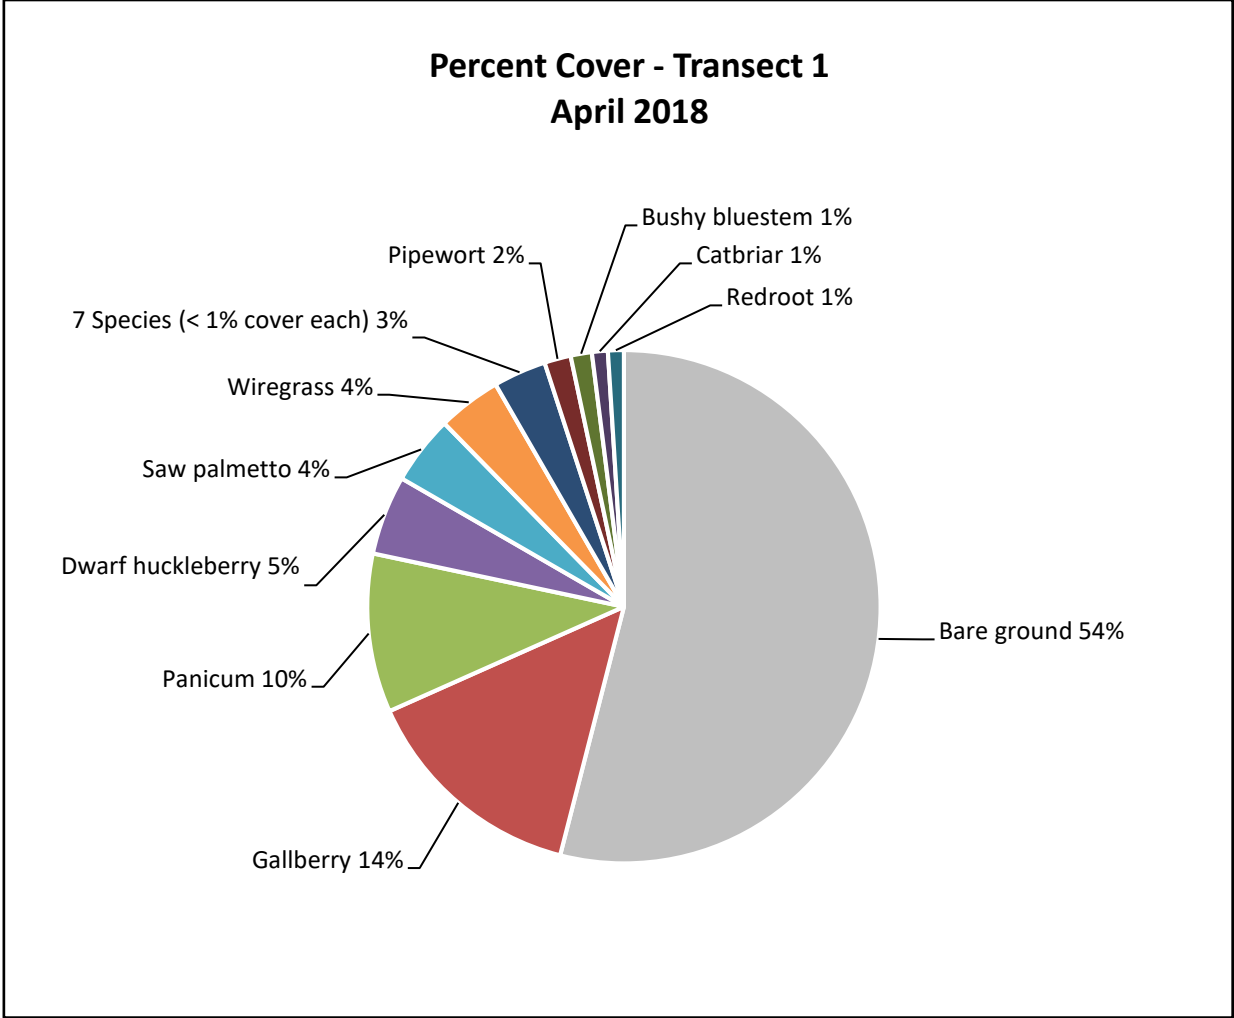
Figure 4. Transect 1, Percent Cover, April 2018

Sixteen species were observed along Transect 1 (Table 2, Figure 4) during the April 2018 monitoring (15 species were observed during the November 2017 baseline monitoring). Bare ground, following initial reintroduction of fire, increased from 32% to 54%. Shrub coverage, measured as stems per m², increased from 27 stems per m² to 42 stems per m². Dominant shrub cover was primarily gallberry. Estimated wiregrass coverage effectively did not change (3.7% baseline versus 4.0% post-fire). Species were typical of those found within a fire suppressed, shrub dominated hydric flatwood. Shrub removal and a fire interval of two years should greatly increase the dominance of grasses and forbs.

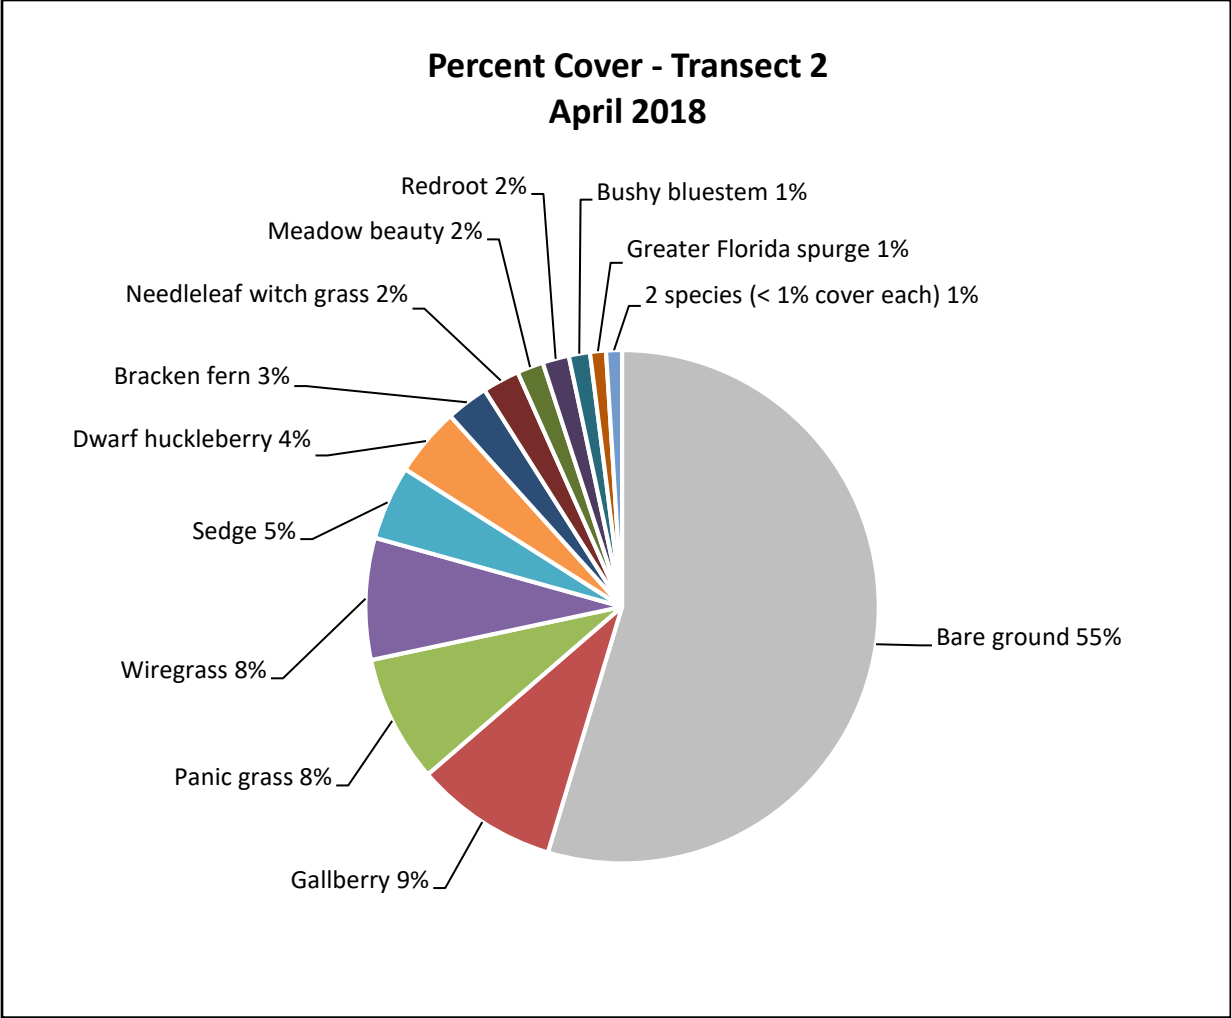
Figure 5. Transect 2, Percent Cover, April 2018

Thirteen species were observed along Transect 2 (Table 3, Figure 5) during the April 2018 monitoring (17 species were observed during the November 2017 baseline monitoring). Bare ground increased from 32% to 55%. Shrub coverage, measured as stems per m², decreased from 28 stems per m² to 50 stems per m². The dominant shrub was gallberry. Estimated wiregrass coverage increased from approximately 6% to 8%.

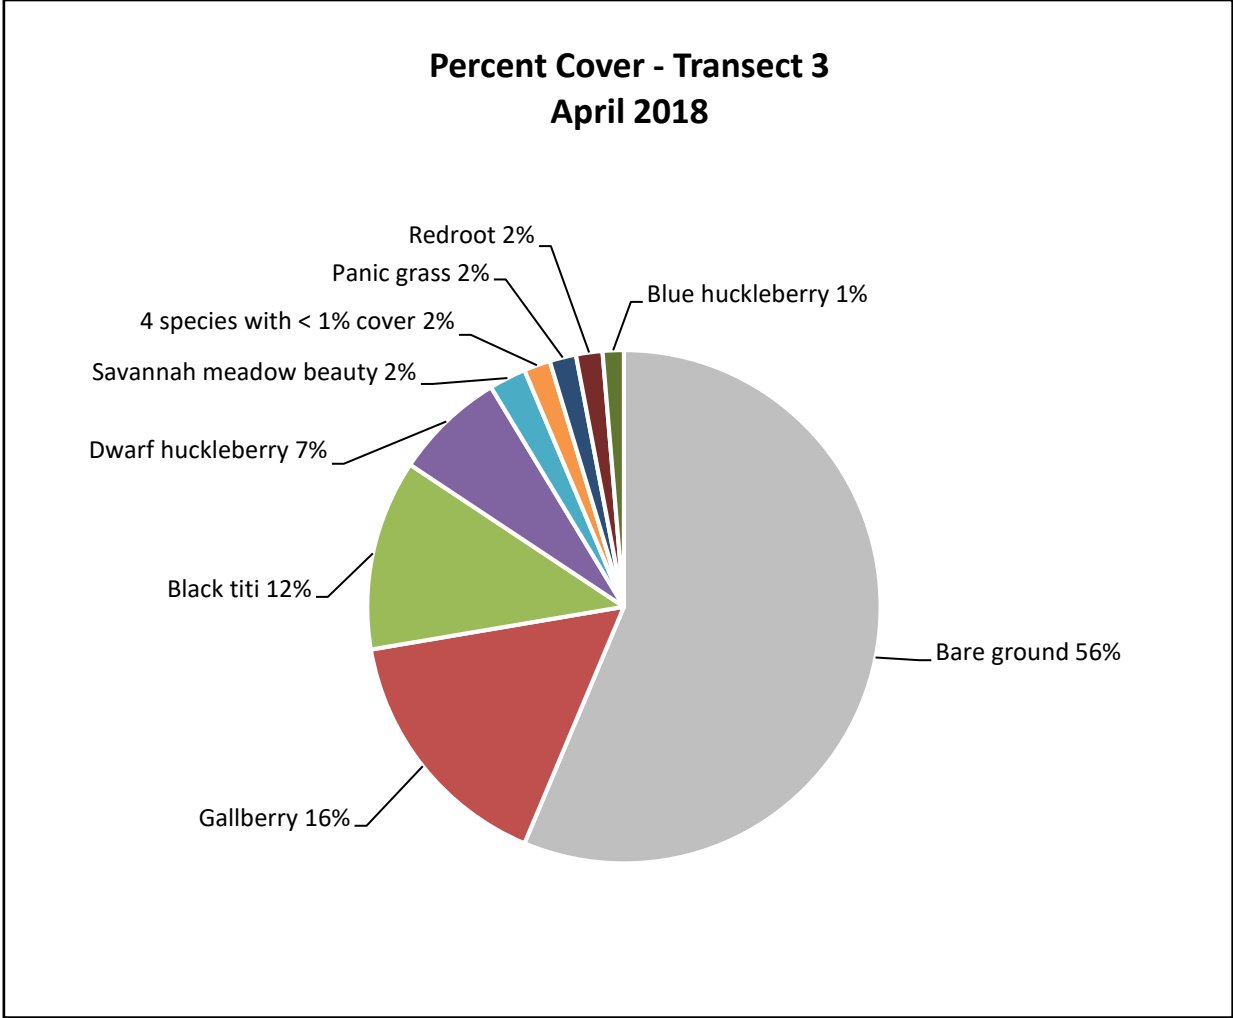
Figure 6. Transect 3, Percent Cover, April 2018

Eleven species were observed along Transect 3 (Table 4, Figure 6) during the April 2018 monitoring (19 species were observed during the November 2017 baseline monitoring). Bare ground increased from 24% to 56%. Shrub cover, measured as stems per m², increased from 44 stems per m² to 72 stems per m². Dominant shrub cover was primarily black titi and gallberry. Wiregrass cover decreased from 10% to 0.33%.

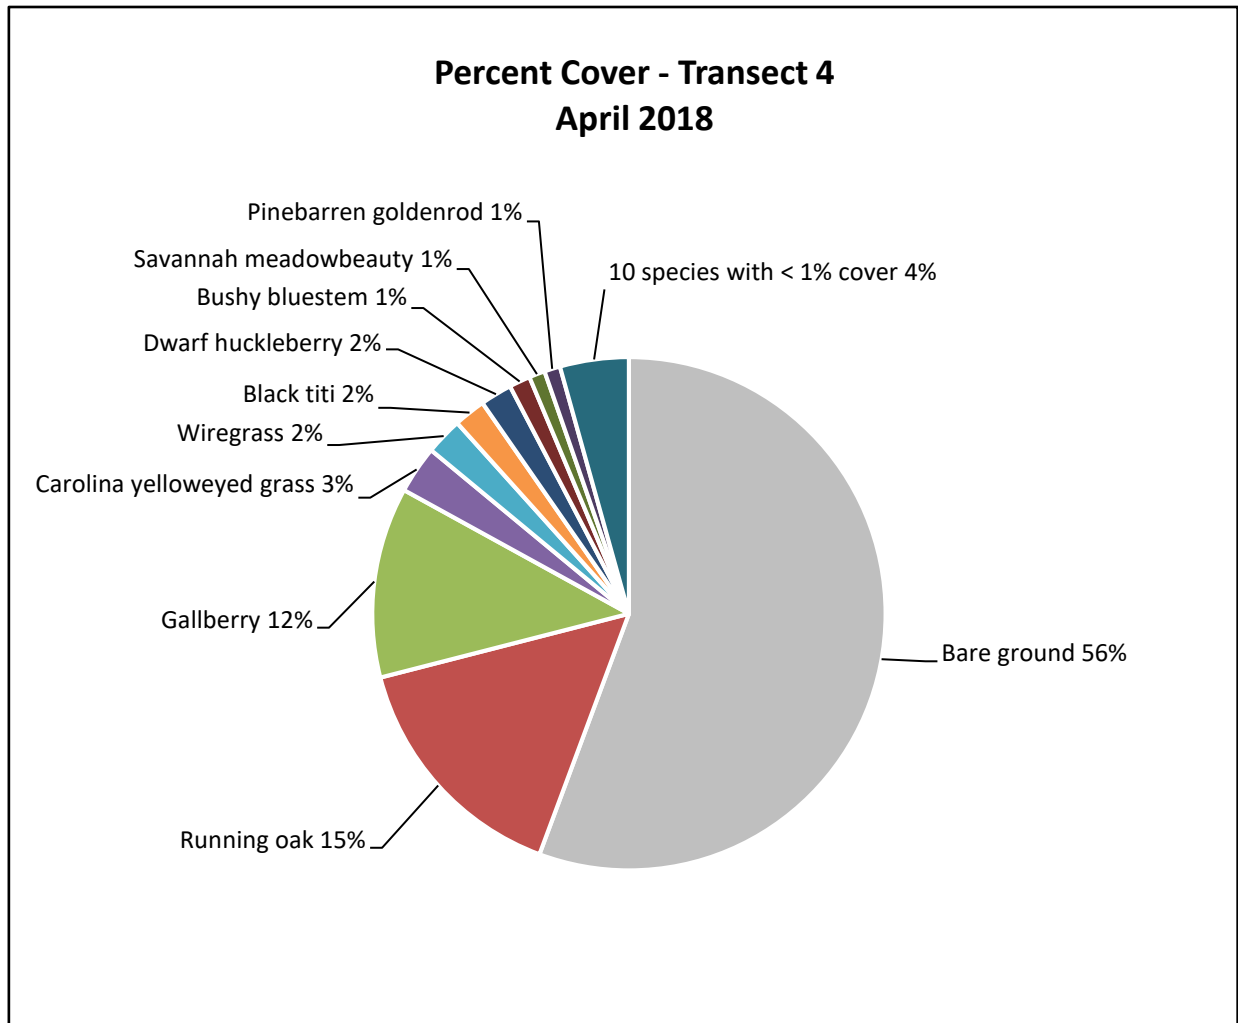
Figure 7. Transect 4, Percent Cover, April 2018

Nineteen species were observed along Transect 4 (Table 5, Figure 7) during the April 2018 monitoring (14 species were observed during the November 2017 baseline monitoring). Bare ground increased from 35% to 56%. Shrub cover, measured as stems per m², remained effectively constant (51 stems per m² in November 2017 versus 52 stems per m² in April 2018). Running oak and gallberry were dominant species. Wiregrass cover decreased from 5.3% to 2.3%.
