ISLAND ROAD MITIGATION SITE

2018 Annual Monitoring Report

USACE Permit No.: SAJ-2014-00624 (NW-JML), issued 3/9/2015

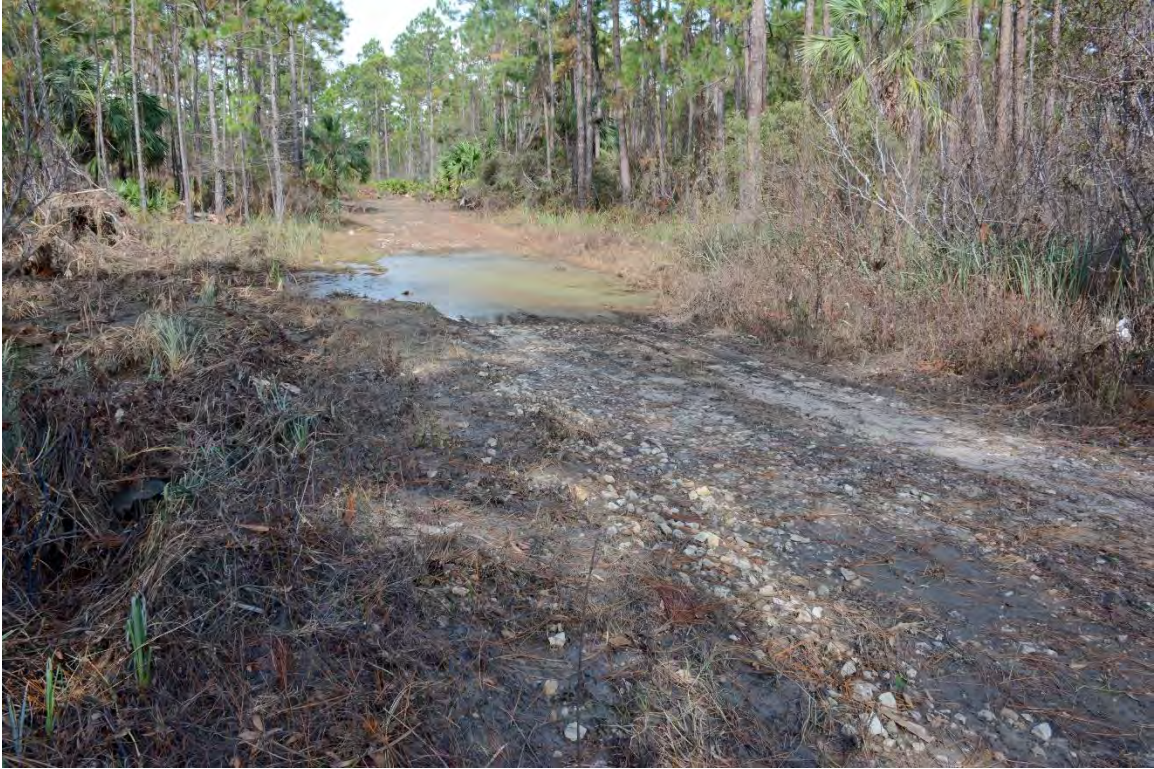
Figure 1: Island Road LWC (11/5/2018; Looking North)

An annual inspection by NFWMD staff on 11/5/2018, conducted 26 days after landfall of Hurricane Michael west of the Buffer Preserve, concluded that the low-water-crossing is in excellent condition, is functioning as designed, and that natural hydrologic flows have been reestablished. Although storm surge associated with Hurricane Michael overflowed the site, the low-water-crossing suffered no apparent damage. The adjacent marsh and pine flatwoods also appear to have weathered the storm well. Wood and plastic debris brought in by the storm surge is being cleaned up by Buffer Preserve staff. The site will continue to be being managed for ecological integrity by Buffer Preserve staff in accordance with an ARC-approved (Acquisitions

During the most recent site inspection of 11/5/2018, all performance standards were found to be met.
