SACRED HEART MITIGATION

Fall 2020 Monitoring Report

USACE Permit No.: SAJ-1998-4720 IP-RVH

Date of Inspection: 11/10/2020

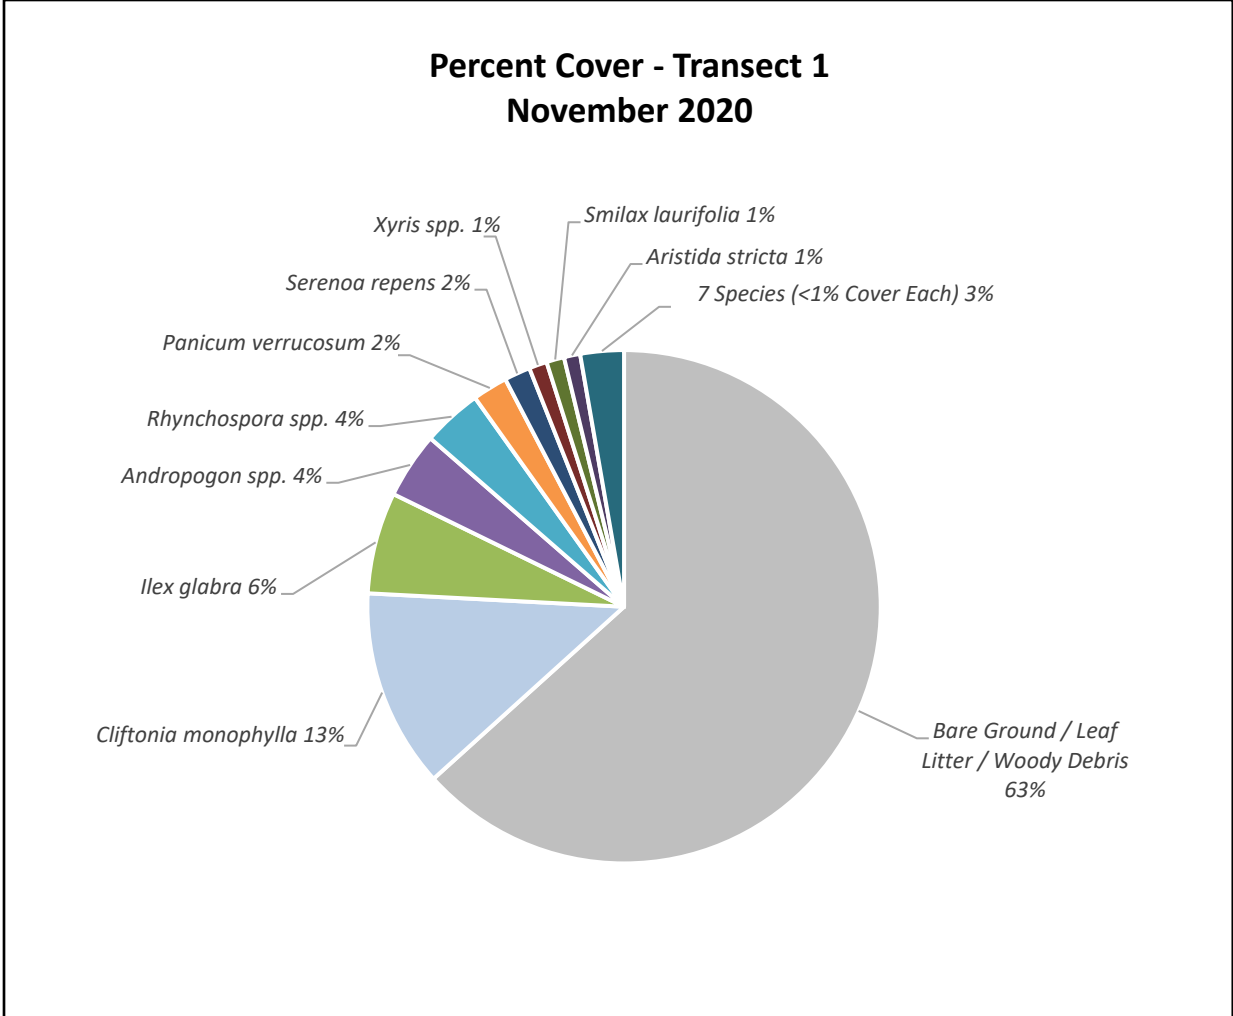
Figure 3. Sacred Heart Mitigation - Transect 1 (November 2020)

Table 1. Sacred Heart Mitigation - Transect 1 (November 2020)

Scientific Name	Common Name	Percent Cover Across Transect*
<i>Andropogon glomeratus</i>	Bushy bluestem	3.9
<i>Andropogon</i> spp.	Bluestem	0.3
<i>Aristida stricta</i>	Wiregrass	1.0
<i>Aronia arbutifolia</i>	Red chokeberry	0.1
Bare Ground / Leaf Litter / Woody Debris	Bare Ground / Leaf Litter / Woody Debris	63.3
<i>Carex verrucosa</i>	Warty sedge	0.6
<i>Cliftonia monophylla</i>	Black titi	12.5
<i>Dichanthelium aciculare</i>	Needleleaf witchgrass	0.2
<i>Ilex glabra</i>	Gallberry	6.4
<i>Lachnocaulon minus</i>	Small's bogbutton	0.1
<i>Lycopodiella</i> spp.	Clubmoss	0.5
<i>Panicum verrucosum</i>	Warty panicgrass	2.2
<i>Paspalum</i> spp.	Crowngrass	0.5
<i>Pinus elliottii</i>	Slash pine	0.8
<i>Rhynchospora plumosa</i>	Plumed beaksedge	1.6
<i>Rhynchospora</i> spp.	Beaksedge	2.2
<i>Serenoa repens</i>	Saw palmetto	1.6
<i>Smilax laurifolia</i>	Greenbrier	1.1
<i>Xyris</i> spp.	Yelloweyed grass	1.1

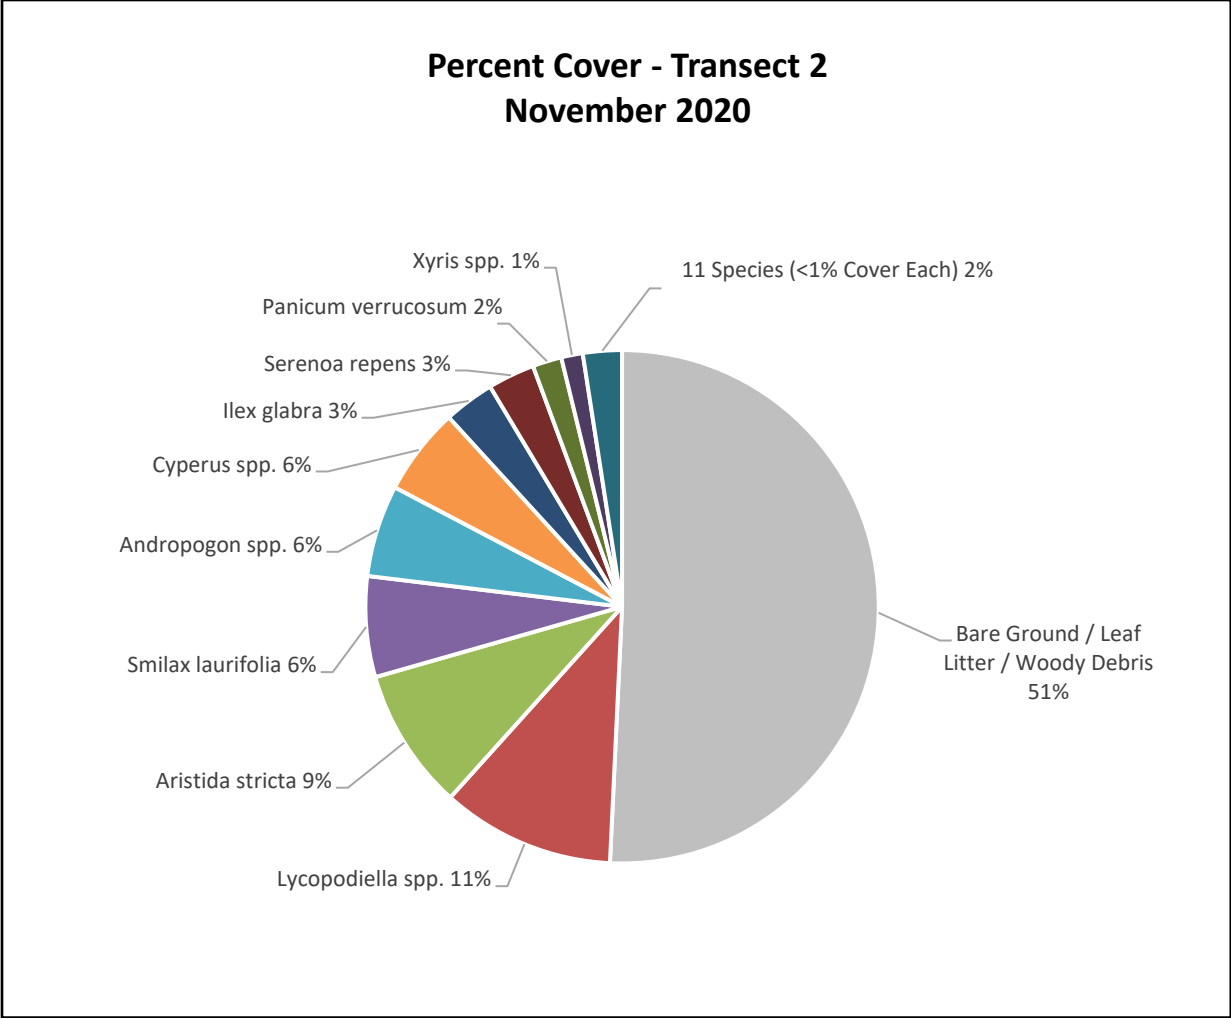
Figure 4. Sacred Heart Mitigation - Transect 2 (November 2020)

Table 2. Sacred Heart Mitigation - Transect 2 (November 2020)

Scientific Name	Common Name	Percent Cover Across Transect*
<i>Andropogon glomeratus</i>	Bushy bluestem	0.3
<i>Andropogon</i> spp.	Bluestem	5.5
<i>Aristida stricta</i>	Wiregrass	8.9
Bare Ground / Leaf Litter / Woody Debris	Bare Ground / Leaf Litter / Woody Debris	50.8
<i>Cliftonia monophylla</i>	Black titi	0.4
<i>Cyperus</i> spp.	Flatsedge	5.5
<i>Dichanthelium</i> spp.	Witchgrass	0.1
<i>Eriocaulon decangulare</i>	Tenangle pipewort	0.3
<i>Ilex glabra</i>	Gallberry	3.2
<i>Ilex</i> spp.	Holly	0.0
<i>Lachnocaulon anceps</i>	Whitehead bogbutton	0.1
<i>Lachnocaulon</i> spp.	Bogbutton	0.1
<i>Lycopodiella</i> spp.	Clubmoss	10.9
<i>Panicum verrucosum</i>	Warty panicgrass	1.8
<i>Pinus elliotii</i>	Slash pine	0.2
<i>Quercus</i> spp.	Oak	0.2
<i>Rhynchospora</i> spp.	Beaksedge	0.2
<i>Serenoa repens</i>	Saw palmetto	3.0
<i>Smilax laurifolia</i>	Greenbrier	6.3
Unknown	Unknown	0.7
<i>Vaccinium</i> spp.	Blueberry	0.1
<i>Xyris</i> spp.	Yelloweyed grass	1.4

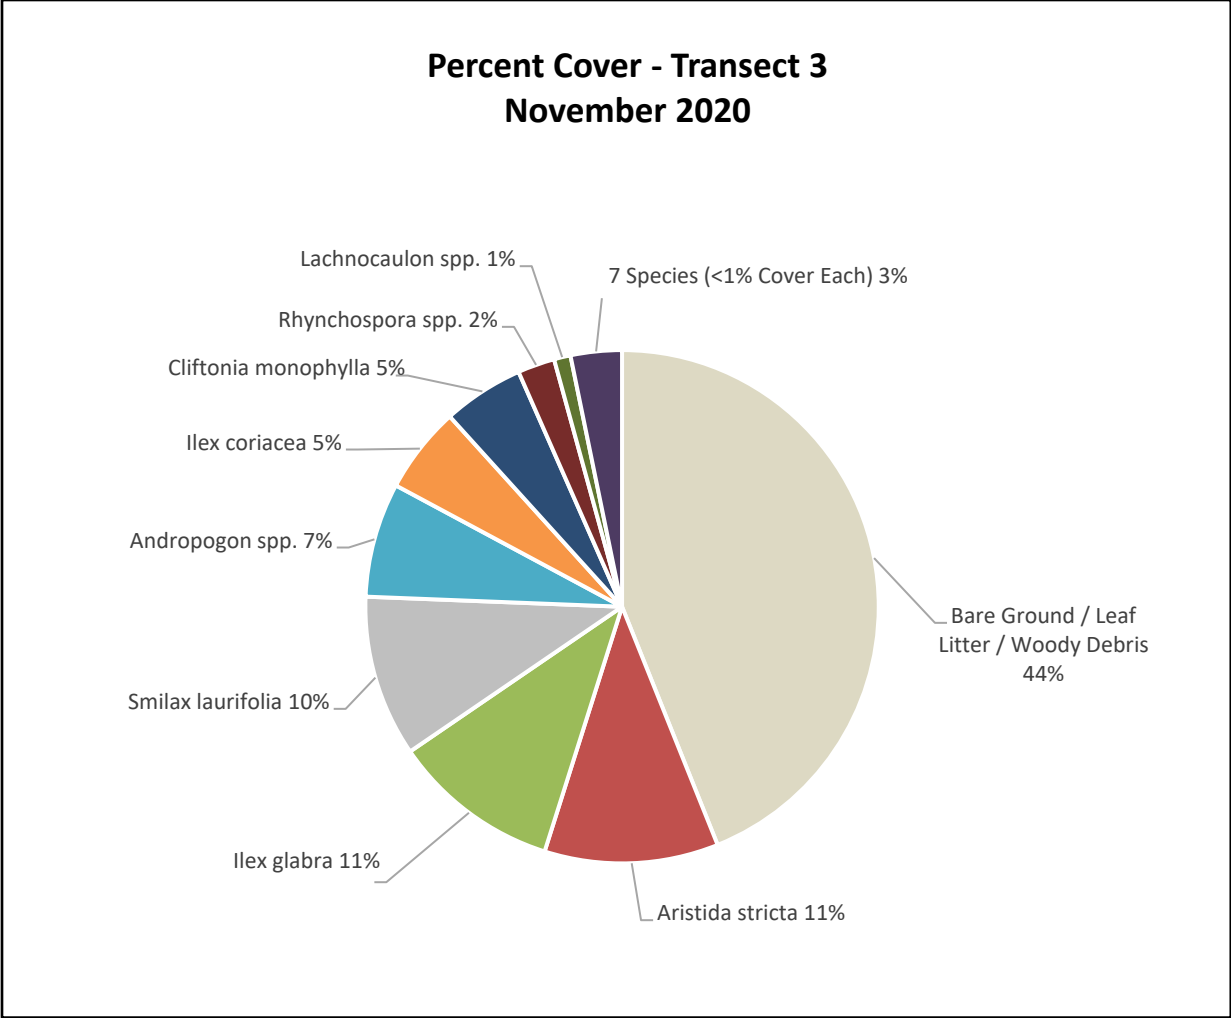
Figure 5. Sacred Heart Mitigation - Transect 3 (November 2020)

Table 3. Sacred Heart Mitigation - Transect 3 (November 2020)

Scientific Name	Common Name	Percent Cover Across Transect*
Andropogon spp.	Bluestem	7.2
Aristida stricta	Wiregrass	11.0
Bare Ground / Leaf Litter / Woody Debris	Bare Ground / Leaf Litter / Woody Debris	43.9
Cliftonia monophylla	Black titi	5.1
Cyperus spp.	Flatsedge	0.8
Dichanthelium spp.	Witchgrass	0.6
Eriocaulon spp.	Pipewort	0.7
Ilex coriacea	Sweet gallberry	5.5
Ilex glabra	Gallberry	10.6
Lachnanthes caroliniana	Carolina redroot	0.1
Lachnocaulon spp.	Bogbutton	1.0
Panicum verrucosum	Warty panicgrass	0.3
Pinus elliottii	Slash pine	0.3
Rhynchospora spp.	Beaksedge	2.3
Serenoa repens	Saw palmetto	0.5
Smilax laurifolia	Greenbrier	10.2
		100.0

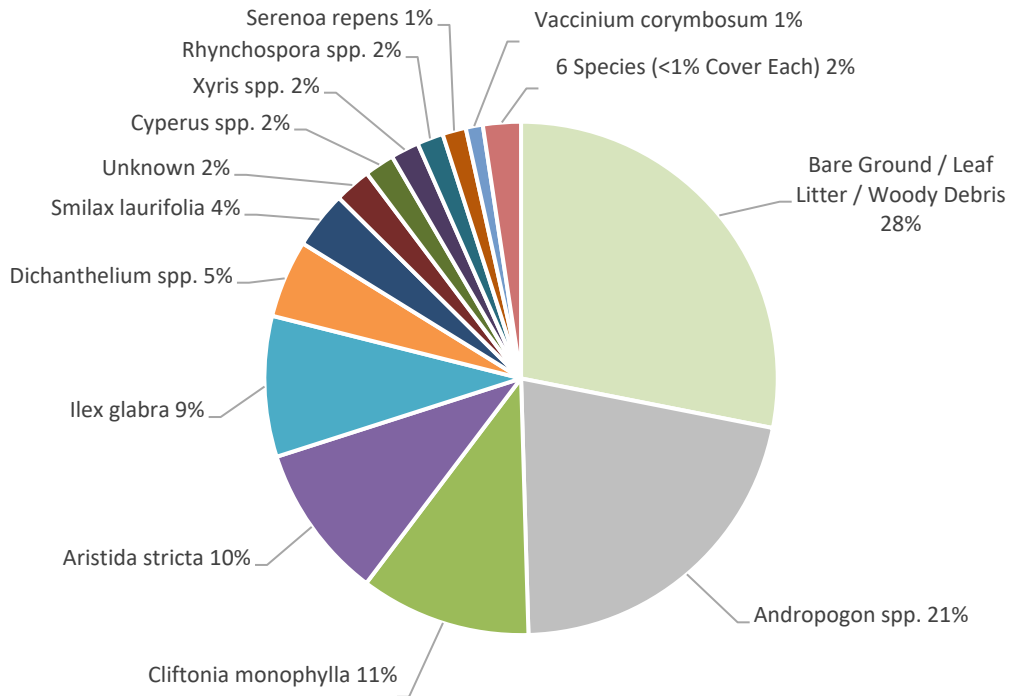
Figure 6. Sacred Heart Mitigation - Transect 4 (November 2020)

Table 4. Sacred Heart Mitigation - Transect 4 (November 2020)

Scientific Name	Common Name	Percent Cover Across Transect*
Andropogon spp.	Bluestem	21.4
Aristida stricta	Wiregrass	9.8
Bare Ground / Leaf Litter / Woody Debris	Bare Ground / Leaf Litter / Woody Debris	28.1
Cliftonia monophylla	Black titi	10.8
Cyperus spp.	Flatsedge	1.9
Dichanthelium spp.	Witchgrass	4.9
Eriocaulon spp.	Pipewort	0.5
Eubotrys racemosus	Swamp doghobble	0.3
Hypericum spp.	St. John's wort	0.1
Ilex glabra	Gallberry	8.9
Lachnocaulon spp.	Bogbutton	0.6
Lycopodiella spp.	Clubmoss	0.6
Pinus elliottii	Slash pine	0.3
Rhynchospora spp.	Beaksedge	1.7
Serenoa repens	Saw palmetto	1.5
Smilax laurifolia	Greenbrier	3.6
Unknown	Unknown	2.3
Vaccinium corymbosum	Highbush blueberry	1.1
Xyris spp.	Yelloweyed grass	1.8
		100.0
