**Northwest Florida Water Management District**

**Live Oak Point Living Shorelines  
Walton County, Florida**

**NFWFMD In-Lieu Fee Program (SAJ-2011-00287 TMF)**

February 2021

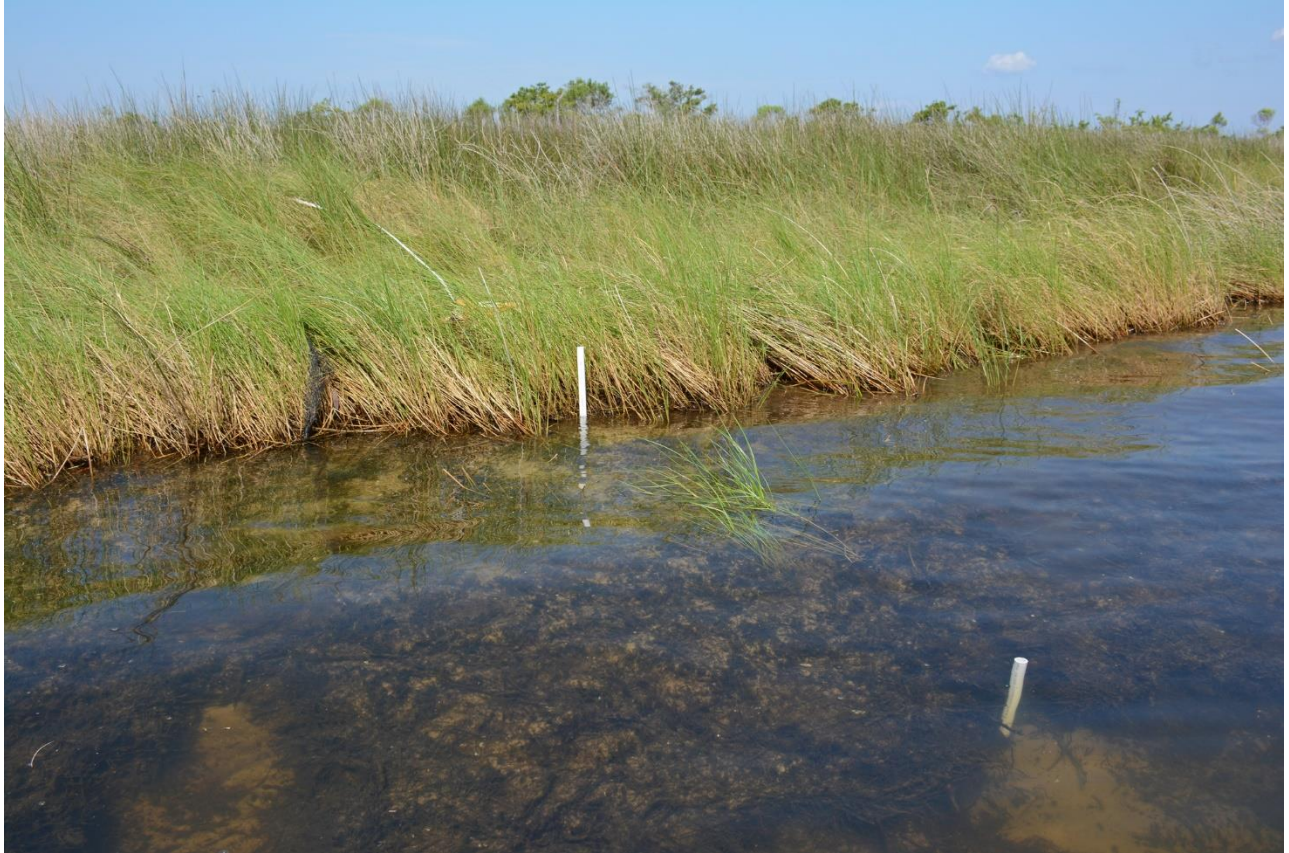
**Figure 20. Undercutting of Salt Marsh (6/12/2019)**

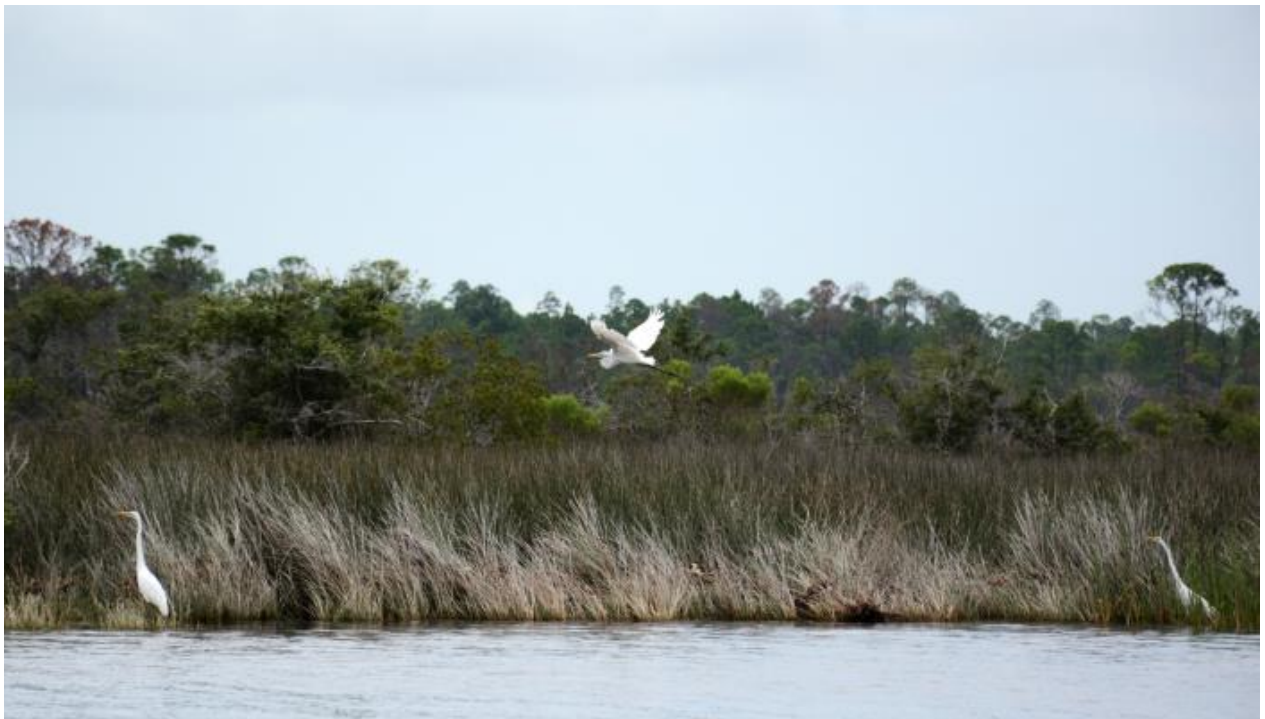
**Figure 21. Live Oak Point, Undercutting of Salt Marsh (8/9/2017)**

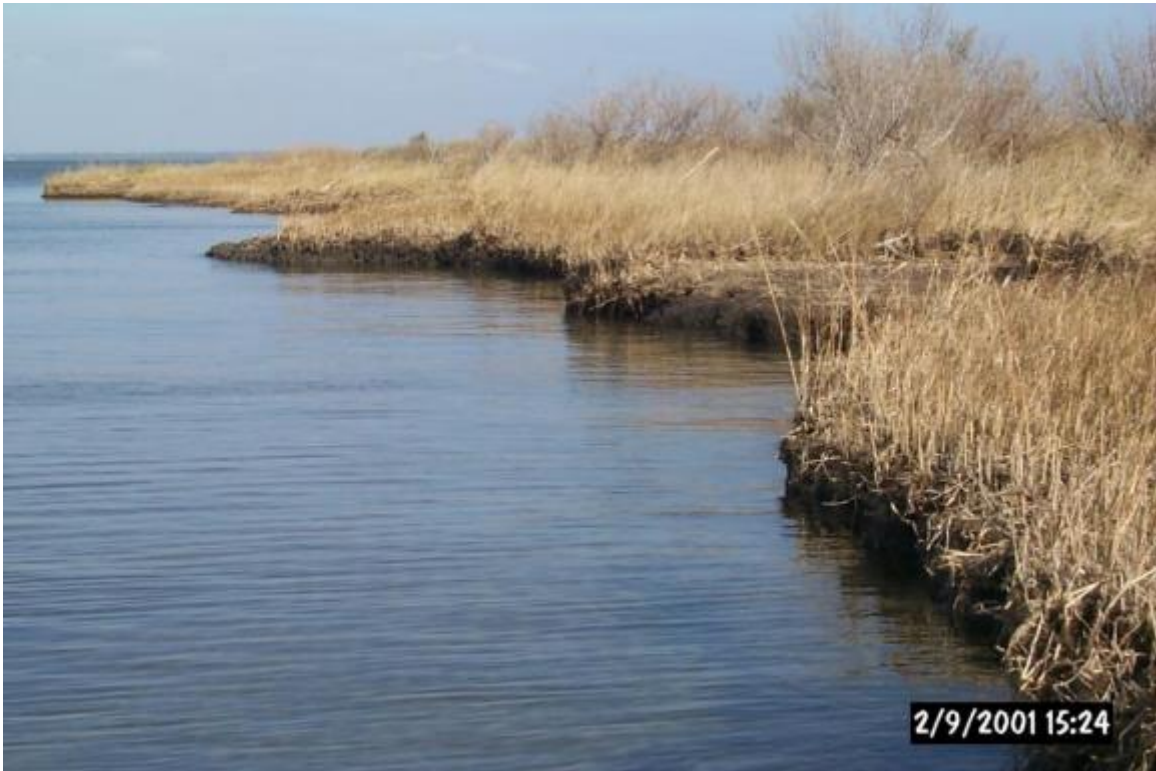
Figure 22. Live Oak Point, Undercutting of Salt Marsh (2/9/2001)

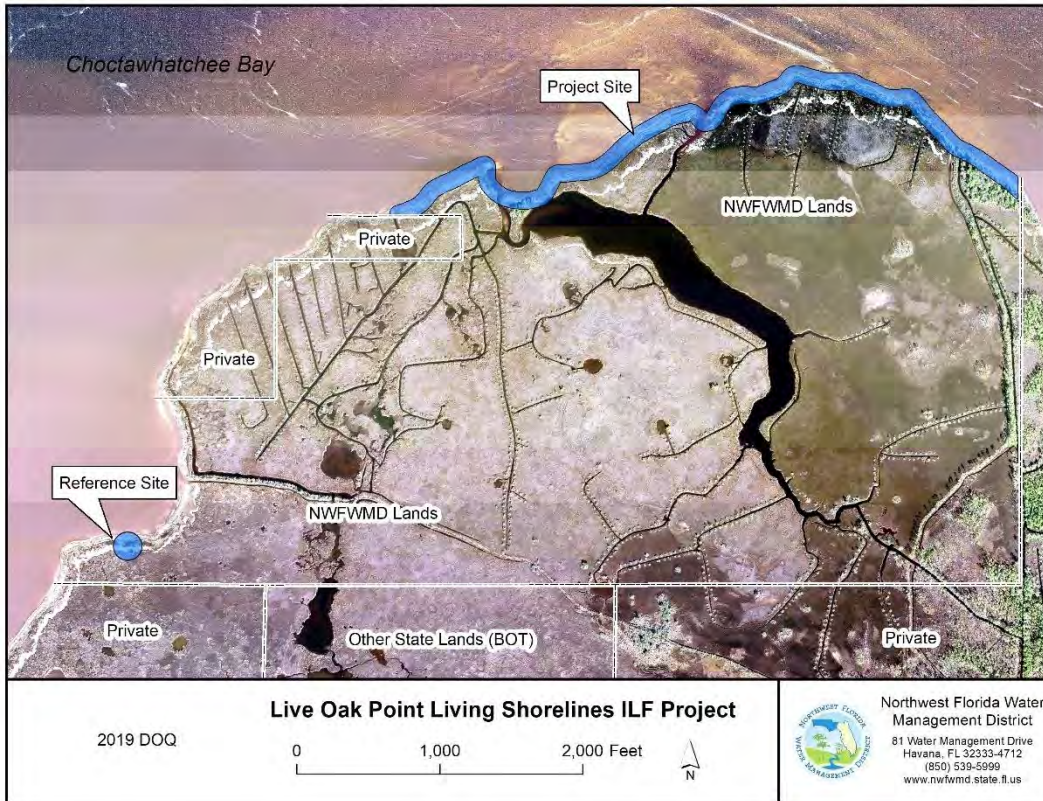
The success of the saltmarsh restoration will be evaluated in relationship to a reference saltmarsh occurring on NFWFMD-owned lands at Live Oak Point approximately 3,000 FT southwest of the Living Shorelines project area (Figure 1). The reference site has similar geomorphology, tidal range, elevations, and vegetation community structure relative to the project area and will be used to guide the development of restoration targets and measurable performance standards.

Figure 1. Reference Wetlands Site in Relation to Project Area
