Sand Hill Lakes Mitigation Bank Combined DEP/ACOE Sixth Annual Report December 2011

FDEP Permit # 0227351-001 Issued 9/6/2005, Washington County

**Submitted by David Clayton on behalf of the Northwest Florida Water Management District
In support of specific conditions 26 and 28**

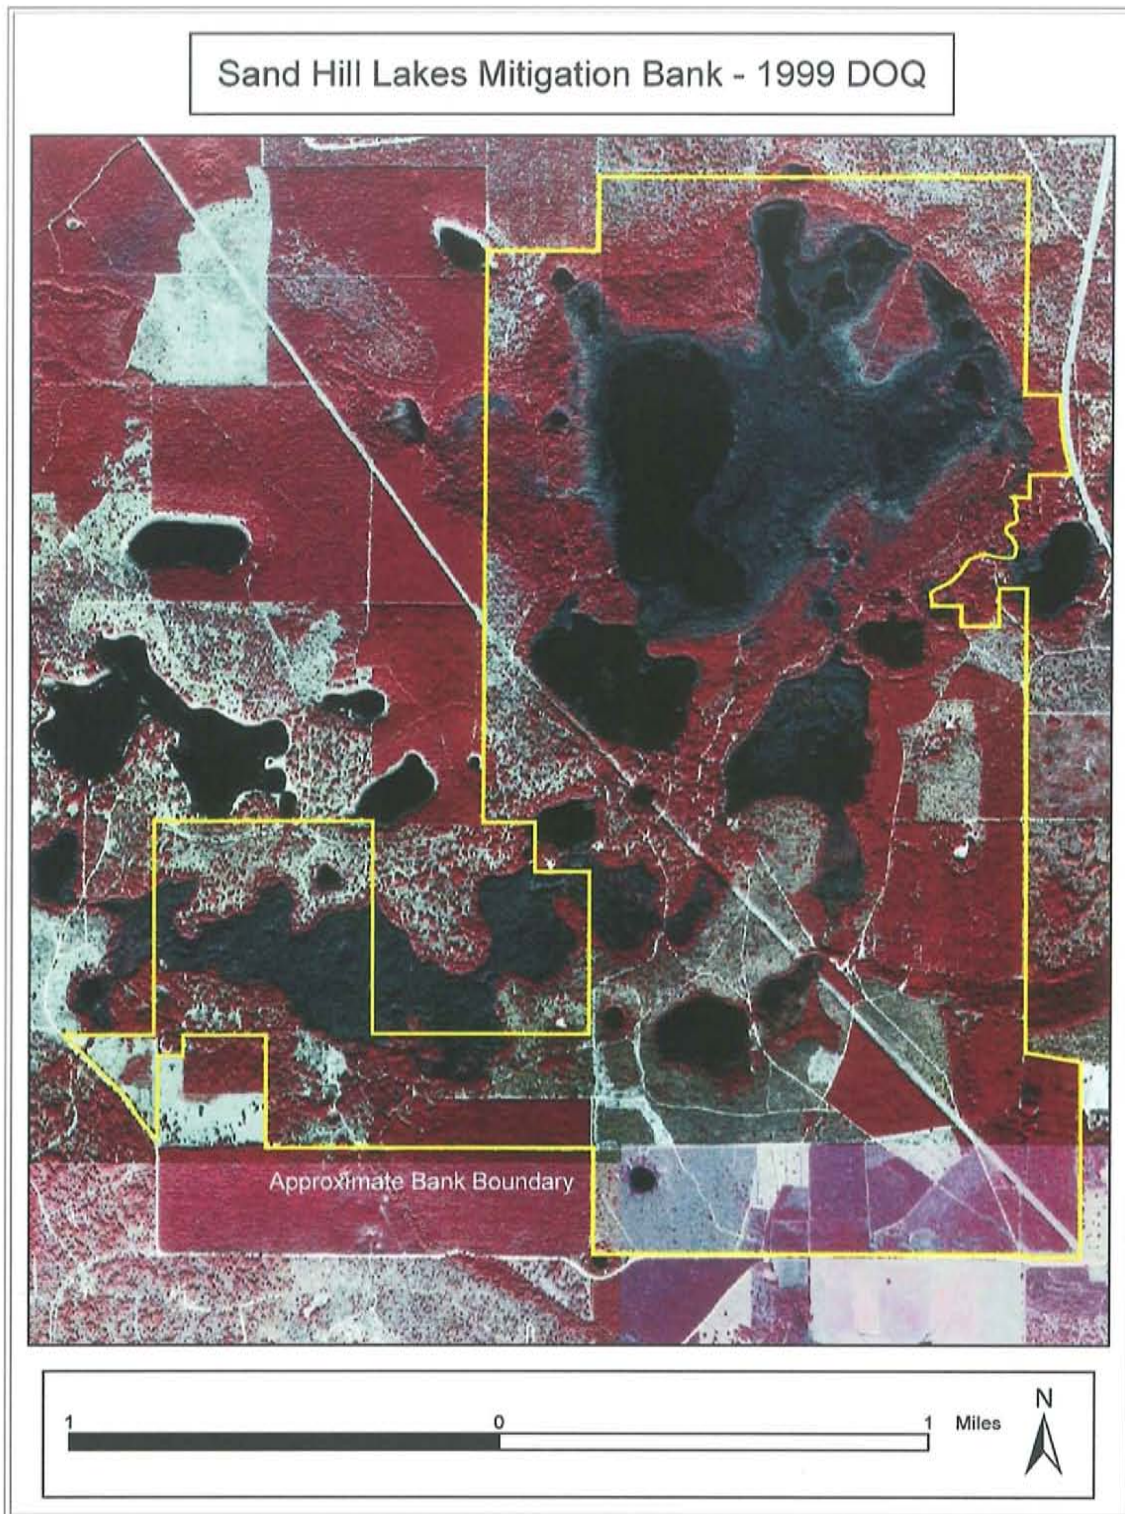
Figure 1a. SHLMB boundary map and habitats

acres of natural solution ponds and shallow, gently-sloped lakes connected by streams and ditches. The remaining 1,150 acres consist of secondary growth upland buffer communities (including high quality and degraded sand hill communities as well as sand pine plantation, slash pine plantation, and mixed hardwoods) (Figure 1a).

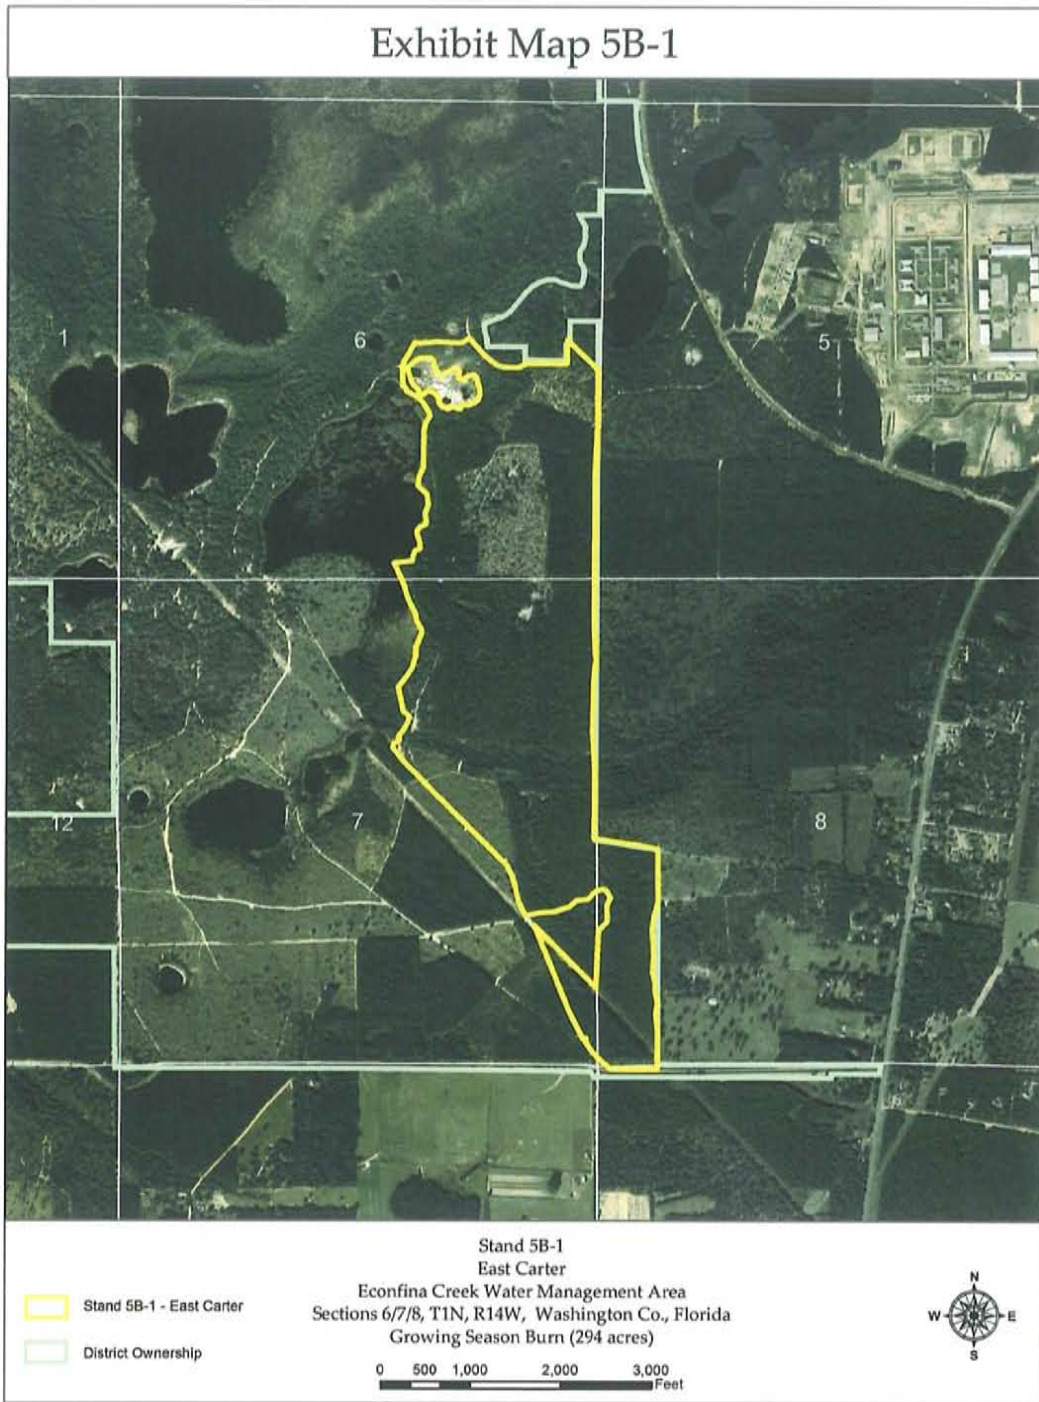
Figure 7. Warm Season Burn (294 Acres)

In 2011, a total of 717 acres were burned in the uplands. A warm season burn was utilized to burn 294 acres and a fall 423 fire was set adjacent to Deep Edge and Little Deep Edge ponds in October to reduce shrub and seedling cover (Figures 7 and 7a). Planted long leaf pine seedlings exceeded permit conditions in the uplands of 200 trees per acre. This burn was designed to reduce long leaf pine seedling cover by approximately 100-150 trees per acre. From early observations a significant number of long leaf pines had been eradicated.

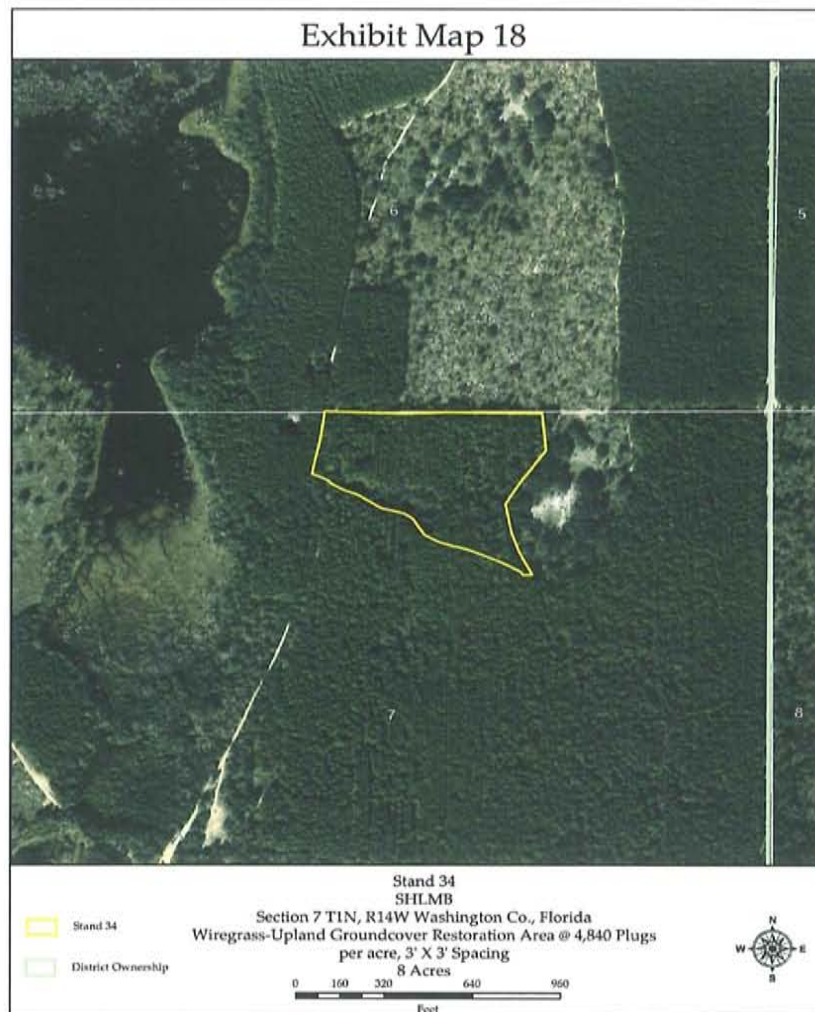
Figure 11. 2011 Upland Wire grass plantings at SHLMB

The majority of the areas with sand pine plantation had remnant sand hill species in the understory prior to harvest of the sand pine. Once the sand pine was removed, the sand hill seed bank and remnant wire grass greatly increased in cover in response to added light. However, in areas where few sand hill species were observed or areas without wire grass, wire grass tublings have been planted. Due to limited seed source a maximum of 30 acres each year was planted in accordance with the permit requirements. In 2008, 53 acres of historic sand hill were planted with upland wire grass tublings on 3' centers (256,520 plants). In 2009, an additional 27 acres of upland wire grass tublings were planted on 3' centers (130,680 plants) in areas where the sand hill species were absent. An additional 30 acres of upland wire grass tublings were planted in 2010 (Figure 11b and 11c). As of December 2010, a total of 140 acres of upland wire grass tublings have been planted for a total of 677,600 tublings. In 2011, the remaining 30 acres of sand pine plantation restored to sandhill was installed (Figure 11 and Figure 11a).

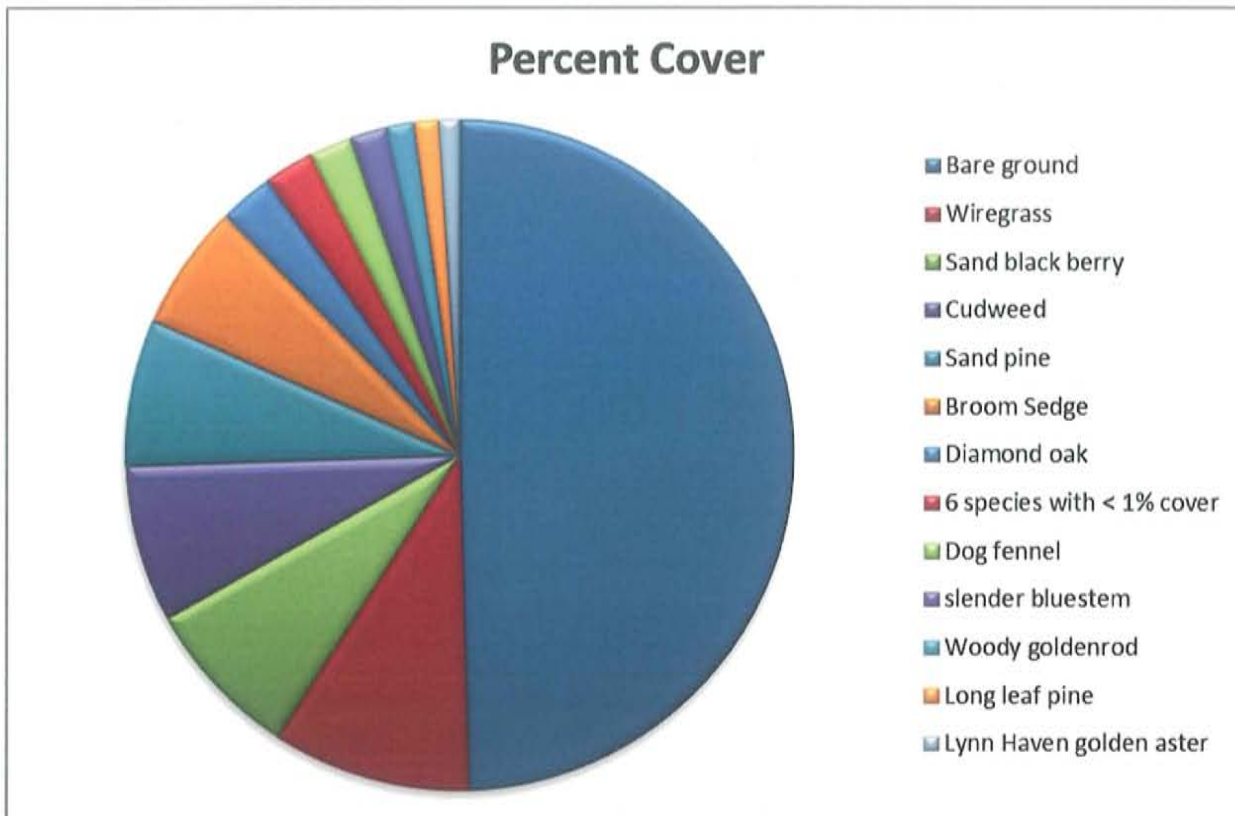
Figure 14. Sand Pine Plantation Restored to Sandhill (Transect 1)

Scientific Name	Species	Percent Cover
<i>Andropogon virginicus</i>	Broom Sedge	6
<i>Aristida stricta</i>	Wiregrass	9.5
<i>Artemisia campestris</i>	Wormwood	0.16
<i>Chrysoma pauciflosculosa</i>	Woody goldenrod	1.3
<i>Chrysopsis lanuginosa</i>	Lynn Haven golden aster	1
<i>Gamochaeta sp.</i>	Cudweed	7.5
<i>Cyperus sp.</i>	Cyperus	0.2
<i>Digitaria filiformis</i>	Crab grass	0.83
<i>Krigia virginica</i>	Dwarf dandelion	0.167
<i>Opuntia humistrata</i>	Opuntia	0.7
<i>Eremochloa ophiuroides</i>	Centipede grass	0.33
<i>Eupatorium capillifolium</i>	Dog fennel	2
<i>Pinus clausa</i>	Sand pine	7
<i>Pinus palustris</i>	Long leaf pine	1.2
<i>Quercus hemisphaerica</i>	Diamond oak	2.6
<i>Rubus cuneifolius</i>	Sand black berry	7.8
<i>Schizachyrium tenerum</i>	Slender bluestem	1.8
	Bare ground	49.2

In 2011, a total of 21 species were observed in transect 1, 18 in transect 2, and 24 in transect 4. This represents a decrease in number of species along each transect and maybe due to a late summer burn. (Table 3, 4 and Figures 15 and 16). A total of 11 species common to sandhills were found in transect 1, 18 in transect 2, and 19 in transect 4. Wiregrass had the greatest cover of any species in transect 1 and 2. Along transect 4, it was second in cover with 15% to Lynn Haven golden aster with 17.2% cover. Wire grass cover ranged from 9.5% in transect 1 to 35.3% found in transect 2. Wire grass was planted in the former sand pine plantations in the area of Transects 1 and 4 and was persistent in Transect 2. Wire grass cover continues to increase within each transect. Overall vegetative cover was similar to 2010. Bahia grass was observed only along transect 4 with 3.3% cover. Bahia grass will continue to be treated as needed. Centipede grass cover was observed in Transects 1 with less than 1% cover and 1% cover in transect 4. Centipede grass will be treated in 2012 as needed. Worm wood which also had been treated in previous years did not have significant cover in 2011.

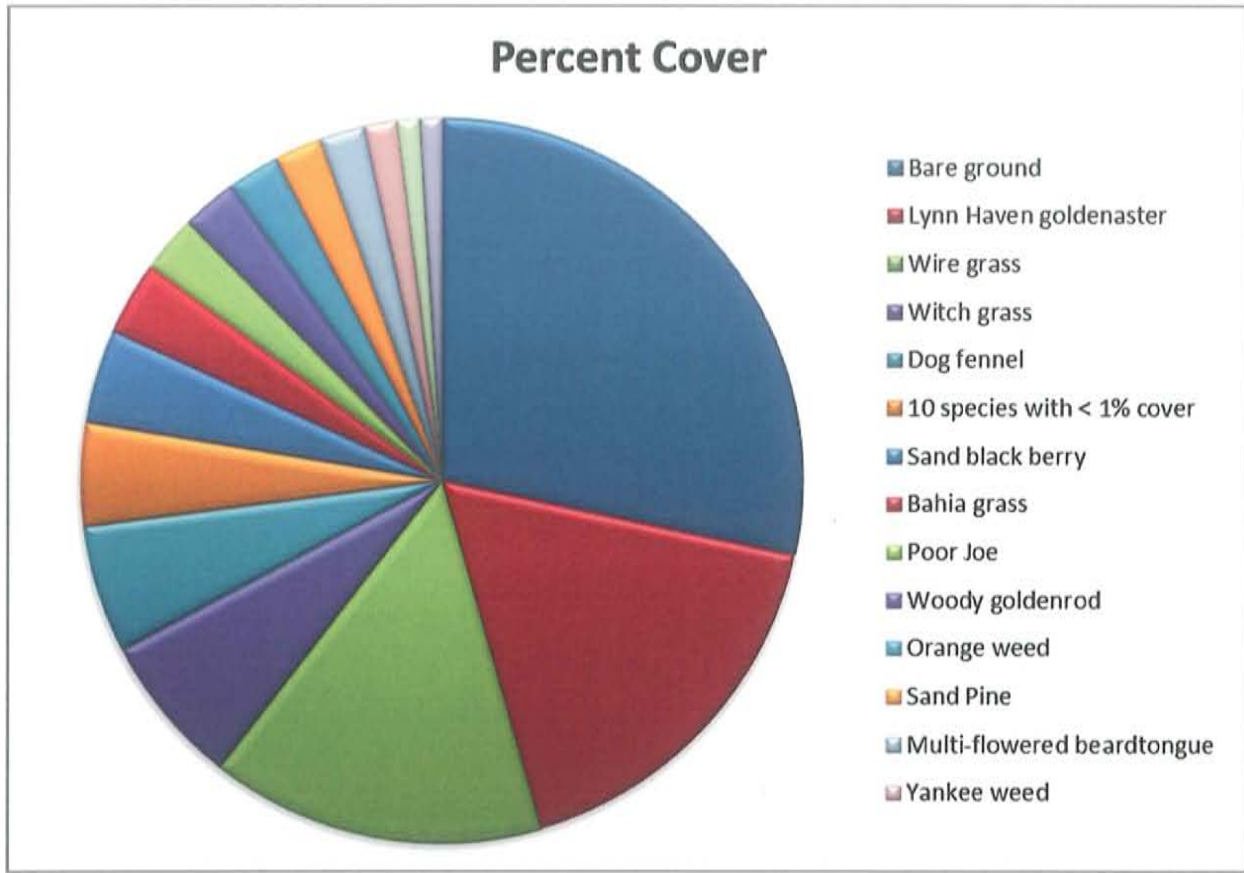
Figure 16. Transect 4: Species Cover and Occurrence (Sand Pine Plantation)

<i>Quercus hemaespherica</i>	Diamond Oak	0.3	20
<i>Quercus geminata</i>	Sand liveoak	1	21
<i>Rubus cuneifolius</i>	Sand black berry	4.2	22
<i>Schizachyrium</i> sp	Little blue stem	0.33	23
<i>Solidago fistulosa</i>	Pine barren goldenrod	0.33	24
	Bare ground	28.3	25

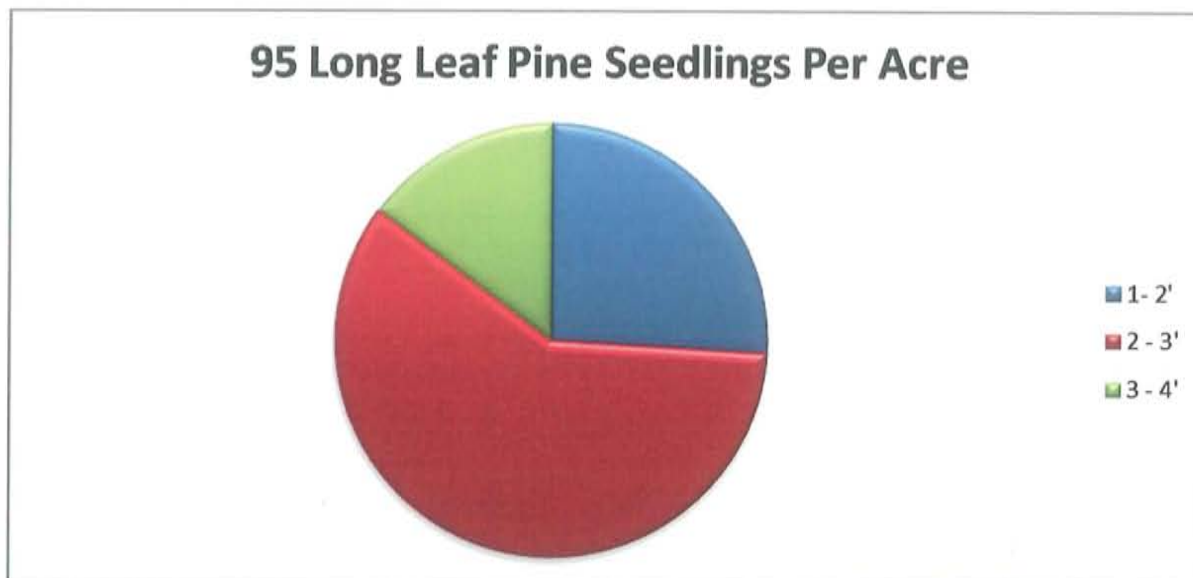
Figure 17 Planted Long Leaf Pine Seedlings (Transect 1)

The survival of long leaf pine seedlings along each transect was observed to be within the 100-200 tree per acre requirements found in the permit. A total of 95 long leaf pine seedlings were observed along transect 1, 47 for transect 2, and 90 in transect 4. This is greatly reduced from 2010 of 156 trees per acre in transect 1, 160 along Transect 2, and 182 along transect 4 (Figure 17-19). Overall health of the planted seedlings was good. only 2-3 trees per transect were in poor condition, while the remaining trees were found to be in excellent condition. It maybe that the continued drought combined with summer burns resulted in a loss of tree survival for those long leaf pine trees beginning to bolt.

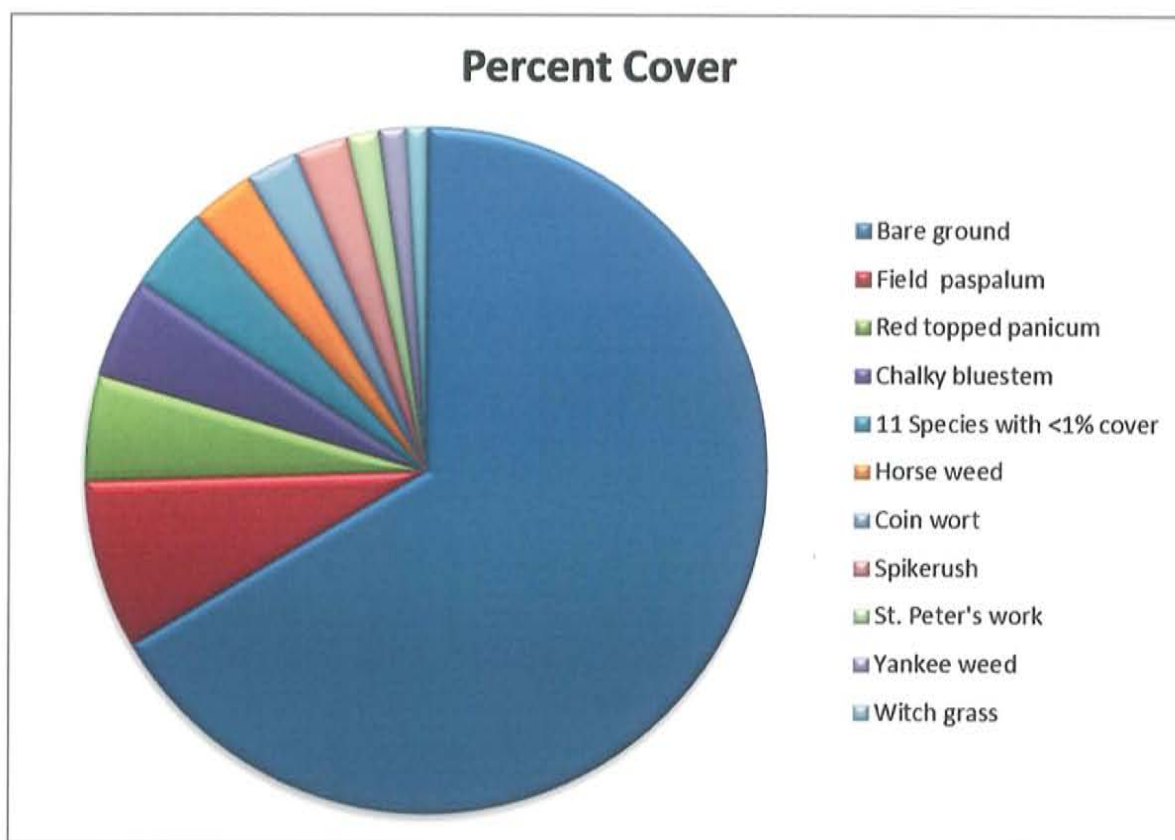
Figure 24. Transect 8, Planted slash pine species cover and occurrence

<i>Eupatorium compositifolium</i>	Yankee weed	1.3
<i>Euthamia caroliniana</i>	Flat topped goldenrod	0.33
<i>Hypericum cistifolium</i>	Round pod St, John's wort	0.67
<i>Hypericum crux-andreae</i>	St. Peter's work	1.5
<i>Myrica cerifera</i>	Wax myrtle	0.16
<i>Panicum rigidulum</i>	Red topped panicum	5
<i>Panicum verucosum</i>	Warty panic grass	0.16
<i>Paspalum leave</i>	flatwoods paspalum	8
<i>Polyprenum procumbens</i>	Rustweed	0.16
<i>Rhynchospora sp.</i>	Spikerush	2.5
<i>Rubus pensilvanicus</i>	Balack berry	0.16
<i>Solidago fistulosa</i>	Pine barrens godlenrod	0.38
	Bare ground	66.5

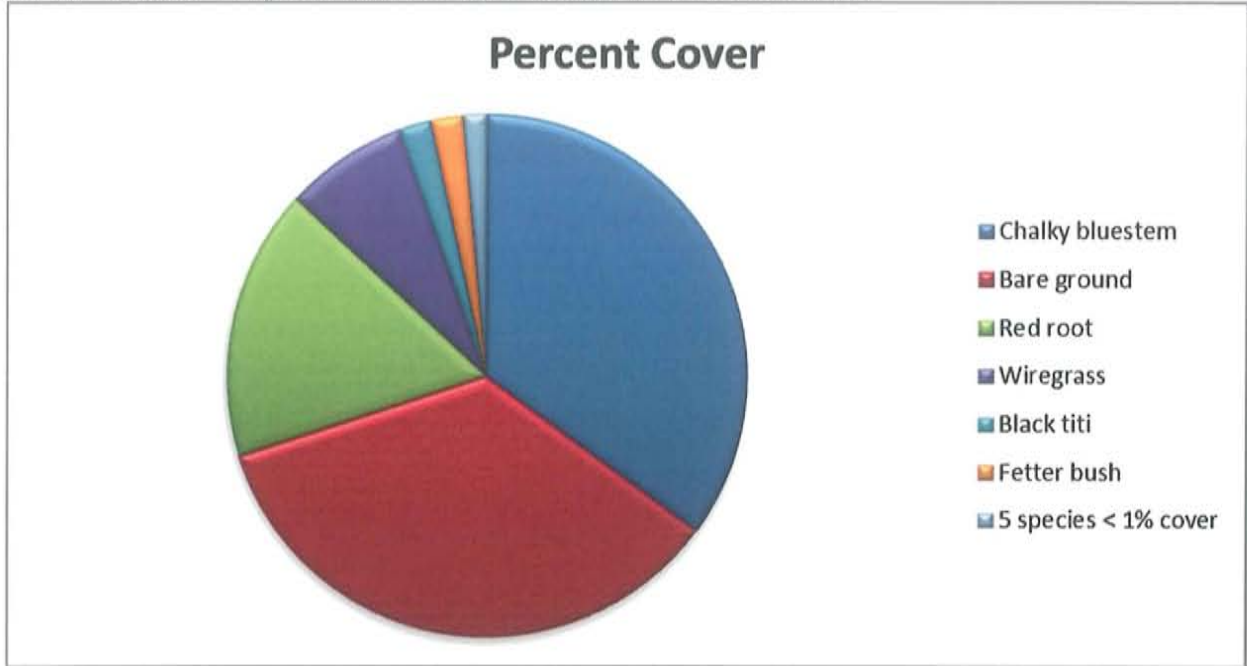
Figure 26. Transect 7. Species and Occurrence (Hydric Pine Flatwoods)

Scientific name	Species	Percent Cover	
Andropogon glauca	Chalky bluestem	35.1	1
Aristida stricta	Wiregrass	7.7	2
Cliftonia monophylla	Black titi	2	3
Cyrilla racemiflora	Red titi	0.33	4
Dichanthelium sp.	Witch grass	0.16	5
Ebotrys racemosa	Swamp dog hobble	0.33	6
Lachnanthes caroliniana	Red root	16.8	7
Lyonia lucida	Fetter bush	2	8
Pinus eliottii	Slash pine	0.16	9
Rhynchospora sp.	Spikerush	0.5	10
	Bare ground	35

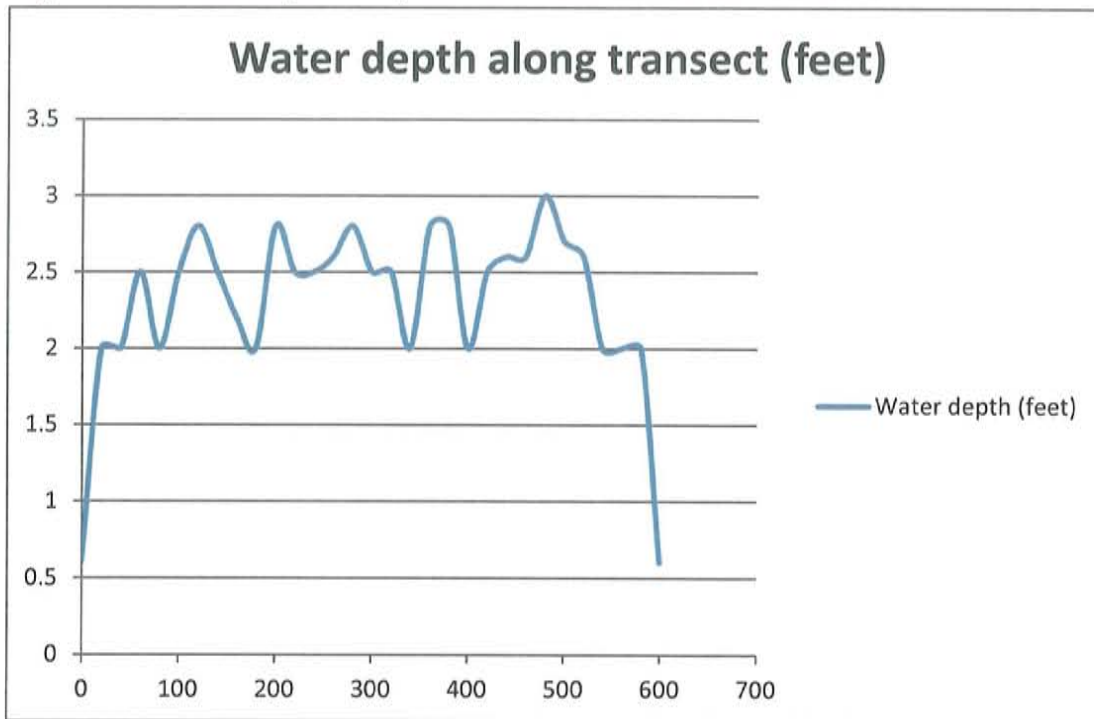
Figure 28. Water Depth at Dykes Mill Pond Across the Transect

UMAM Polygon V1, Management Unit 5 consists of 24,880 acres of a dammed slough (Dykes Mill Pond) that will be restored to slough/marsh. The overstory for most of the area is absent though a fringe of cypress remains along the ponds edge. The majority of the area is dominated by water lilies and other aquatic submerged vegetation. Reclamation activities within this polygon include the removal of Dykes Mill Pond dam, and spanning the gap with railcar bridge, planting of cypress and black gum saplings and planting the area with herbaceous and shrub species, if after 2 years, the native wetland understory is < 50%. Dykes Mill Pond was removed in August of 2006 and bridge construction completed in April 2007. With the removal of the dam there have been great changes to the pond. By September 2007 most of the pond had evaporated leaving only small flooded areas. Wet prairie vegetation has greatly spread across the newly exposed sediments and a braided stream channel has emerged across most of the previously flooded area. Sampling last year occurred from a canoe while this year I was able to walk across the entire pond.

The management activities used to restore UMAM VI, Management Unit 5 have been completed. The archeological study was completed and the dam removed in August of 2006. The new bridge was completed in April of 2007. Since the removal of the dam the pond drained during the drought and much of the dry pond area was dominated by grasses and sedges. In 2008, the water levels increased due to the end of the drought and a shallow pond formed in 2008. Water levels have stabilized 1.5-2 feet lower than when the dam was in place. Cypress trees and black gums were planted along the edges of this system in the spring of 2007/2008. The shrub areas adjacent to Dykes Mill Pond were Gyro-Trac'd in 2007. Due to increasing shrub cover in the area, selective herbicides were used to reduce shrub cover. In 2010 and 2011, the area supported a diverse herbaceous cover dominated by wetland grasses and *Rhyncospora*, and provided excellent habitat for birds, small reptiles and amphibians.
