Sand Hill Lakes Mitigation Bank
Second Annual Report
December 2007

Executive Summary

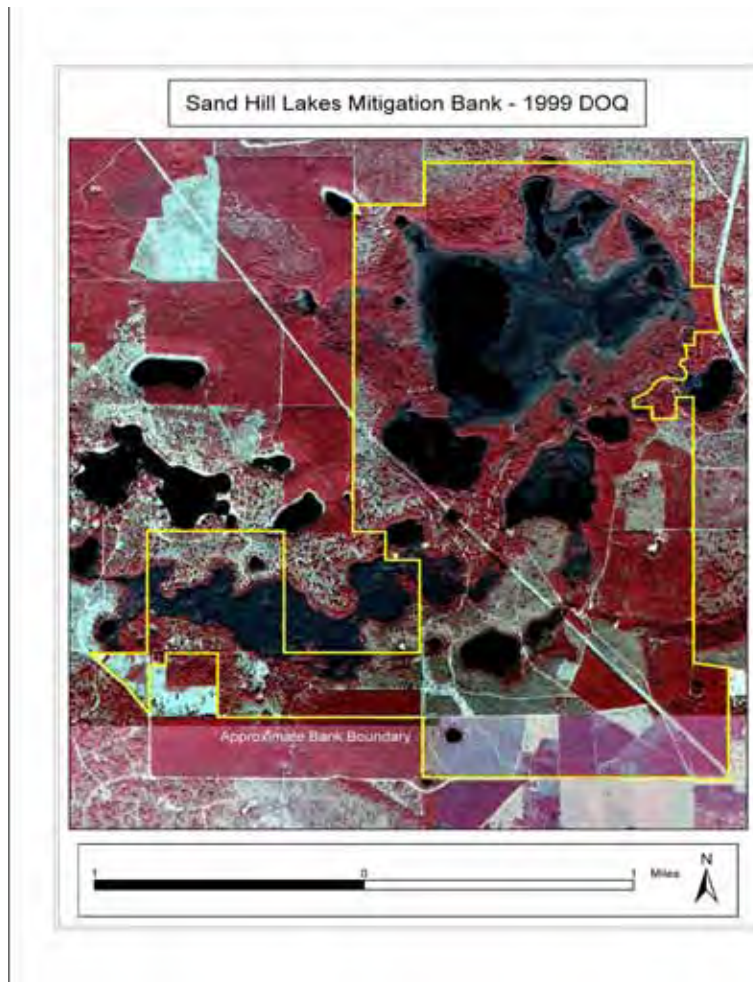
Figure 1a. SHLMB boundary map and habitats

The Sand Hill Lakes Mitigation Bank (SLMB) consists of 2,155 acres in the southern portion of Washington Co. in the Sand Hill Lakes region of the Florida Panhandle (Figure 1). It is located just west of the intersection of SR77 and SR 279, and is within Township 1 North, Range 14 & 15 West. It contains approximately 850 acres of wetlands including high quality cypress sloughs and strands, degraded hydric pine flatwoods, bayheads, seepage slopes, and approximately 155 acres of natural solution ponds and shallow, gently-sloped lakes connected by streams and ditches. The remaining 1,150 acres consist of secondary growth upland buffer communities (including high quality and degraded sand hill communities as well as sand pine plantation, slash pine plantation, and mixed hardwoods) (Figure 1a).

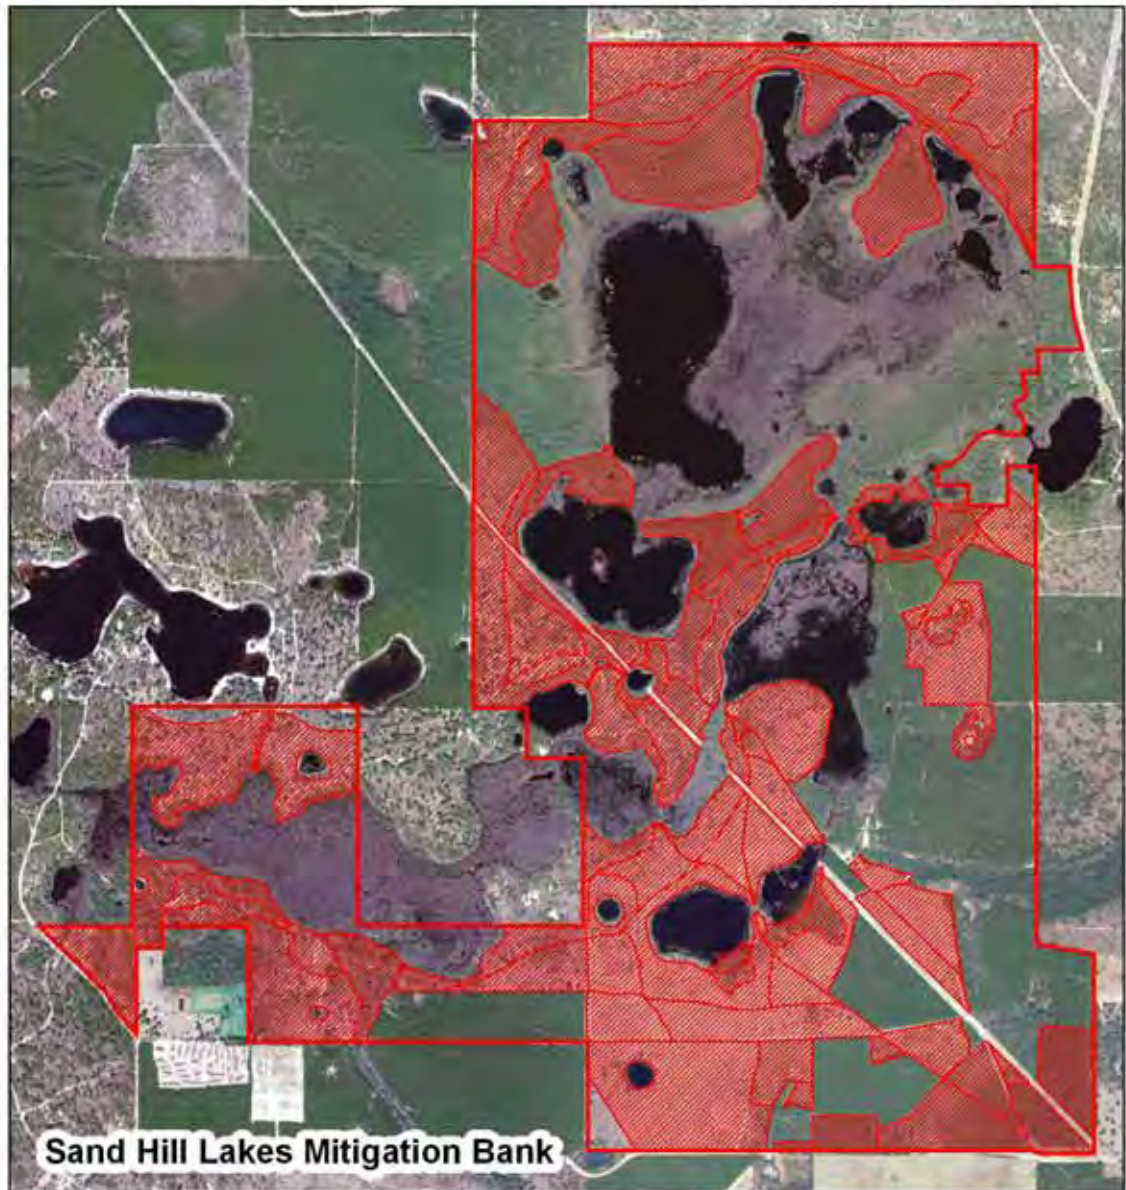
Figure 6 - Areas Burned Since Inception of Bank Through 2006

Fire was re-introduced to the SHLMB during the winter of 2004 to portions of Management Unit 11 and 12. Subsequently portions of the sand hills and hydric pine flatwoods were burned during the summer of 2005 with the remaining initial burns completed by December of 2005 in accordance with the Fire Management Plan (Figure 6). In areas with a high fuel loads such as Management Unit 2, 3, 8 and some portions of Management Unit 10 adjacent to Black pond dormant season fuel reduction fires were utilized. However in Management Unit 11 and 12 initial burns reduced fuel loads to the extent that warm season burns were conducted. Wire grass flowered in these areas following the fire and plants appeared healthy. The burns at the SHLMB have also been successful in reducing woody vegetation coverage as well as stimulating a seed bank of fire adapted species. Prior to the initiation of fire, woody goldenrod was the dominant species, but the initial fires greatly reduced the woody goldenrod cover and stimulated the wire grass.

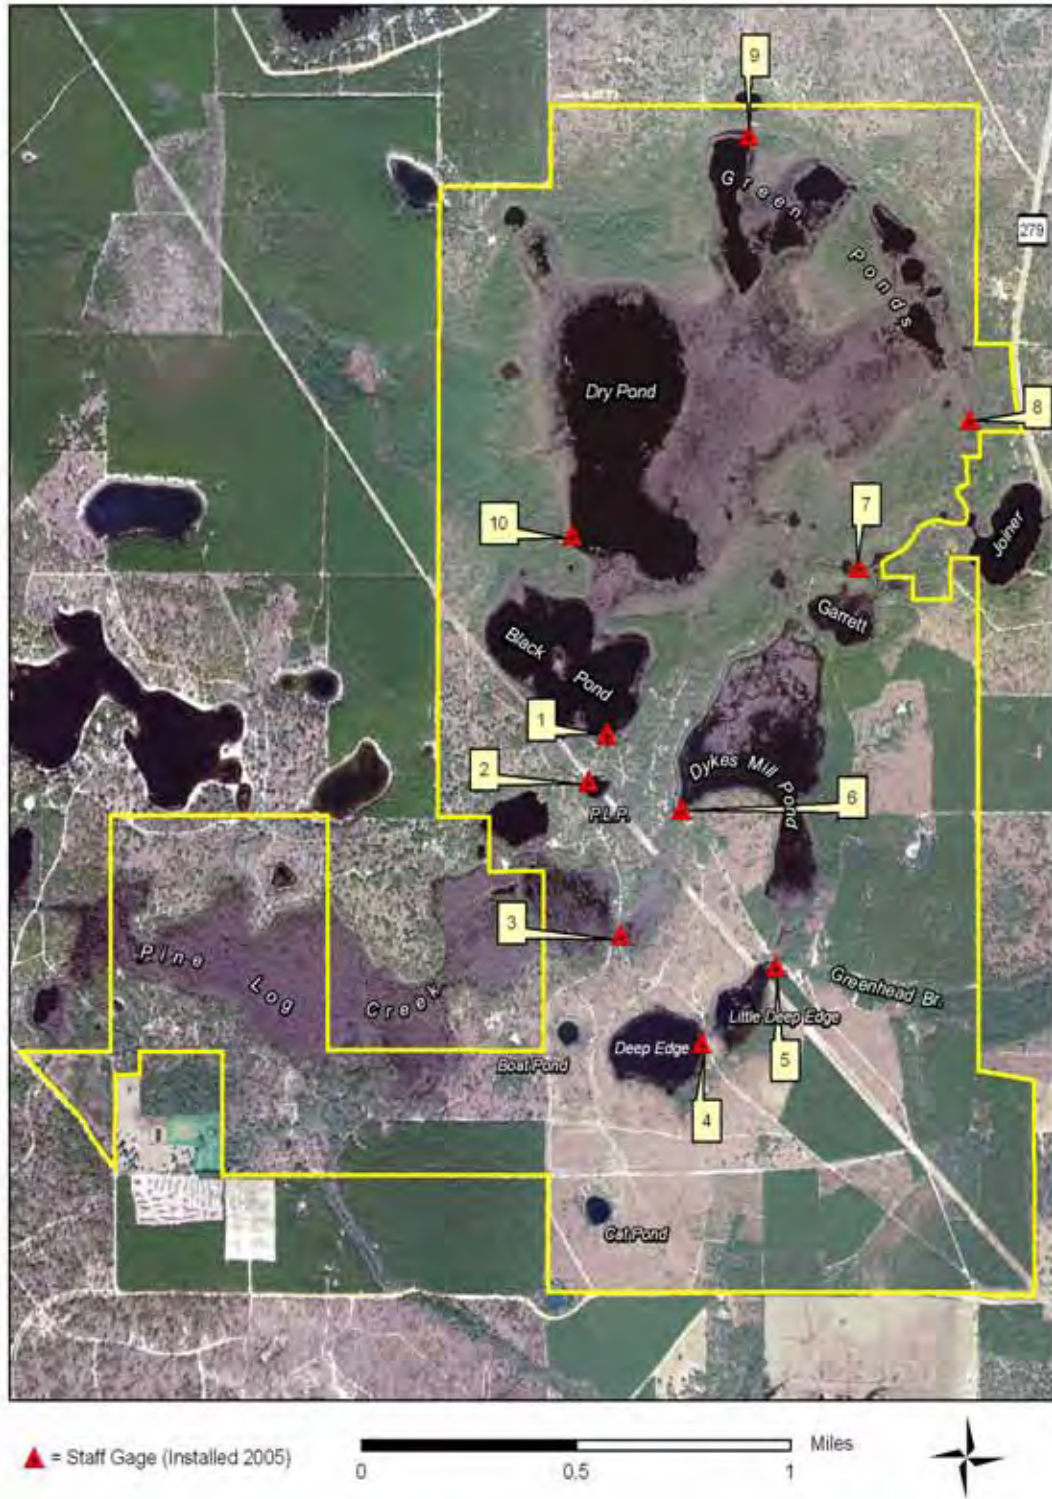
Figure 9 - Water Level Staff Gage Locations

Water levels gauges were installed and surveyed in on December of 2005 for 10 locations throughout the bank. These locations include Black Pond, Power Line Pond, Pine Log Creek, Deep Edge Pond, Little Deep Edge Pond, Dykes Mill Pond, Ditch connecting to Pine Log Creek #7, natural channel from Joiner Lake to the Green Pond, Green Ponds, and Dry Lake (Table 2, Figure 9). The gauges were read monthly by the Florida Wildlife Conservation Commission staff and the results submitted to the NFWFMD (Table 2, Figure 9). In 2006, the water levels were above the gages until April, then from May to December then water levels were below the staff gages for all but Little Deep Edge and Dykes Mill Pond. The drought continued in 2007. Water levels were below the staff gages for all the entire year for all locations except Little Deep Edge Pond and Dykes Mill Pond, and Dry Pond.

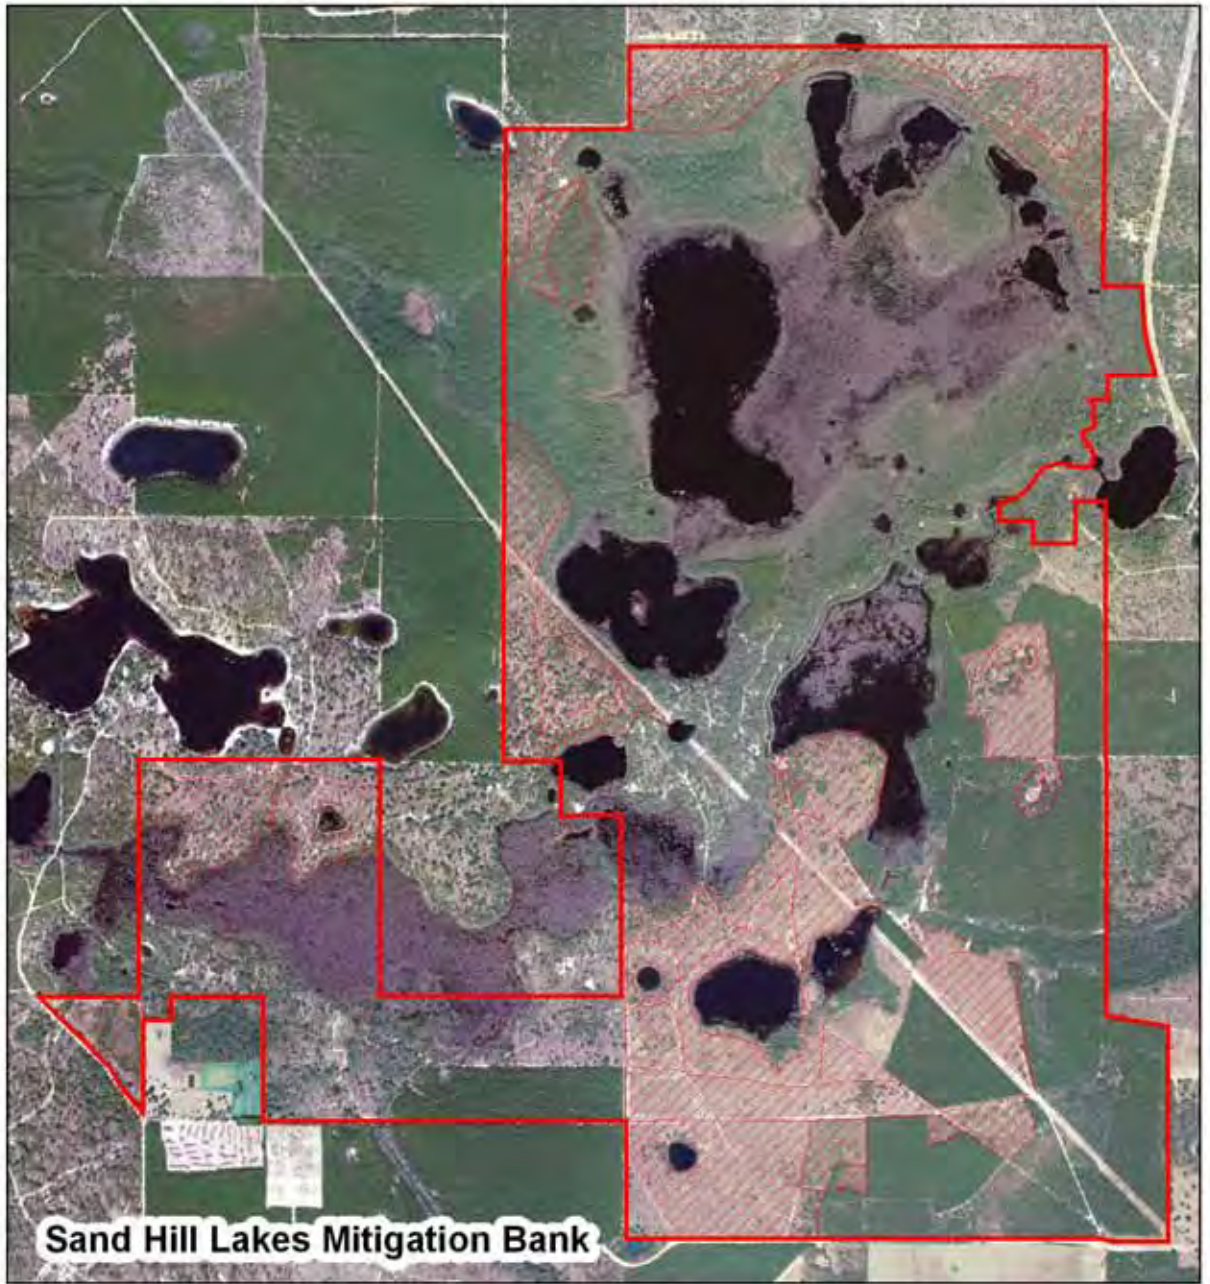
Figure 10 - Oak Removed Through 2006

Oak Removal Areas Through 2006 (550 Acres)

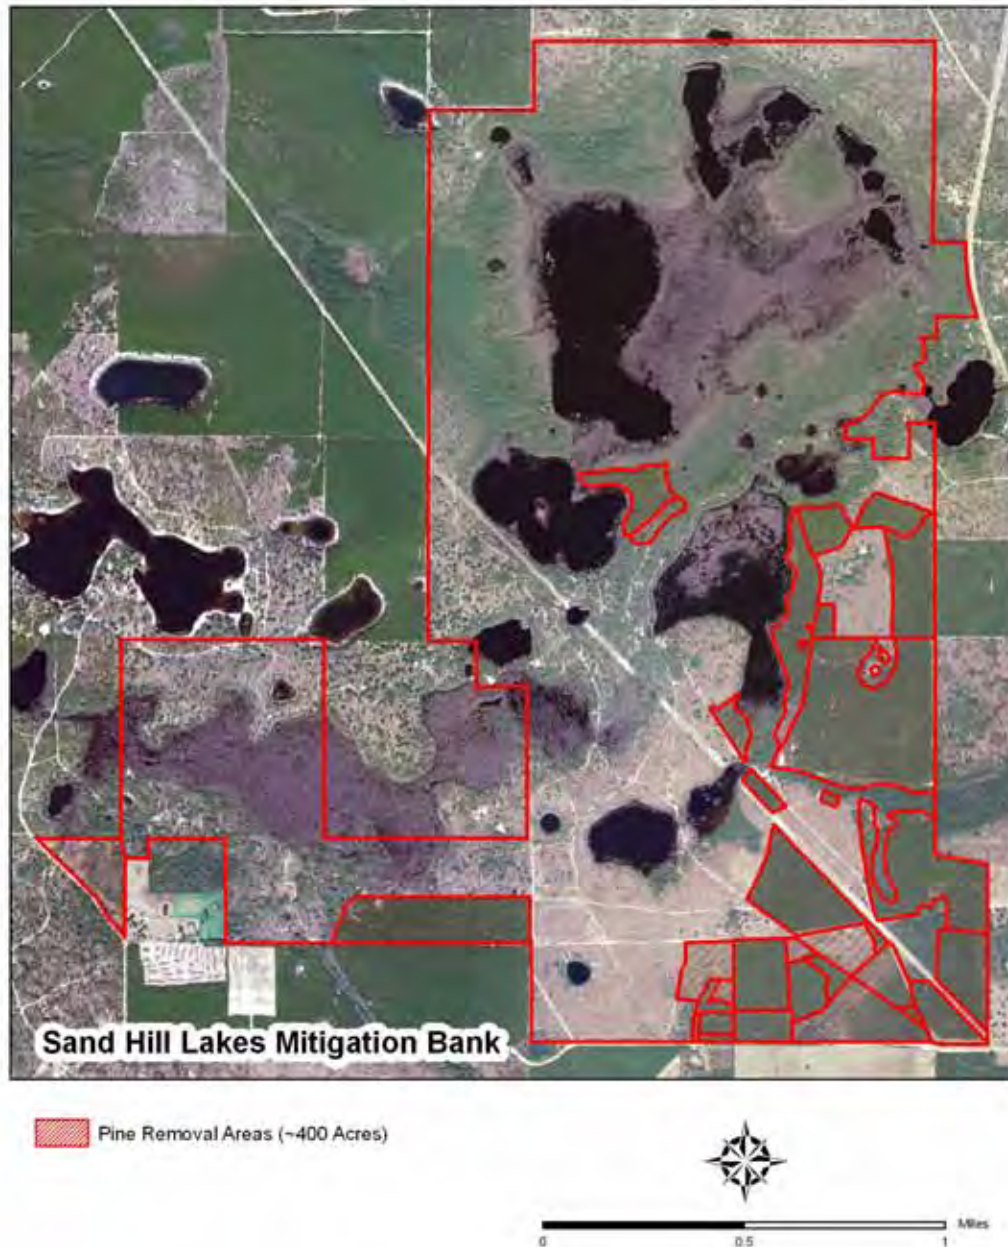
Figure 11 - Management Unit 11 Pine Removal

Restoration activities for the existing sand pine plantation (~385 acres) and slash pine plantations (11.5 acres) were initiated in 2007 (Figure 11). The sand pine and slash pine plantations harvest began on June 15 and completed in November 16, 2007. All sand pine and slash pine scheduled for removal has been completed in accordance with permit requirements. These areas will be burned in the fall of 2008 and replanted in the winter of 2008/2009 with long leaf pine and supplemental plantings of wire grass tublings if necessary.

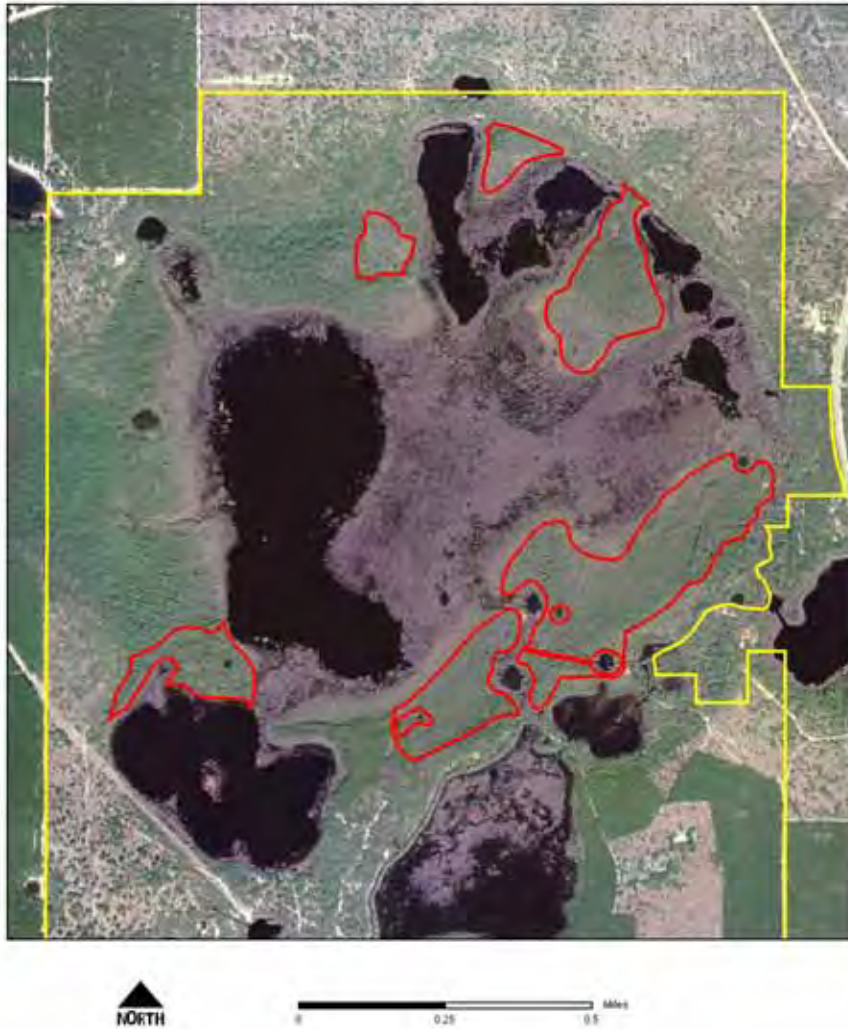
Figure 12 - Management Unit 2 Brush Reduction

gyrotract was used in Management Unit 2 to reduce the standing biomass of shrubs (Figure 12). The gyrotack work was initiated on March 13 and was completed by June 16 2007. The black titi in these areas was extremely thick often with a dbh of 8-10". Even with the large "tree" size black titi, the gyrotrack was excellent in reducing the thick dense shrub cover to mulch. There were no noticeable track marks or ruts left by the gyrtotrack. The mulch within these areas was allowed to dry for several months prior to burning. Sites were burned in December of 2007. Shrub re-sprouts were observed in all areas. During the remainder of the growing season the shrub re-sprouts reached a height of about 3 foot in height. However shrub densities were greatly reduced, open ground was observed, and herbaceous species re-sprouted from the seedbank.

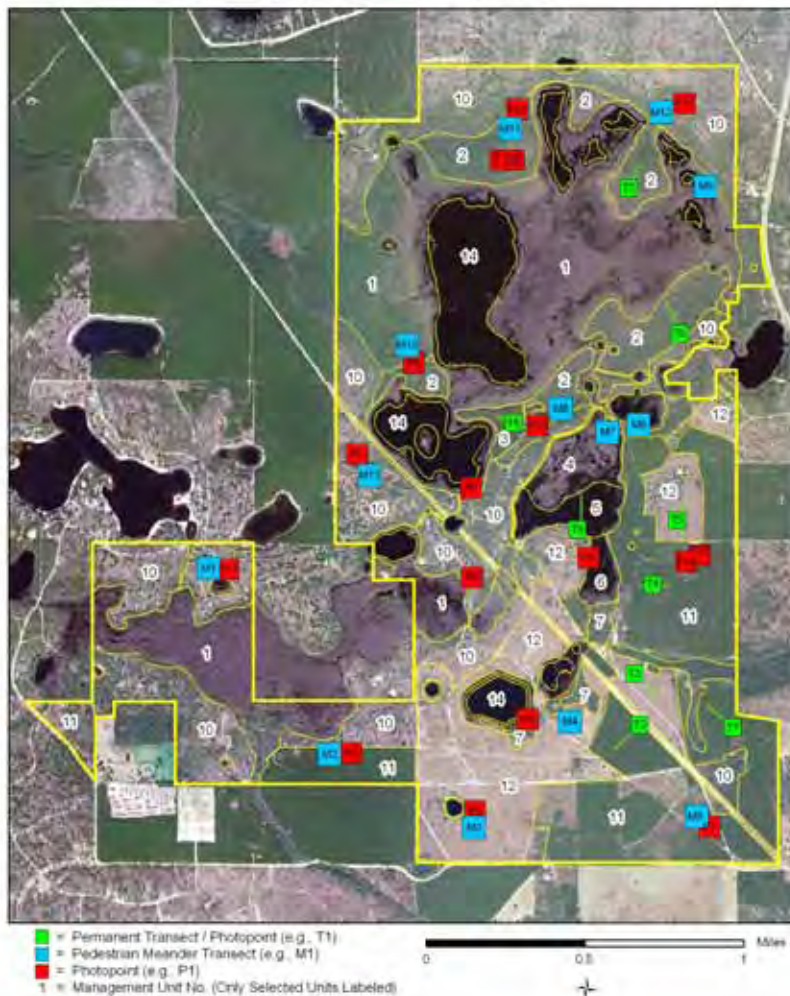
Figure 13 - Monitoring Locations

In accordance with Specific Condition 26, all sampling locations have been identified (Figure 13). Fall monitoring methods as well as data analysis are described below. Sampling for the annual report was conducted on November 6-9, 15 and 16 2007. Raw data sheet, computational analysis, pedestrian surveys and photographic documentation are included in Appendix 2, 3 and 4. Oblique aerals were taken for the SHLMB on October 30, 2007 and have been included in Appendix 5.

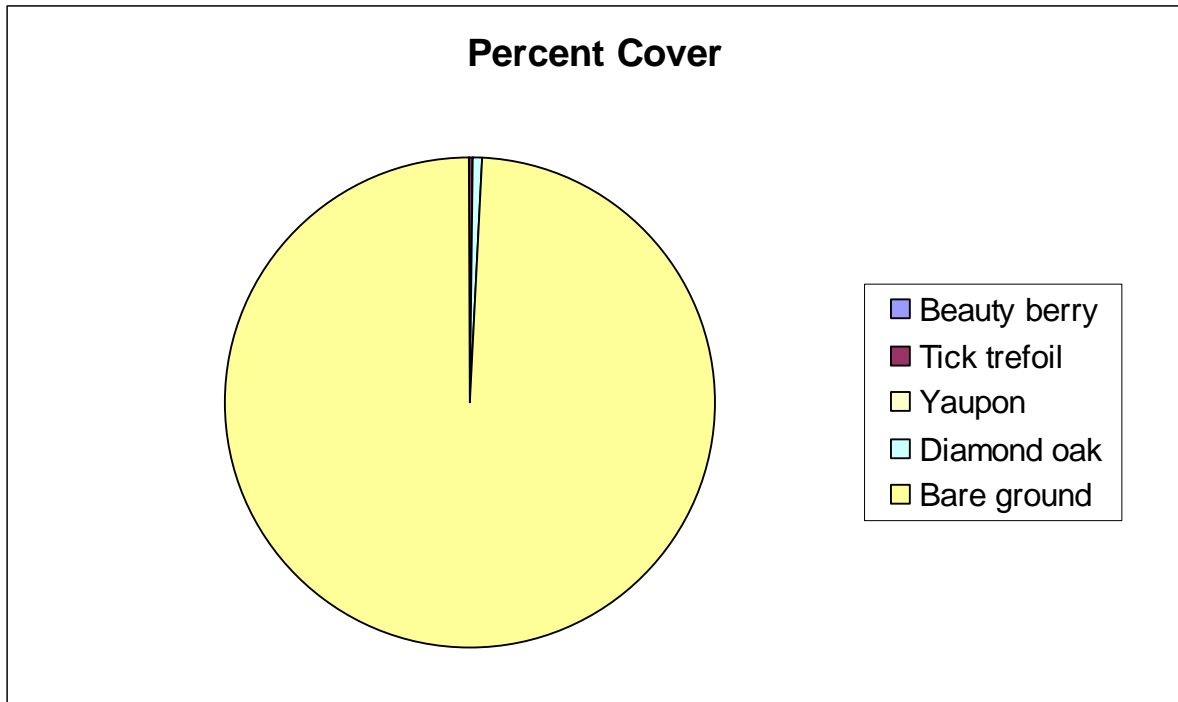
Figure 14. Transect 1. Percent Cover and occurrence (Sand Pine Plantation)

In 2007, the pine canopy was harvested drastically increasing light levels reaching the ground layer. A total of 4 species were observed in transect 1, 15 in transect 2 and 22 in transect 4 (Tables 3-5, Figures 14-16). The reduction in the number of species observed in Transect 1 may be due to a combination of mechanical removal and recent pine harvest whereas other transect were harvested months earlier and had longer to re-vegetate. Wire grass was again only observed along Transect 2, but with 2.6% cover was the dominant species within that transect. The cover is reduced from the 5.5% cover observed in 2006, but this may be due to allot of mechanical damage that occurred during the pine harvest. The dominant cover class was again bare ground ranging from 68.5 to 99.29%. The reduction in bare ground from transect 4, may be due to the pines being removed earlier allowing longer for the sandhill community to recover. Bahia grass and centipede grass were observed in Transect 4 in 2007, but centipede grass was observed in Transects 1 and 4 in 2006. Similarly the cover of Bahia grass was slightly reduced in 2007, while the cover of centipede grass increased by about 5%. This may be due to increased light reaching the herbaceous layer. It is expected that the cover of centipede grass will be reduced during the site preparation burns. No wildlife or tracks were observed within these transects, probably due to the lack of vegetation.

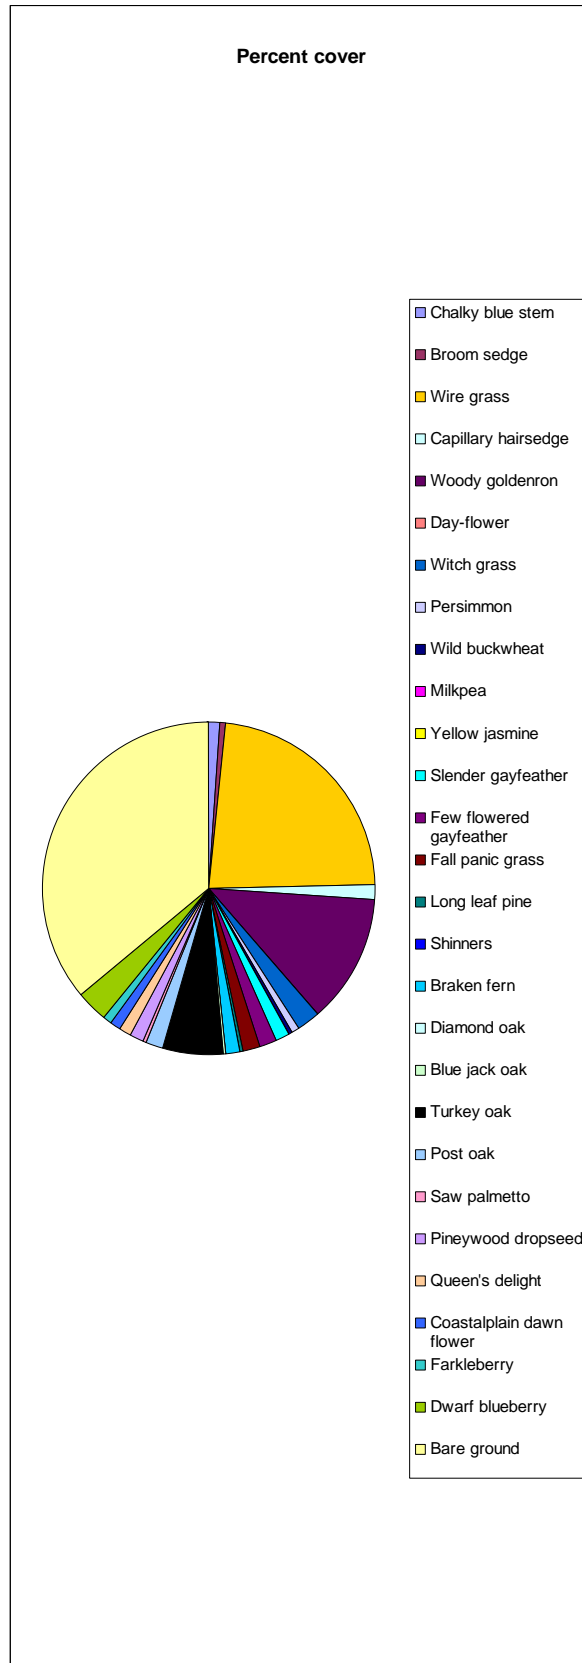
Figure 17. Transect 3: Species Cover and Occurrence (Sand Hill)

In 2007, a total of 27 species were observed in transect 3 and 32 species in transect 5 slightly higher than last year. A diverse understory of sand hill vegetation was observed again this year and no nuisance or exotic species were observed (Table 6, 7, Figure 16 and 17). The greatest cover class again was bareground with 36.1% cover for transect 3 and 37% for transect 5. The amount of bareground for each transect was greatly reduced and may be due to the re-introduction of fire. Wire grass was again the dominant vegetative species for both transects with 23% for transect 3 and 35.6% cover for transect 5. Wire grass cover was slightly less for transect 3 but cover was significantly increased for transect 5. A total of 18 species were common to both transects and included bushy blue stem, broomsedge, wire grass, woody goldenrod, witch grass, persimmon, buckwheat, milkpea, slender shooting star, few flowered shooting star, panicum, shiners, bracken fern, bluejack oak, turkey oak, queens delight and shiny blueberry.

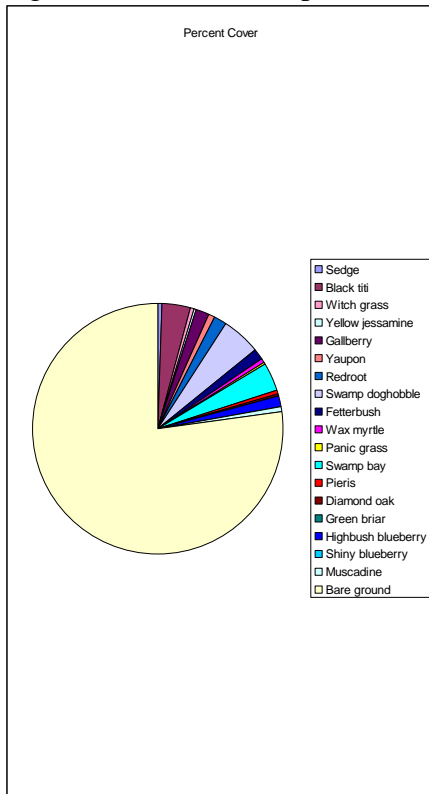
Figure 19. Transect 8 Species and Occurrence

In 2007, a total of 18 species were observed, similar to baseline observations. The majority of the species were common to wet flatwoods. No nuisance or exotic species cover was observed. The greatest cover class was again bare ground with 77.3 percent cover. The slight increase in vegetative cover may be due to increased light reaching the understory since the dense pine canopy has been thinned. Swamp dog hobble had the greatest percent vegetative, each with 5 percent. Black titi cover was reduced from 6.5 % to 3.7%. This represents a reduction in black titi cover from the baseline observations. Overall shrub coverage within this polygon slightly increased from 12% in 2006 to 13.4% in 2007 and herbaceous cover has increased from last year. Wildlife observations included a blue jay, towhee, and cardinal.

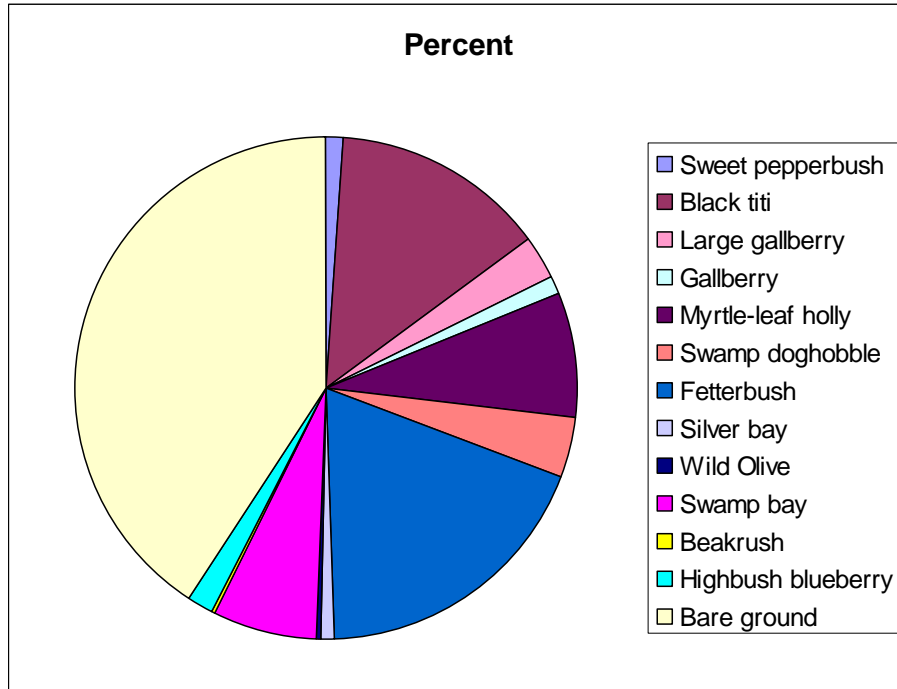
Figure 20. Transect 6: Species Cover and Occurrence (Hydric Pine Flatwoods)

In 2007, a total of 12 species were observed within transect 6 and 9 in transect 7. Transect 6 had a similar species composition to the baseline while transect 7 had significantly fewer species observed probably due to the gyrotrack. Seven species were common to both sites, and all were shrubs. Both sites were dominated by 3-3.5' shrubs though each had an herbaceous component. While this did not represent significant cover in transect 6, 3.7% cover in transect 7 was red root, and early colonizing wetland species. The greatest cover class for both transects was bare ground with 40.8% for transect 6 and 48.2% cover for transect 7. This represents a significant shift in cover from black titi to bare ground due to the gyrotrack. Black titi cover was also greatly reduced from nearly 70% to 14% in transect 6 and from 31.77% to 28.1% cover in transect 7. The relative minor decrease in black titi cover in transect 7 may be the result of the intense warm season fire in 2006. Fetterbush was the dominant species by cover in transect 6 while black titi remained the

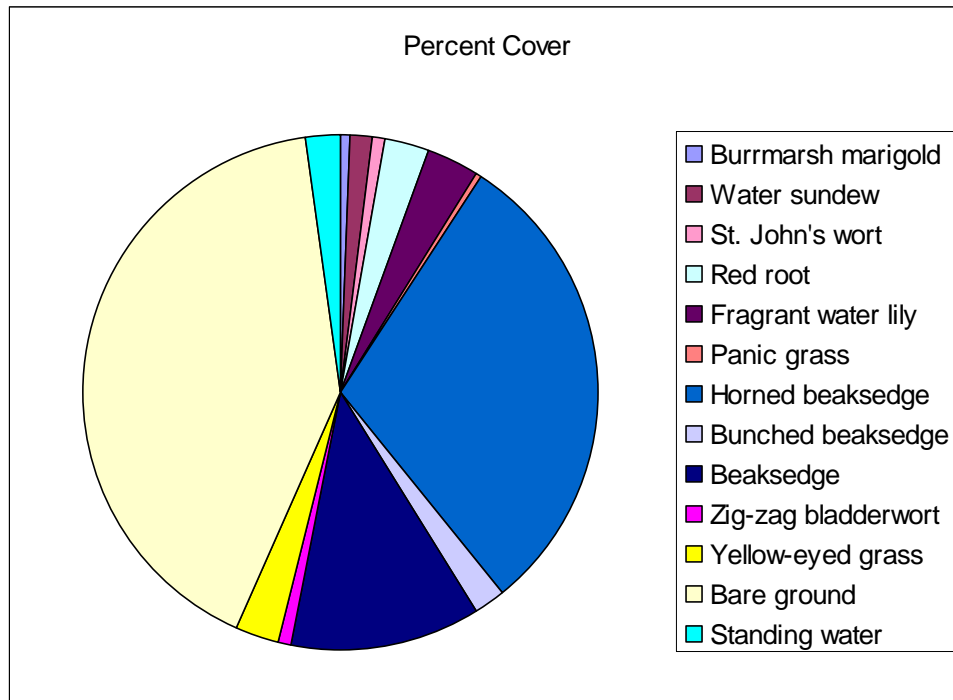
Figure 22. Transect 9. Species and Occurrence

In 2007, a total of 11 species were observed within transect 9. Species were common to wet prairies with some minor freshwater marsh species. This represents a major

shift in species composition and reflects the shift from an aquatic to wet prairie. No exotic species were observed. Fragrant water lily cover was greatly reduced from 45% in 2006 to 3.23% cover in 2007. Florida yellow bladderwort was not observed within the transect and open water was also greatly reduced from 34% cover to 2.2 % cover. Another significant occurrence was the cover of bare ground which did not exist in 2006, but represented 41% of the cover in 2007. The two dominant plant species were horned beaksedge with 30% cover and a beaksedge that was not in flower with 12% cover, both species common to wet soils and not tolerant of aquatic systems. A species of note, *Drosera intermedia* (Water Sundew) a state threatened species was commonly observed. Wildlife observations included a pair of sandhill cranes (State Threatened species), fresh hog tracks, little blue heron, great egret, and chipping sparrows.
