Lafayette Creek – Fourth Annual Monitoring Report 2009
CORPS Permit No. SAJ-2001-1118 (IP-DEB) Issued 2/4/05
Walton County

Impact: US 331 Freeport Re-alignment; 8.63 Acre impact
Monitoring date: October 30, 2009

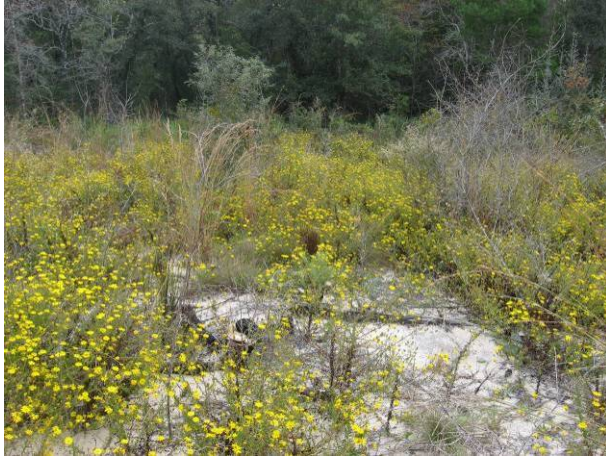
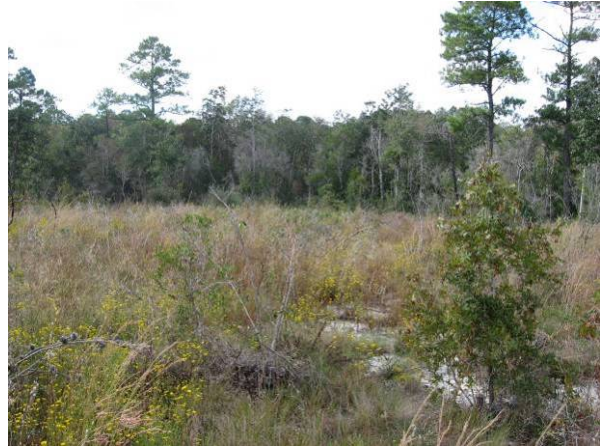
- The sandhill adjacent to the upper ravine has some patchy Bahia grass cover, remaining from before acquisition when the area was an abandoned sod farm. **Herbicide treatments have helped reduce the Bahia grass cover and additional treatments are planned for Spring and Summer 2010. One small, less than 0.25 acre, patch of Cogon grass remains. It was treated again in 2009 and will be treated in 2010.**

Figures 3 (1) & 4 (6). Sandhill adjacent to upper ravine (Former Bahia grass pasture)

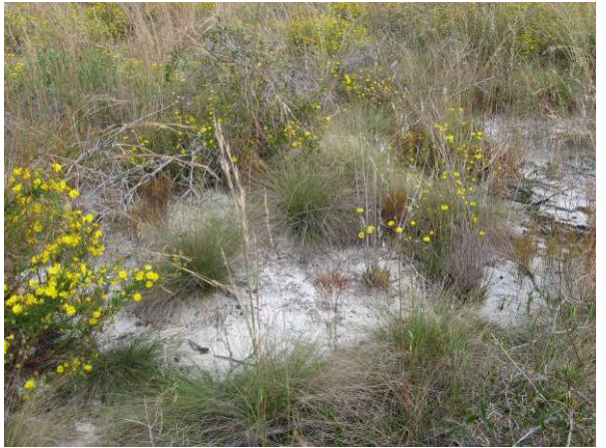
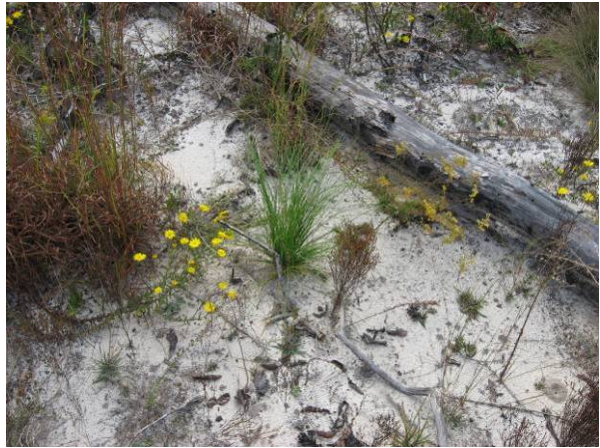
Figures 5 (7) & 6 (8). Upland sandhill, thinned, burned, seeded with wire grass and planted with longleaf pine seedlings (Adjacent to upper ravine).

<p>C: All construction areas for stabilization and re-vegetation, structure, operation, and integrity;</p> <p>N/A</p>	
<p>D: Representative polygons for each UMAM community for fuel load, exotic or nuisance species, planted material survival, groundcover, and shrub condition.</p> <ul style="list-style-type: none"> -fuel load minimal -no exotic/invasive/nuisance noted -wiregrass plugs doing well; excellent survivorship and growth -shrubs defoliated mostly -minimal coverage of oaks -approximately 80% groundcover by desirable grasses and herbs -very few longleaf pine seedlings noted; very poor survivorship -many dead <i>Smilax</i> spp. vines

Vegetation Assessment Field Form Qualitative Assessment: Lafayette Creek	
Project: Date:	
Name(s) of Data Collectors: Brandon Tidwell	Weather:
Environmental Description: Photo #'s	
Polygon: GPS Location: Time:	
Nuisance Species: Fuel Load:	
Wildlife Observations: Deer and small mammal tracks. Numerous passerines/songbirds noted. Water depth: N/A Is the community observed along the walk path representative of the community being measured? Yes To what degree is the restoration in this area trending towards success? Wire grass plugs doing very well, very few longleaf pine seedlings noted, oaks well-thinned, Bahia grass <5% cover, overall doing well and trending towards success criteria. Potential Problems and solutions: Suggest replanting of longleaf

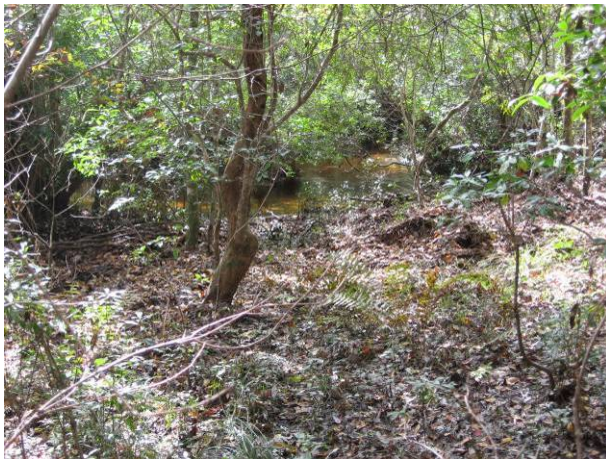
Figure 7 (3). Lafayette Creek stream

<p>C: All construction areas for stabilization and re-vegetation, structure, operation, and integrity; N/A</p>	
<p>D: Representative polygons for each UMAM community for fuel load, exotic or nuisance species, planted material survival, groundcover, and shrub condition.</p> <p>-fuel load low to moderate -relatively open shrub stratum -no exotic/nuisance/invasives noted -overall, community appears healthy and is appropriately diverse and stratified</p>

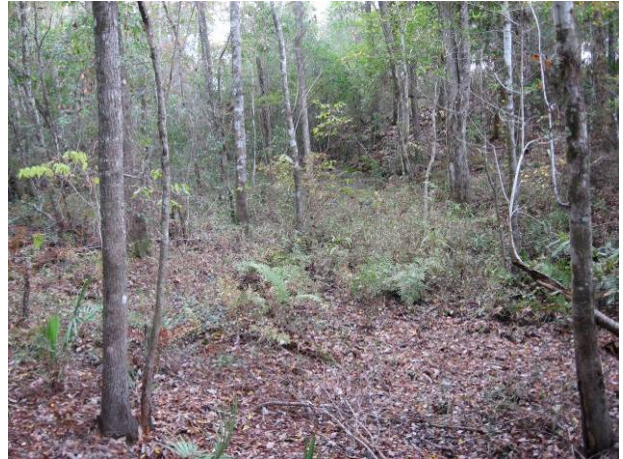
Figure 8 (4). Lafayette Creek floodplain
